LONG ISLAND LIGHTING COMPANY

(Shoreham Nuclear Power Plant,
Unit 1).

SUFFOLK COUNTY'S EXHIBITS TO JOINT DIRECT TESTIMONY

DESIGN REVIEW OF TDI R-4 AND RV-4 SERIES
EMERGENCY DIESEL GENERATOR CYLINDER BLOCKS AND LINERS

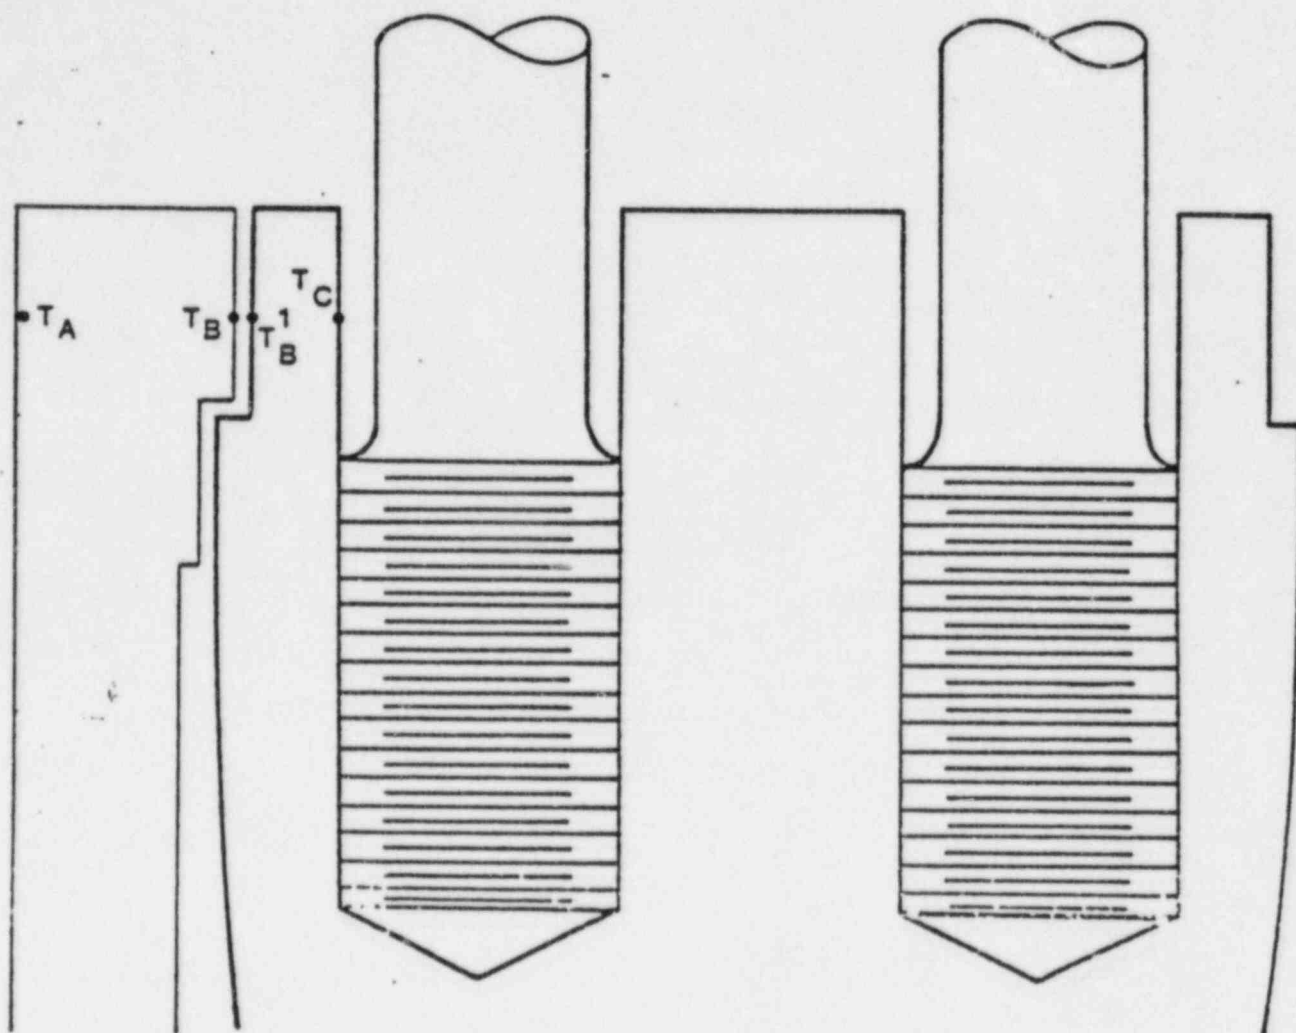
Figure 2-1. Location of T_A , T_B , T_B^1 , T_C .

The liner and block top have a thermal gradient from the cylinder bore to the centerline between adjacent cylinders, such that $T_A > T_B > T_B^1 > T_C$ in Figure 2-1. The liner and block both expand radially from the cylinder centerline as the temperatures rise, creating thermal stresses. Because of the thermal gradient, the liner expands more than the block, closing the liner-to-block clearance gap and adding interference stresses. The combined effect is a radial stress in the block top that is resisted by circumferential tension. The effect of the stud holes is to make the stresses non-uniform in the circumferential direction, with circumferential tension near the stud holes and compression midway between adjacent stud holes for the same cylinder.

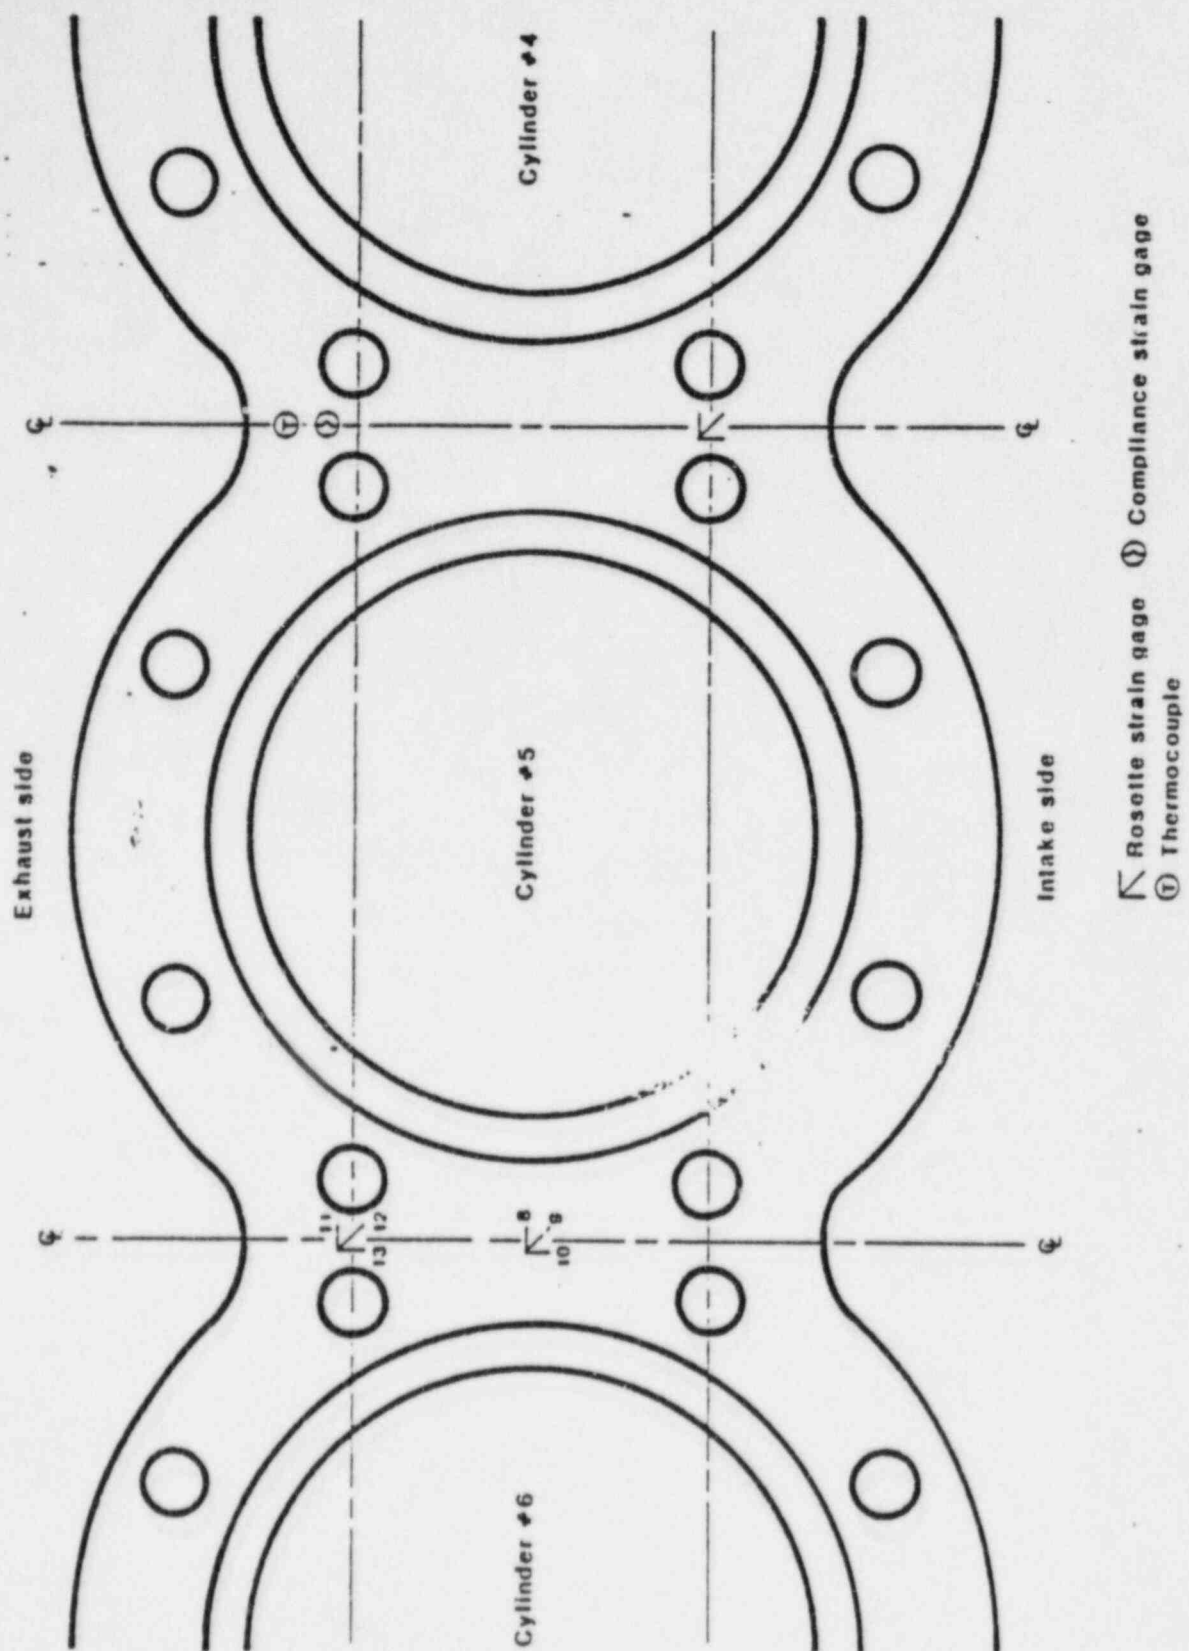
Figure 3-1. Strain gage placement.

After the 100 hour full power endurance test run on SNPS DG103, a cylinder block strain gage test was conducted by FaAA. The test included strain measurements at three locations: midway between Cylinder Nos. 4 and 6, on the centerline between the adjacent exhaust side cylinder head studs; between Cylinder Nos. 5 and 6 at the intersection of the longitudinal and transverse centerlines between the cylinders; and at Cylinder No. 1 between the No. 3 cylinder stud and the edge of the engine. The location and nomenclature for the three gages are shown on Figures 3-1 and 3-2.

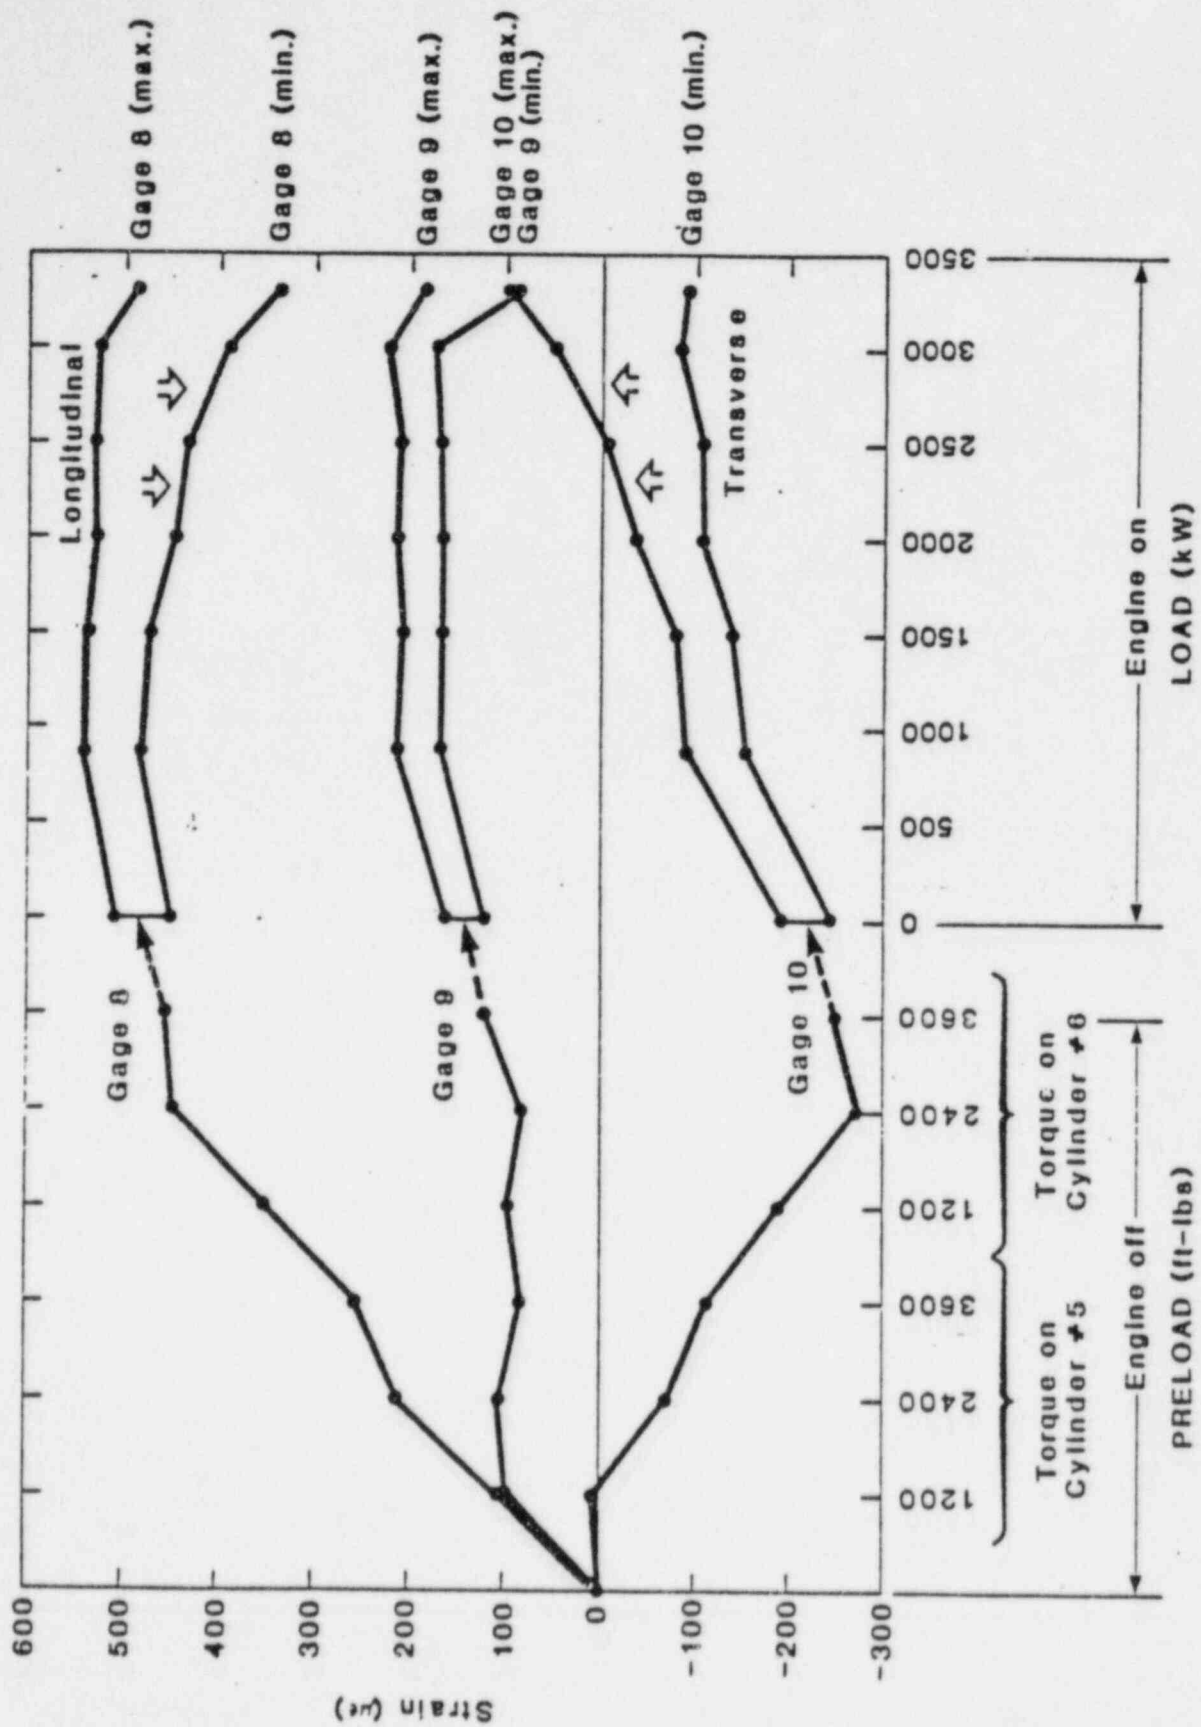
Figure 3-3. Strain vs. Load for Gages 8, 9 and 10 (located on engine centerline).

Figures 3-3 and 3-4 depict the strain components for each gage during preload and operation. The band of data at operational loads depicts the range of the signal from each gage in the rosette for Gage Nos. 8 through 13. The arrows represent the direction of the strain during firing. This data was reduced to principal stresses as shown in Figures 3-5 and 3-6 for Gage Nos. 8 through 13. The maximum principal stresses were approximately parallel to Gage Nos. 8 and 13. The key stresses for stud-to-stud crack initiation and propagation are those measured by Gage No. 13.

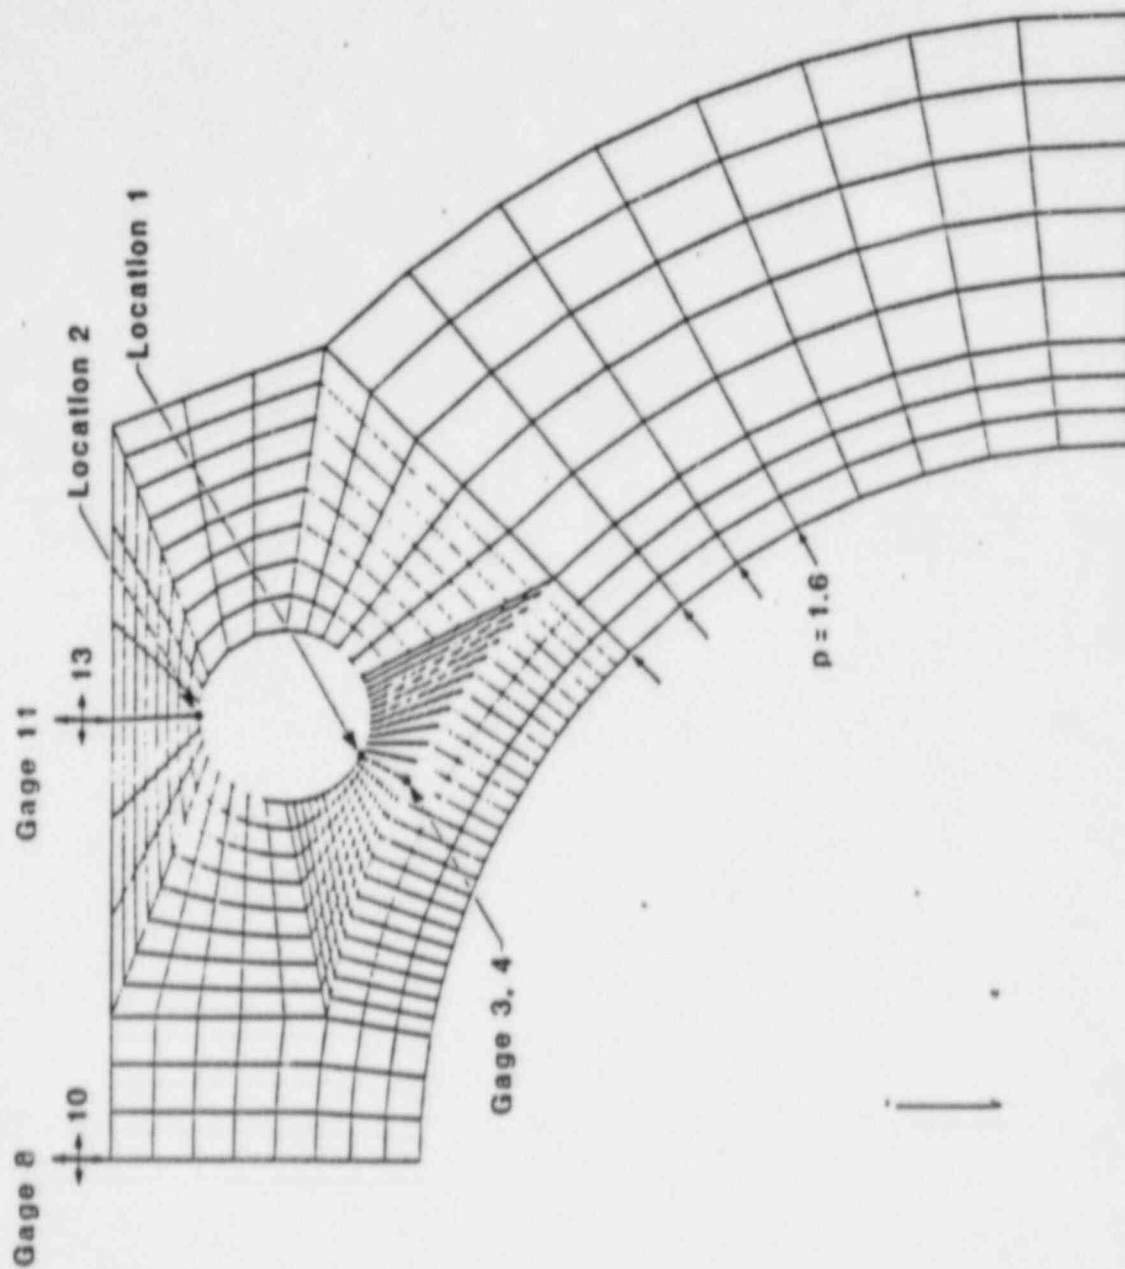
Figure 3-8. Block top model with internal pressure equal to 1.6 ksi.

A qualitative understanding of the effects of pressure, liner temperature, and assembly clearance on stresses at the stud hole counterbores has been obtained from a 2-D finite element model of a quarter section of the block top. The finite element model, shown in Figure 3-8, represents the block top and liner between the engine centerline and the midplane between adjacent cylinders. The liner is assumed to have expanded due to thermal stresses such that the gap is closed. The inner boundary of the liner was subjected to uniform pressure loading, and the symmetrical boundaries were restrained against rotations and displacements normal to the boundaries. Two sets of boundary conditions were analyzed, symmetric (both adjacent cylinders have internal pressure) and antisymmetric (one has pressure, the other zero pressure). Both thermal and pressure effects could be analyzed by combinations of these two cases. The model neglected the 3-D effects of the web between the cylinders and the cylinder head stud bosses beneath the block deck. Forces and deflections out of the plane of the block top were not included in this analysis.

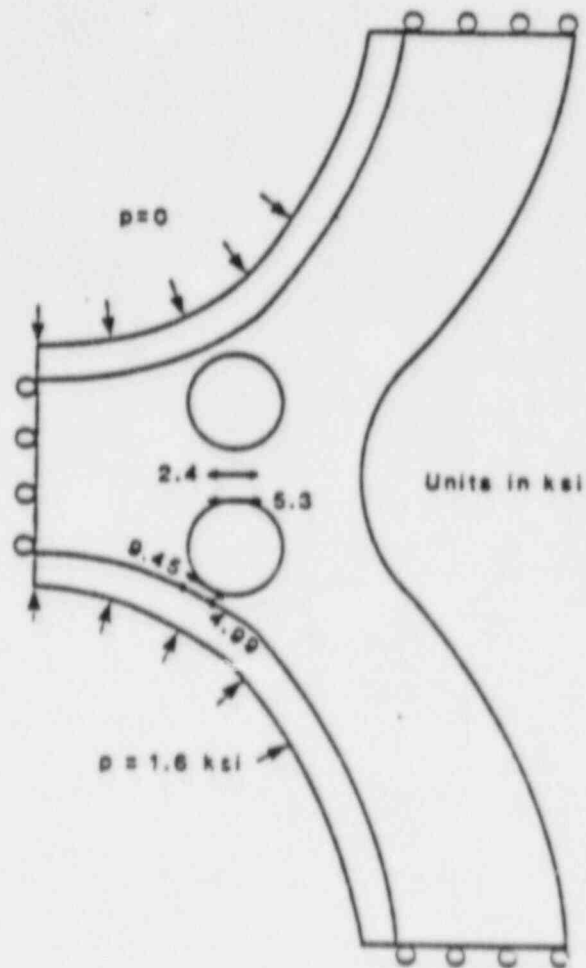
Figure 3-9. Effect of one cylinder firing.

This model was used directly to analyze the stresses in the ligament resulting from firing pressure in one cylinder, given appropriate clearances such that the liner-to-block gap is closed by thermal expansion. The results are shown in Figure 3-9 and Table 3-2. Reasonably good agreement with the pressure stress at full load at TDI Gage No. 4 is apparent in Table 3-2. The experimental pressure stress at Location 1 was scaled up from TDI Gage No. 4 using the stresses at the corresponding locations, i.e., $6.3 \text{ ksi} = 3.3 (9.5/5)$, and the result is in reasonable agreement with the analysis at full load.

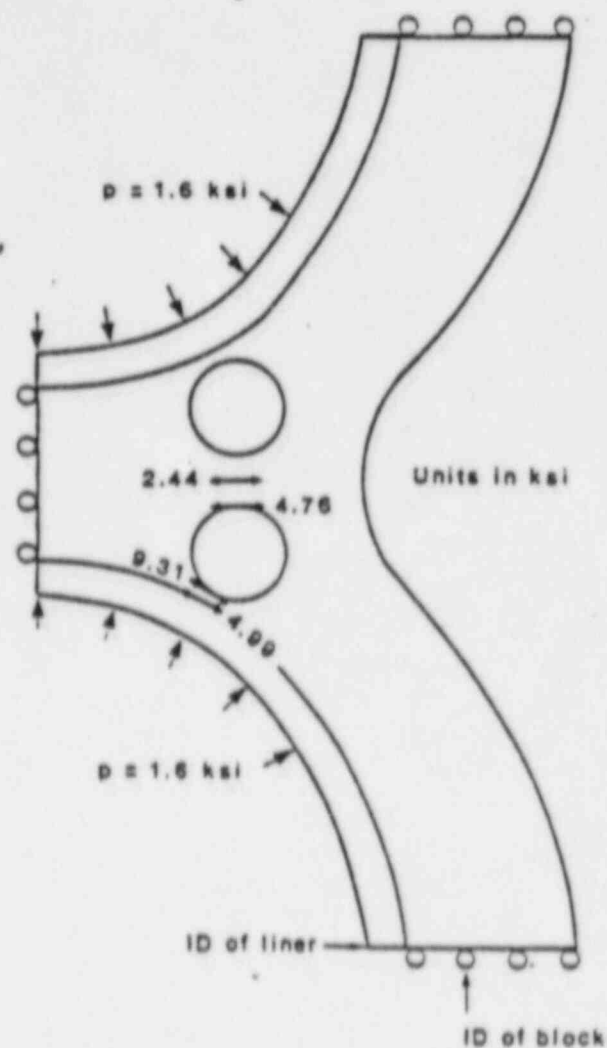
Figure 3-10. Block-top model (2-D) with liner subjected to internal pressure $p = 1.6$ ksi in adjacent cylinders.

The model was also used to obtain the ratio of stresses in the ligament resulting from thermal expansion, using symmetric boundary conditions as in Figure 3-10. The thermal stresses are symmetric between cylinders because both cylinders heat up, analogous to both cylinders firing at once. All thermal stresses are assumed to act radially in the plane of the block top.

Under this assumption, Figure 3-10 can be used to scale the thermal stress from the Gage No. 13 reading to the ligament Location 1. However, Gage No. 13 corresponds to a cracked ligament, so it is necessary to scale the reading to reflect an uncracked ligament. For this computation the thermal stress is taken to be σ_{\min} minus σ_{preload} . The result is 14.9 ksi = 9.7 (9.31/6.06) at 100% load.

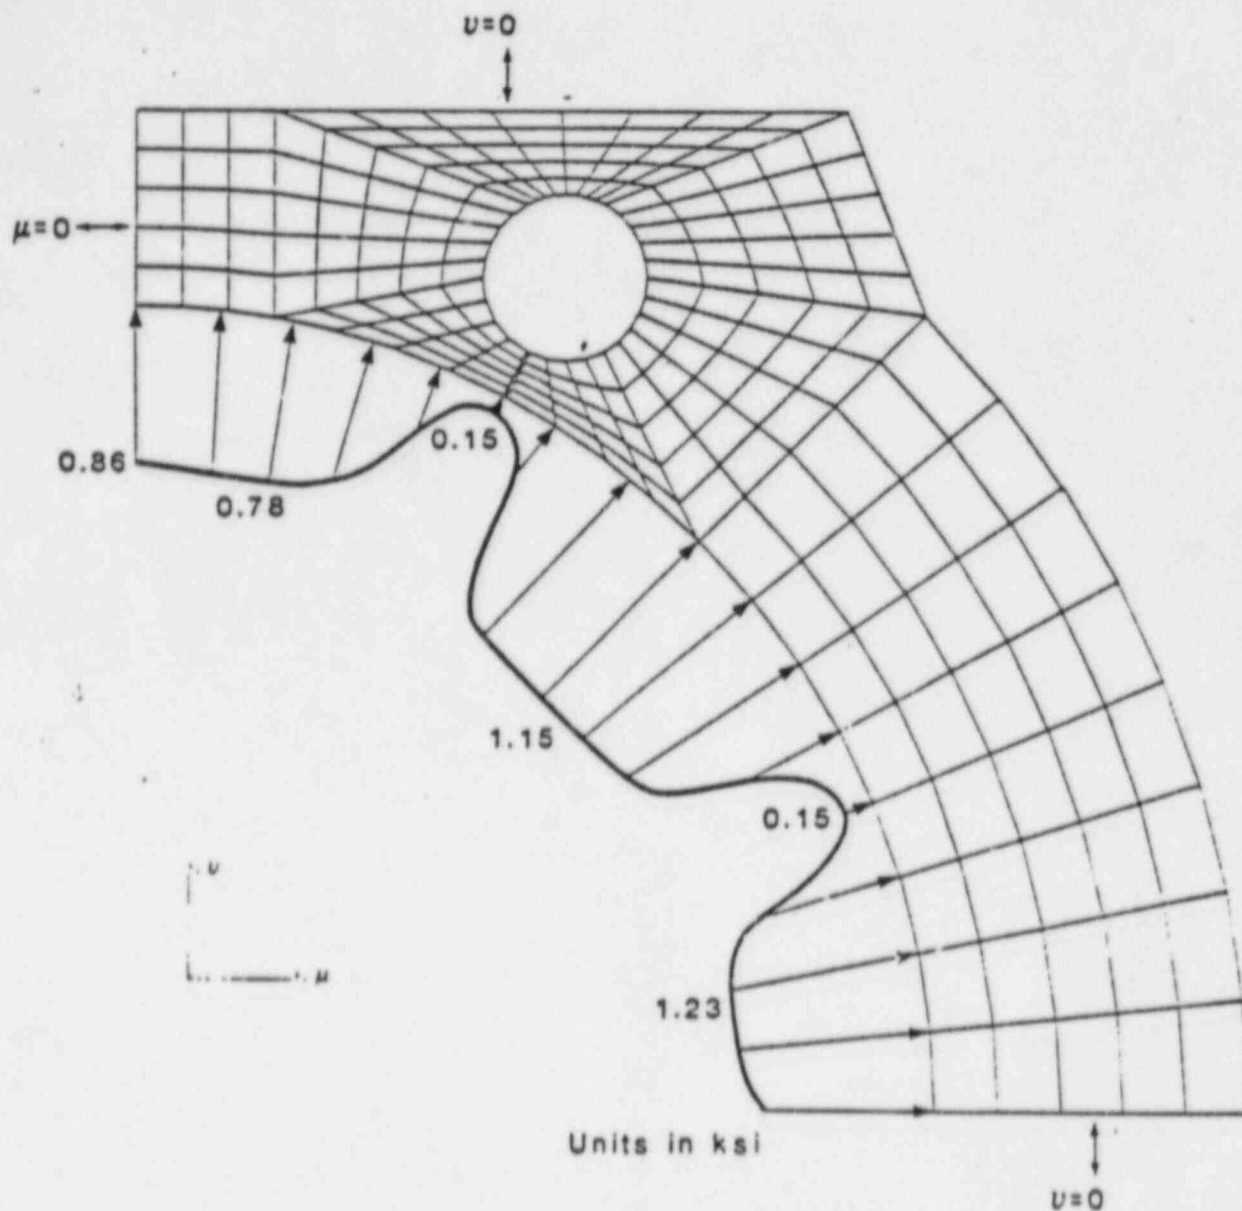
Figure 3-11. Cracked ligament block model with radial stress distribution due to liner under uniform pressure.

The third application of the model was to determine the radial stress distribution on the inside surface of the block resulting from a uniform pressure on the inside surface of the liner. This distribution is not uniform around the circumference, as shown by Figure 3-11, where the distribution is superimposed on the cracked ligament model discussed below. The ligament will not support as much radial stress as the surrounding regions; rather, it bends away from the liner, which must therefore carry higher stress locally.

Once a ligament crack is present, the transverse stress between the stud holes increases by a factor of 2. This is shown (for pressure stresses) by the model shown in Figure 3-11, where the radial stress distribution was determined from the stress at the liner/block interface in the uncracked model. The results are shown in Table 3-2 and Figure 3-12, which may be compared with Figure 3-9 at Location 2 and Gage No. 13. The stress at Location 2 is obtained by scaling the gage reading, i.e., 6.6 ksi = 3.7 (10.85/6.06) at 100% load.

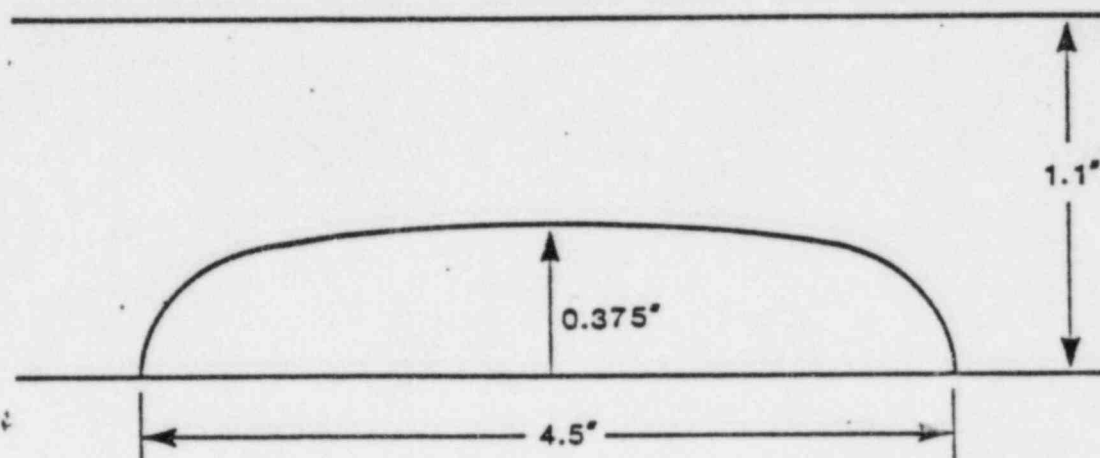
Figure 4-2. Cam gallery crack shape.

An inspection of the emergency diesel generators at Shoreham revealed crack indications in the cam galleries of all three SNPS engines. These indications were of varying lengths, the longest being 4 1/2 inches long and 0.375 inch deep in DG103. A typical cross-section of the cam gallery is displayed in Figure 4-2, indicating the crack region. TDI installed strain gages on an experimental engine (DSR-46) at the locations of the crack-like defects and recorded the dynamic strains in a running engine. The strain gage data were reduced by TDI to obtain the mean and alternating stresses [4-7]. These stresses are reproduced here in Table 4-2. For the present analysis, stresses obtained at the Gage No. 1 location at 100% load were used.

crack growth rate of the defect shown in Figure 4-2. The following conventional expression of material fatigue crack growth was used in conjunction with the cyclic and mean stress in the block to compute the fatigue crack growth rate of:
