JOB NO. 7597-03	ACCESSION NO.
UNIT 1	U-400932
TITLE ENVIRONMENTAL QUALIFICATION TEST REPORT OF RAYCHEM NUCLEAR CABLE BREAKOUT AND END SEALING KITS	
JOB: JOSEPH M. FARLEY NUCLEAR PLANT ALABAMA POWER CO.	
Supplier: RAYCHEM CORPORATION (071508)	P.O. APCO Req. APCO PCN No. (If Applic.) B-87-0-4475

Environmental Qualification Test Report
of
Raychem Nuclear Cable Breakout and End Sealing Kits
for
Raychem Corporation
Menlo Park, California

REPORT NO. 58442-2
OUR JOB NO. NDQ 58442
CONTRACT ---
YOUR P. O. NO. A01183

ENVIRONMENTAL QUALIFICATION TEST REPORT
OF
RAYCHEM NUCLEAR CABLE BREAKOUT AND END SEALING KITS
FOR
RAYCHEM CORPORATION
MENLO PARK, CALIFORNIA

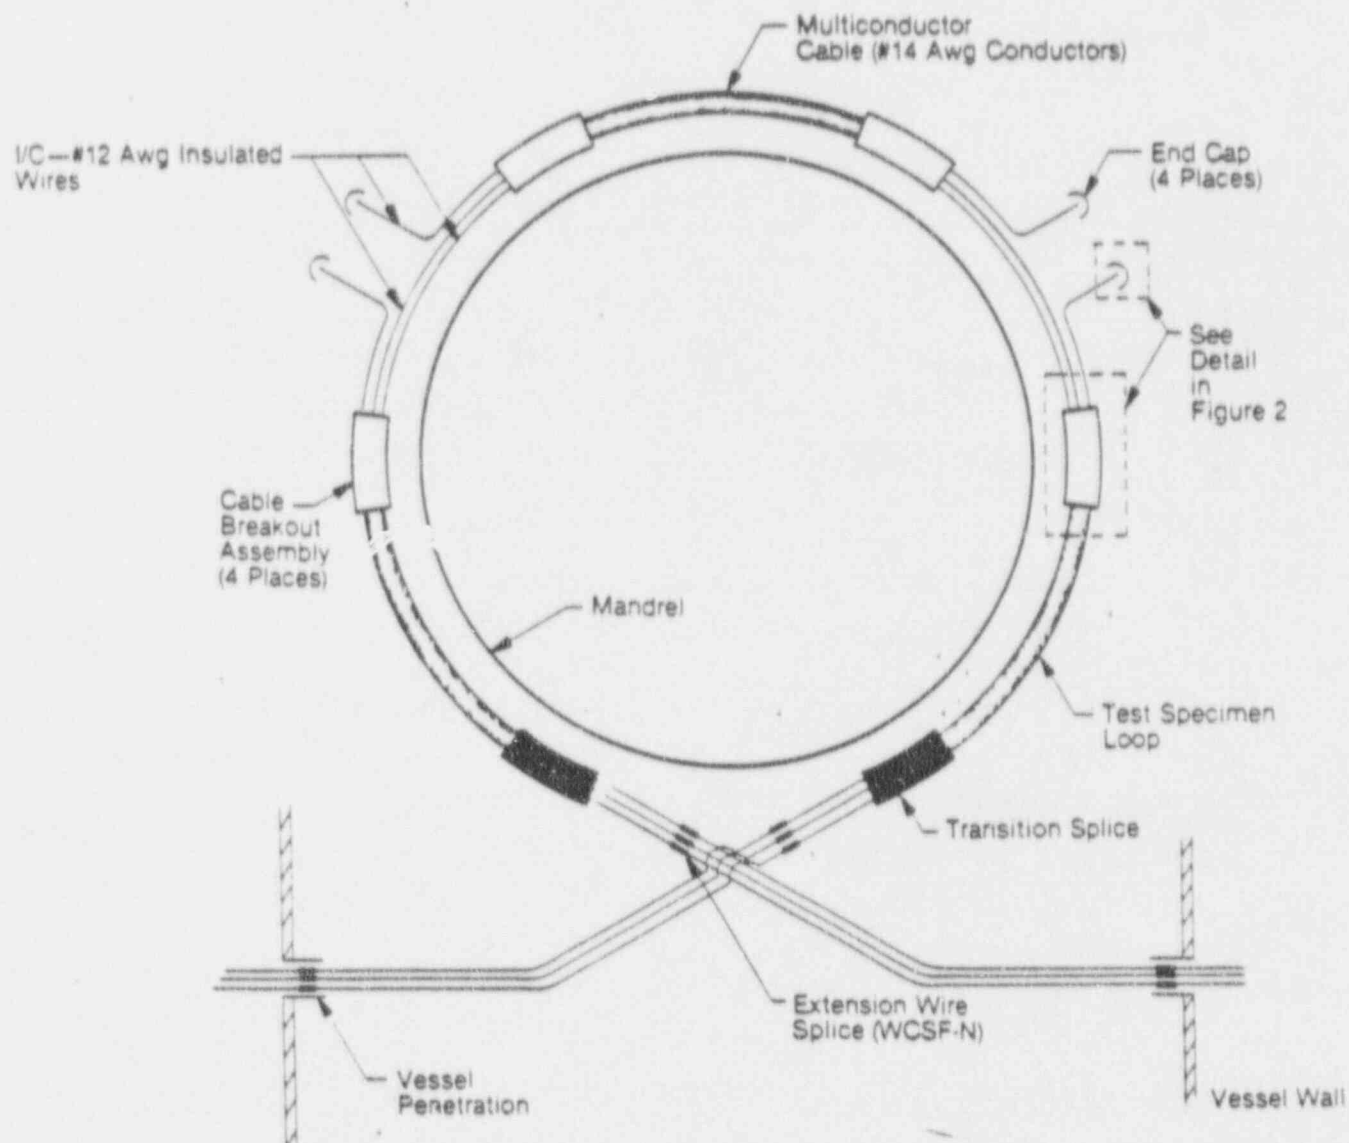
Figure 1 SAMPLE CONSTRUCTION

Each test specimen was comprised of four cable breakouts and four end caps forming a loop as shown in Figure 1. The cable breakouts were tested as part of a transition splice assembly

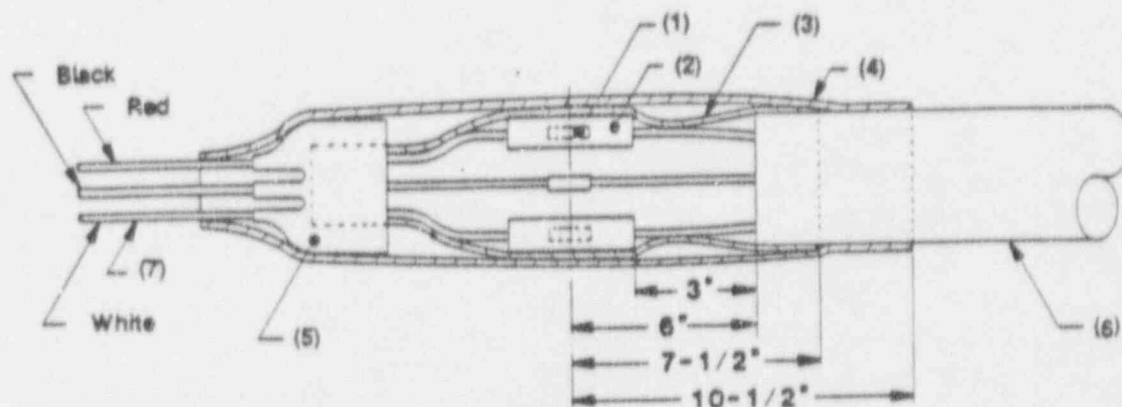
- (1) Raychem Crimp Connector, D609-1
- (2) Raychem WCSF-N, Insulating Sleeve, Size 115, 6 inches, S-1119 Adhesive
- (3) Raychem WCSF-N, Insulating Sleeve, Size 300, 15 inches, S-1119 Adhesive
- (4) Raychem WCSF-N, Insulating Sleeve, Size 300, 21 inches, uncoated
- (5) Raychem 403A112-52, Cable Breakout S-1119 Adhesive
- (6) Rockbestos Firewall III Insulated Cable, 5/C, 14 Awg, XLPE Insulation and Jacket
- (7) Rockbestos Firewall III Insulated Wire, 1/C, 12 Awg, .030 inch XLPE Insulation

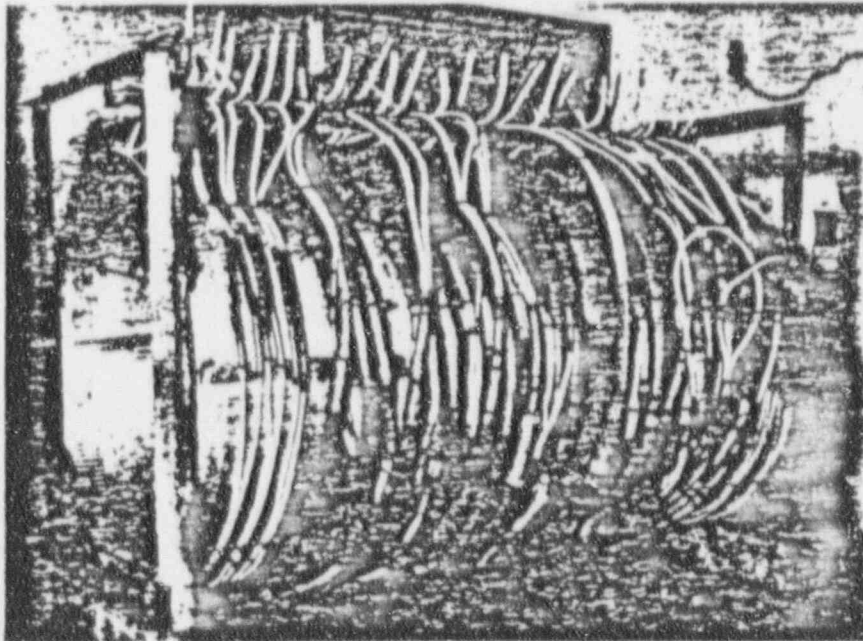
FIGURE 3. Mandrel and Samples

(Specimens 2-1 through 2-6 are located in the center section of the mandrel.)

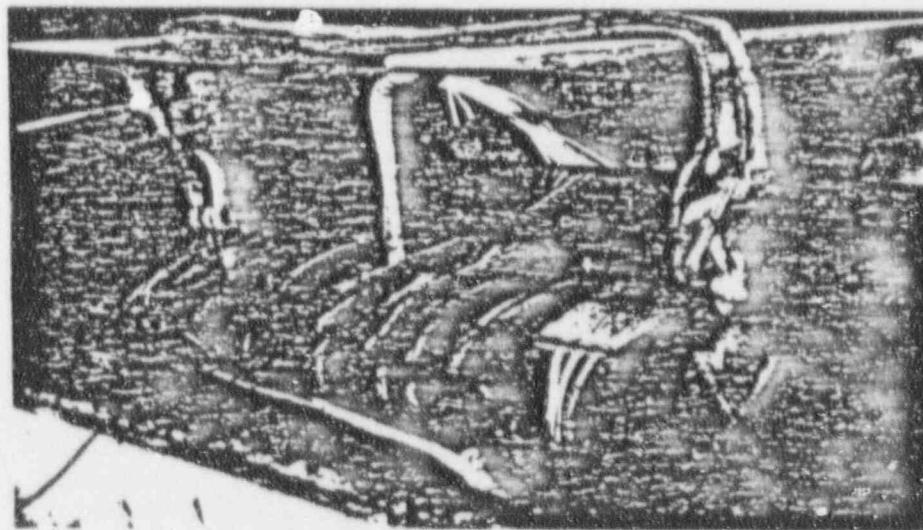
FIGURE 4. Mandrel and Samples Immersed in Water

The mandrel with the specimens in place was immersed in water for functional tests as described in 3.1.1. This was accomplished by splicing long extension leads to each end of the test loops. The splices between the specimens and the extension leads were covered with WCSF-N heat shrinkable tubing. The mandrel in the water is shown in Figure 4.

All specimens again passed the 3.6kV a-c voltage withstand test for five minutes. The insulation resistance values are given in Table 1 on page 14.
