SONGS 2 EMERGENCY DIESEL GENERATOR 2G003
CAMSHAFT ASSEMBLY FAILURE
RCE 91-022

EXECUTIVE SUMMARY

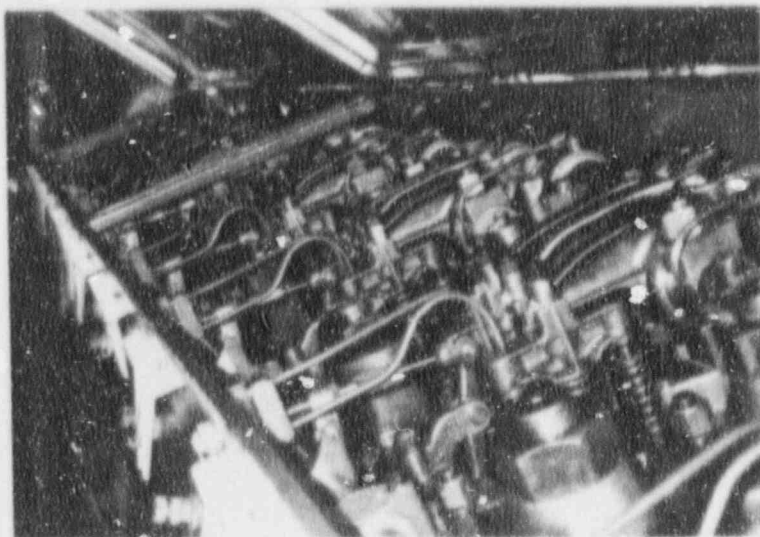
Figure B.2: Overall view of the left top deck area of the engine.

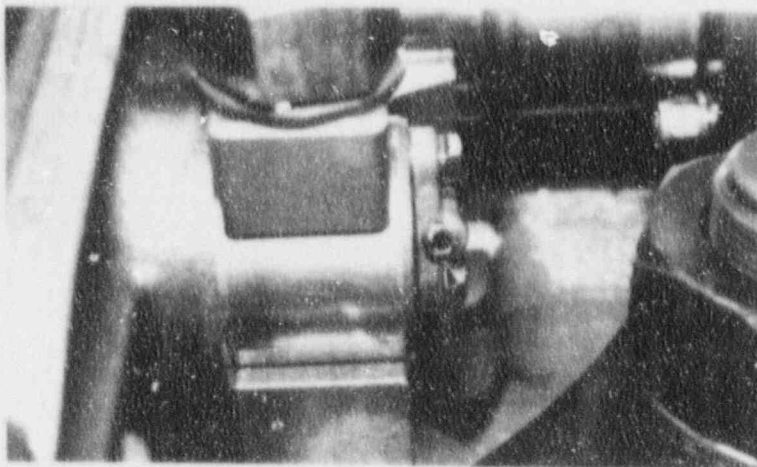
Figure B.6: View of the rocker arm end of the broken oil line that provided oil from bearing cap number 1 to the rocker arm assembly of cylinder number 20. The arrow points to the fracture surface. The oil line failure was considered a secondary event, as a result of the bearing cap coming loose.

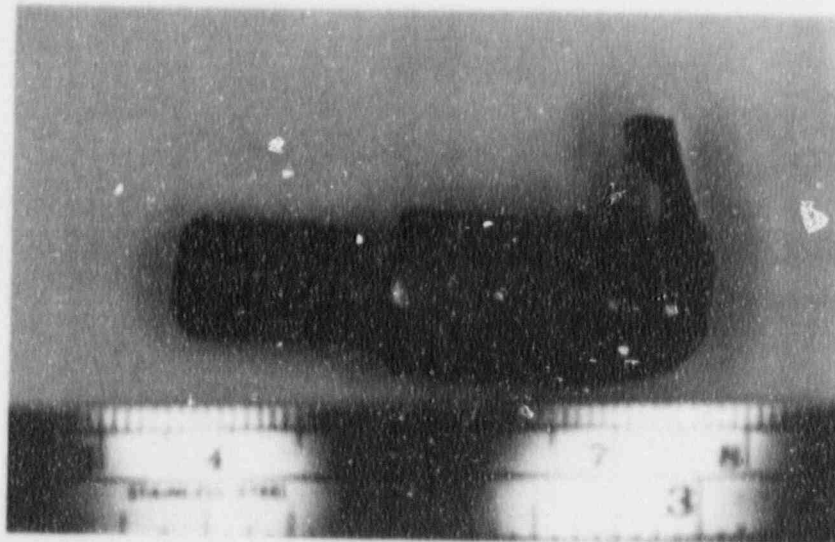
Figure E.2: View of dowel bolt number 1.

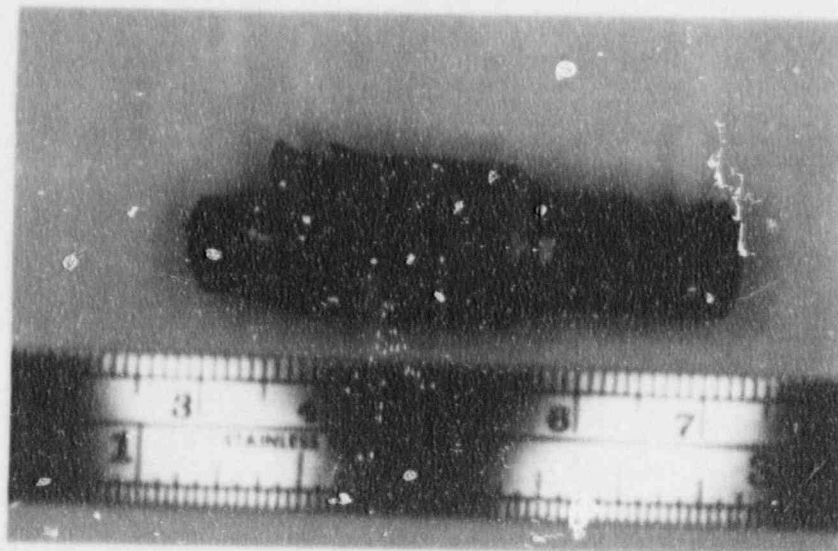
Figure E.3: View of dowel bolt number 2.

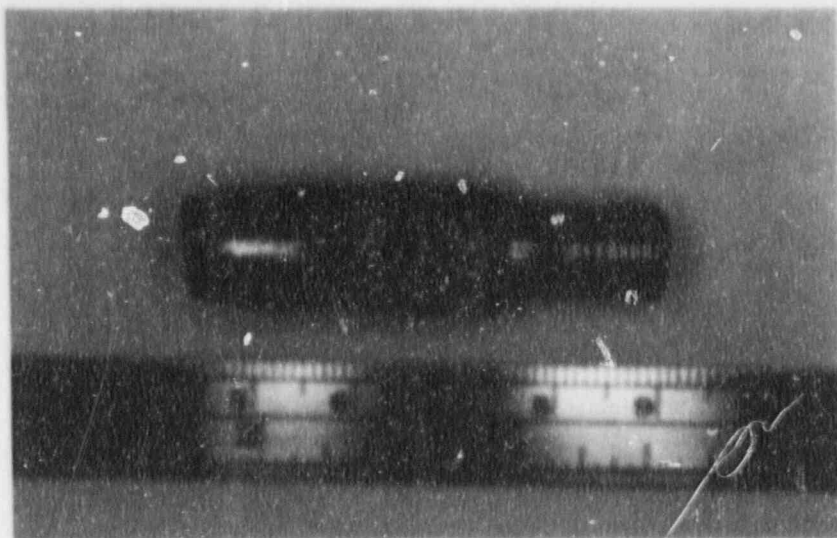
Figure E.4: View of dowel bolt number 3.

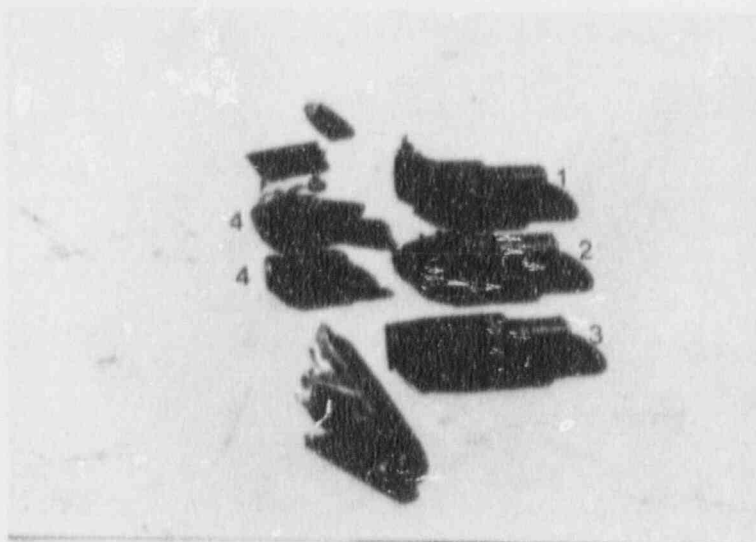
Figure E.5: View of fragments of the dowel bolts

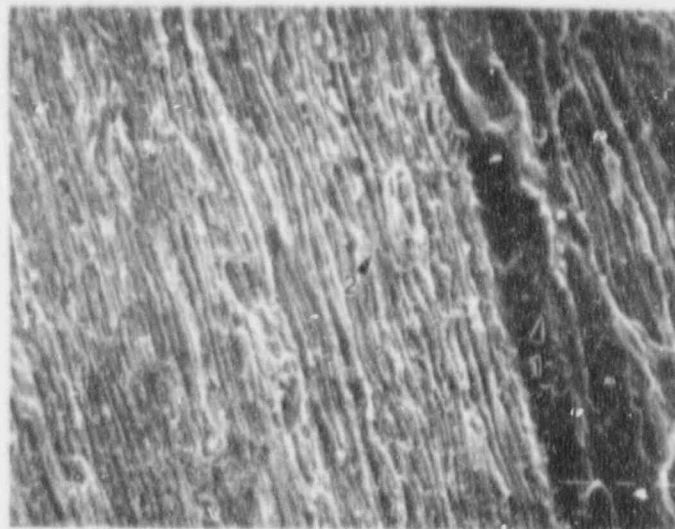
Figure E.7: SEM fractograph of fractured dowel bolt number 4, at 500 X magnification. Arrow 1 points to the location of a large sulfide stringer, and arrow 2 points to a sulfide inclusion.

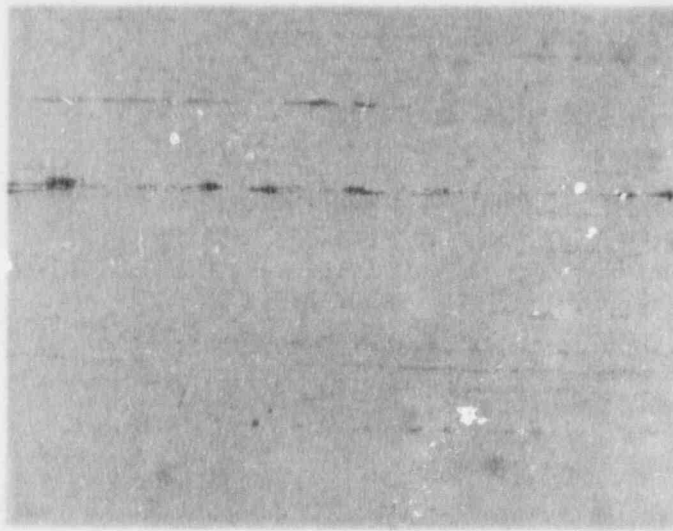
Figure E.10: Optical micrograph of dowel bolt number 3, with an as-polished surface, showing a sulfide stringer, at 100 X magnification.

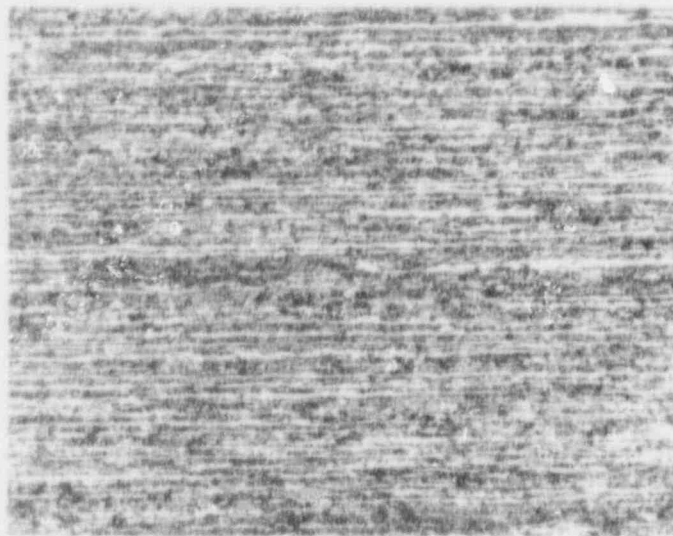
Figure E.11: Optical micrograph of dowel bolt number 3, showing banded microstructure (etched: vital), at 100 X magnification. The microstructure shows bands of ferrite (white paste) and pearlite (dark paste).

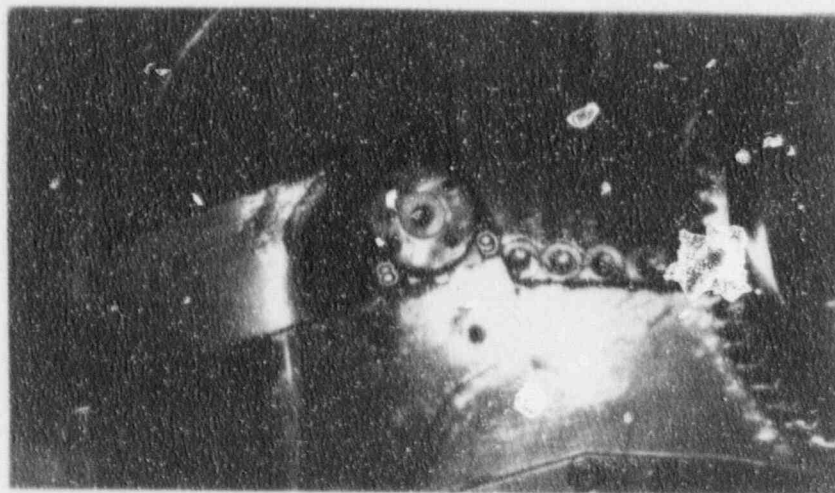
Figure F.2: View of the left rear end sheet of the 20 cylinder engine of 2G003, showing the location of the bolt holes for the 2 vertical bolts that attach the bracket to the engine end sheet.

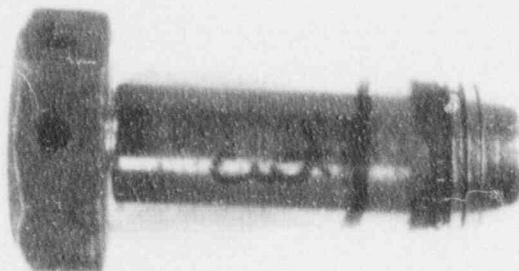
Figure F.3: View of the overall appearance of bolt number 3, illustrating the rubbing and polishing of remaining bolt threads.

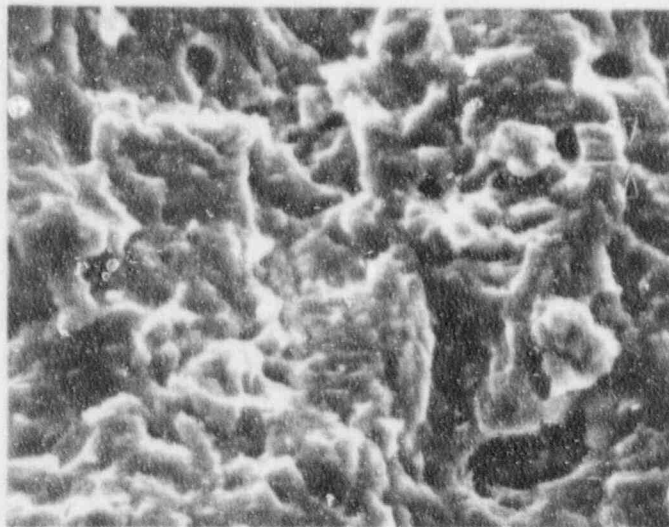
Figure F.5: SEM fractograph of bolt number 3, illustrating the fatigue zone. The arrows contain fatigue striations, and a rough estimate of the coarse fatigue striation was 3.7×10^4 cycles. Taking into consideration the finer striations near the origin area, the total number of cycles would become 4.1×10^4 .

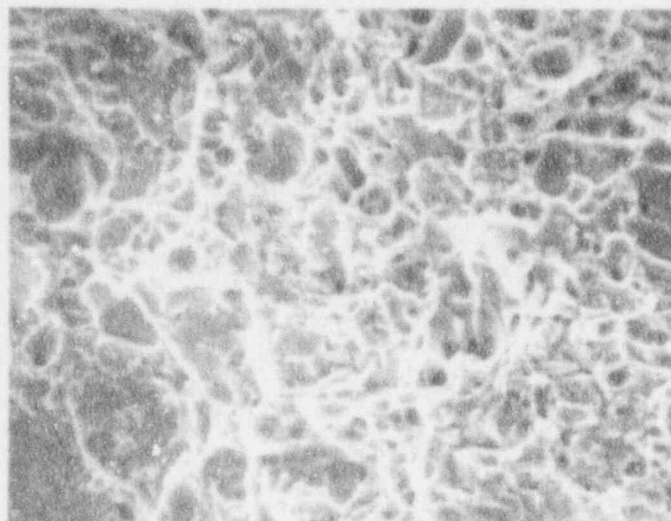
Figure F.6: SEM fractograph of bolt number 3, illustrating the overload zone as a dimple rupture which is indicative of the ductile behavior of the bolt, at 1000 X magnification.

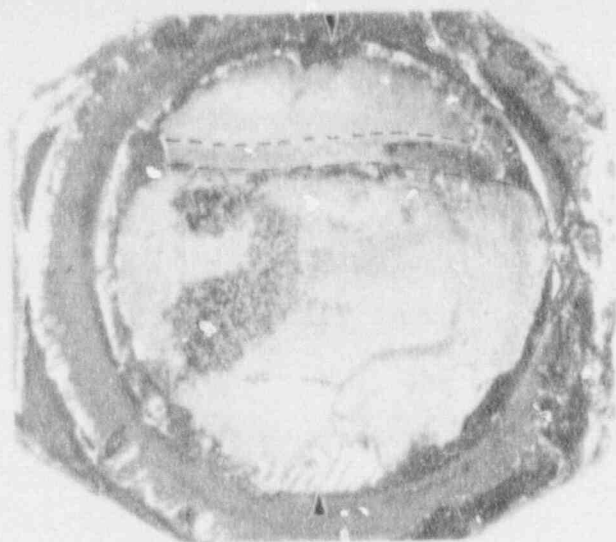
View of a macrofractograph of bolt number 1, illustrating reverse bending fatigue fracture. The overload zone is off center, indicating that the applied bending stresses were not equal in opposite loading directions. The arrows point to the fatigue initiation sites.

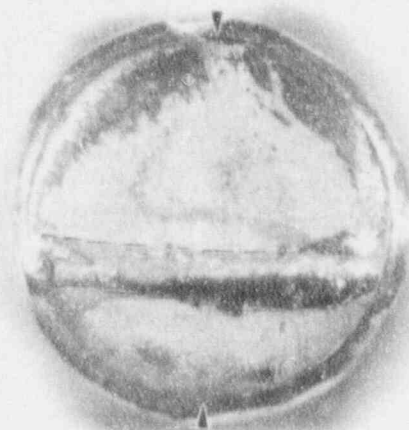
View of a fractograph of bolt number 5, illustrating reverse bending fatigue. The overload zone is bounded by the dotted lines and is only slightly off center, which is indicative of the reverse loading approaching uniaxial conditions.

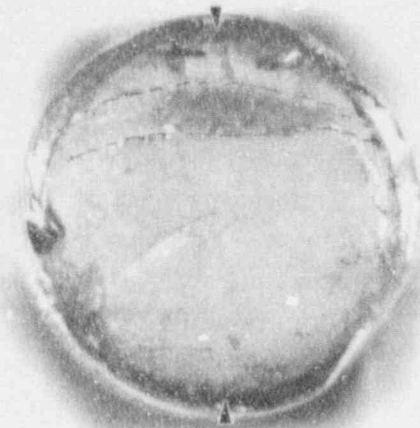
Figure F.10: View of a fractograph of bolt number 4, illustrating reverse bending fatigue. The overload zone is bounded by the dotted lines. The arrows in the figure point to fracture origins. The overload zone is off center which is indicative of unequal bending stresses.

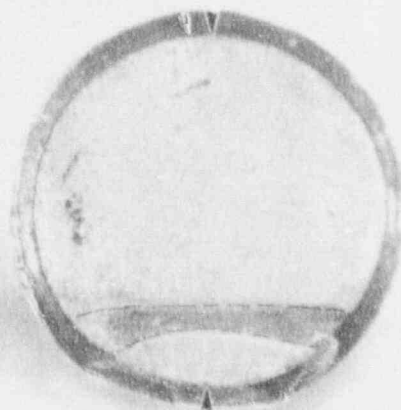
Figure F.11: View of a fractograph of bolt number 7, illustrating reverse bending fatigue. The overload zone is bounded by the dotted lines and the overload zone is off center which is indicative of unequal reverse bending loading.

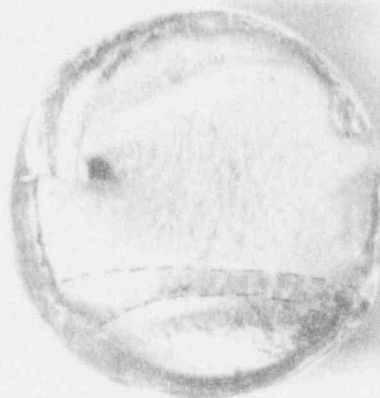
Figure F.12: View of a fractograph of bolt number 6, illustrating reverse bending fatigue. The overload zone is off center which is indicative of unequal bending stresses on both sides of the bolt.

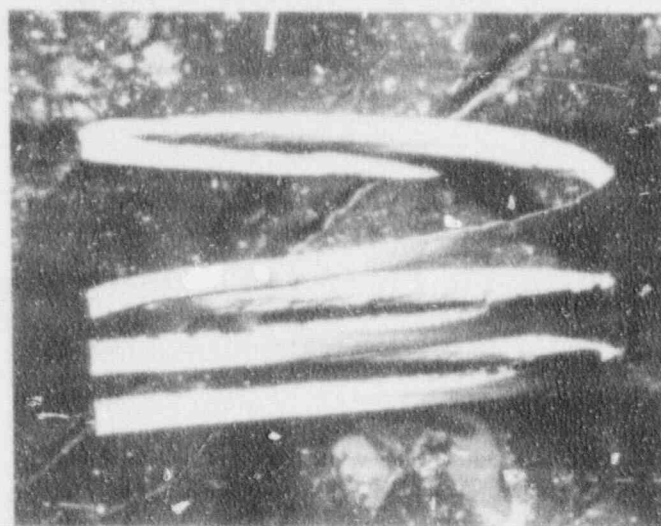
Figure G.2: SEM fractograph of stripped threads found entrapped on the threads of the outboard bolt of bearing block number 3, at 6 X magnification.

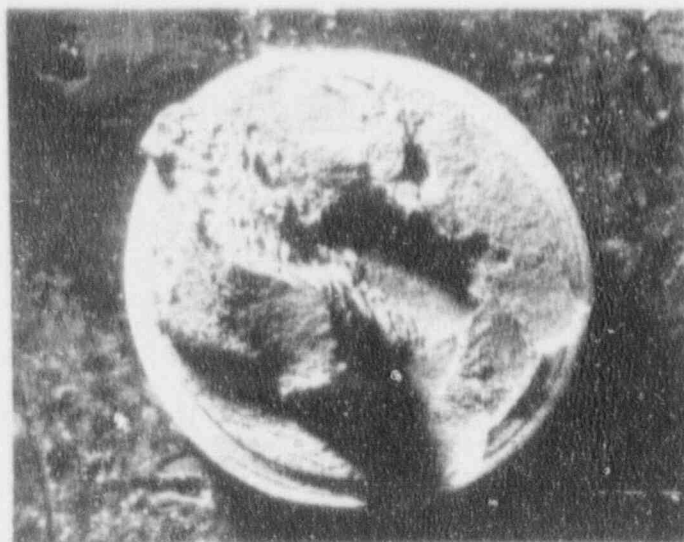
Figure K.3: A macrophotograph of the fracture surface of broken bolt 1, at 7 X magnification.

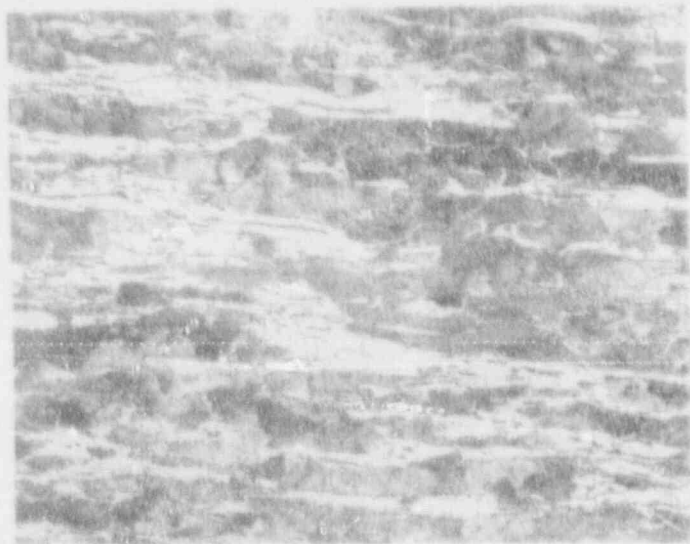
Figure K.10: A photograph of the longitudinal microstructure of cracked bolt 2, in the as-etched condition, illustrating platelets of ferrite and pearlite, at 400 X magnification.

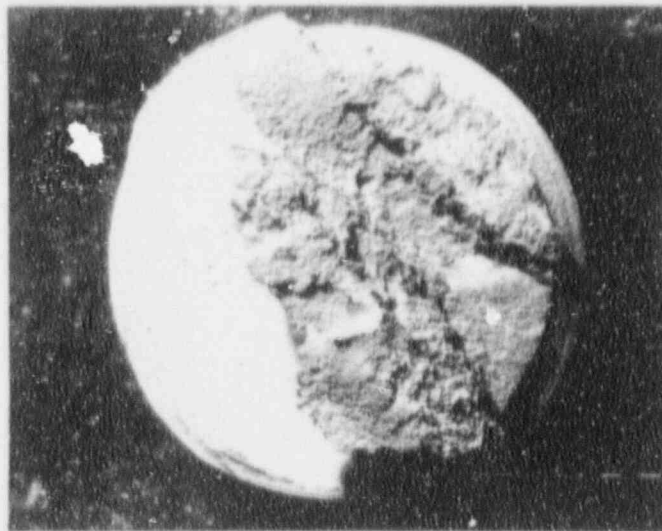
The depth of crack propagation in the 3 cracked dowel bolts varied depending on size and distribution of sulfide inclusions. The greater the population and size of the inclusions the greater the crack propagation. The cracks were pure fatigue and involved approximately 20, 40 and 67, percent of the cross sectional areas of dowel bolts number 2, 3 and 4, respectively.

Figure K.20: A SEM photograph of cracked bolt 4, illustrating crack propagation to approximately 67 percent of the cross section of the bolt, at 6 X magnification.

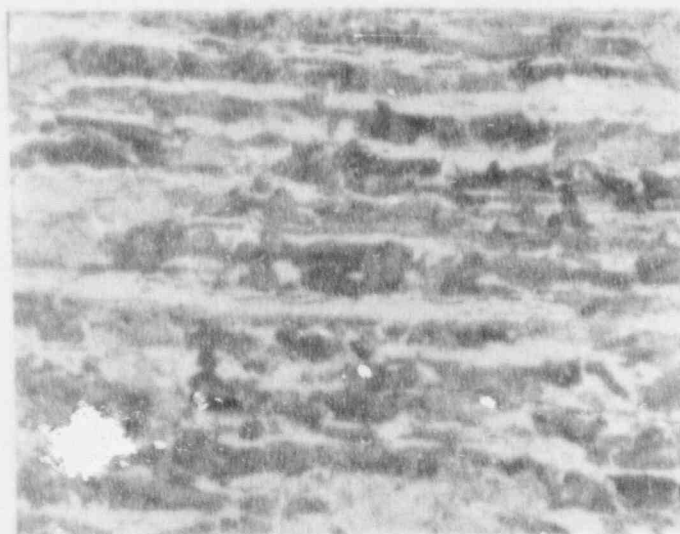
Figure K.24: A photograph of the longitudinal microstructure of cracked bolt 4, in the as-etched condition, illustrating platelets of ferrite and pearlite, at 400 X magnification.

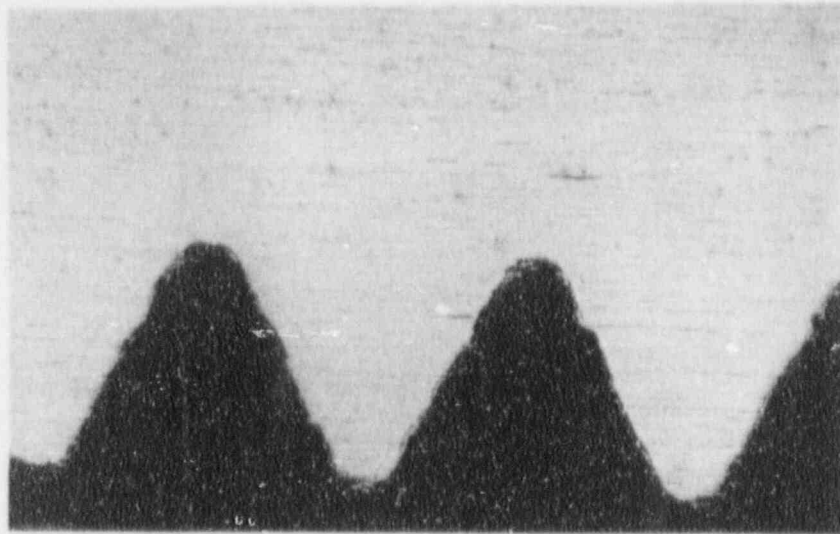
The analysis of the sampled dowel bolts indicated an absence of large sulfide inclusions. The sulfide distribution was acceptable and the batches of new dowel bolts were approved for use in the EDGs.

Figure L.1: Photograph of the longitudinal microsection, in the as-polished condition, of the Batch 1 Sample 1 dowel bolt, illustrating a relatively small population of small sulfide inclusions, at 50 X magnification.

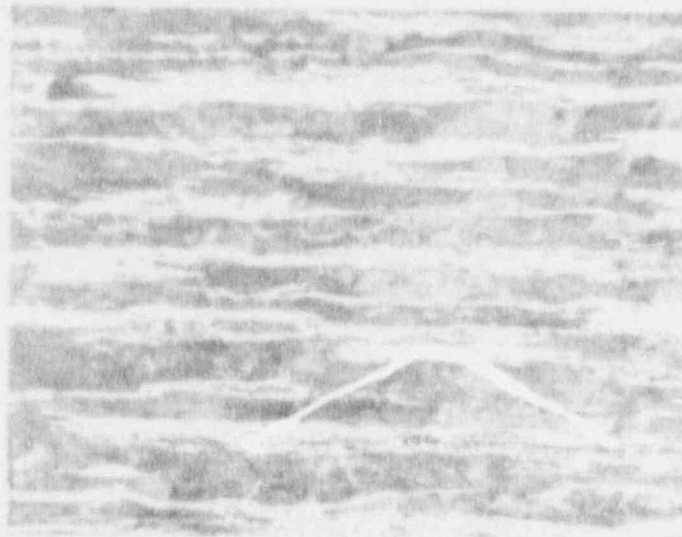
Figure L.2: Photograph of the longitudinal microsections, in the as-etched condition, of the Batch 1 Sample 1 dowel bolt, illustrating platelets of ferrite and pearlite, at 400 X magnification.

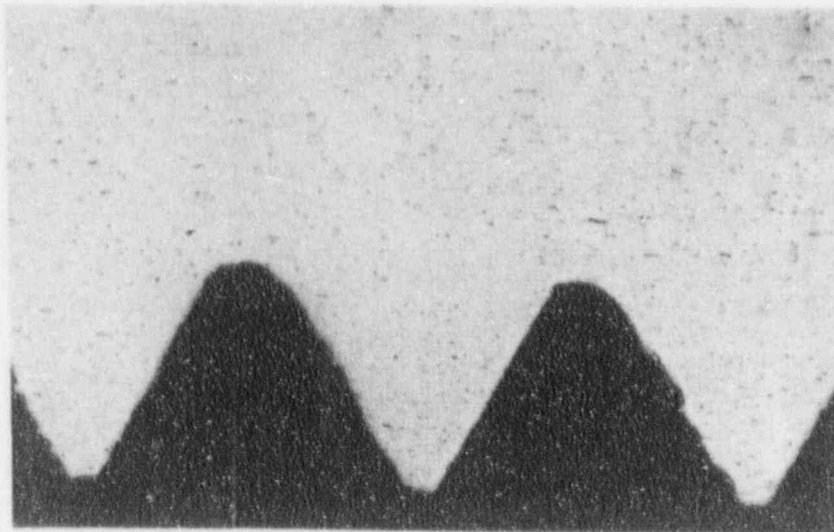
Figure L.3: Photograph of the longitudinal microsection, in the as-polished condition, of the Batch 1 Sample 2 dowel bolt, illustrating a relatively small population of small sulfide inclusions, at 50 X magnification.

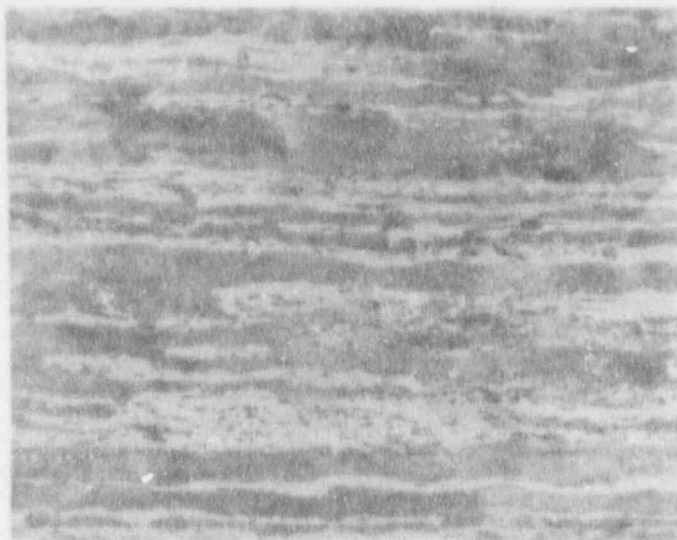
Figure L.4: Photograph of the longitudinal microsections, in the as-etched condition, of the Batch 1 Sample 2 dowel bolt, illustrating platelets of ferrite and pearlite, at 400 X magnification.

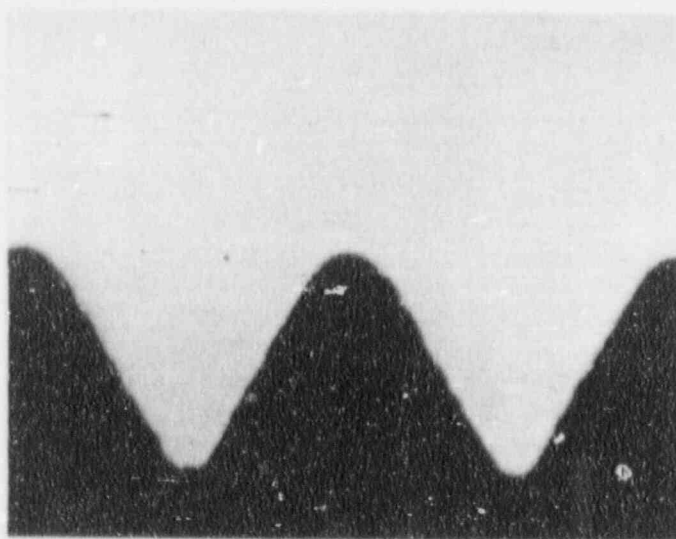
Figure L.5: Photograph of the longitudinal microsection, in the as-polished condition, of the Batch 2 Sample 1 dowel bolt, illustrating a relatively small population of small sulfide inclusions, at 50 X magnification.

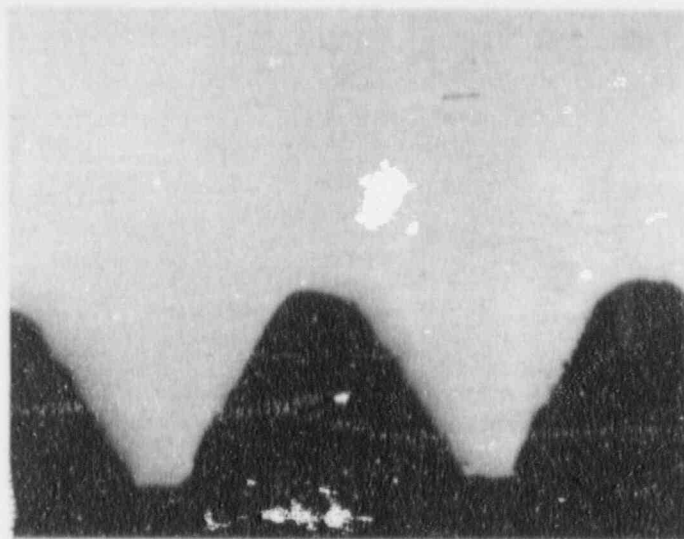
Figure L.7: Photograph of the longitudinal microsection, in the as-polished condition, of the Batch 2 Sample 2 dowel bolt, illustrating a relatively small population of small sulfide inclusions, at 50 X magnification.

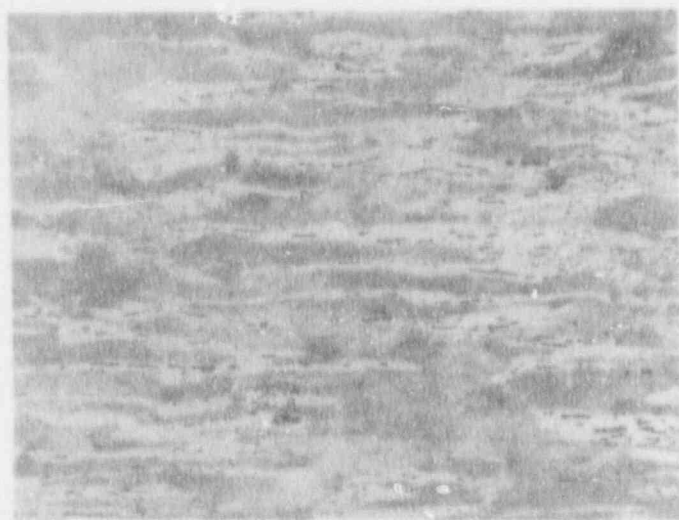
Figure L.8: Photograph of the longitudinal microsections, in the as-etched condition, of the Batch 2 Sample 2 dowel bolt, illustrating platelets of ferrite and pearlite, at 400 X magnification.

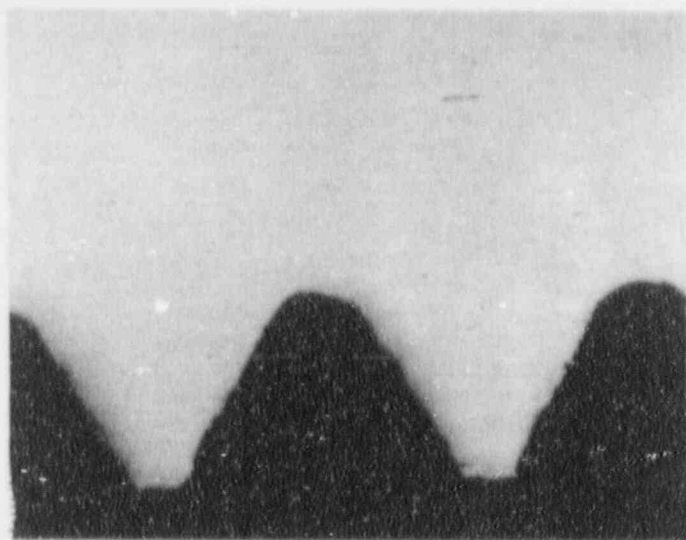
Figure L.7: Photograph of the longitudinal microsection, in the as-polished condition, of the Batch 2 Sample 2 dowel bolt, illustrating a relatively small population of small sulfide inclusions, at 50 X magnification.

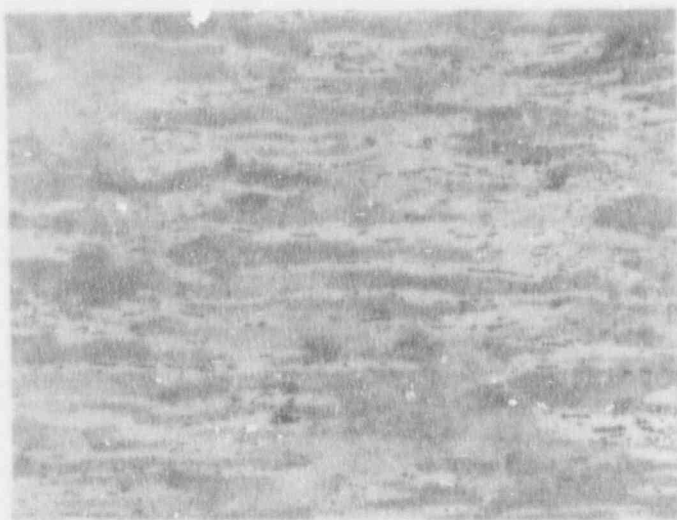
Figure L.8: Photograph of the longitudinal microsections, in the as-etched condition, of the Batch 2 Sample 2 dowel bolt, illustrating platelets of ferrite and pearlite, at 400 X magnification.
