LICENSEE EVENT REPORT (LER)

FACILITY NAME (1) Sequoyah, Unit 1										DOCKET NUMBER (2) 0 5 0 0 0 3 2 7										PAGE (3) 1 OF 0 7									
---------------------------------------	--	--	--	--	--	--	--	--	--	--------------------------------------	--	--	--	--	--	--	--	--	--	----------------------	--	--	--	--	--	--	--	--	--

Thimble Tube Ejection, Revision 1

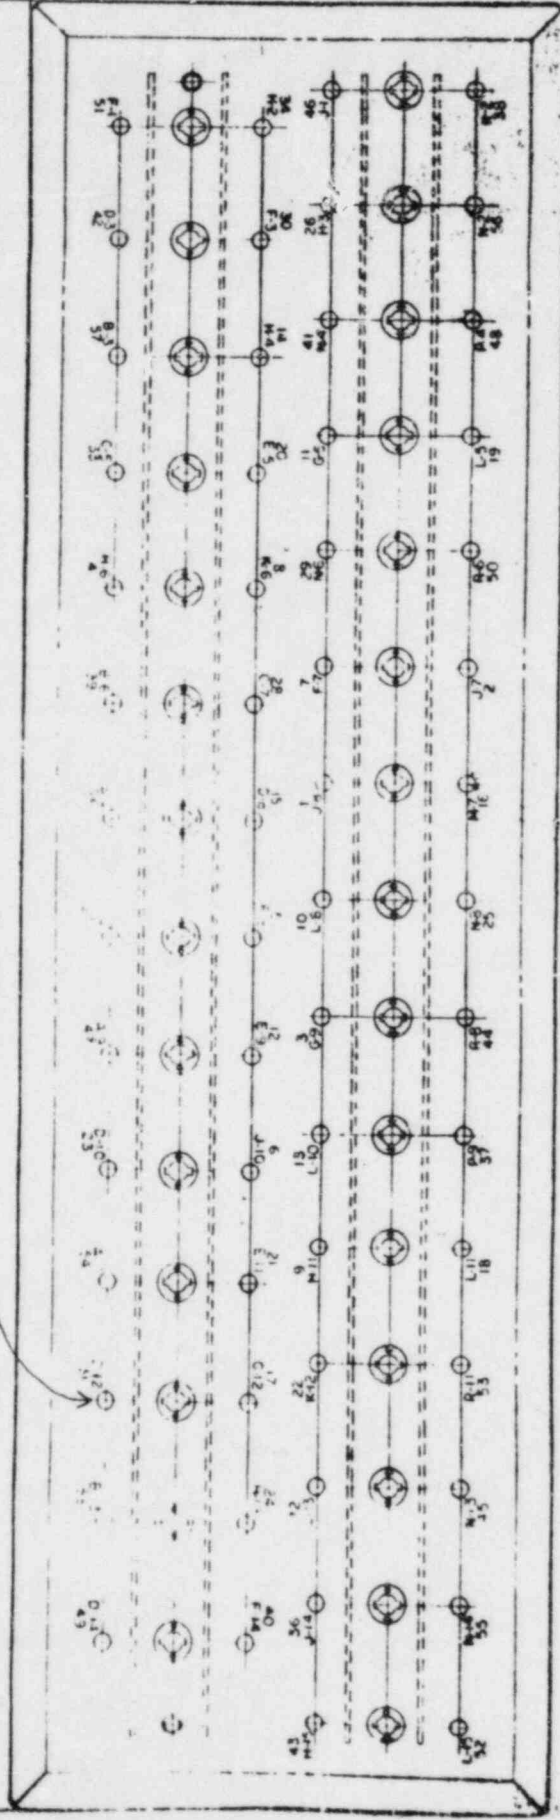
SEAL TABLE
FIGURE 2

NOTE: THIMBLE TUBE EJECTION
OCCURRED FROM D-12 (31) LOCATION

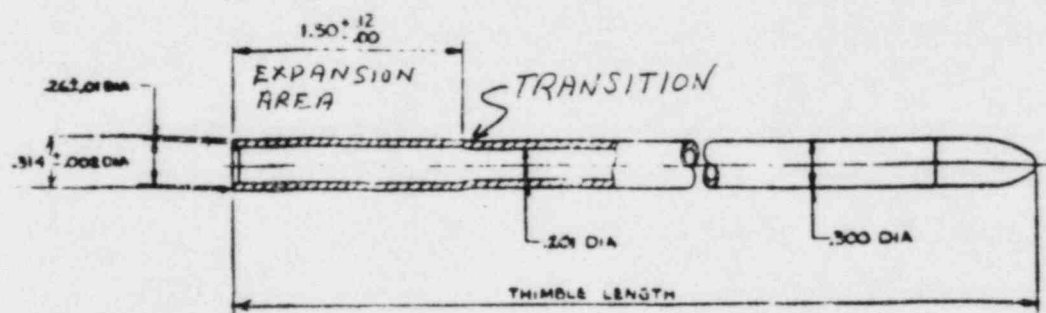
FIGURE 3

LENGTHS VARY FROM 103 TO 117 FEET

THIMBLE TUBE (SHOWING DESIGN
AND EXPANSION FOR MECHANICAL
SEALS AT THE SEAL TABLE)

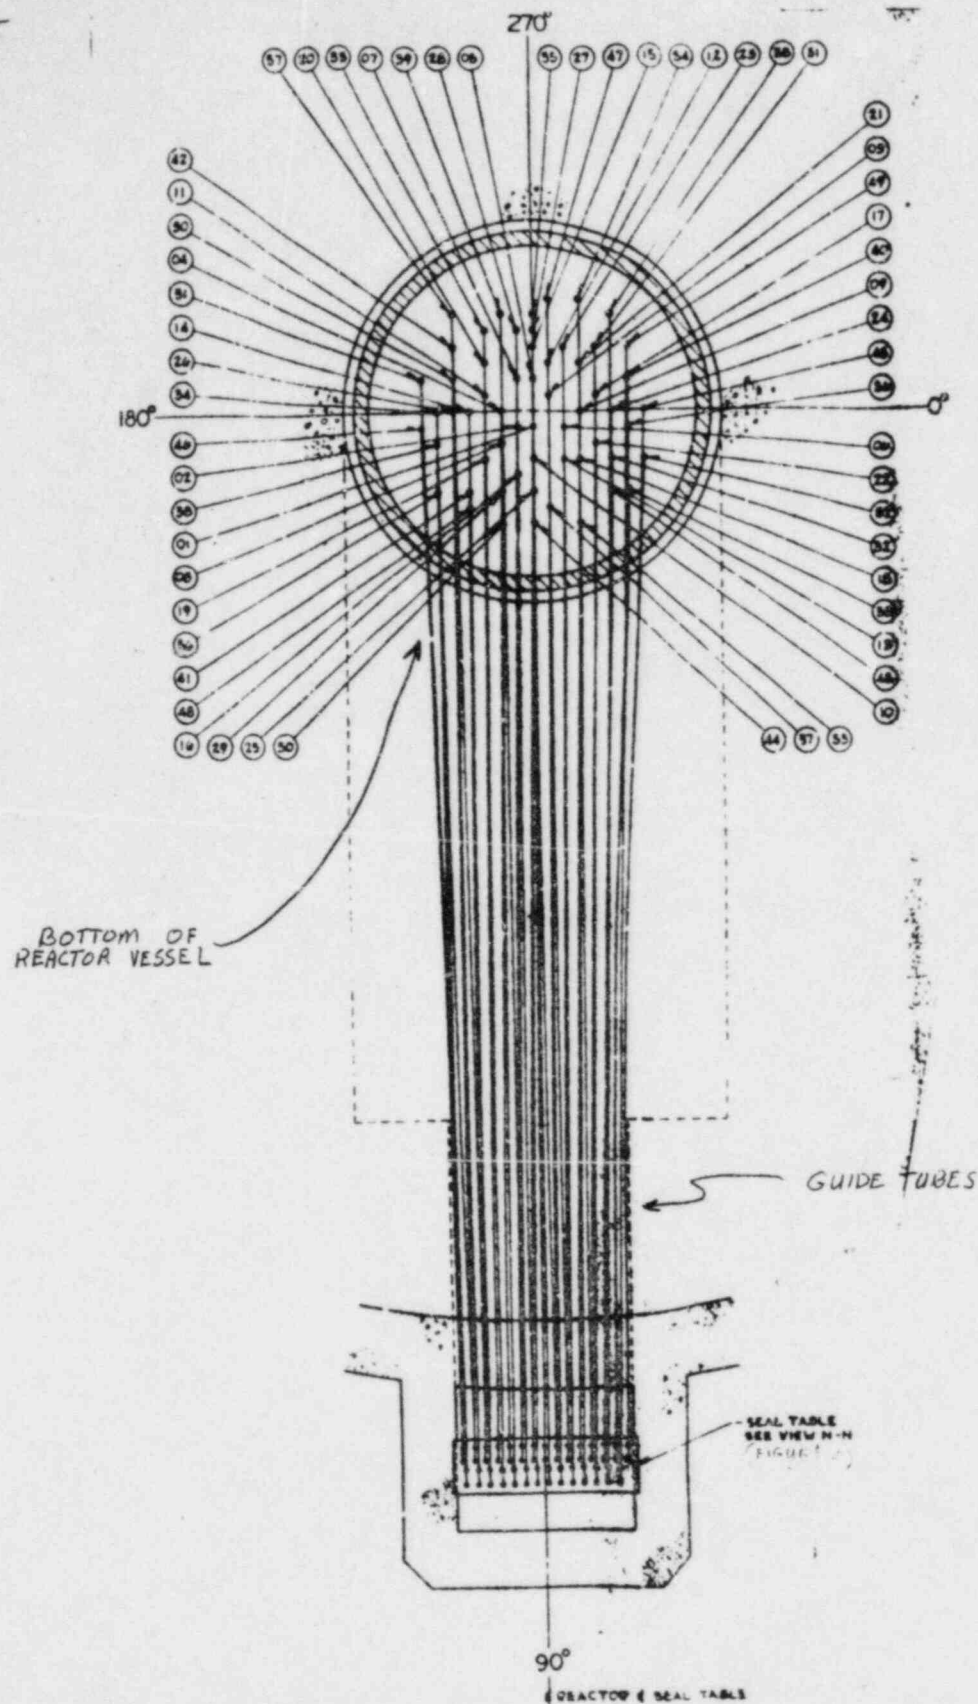
FIGURE 4

CONFIGURATION SHOWING GUIDE TUBES
AND RESPECTIVE THIMBLE TUBES

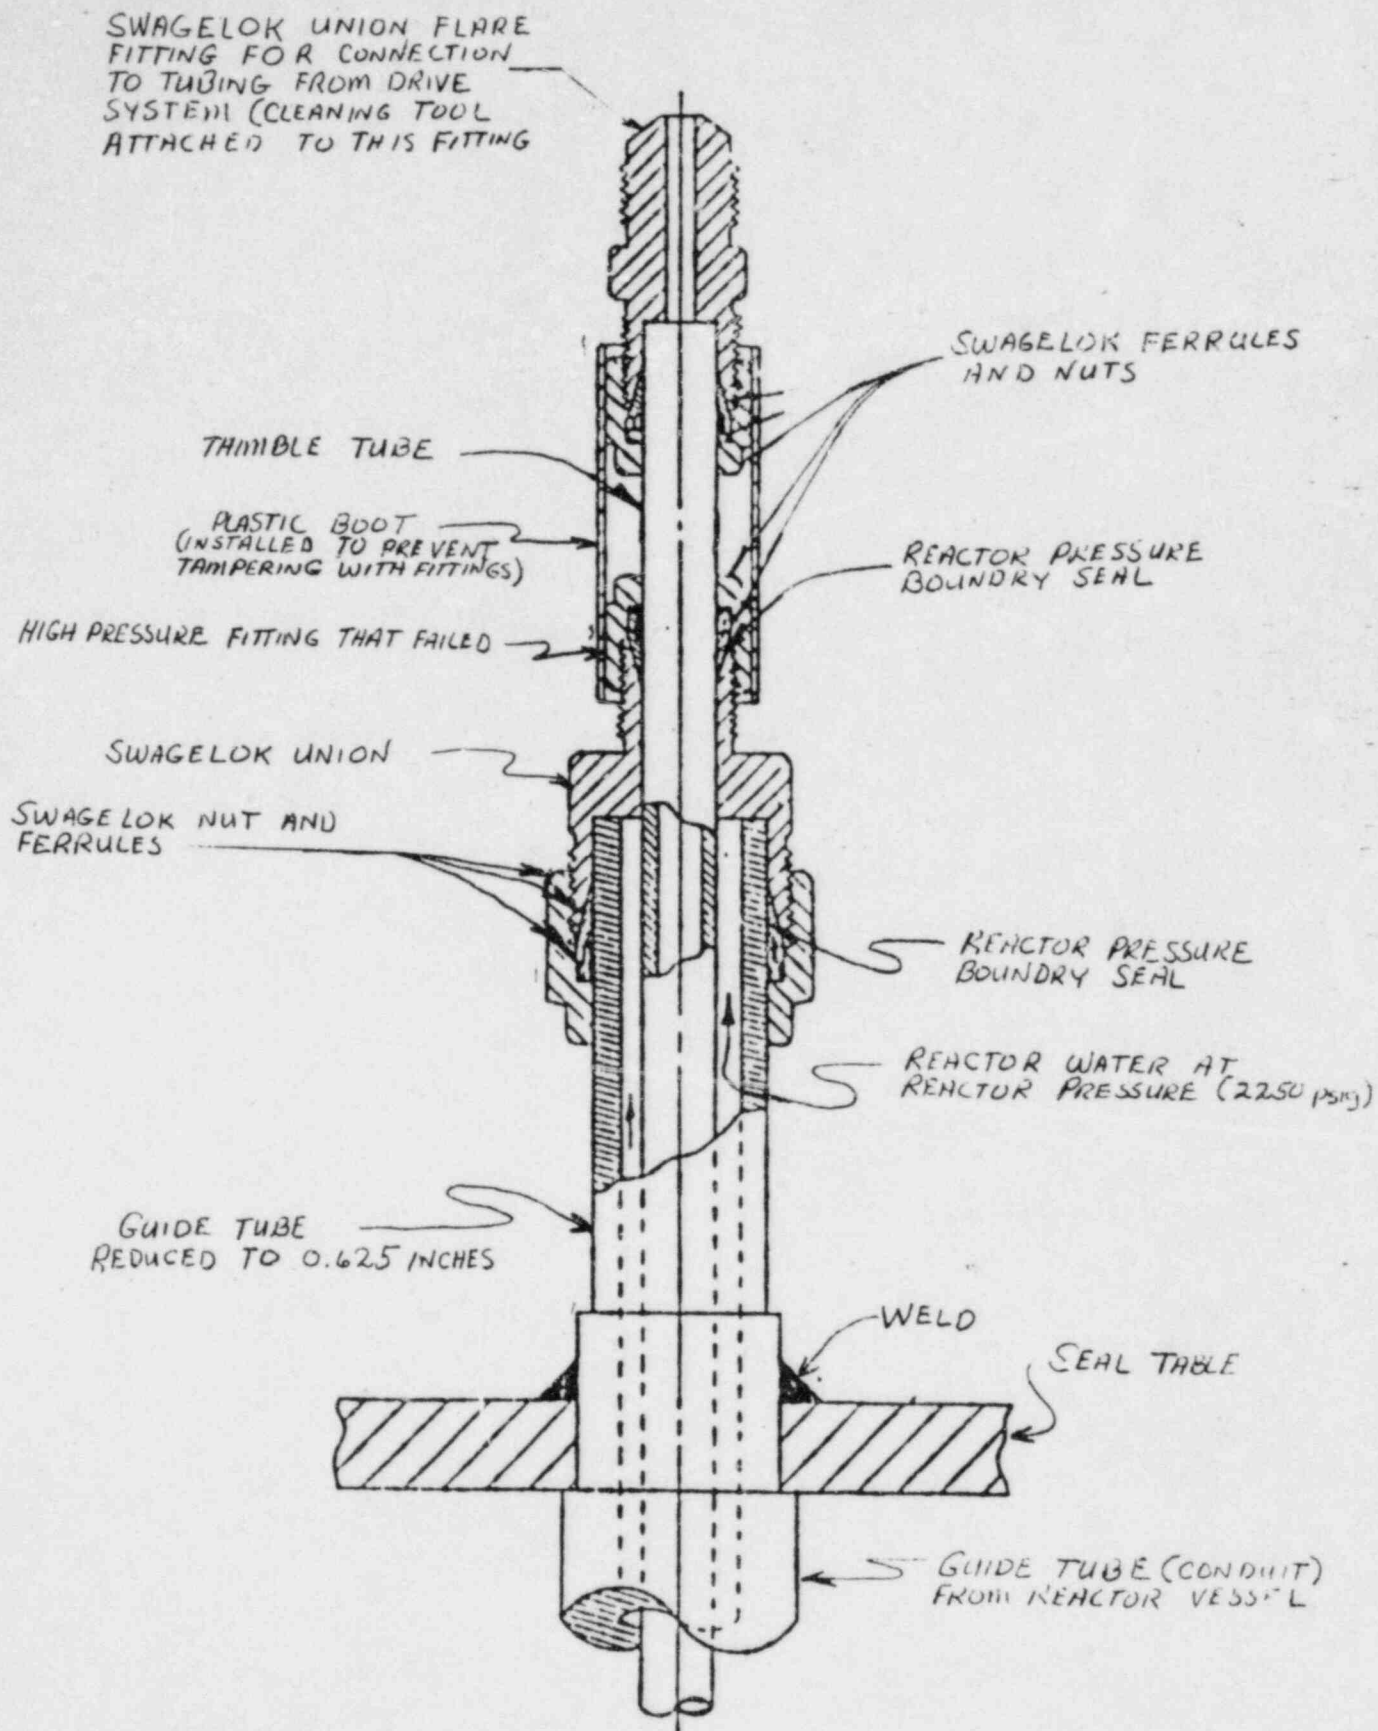
FIGURE 5

THIMBLE TUBE MECHANICAL SEALS

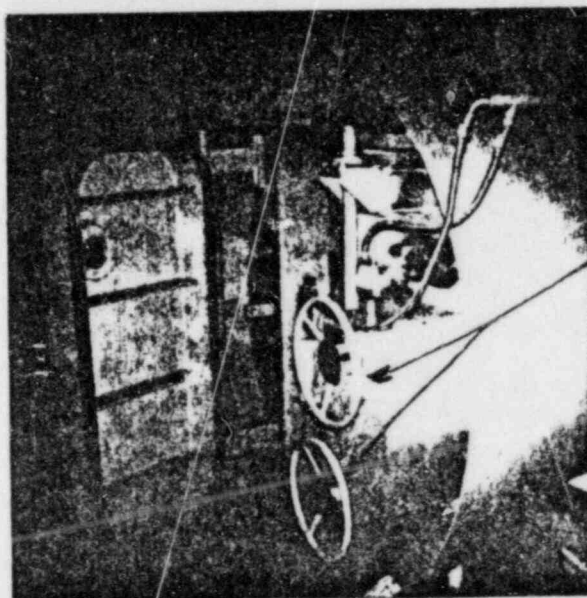
FIGURE 7B

WATTS 134R NUCLEAR PLANT PERSONNEL AIRLOCK
DOOR (SIMILAR TO THE SQN EL 690' AIRLOCK)

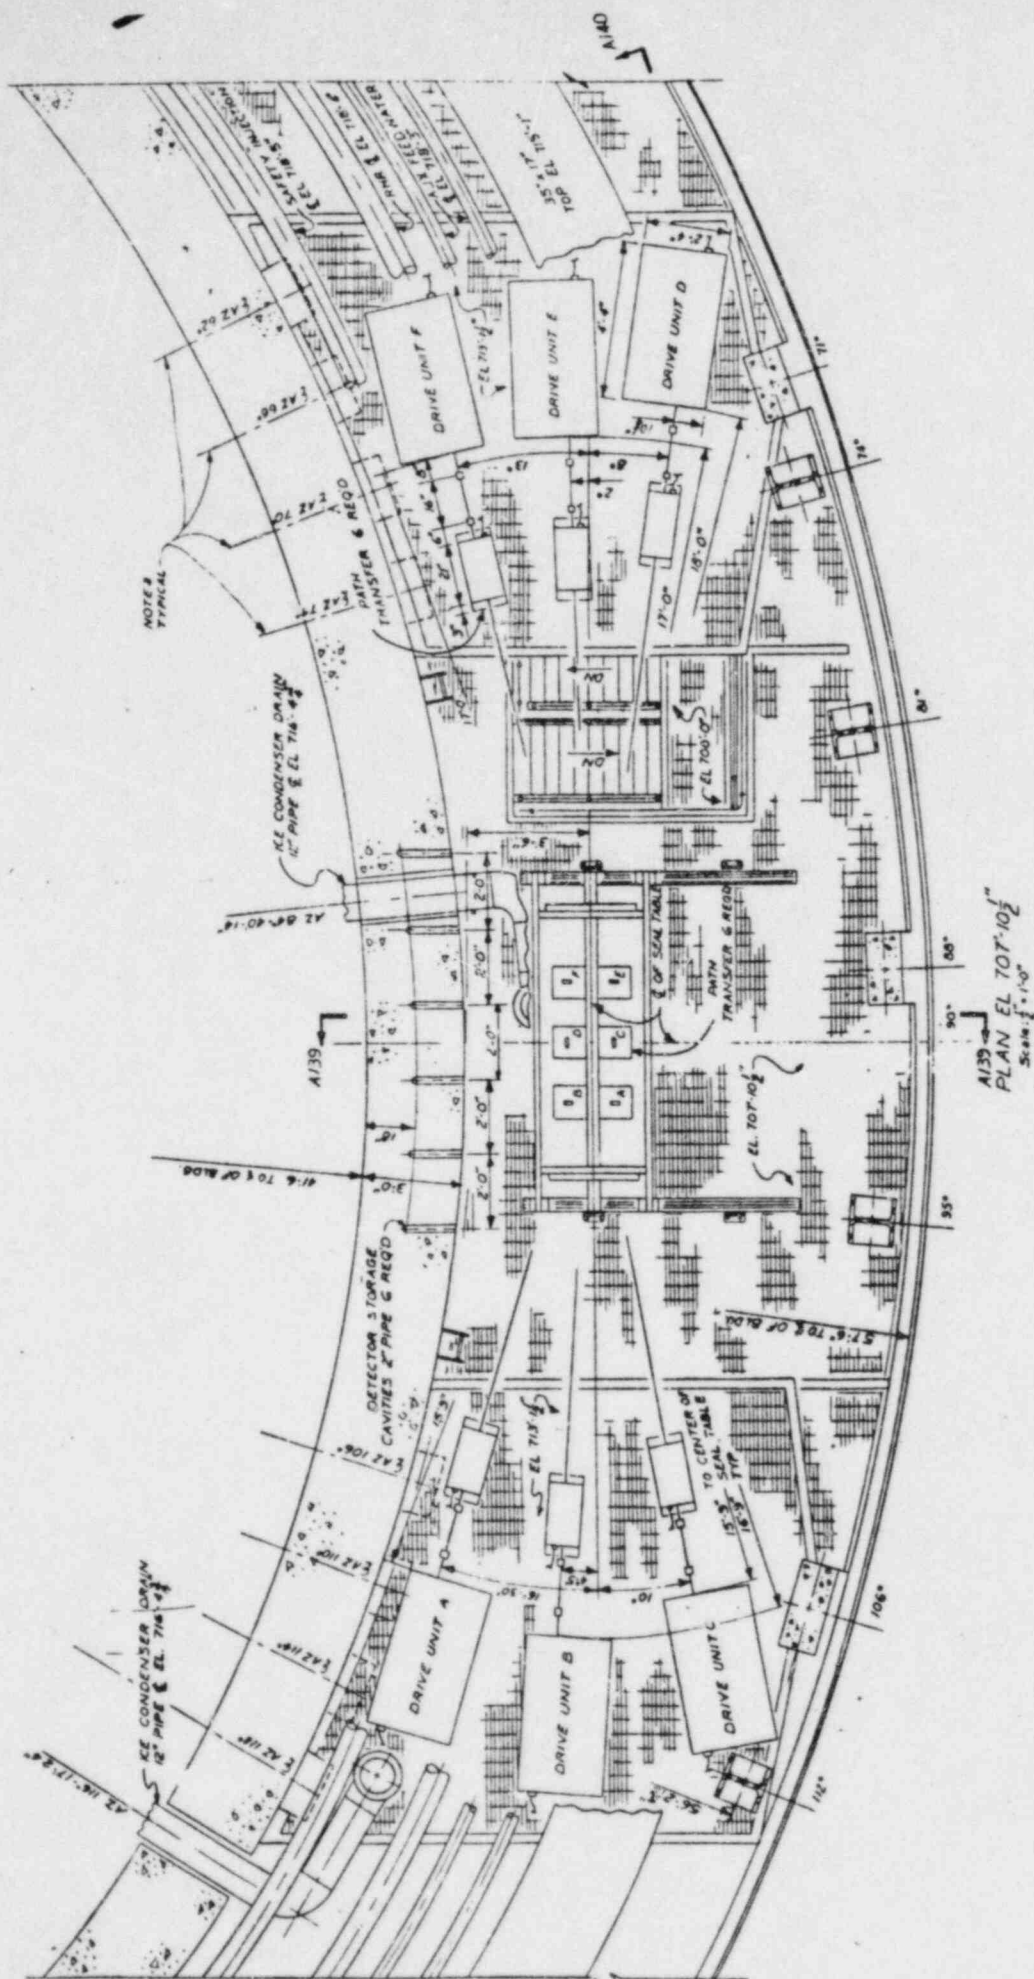
FIGURE 10

Figure 10 is a top view of the location of the incore instrumentation equipment in the instrumentation room. The neutron detectors can be stored in cavities in the polar crane wall for radiation shielding while personnel are working in the area.

TOP VIEW OF THE INCORE INSTRUMENTATION
EQUIPMENT IN THE INSTRUMENT ROOM

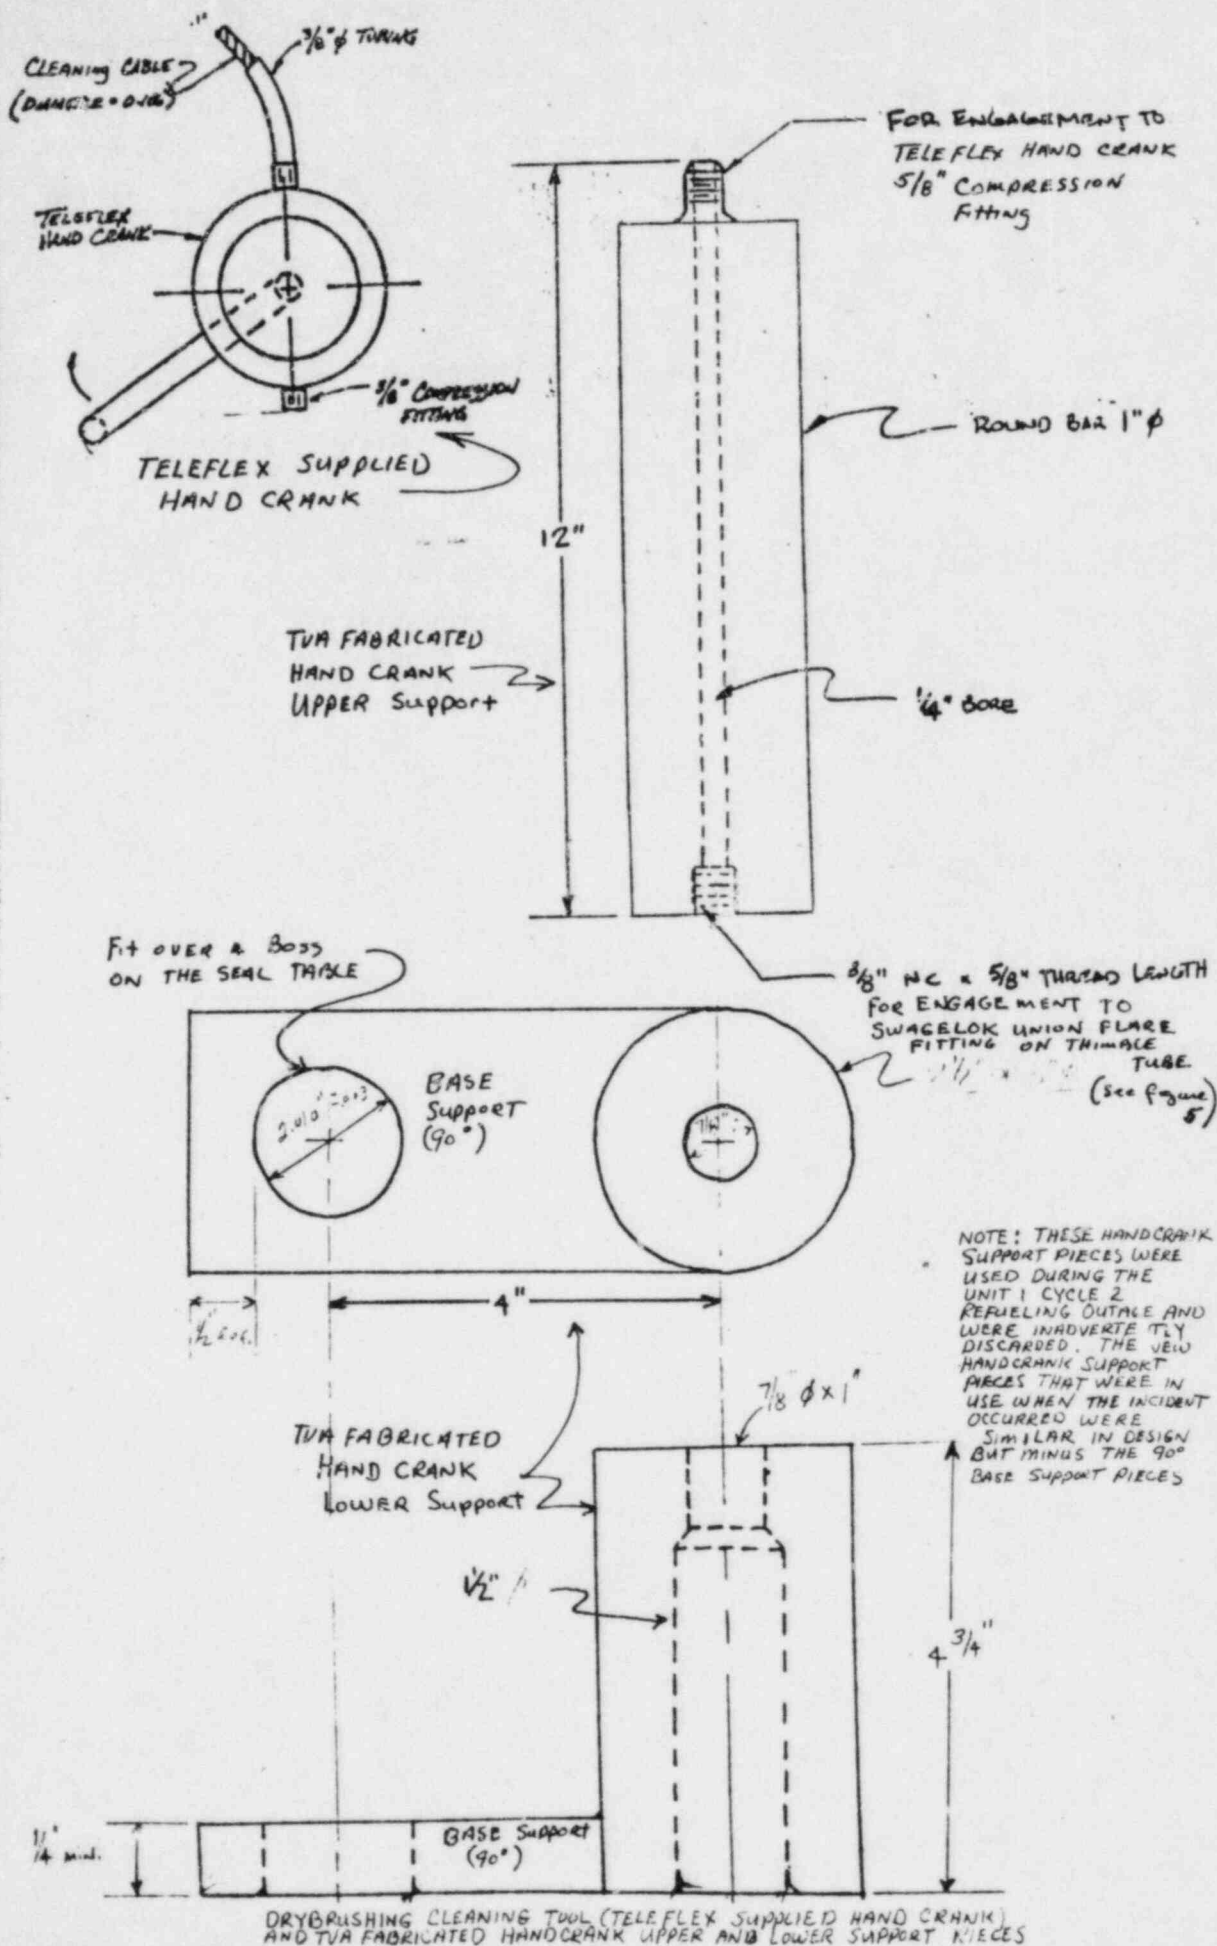
FIGURE 11A

- (2) Dry Brushing (Refer to figures 11A, 11B, 12A, and 12B). The dry brushing step involved the use of a brush assembly which consisted of a 0.200 inch od brass wire brush welded to a 0.187 inch od carbon steel helical (spiral wound) cable driven by a handcranked drivebox. The brush assembly was provided by the same vendor (Teleflex) that provided the detector drive system. The upper and lower supports for the handcrank device were fabricated by TVA. The lower support was equipped with a 90° base support that fit over a boss on a seal table providing additional stability to the support assembly as the handcrank was turned. The fit of the base support over the bosses for all the thimble tubes was not always secure. The brush assembly was used to "dry" brush each of the thimble tubes to dislodge particles and dried lubricant attached to the thimble tube wall by the scrubbing action of the brush. The brush was driven into the thimble 10 inches for each revolution of the handcrank. The brushing motion was strictly linear without any rotation of the brush.
