LICENSEE EVENT REPORT (LER)

FACILITY NAME (1) Fort St. Vrain, Unit No. 1										DOCKET NUMBER (2) 0 5 0 0 0 2 1 6 7 1										PAGE (3) 1 OF 1																													
TITLE (4) During SR 5.1.2c-X, Only 1/2 Of Total RSD Material Was Discharged From CRD#21																																																	
EVENT DATE (5) MONTH DAY YEAR 1 1 0 5 8 4 8 4										LER NUMBER (6) SEQUENTIAL NUMBER REVISION NUMBER 0 1 2 0 1 0 2 2 8 8 5										REPORT DATE (7) MONTH DAY YEAR 0 5 2 8 8 5										OTHER FACILITIES INVOLVED (8) FACILITY NAMES DOCKET NUMBER(S) N/A 0 5 0 0 0 1 1																			
OPERATING MODE (9) N										THIS REPORT IS SUBMITTED PURSUANT TO THE REQUIREMENTS OF 10 CFR 50.73 (Check one or more of the following) (11)																																							
POWER LEVEL (10) 0 0 0										20.402(b) 20.406(a)(1)(i) 20.406(a)(1)(ii) 20.406(a)(1)(iii) 20.406(a)(1)(iv) 20.406(a)(1)(v)										20.406(a) 20.36(a)(1) 20.36(a)(2) 20.73(a)(2)(i) 20.73(a)(2)(ii) 20.73(a)(2)(iii)										20.73(a)(2)(iv) 20.73(a)(2)(v) 20.73(a)(2)(vi)(A) 20.73(a)(2)(vi)(B) 20.73(a)(2)(vi)										73.71(b) 73.71(c) OTHER (Specify in Abstract Below and in Text, NRC Form 306A)

SUBJECT: Licensee Eve

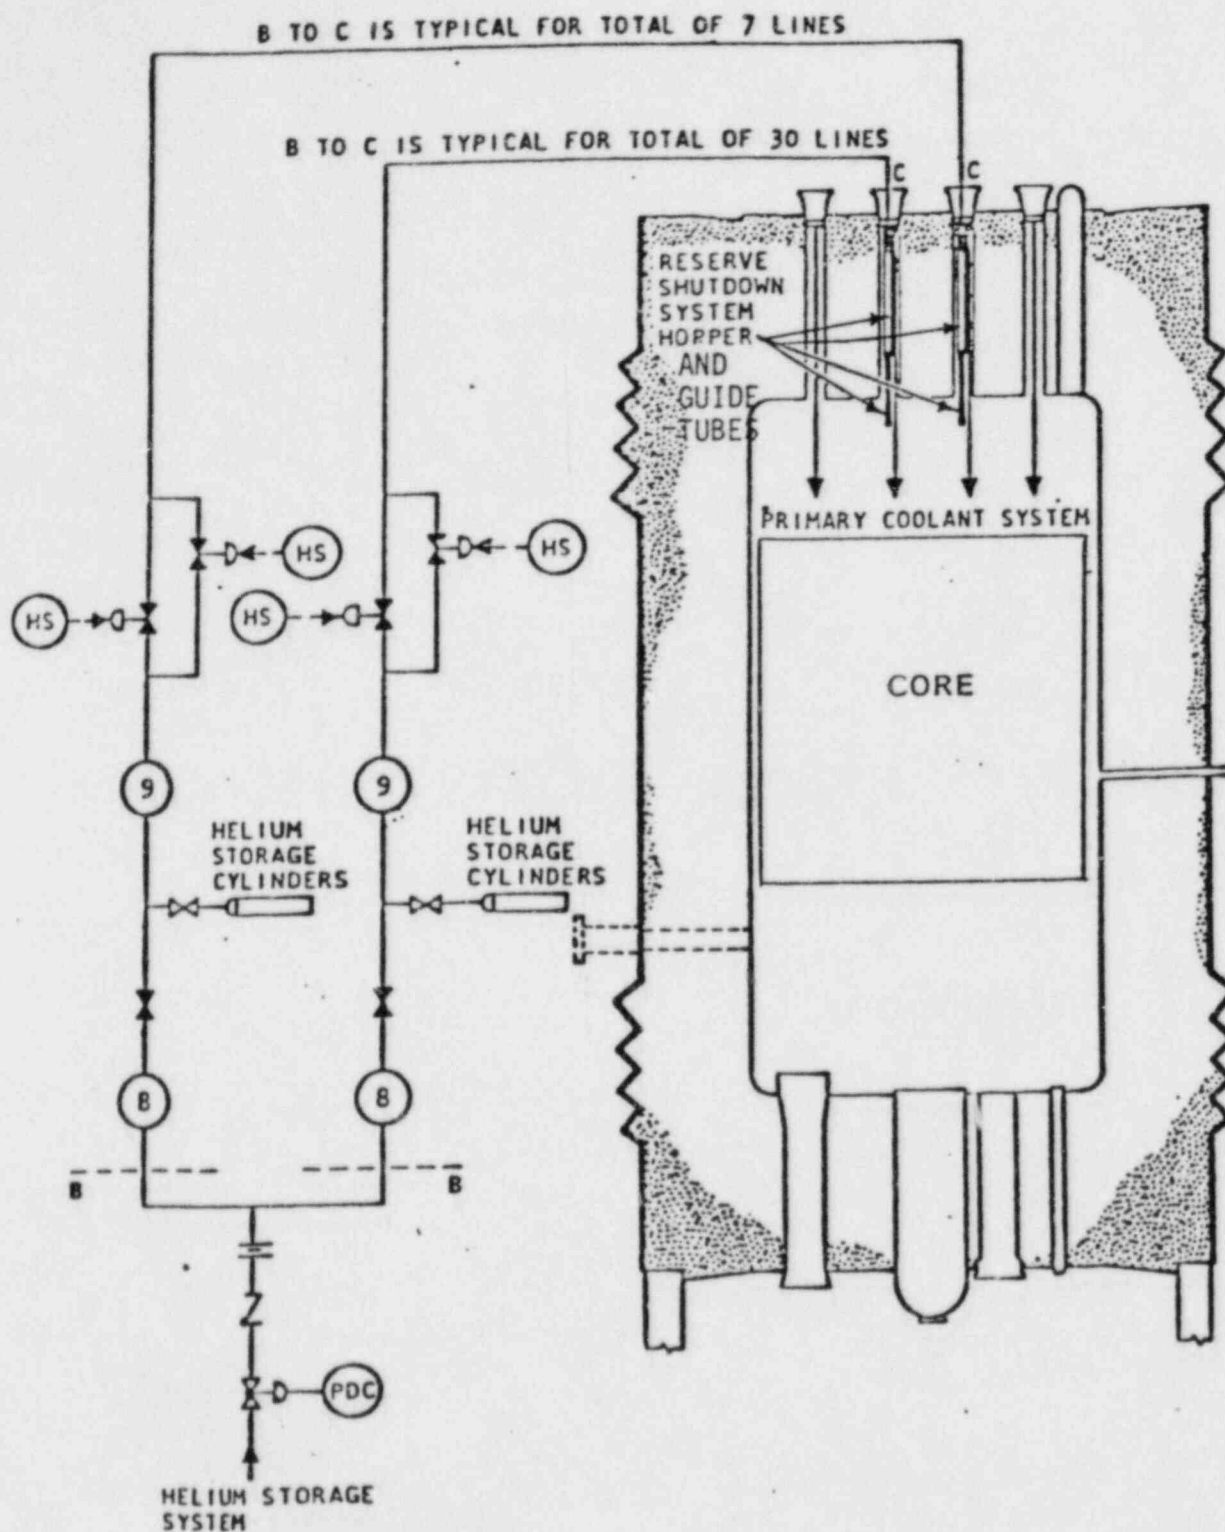
Rupture of the hopper rupture disc and subsequent release of the absorber material into the core is initiated by pressurizing the hopper with helium. Each hopper is connected to a separate high pressure helium bottle (2200 psi nominal) by a pressurizing line that allows helium flow from the bottle into the hopper immediately above the rupture disc (Figure 4). These bottles have an alarm system associated with them that will actuate when the bottle pressure drops below approximately 1640 psig, at which time the bottles are replaced. Section 3.8.3.2 of the FSAR analyzes reserve shutdown system performance with a minimum helium bottle pressure of 1500 psig. In this case, if the rupture discs fail to burst at the design differential pressure of 165 ± 50 psi, the hopper pressure could build to a maximum of 1015 psia. Since the reactor pressure is 700 psia, a minimum differential pressure of 315 psi can be imposed across the disc, assuring its rupture.

Fig. 4. Reserve shutdown system flow diagram.
