LOUISIANA POWER & LIGHT CO

WATERFORD SES NO. 3

REPORT ON LICENSE CONDITION NO. 16

EVALUATION OF THE POTENTIAL
ADVERSE EFFECTS OF THE
FAILURE OF CONTAINMENT COATINGS
ON POST ACCIDENT FLUID SYSTEMS

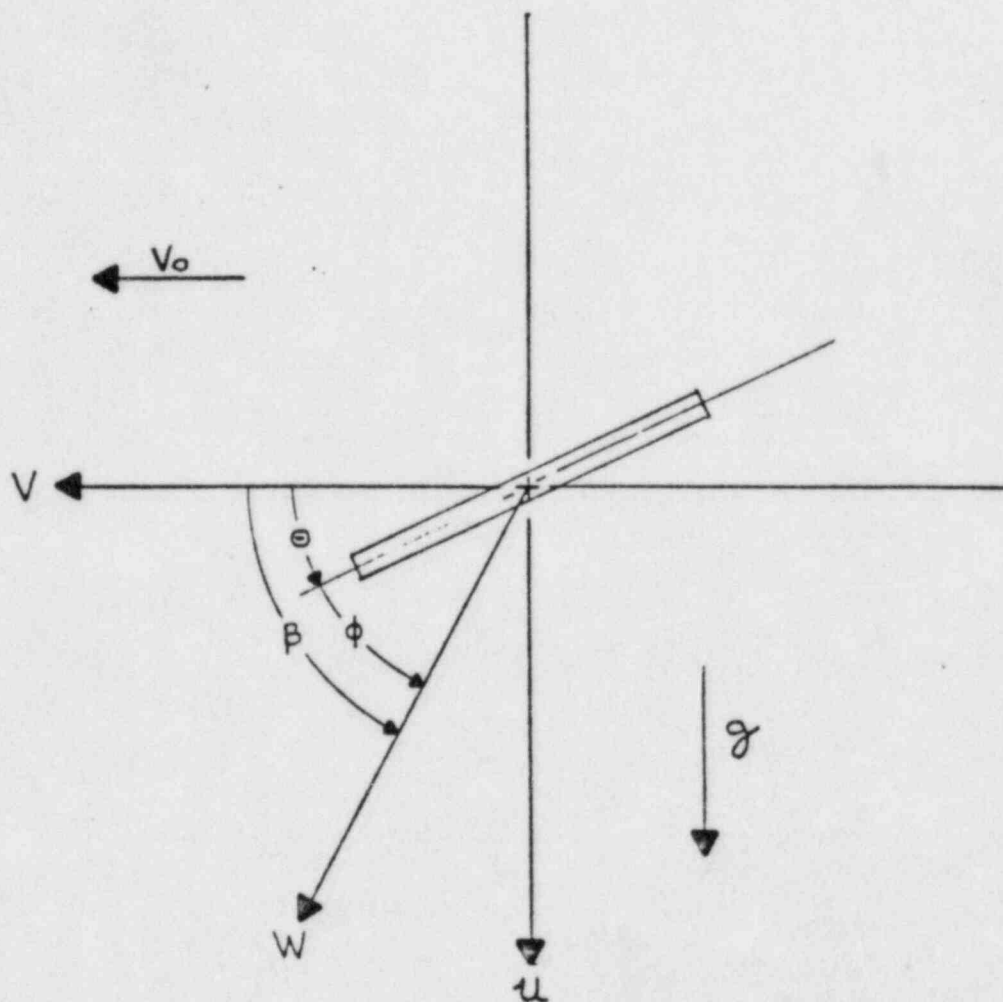
Figure
1

SIS SUMP
FAR FIELD EFFECTS

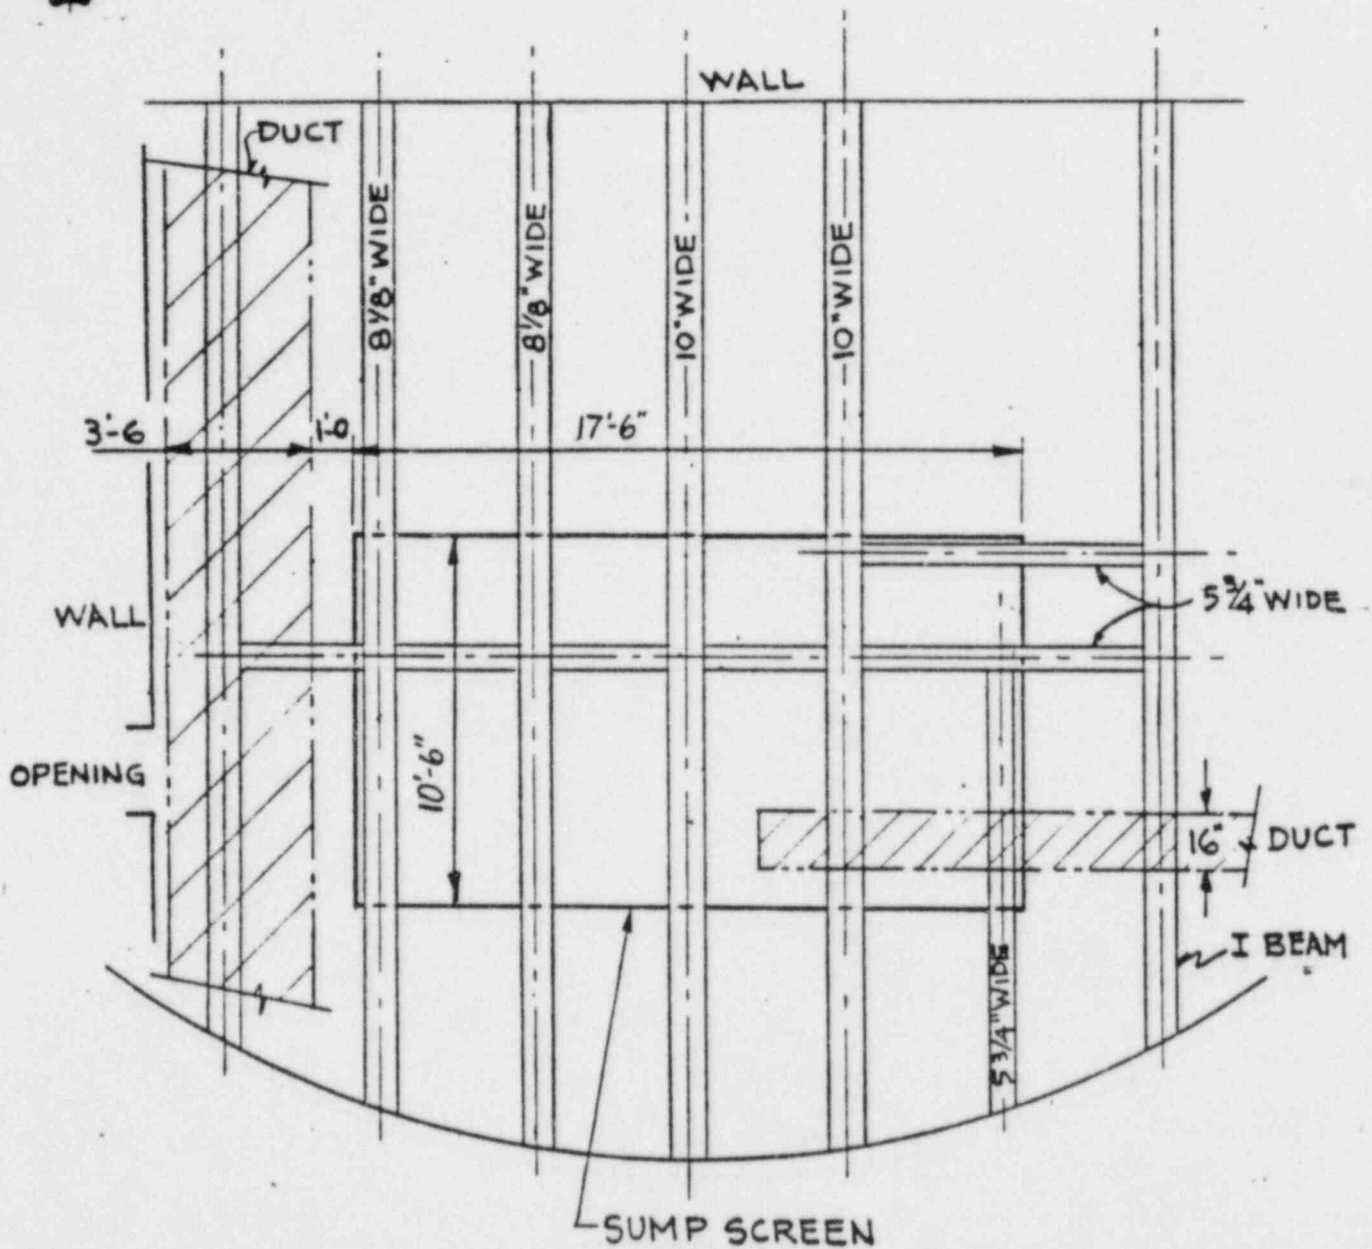
SIS SUMP
PLAN VIEW

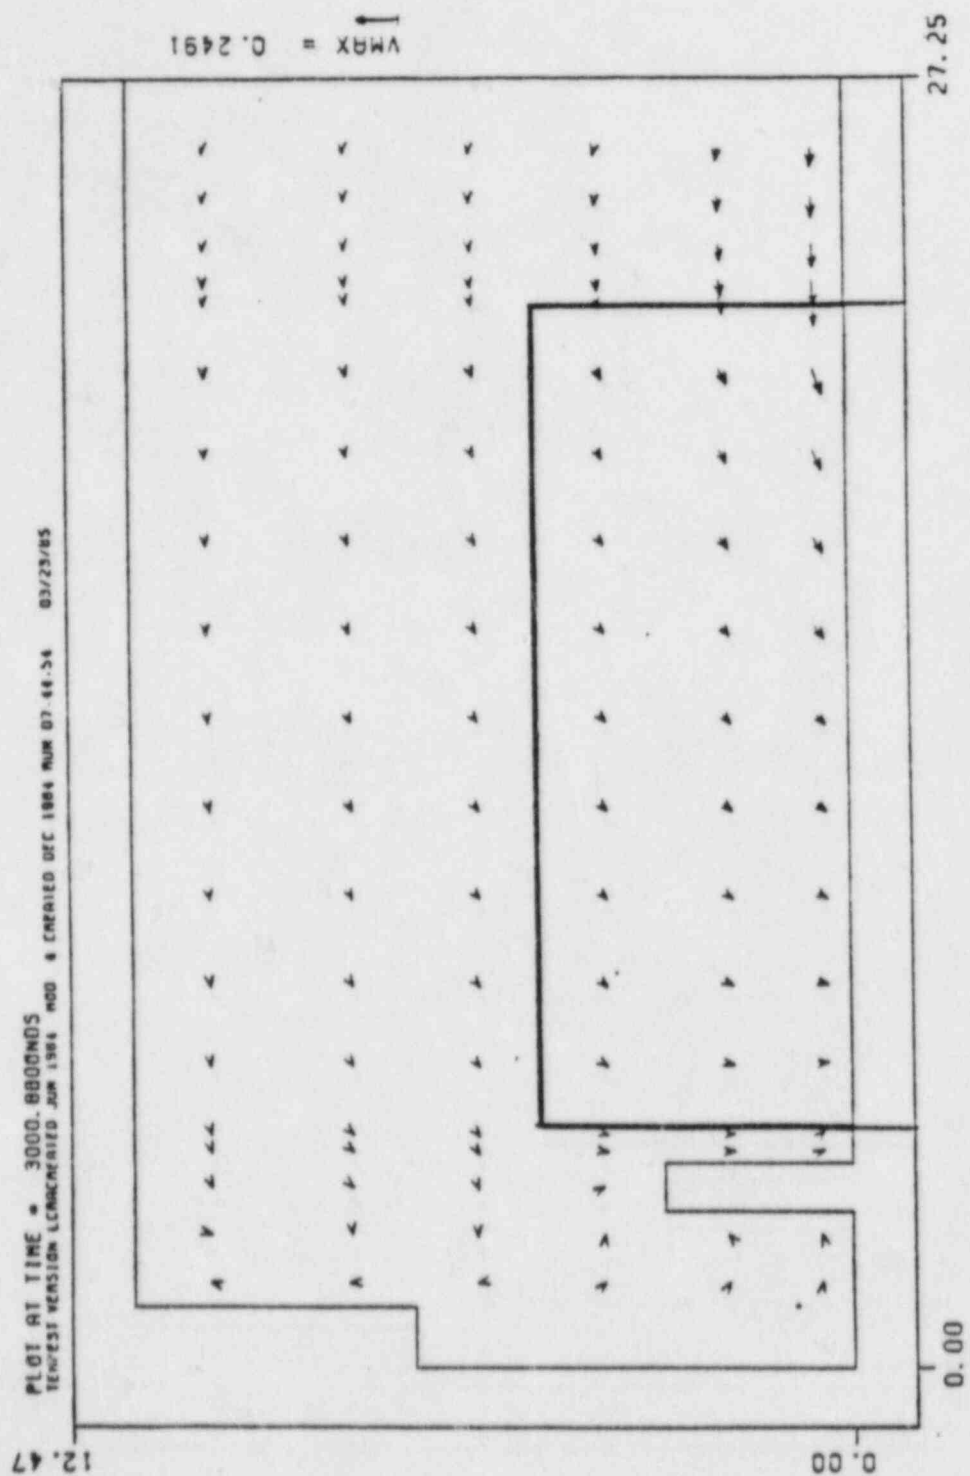
In the Two-Dimensional Analysis, the horizontal (drift) velocity was assumed directed toward the SIS Sump on the four sides of the screen. However, in the Three-Dimensional Analysis, the geometry of the SIS Sump, the location of the openings and the presence of the baskets give a more accurate flow field. Figures 5 and 6 show horizontal cross sections at Elevations -10.5' and -3.0' respectively and Figure 7 shows a vertical cross section for the case of unblocked screens. The results show that most of the flow comes from the right side because of the size of the opening and the presence of only two baskets. Figure 6 shows that the flow on the left and top left is away from the screen, thus confirming that the screen on the left side remains unclogged even without taking credit for the presence of the duct on top. Also, the proximity of the baskets to the screen and their height (60 percent of the screen) gives more unblocked screen area due to the shading effect. Based on the above and the velocity profiles developed in the Three-Dimensional Analysis (which in some cases shows flows parallel to, or away from the screens), the 34-1/2 percent open area of the vertical SIS sump screens as developed by the Two-Dimensional Analysis is conservative.

3-D ANALYSIS
 UNBLOCKED SIS SUMP SCREENS— VERTICAL

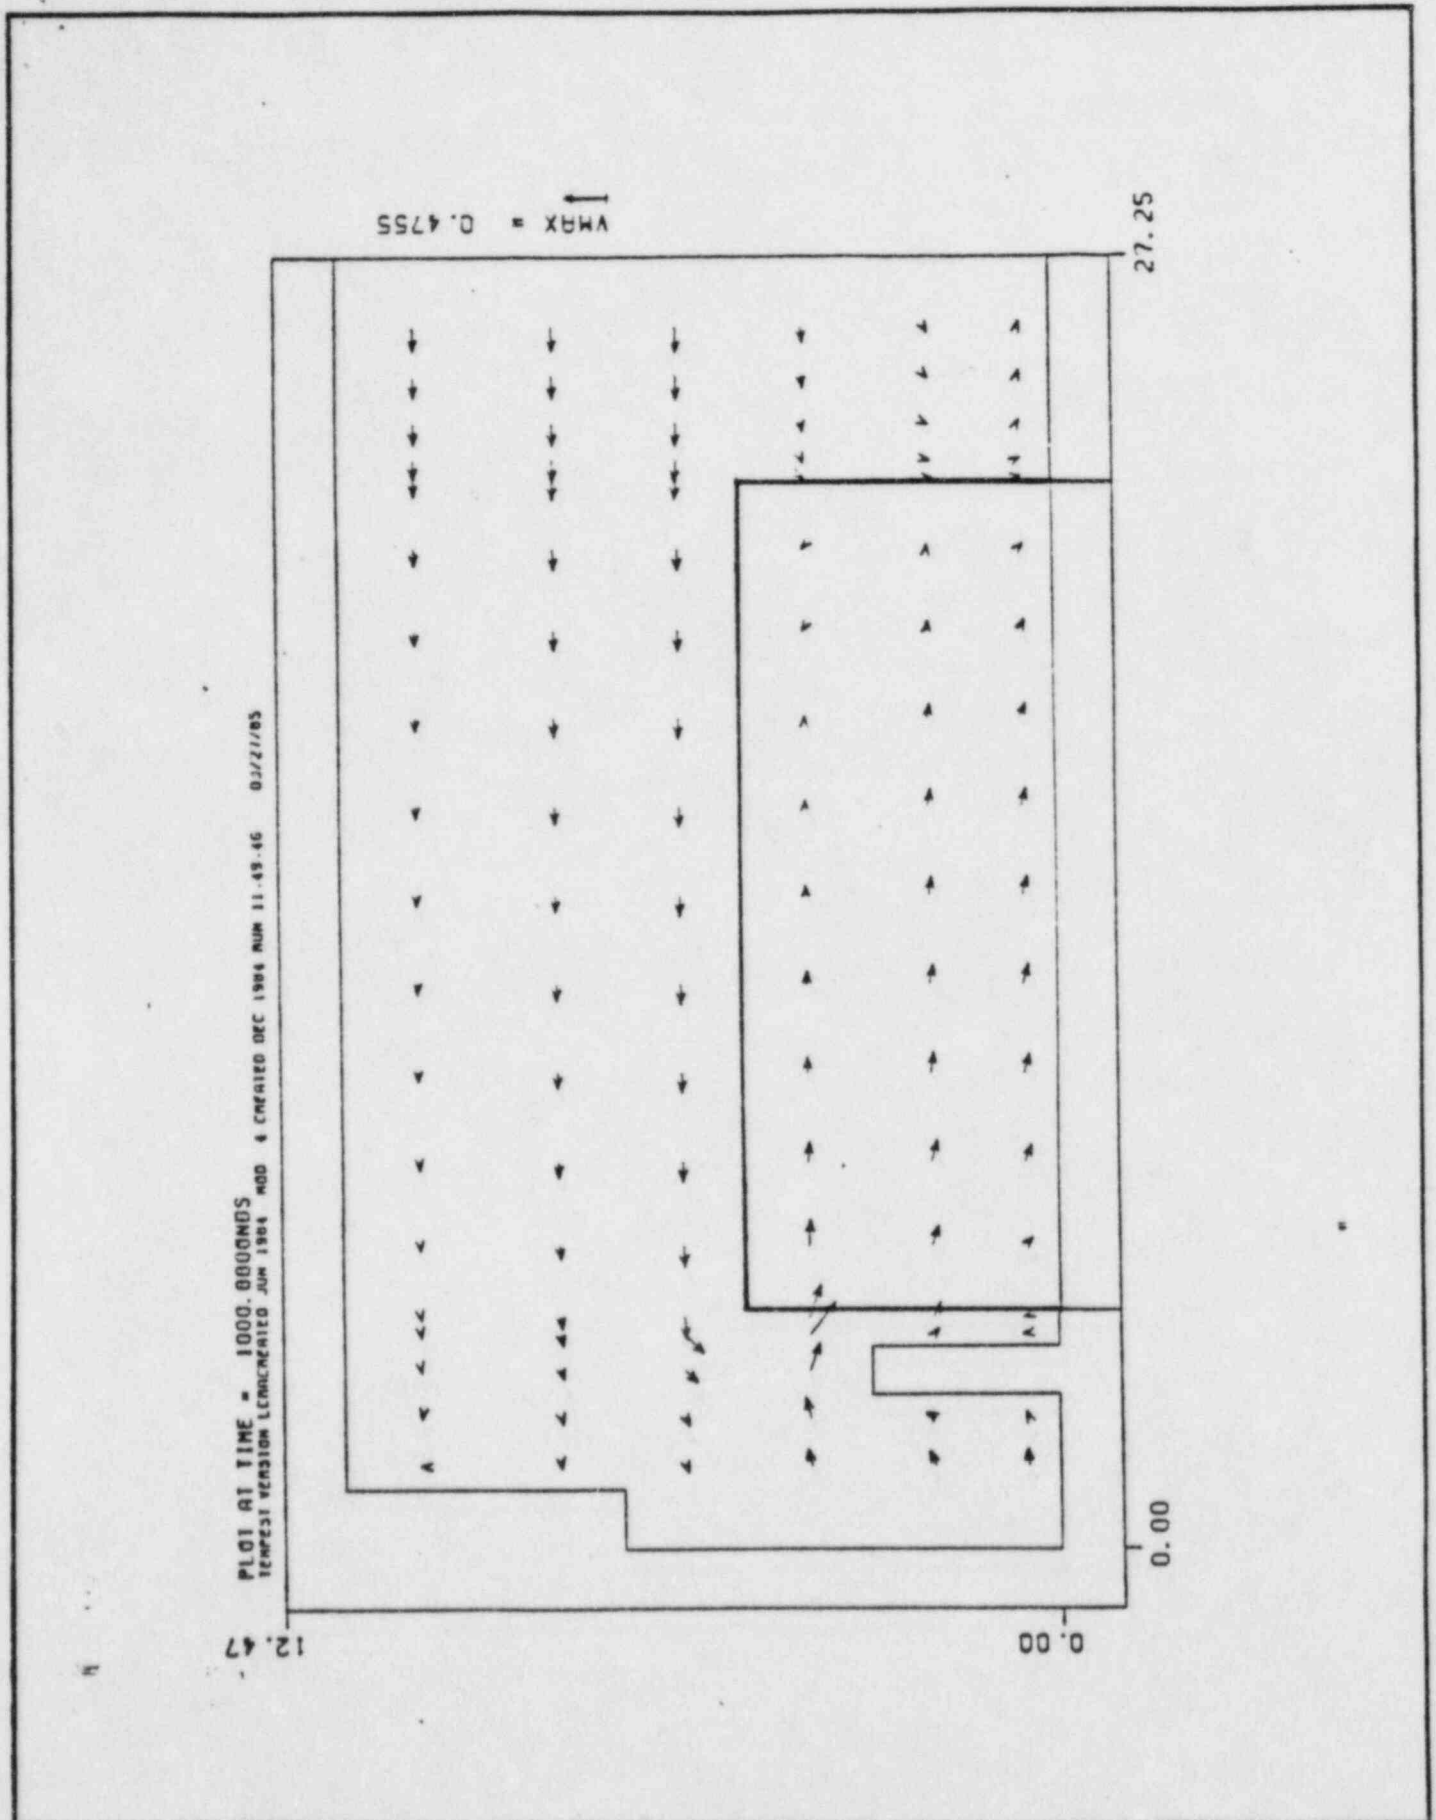
Figure
 8

In addition, an analysis was performed that postulated that except for the vertical screen under the duct all other screens (vertical and horizontal) are blocked. The results shown in Figures 8 and 9 indicate that no additional paint fragments (from the near field or the far field) can be swept up to block the open screen.

3-D ANALYSIS
 BLOCKED SIS SUMP SCREENS - HORIZONTAL
 ELEVATION - 10.5'
