RADIOLOGIC AND ENGINEERING ASSESSMENT

DOE ID NO.: GJ-07866-RS
ADDRESS: 134 MIRIAM AVENUE

MAY 1985

BENDIX FIELD ENGINEERING CORPORATION
P.O. Box 1569
Grand Junction, Colorado 81502

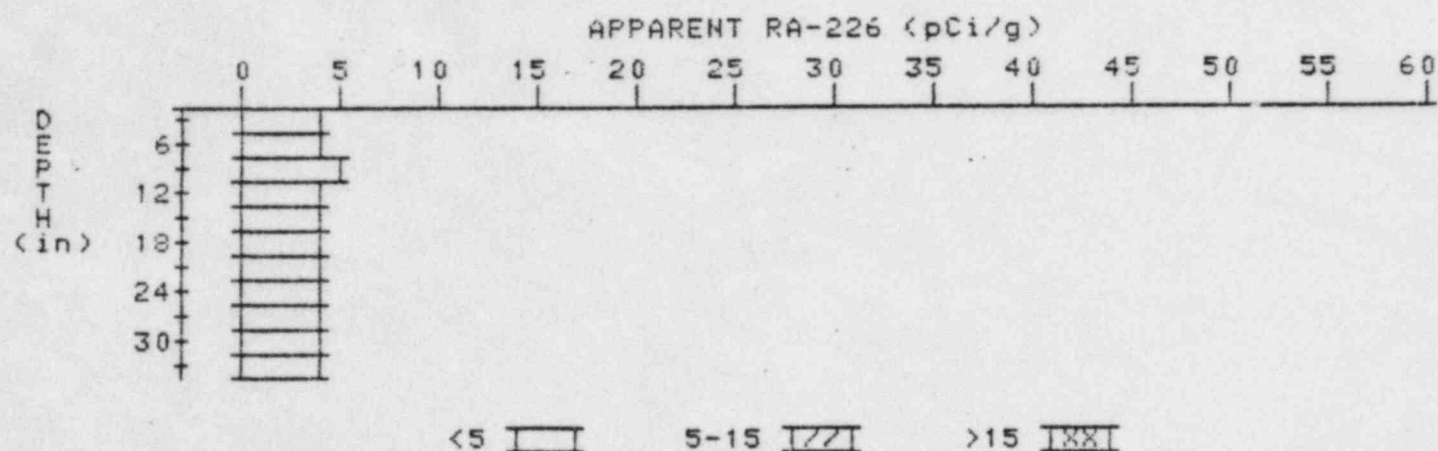
HOLE NUMBER: 2

Depth (in)	Apparent Radium-226 (pCi/g)	Apparent Radium-226 (pCi/g)
	Undeconvolved	Deconvolved
3	3.6	3.6
6	3.9	3.9
9	4.2	4.6
12	4.3	4.5
15	4.3	4.5
18	4.2	4.0
21	4.2	4.4
24	4.1	3.9
27	4.1	4.3
30	4.0	4.0
33	3.9	3.9

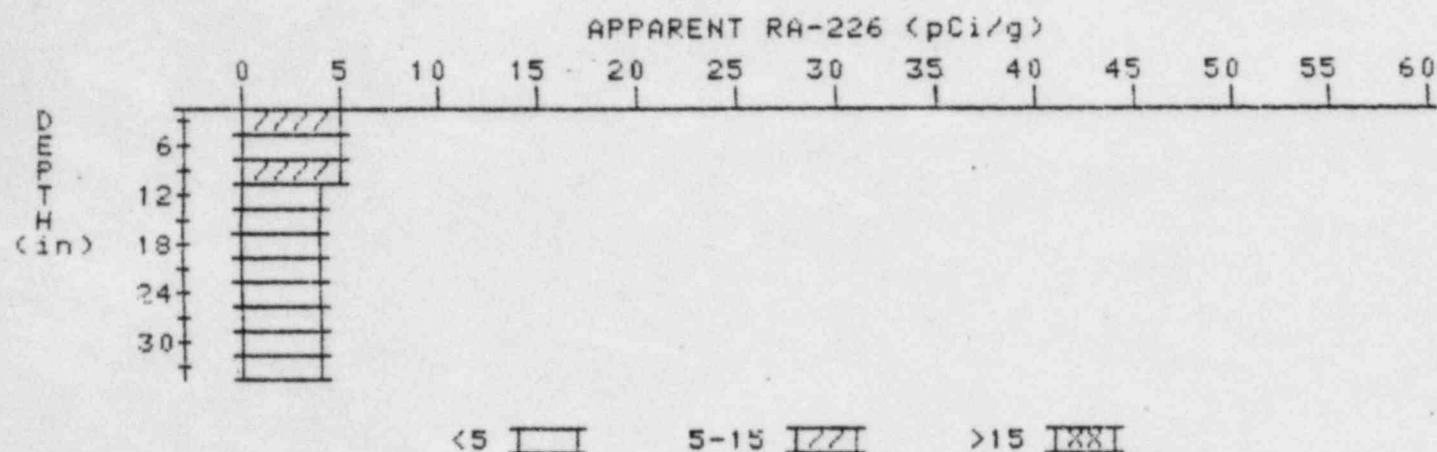
HOLE NUMBER: 5

Depth (in)	Apparent Radium-226 (pCi/g) Undeconvolved	Apparent Radium-226 (pCi/g) Deconvolved
3	5.0	5.0
6	4.8	4.6
9	4.7	5.2
12	4.3	3.8
15	4.2	4.4
18	4.0	3.8
21	3.9	3.7
24	3.9	3.9
27	3.9	3.9
30	3.9	4.1
33	3.8	3.8

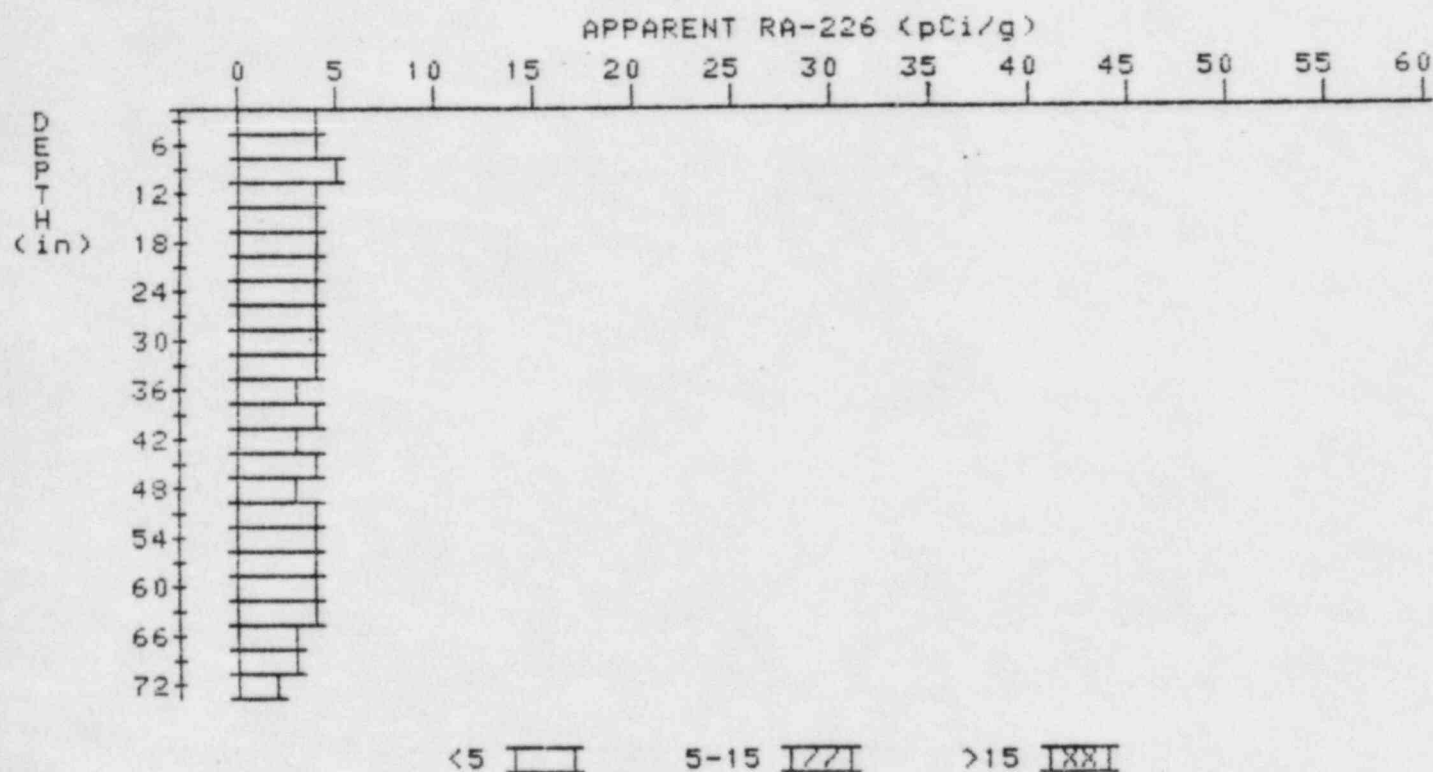
HOLE NUMBER: 8

Depth (in)	Apparent Radium-226 (pCi/g) Undeconvolved	Apparent Radium-226 (pCi/g) Deconvolved
3	3.6	3.6
6	4.0	4.4
9	4.2	4.7
12	4.1	4.1
15	4.0	4.0
18	3.9	3.7
21	3.9	4.1
24	3.8	3.6
27	3.8	4.0
30	3.7	3.5
33	3.7	3.9
36	3.6	3.2
39	3.7	4.2
42	3.5	3.0
45	3.6	4.0

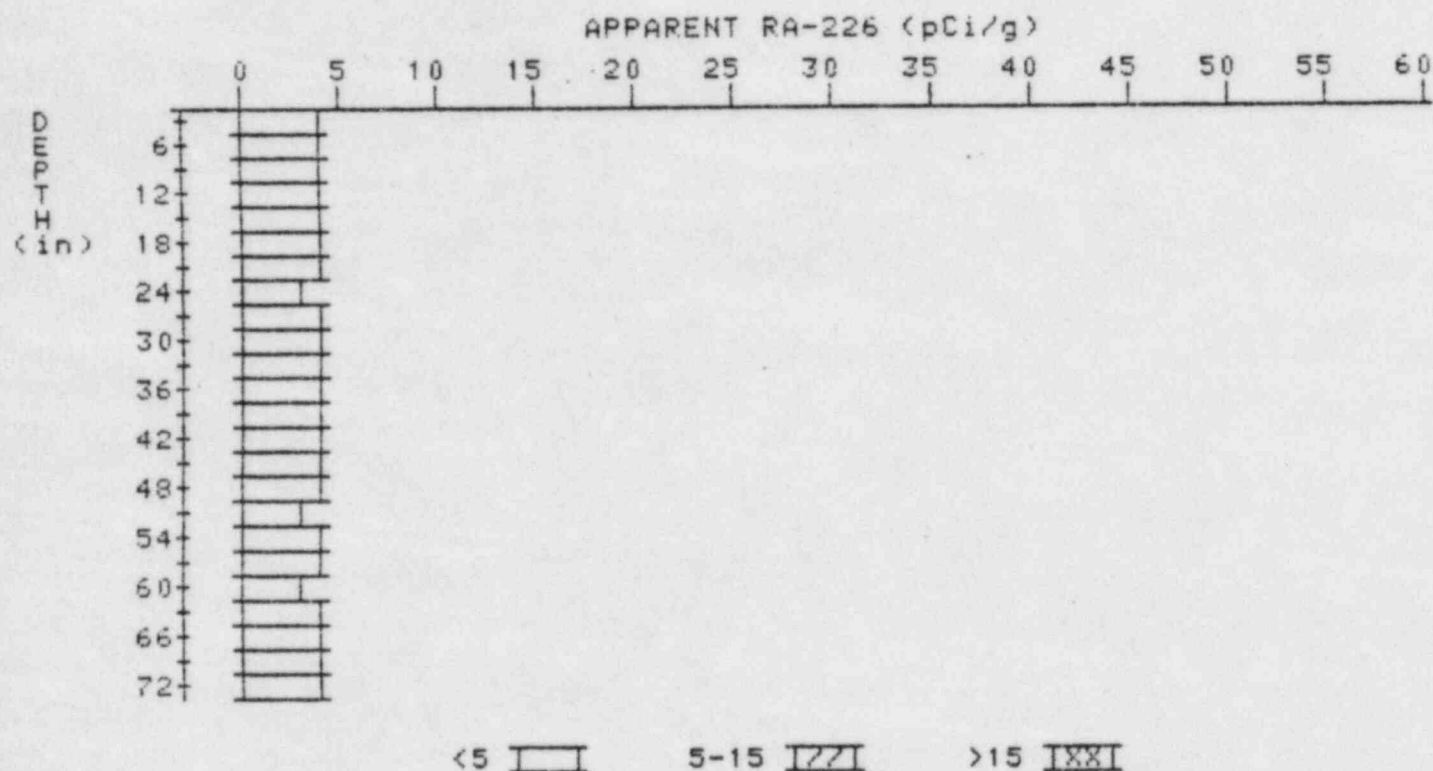
HOLE NUMBER: 11

Depth (in)	Apparent Radium-226 (pCi/g) Undeconvolved	Apparent Radium-226 (pCi/g) Deconvolved
3	3.9	3.9
6	4.1	4.5
9	4.1	4.1
12	4.1	4.1
15	4.1	4.3
18	4.0	3.8
21	4.0	4.4
24	3.8	3.3
27	3.9	4.1
30	3.9	4.1
33	3.8	3.6
36	3.8	4.0
39	3.7	3.5
42	3.7	3.7
45	3.7	3.5

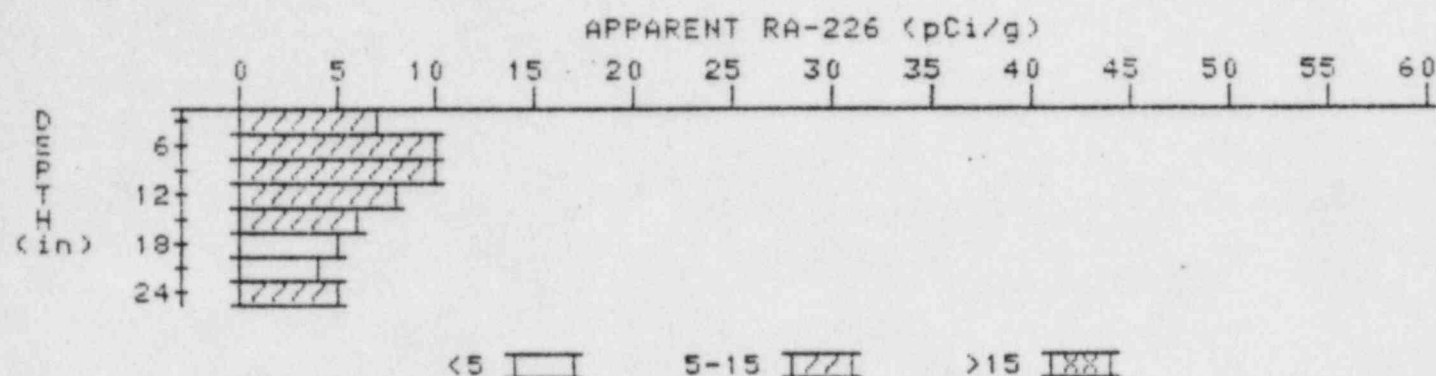
HOLE NUMBER: 12

Depth (in)	Apparent Radium-226 (pCi/g) Undeconvolved	Apparent Radium-226 (pCi/g) Deconvolved
=====	=====	=====
3	6.7	6.7
6	7.9	9.9
9	8.0	9.6
12	7.2	7.6
15	6.2	5.8
18	5.4	4.5
21	5.1	4.2
24	5.3	5.3

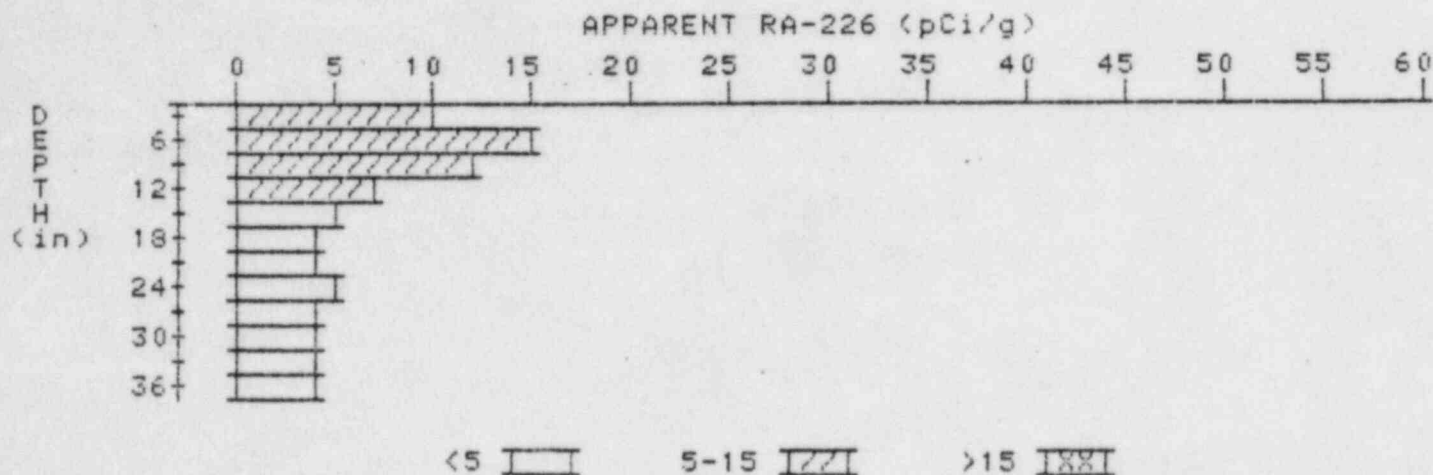
HOLE NUMBER: 15

Loc #	Grid Location	Depth (in.)	Meas. Type	In Situ Ra-226 (pCi/g)		Chem Ra-226 (pCi/g)	Comments
				Tot. Ct	Spectr.		
15	214223	15	TC	6.0		*	
		18	TC	5.1		*	
		21	TC	4.7		*	
		24	TC	4.5		*	
		27	TC	4.3		*	
		30	TC	4.2		*	
		33	TC	4.1		*	
		36	TC	4.2		*	
16	219251	00	DS	1.2		*	South foundation
		06	DS	1.6		*	DC = 0 inches
		00-06	SS			2.3	
17	228236	00	DS	2.4		*	South of house
		06	DS	2.3		*	DC = 12 inches
		12	DS	1.1		*	
		00-06	SS			6.1	
18	232249	00	DS	5.8		*	Southeast corner
		03	TC	6.1		*	of house
		06	TC	6.2		*	DC = 12 inches
		09	TC	5.5		*	Based on the
		12	TC	4.9		*	deconvolution graph
		15	TC	4.4		*	
		18	TC	4.2		*	
		21	TC	4.1		*	
		24	TC	4.1		*	
		27	TC	4.1		*	
		30	TC	4.1		*	
		33	TC	4.0		*	
19	234242	00	DS	3.7		*	Southeast corner
		06	DS	3.2		*	of house
		12	DS	1.9		*	DC = 12 inches
		00-06	SS			7.7	
20	240290	00	DS	<1.0		*	East of house
		00-06	SS			1.8	Background
		03	TC	3.5		*	DC = 0 inches
		06	TC	3.7		*	
		09	TC	3.8		*

Depth (in)	Apparent Radium-226 (pCi/g) Undeconvolved	Apparent Radium-226 (pCi/g) Deconvolved
3	9.5	9.5
6	10.8	14.9
9	9.8	11.8
12	7.7	7.0
15	6.0	4.6
18	5.1	4.2
21	4.7	4.3
24	4.5	4.5
27	4.3	4.1
30	4.2	4.2
33	4.1	3.7
36	4.2	4.2

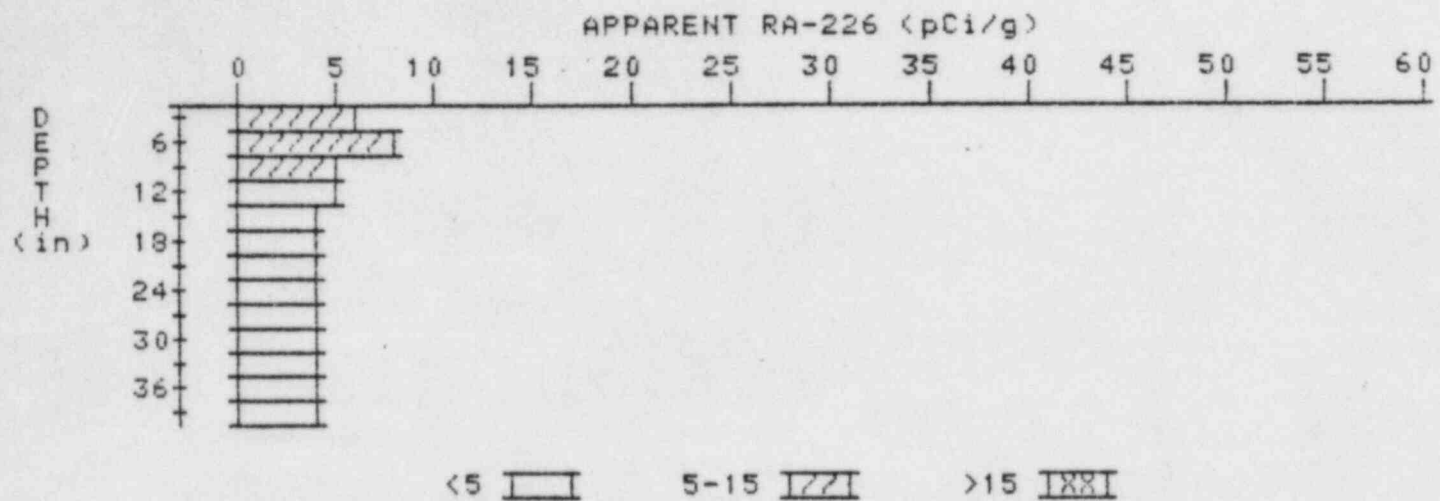
HOLE NUMBER: 18

Depth (in)	Apparent Radium-226 (pCi/g) Undeconvolved	Apparent Radium-226 (pCi/g) Deconvolved
3	6.1	6.1
6	6.2	7.6
9	5.5	5.3
12	4.9	4.7
15	4.4	3.9
18	4.2	4.0
21	4.1	3.9
24	4.1	4.1
27	4.1	4.1
30	4.1	4.3
33	4.0	3.8
36	4.0	4.2
39	3.9	3.9

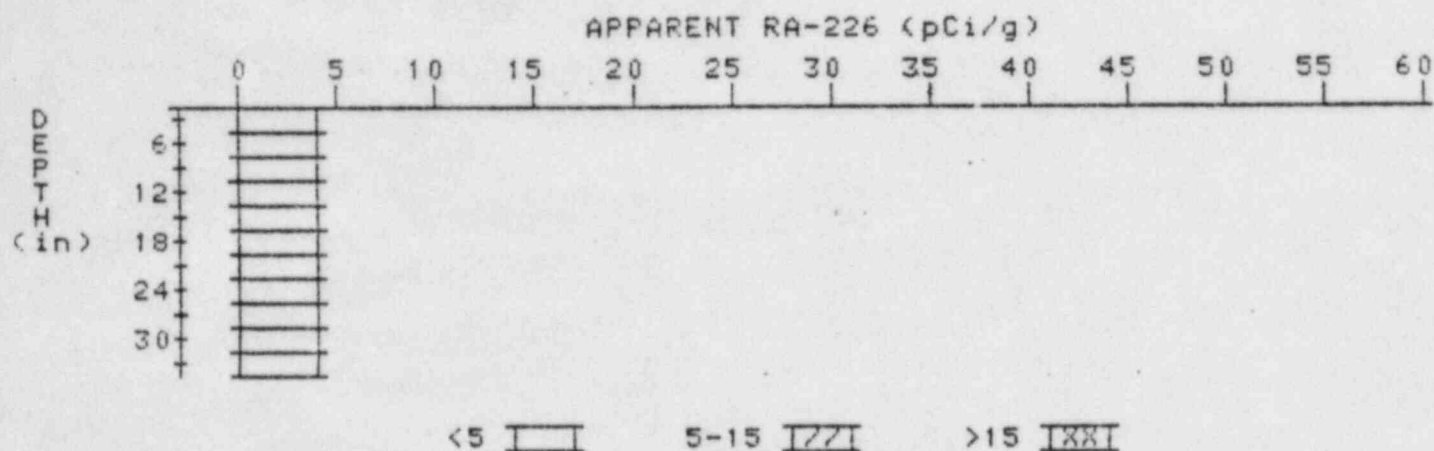
HOLE NUMBER: 20

Depth (in)	Apparent Radium-226 (pCi/g) Undeconvolved	Apparent Radium-226 (pCi/g) Deconvolved
3	3.5	3.5
6	3.7	3.9
9	3.8	4.0
12	3.8	3.8
15	3.8	3.8
18	3.8	3.8
21	3.8	3.8
24	3.8	3.8
27	3.8	3.8
30	3.8	4.0
33	3.7	3.7

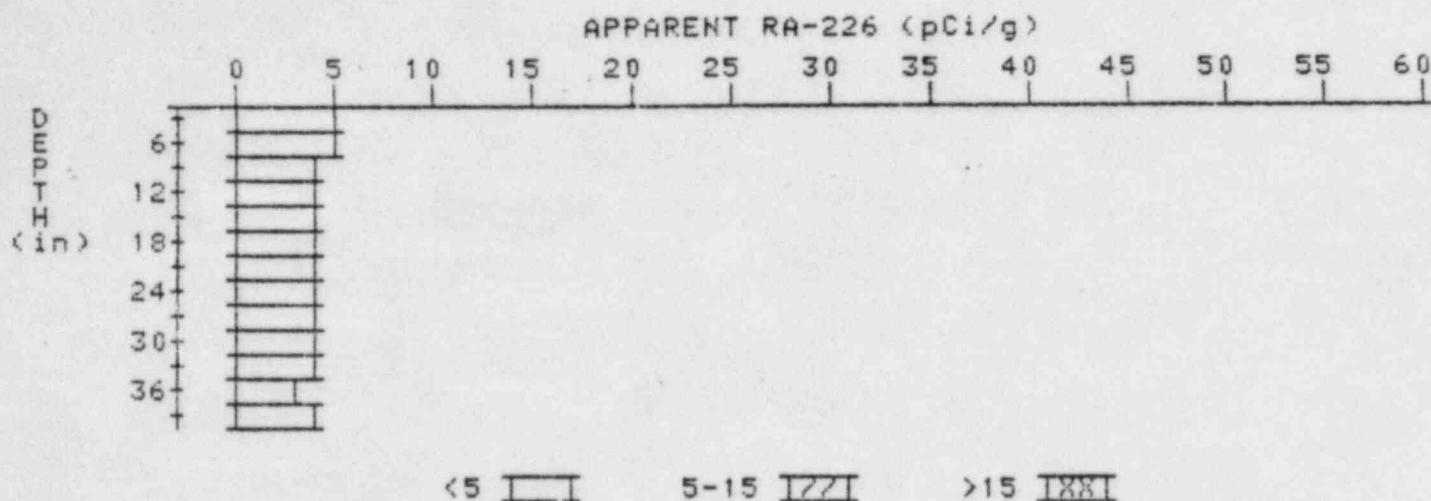
HOLE NUMBER: 21

Depth (in)	Apparent Radium-226 (pCi/g) Undeconvolved	Apparent Radium-226 (pCi/g) Deconvolved
3	4.5	4.5
6	4.5	4.9
9	4.3	4.1
12	4.2	4.2
15	4.1	3.9
18	4.1	4.1
21	4.1	4.5
24	3.9	3.5
27	3.9	3.7
30	4.0	4.4
33	3.9	3.9
36	3.8	3.4
39	3.9	3.9

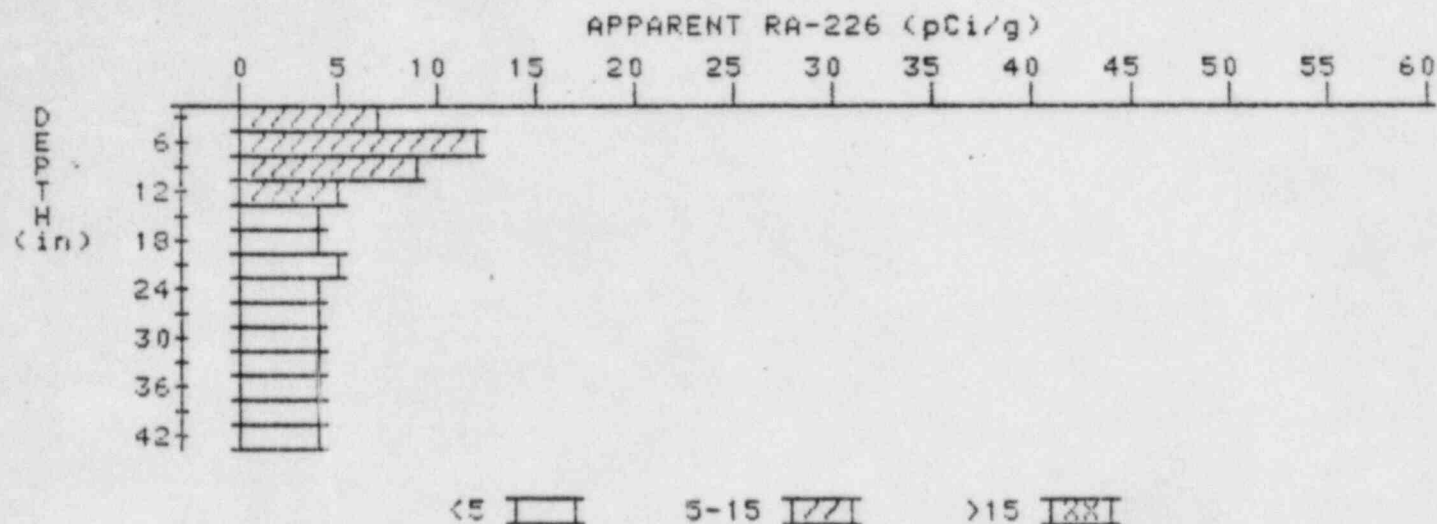
HOLE NUMBER: 22

Depth (in)	Apparent Radium-226 (pCi/g) Undeconvolved	Apparent Radium-226 (pCi/g) Deconvolved
3	7.1	7.1
6	8.3	11.7
9	7.6	9.0
12	6.1	5.0
15	5.2	4.5
18	4.7	4.2
21	4.5	4.7
24	4.2	3.7
27	4.2	4.4
30	4.1	3.9
33	4.1	4.1
36	4.1	4.3
39	4.0	3.8
42	4.0	4.0

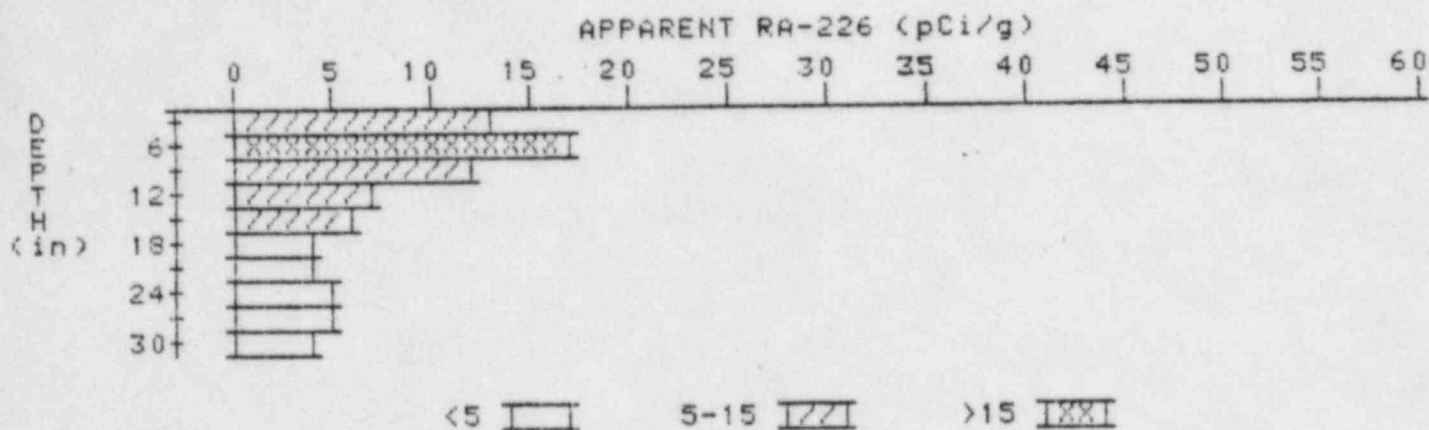
PROPERTY NUMBER: GJ-07866-RS
HOLE NUMBER: 24
LOCATION: 260226

Depth (in)	Apparent Radium-226 (pCi/g) Undeconvolved	Apparent Radium-226 (pCi/g) Deconvolved
3	12.9	12.9
6	13.1	16.8
9	11.2	12.4
12	8.6	7.4
15	6.7	6.0
18	5.2	3.6
21	4.6	3.7
24	4.5	4.5
27	4.4	4.6
30	4.2	4.2

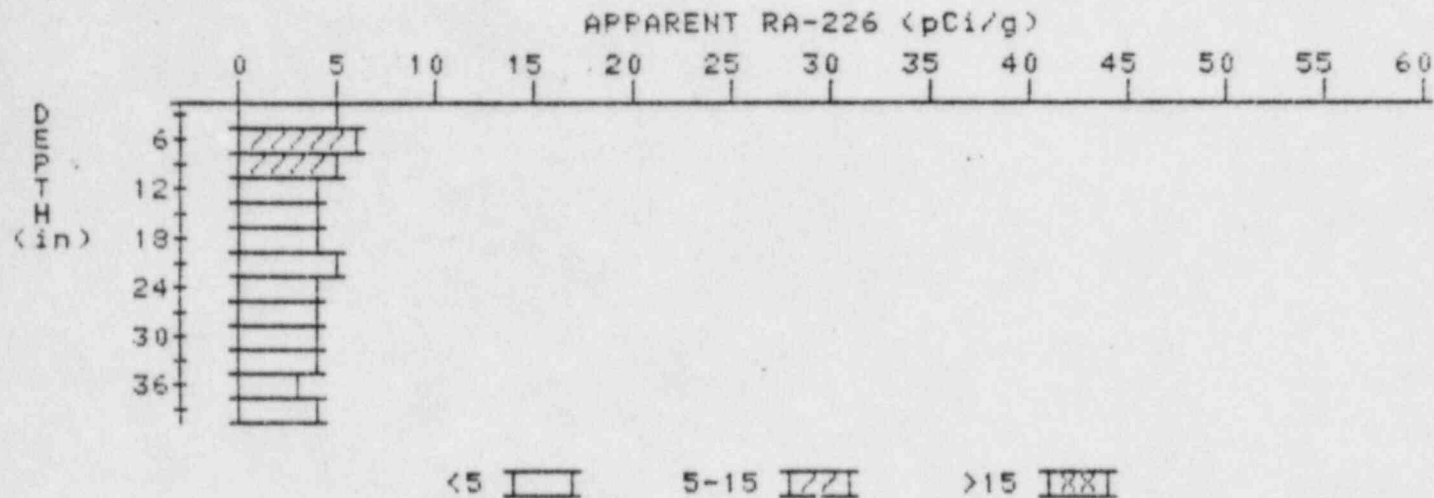
PROPERTY NUMBER: GJ-07866-R5
HOLE NUMBER: 27
LOCATION: 275252

Depth (in)	Apparent Radium-226 (pCi/g) Undeconvolved	Apparent Radium-226 (pCi/g) Deconvolved
3	4.8	4.8
6	5.1	6.0
9	4.9	5.3
12	4.5	4.1
15	4.3	4.1
18	4.2	4.0
21	4.2	4.6
24	4.0	3.6
27	4.0	3.8
30	4.1	4.3
33	4.1	4.5
36	3.9	3.4
39	4.0	4.0
