REGION V

March 31, 1976

The U.S. Nuclear Regulatory Commission and the State of Nevada Department of Human Resources recently cooperated in a joint investigation into allegations that employees at a radioactive waste burial ground near Beatty, Nevada, had been removing equipment and materials from the site.

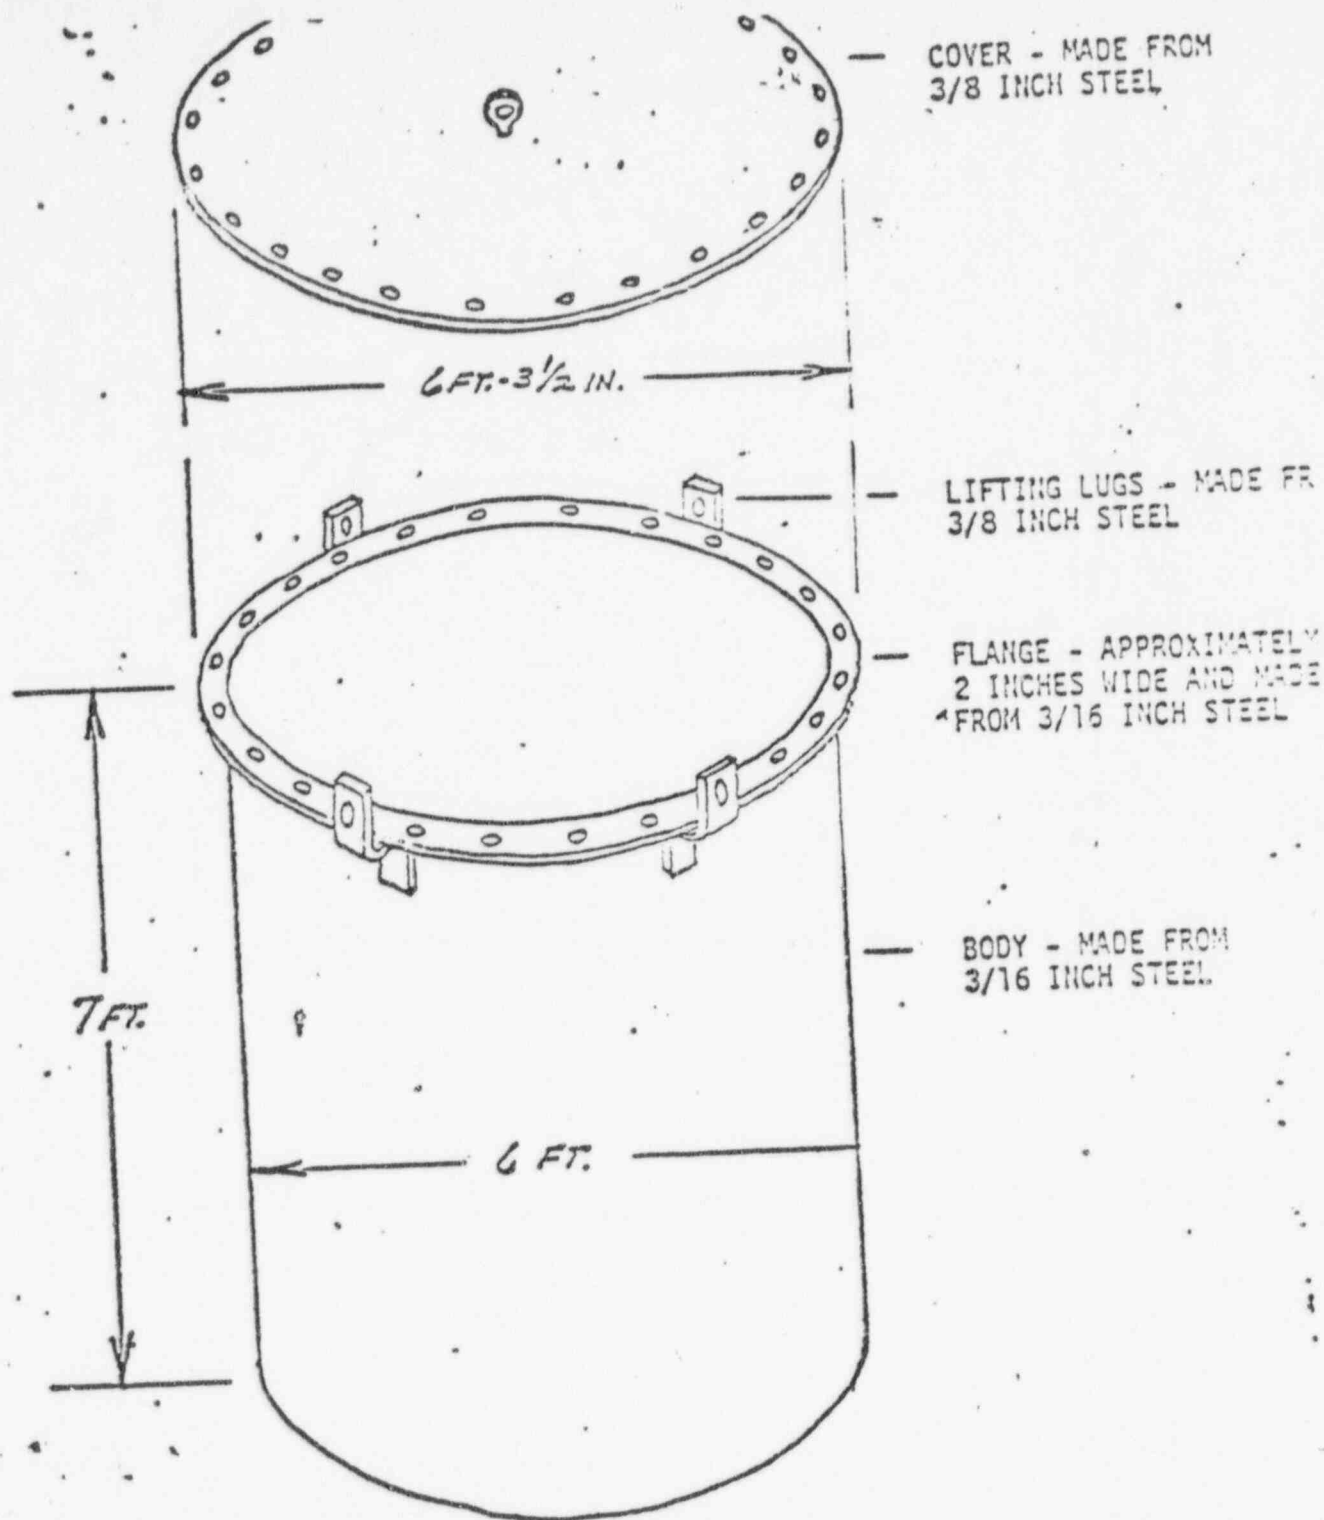
NOTE: TANK CONFIGURATION MAY VARY, FOR EXAMPLE: A TANK MAY CONSIST OF ONE AND A HALF TANKS OR TWO OR MORE TANKS WELDED TOGETHER TO FORM A LARGER TANK.

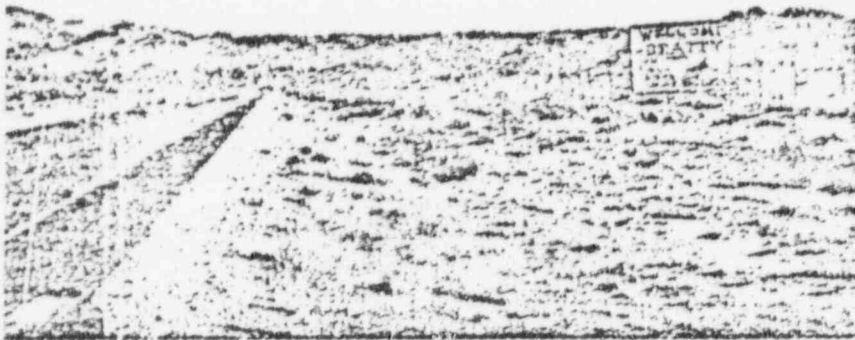
#1

Road into Beatty; northbound Highway 95, photograph taken approximately 1 mile south of town.
