UNITED STATES
NUCLEAR REGULATORY COMMISSION
WASHINGTON, D. C. 20555
July 14, 1982

FACILITY: Three Mile Island, Unit No. 1 (TMI-1)
LICENSEE: GPU Nuclear Corporation (GPUN)
SUBJECT: SUMMARY OF MEETING WITH GPUN ON JUNE 28 and 29, 1982
CONCERNING GPUN'S STEAM GENERATOR RECOVERY PROGRAM

**TMI-1 OTSG Status
and
Repair Process Description**

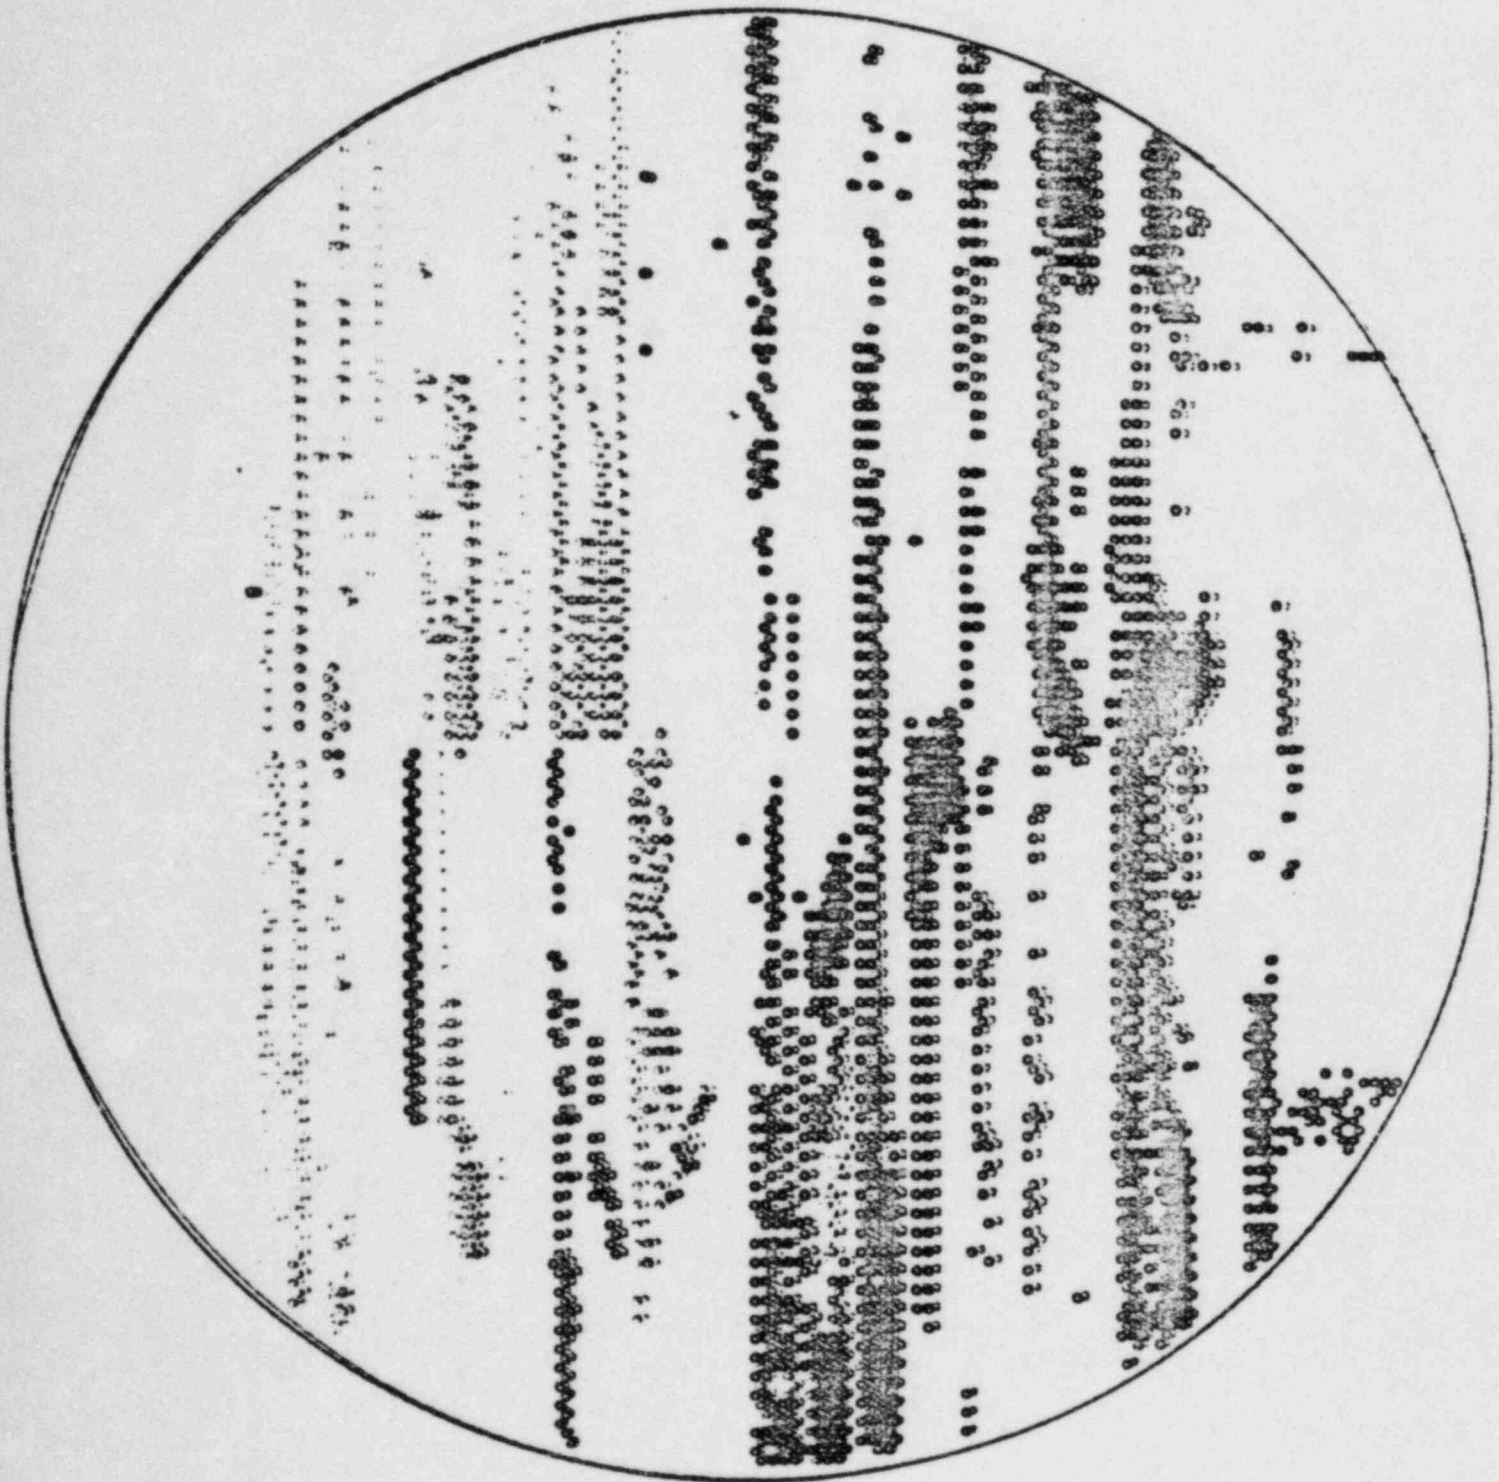
THREE MILE ISLAND NUCLEAR
GENERATING STATION
UNIT 1 STEAM GENERATOR A

TUBE LOCATIONS OF ALL TUBES
FOR TUBE HEAT NUMBERS

- o TUBE FAILURES ARE ASSOCIATED WITH SPECIFIC LOCATIONS IN THE GENERATOR NOT HEAT RELATIONSHIPS.
- o THE DEFECT PATTERNS IN THE TWO GENERATORS APPEAR TO BE DIFFERENT AND THIS WILL NEED TO BE EXPLAINED BY A PARAMETER OTHER THAN HEAT NUMBER.
- o HEATS OF MATERIAL EXIST WHICH HAVE HIGH DEFECT FREQUENCIES IN BAD AREAS AND THE SAME HEATS WILL HAVE LOW DEFECT FREQUENCIES IN GOOD AREAS.

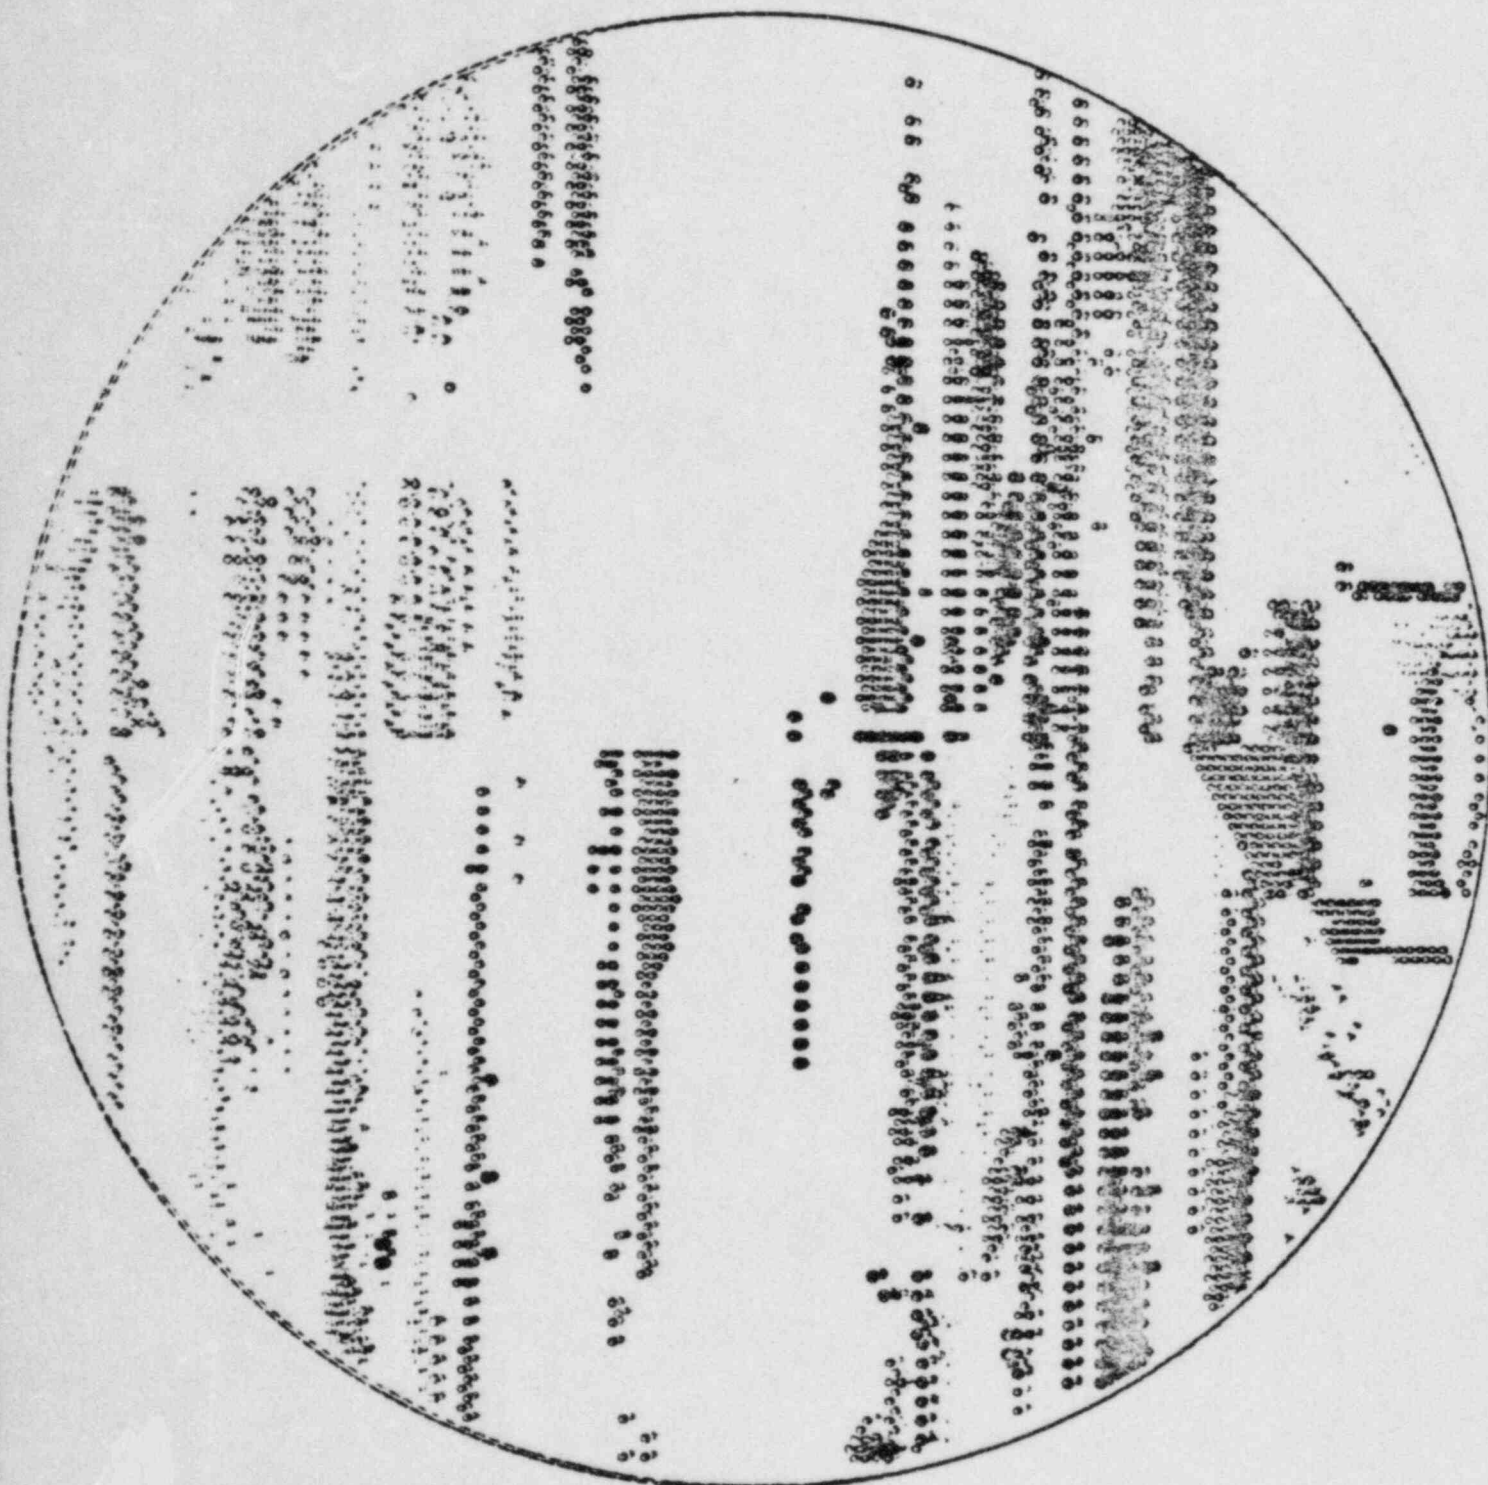
THREE MILE ISLAND NUCLEAR
GENERATING STATION
UNIT 1 STEAM GENERATOR B

TUBE LOCATIONS OF ALL TUBES
FOR TUBE HEAT NUMBERS

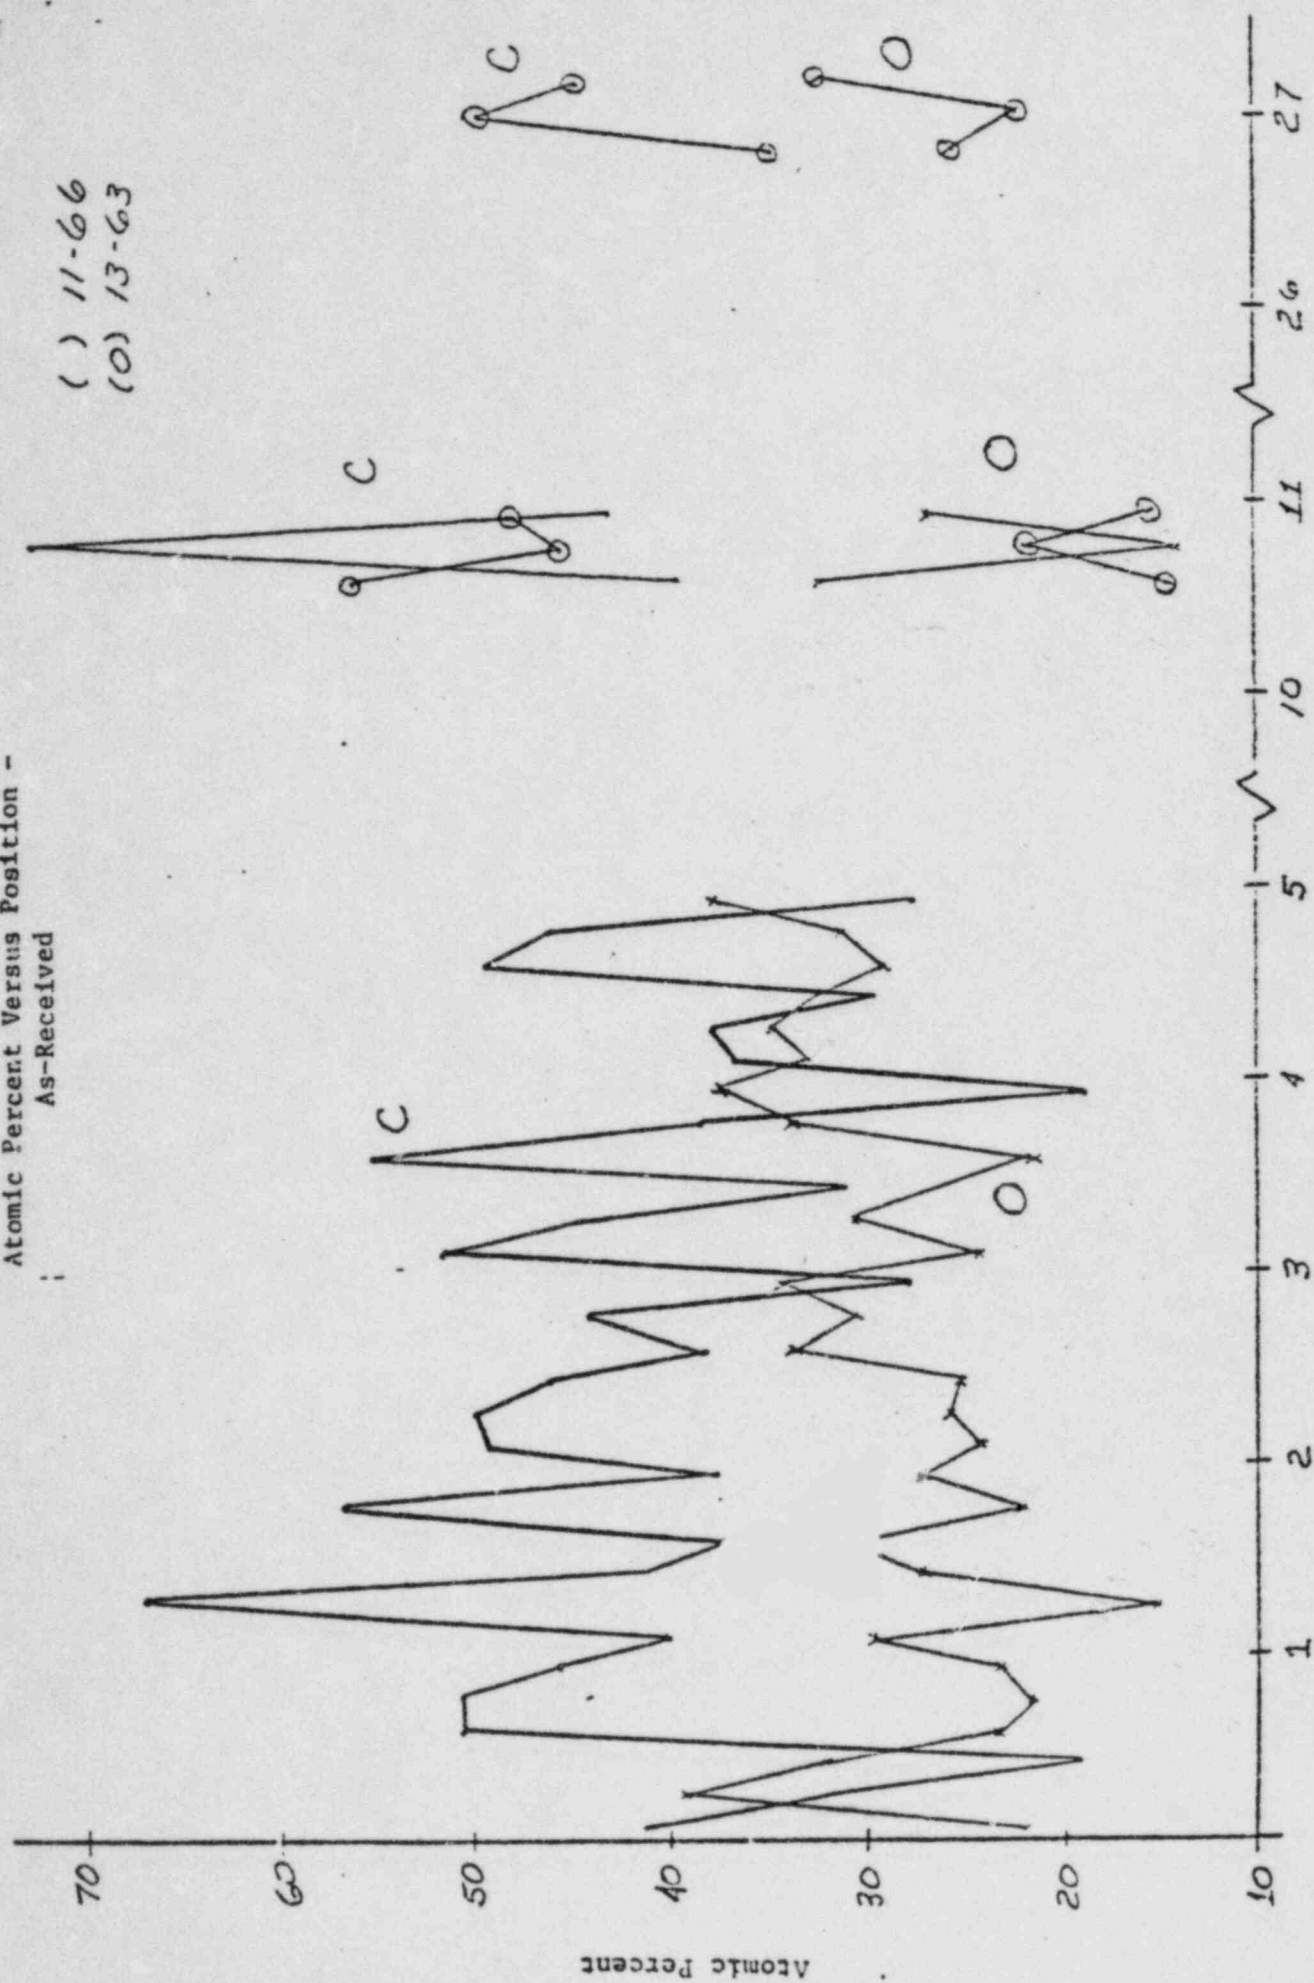
Atomic Percent Versus Position -
As-Received

Distance From Top of Sample, Inches

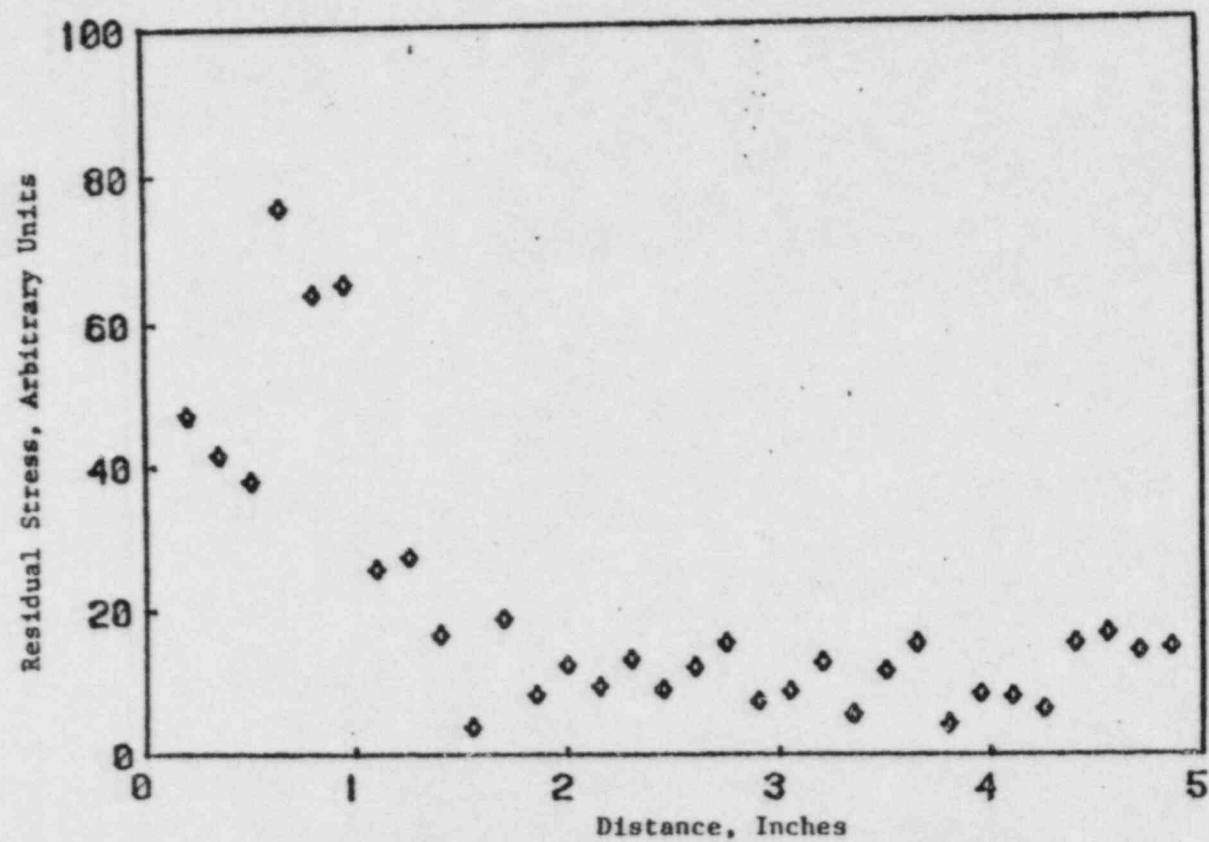
Figure 2.15.1 "Residual Stress" as a Function of Distance from the Top of All-66

- o CARBON APPEARS AS THE MAJOR CONTAMINANT ON FRACTURE SURFACES. SULFUR AND CHLORINE ARE PRESENT AS SECONDARY CONTAMINANTS
- o RESIDUAL STRESS MEASUREMENTS SHOW A PEAK AT THE ROLL TRANSITION AND A UNIFORM DISTRIBUTION THROUGH THE ROLL REGION.

TUBE/TUBESHEET ROLLED/WELDED JOINT
ESTIMATED DISTRIBUTION OF TUBE RESIDUAL STRESSES

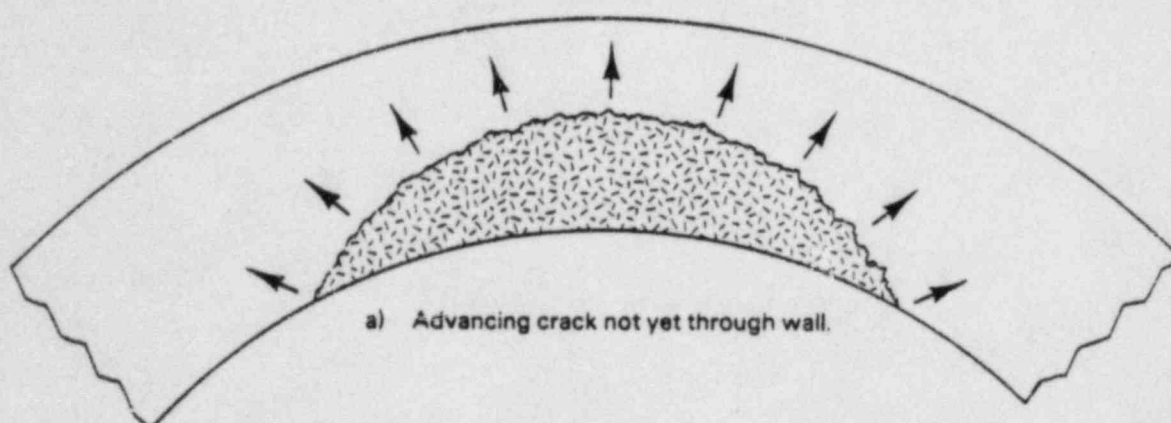
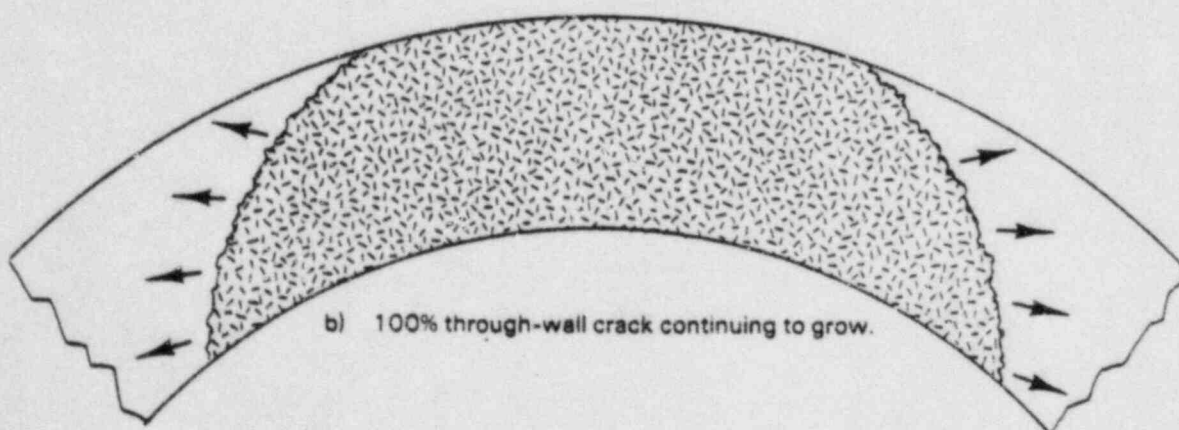
SKETCH OF TYPICAL CRACK SHAPES

a) Advancing crack not yet through wall.

b) 100% through-wall crack continuing to grow.
