FILE NO. G9.25.1.1
CODE OF FEDERAL REGULATIONS
REPORTABLE DEFICIENCY - 10CFR50.55(e)
RIVER BEND STATION - UNIT 1

CAUSE-AND-CORRECTIVE-ACTION ANALYSIS
CONCERNING SUB-SURFACE DEFECTS FOUND
IN
RIVER BEND CORNER JUNCTION TEE WELDS

This report describes the metallurgical investigation undertaken to determine the cause of cracking in River Bend Units 1 and 2 containment shell to mat embedment plate tee weld (corner junction). This investigation was also undertaken to determine if a proper metallurgical structure exists for the weld and its heat-affected zone if it were decided to simply remove the cracks and use the remaining weld. It was determined that the crack was actually a centerline linear shrinkage-voids, interconnected by fine cracks, which occurred during solidification of the undesirable weld nugget or bead shape deposited at the root. If the defect is removed, the remaining weld material is metallurgically acceptable to the ASME Section III, Class MC Code requirements.

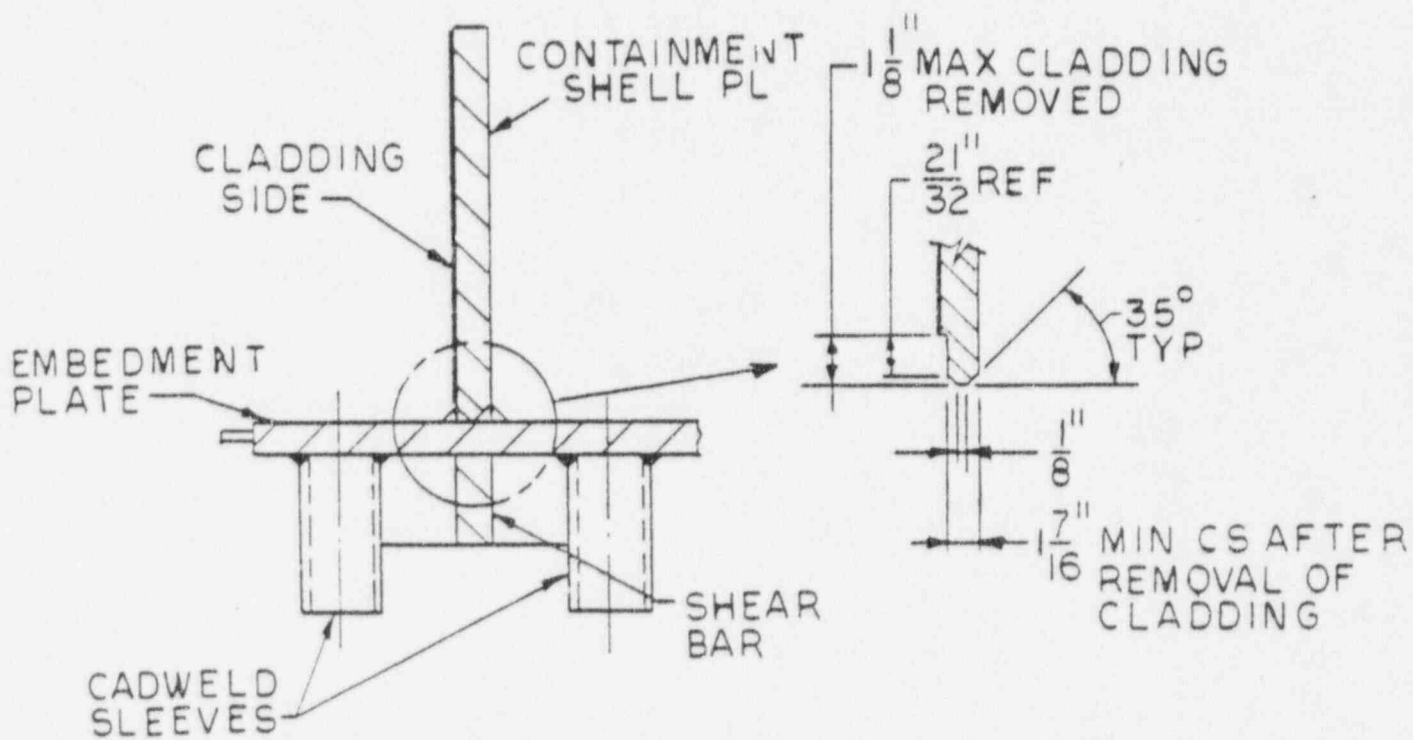
FIGURE 1 CORNER JUNCTION
 WELD JOINT DETAIL

The sub-surface cracks, which are covered by NCR No. 77 (Reference (1)) and illustrated in Figure 1, are probably the result of a solidification phenomenon, related to the convergence of two solidification fronts.

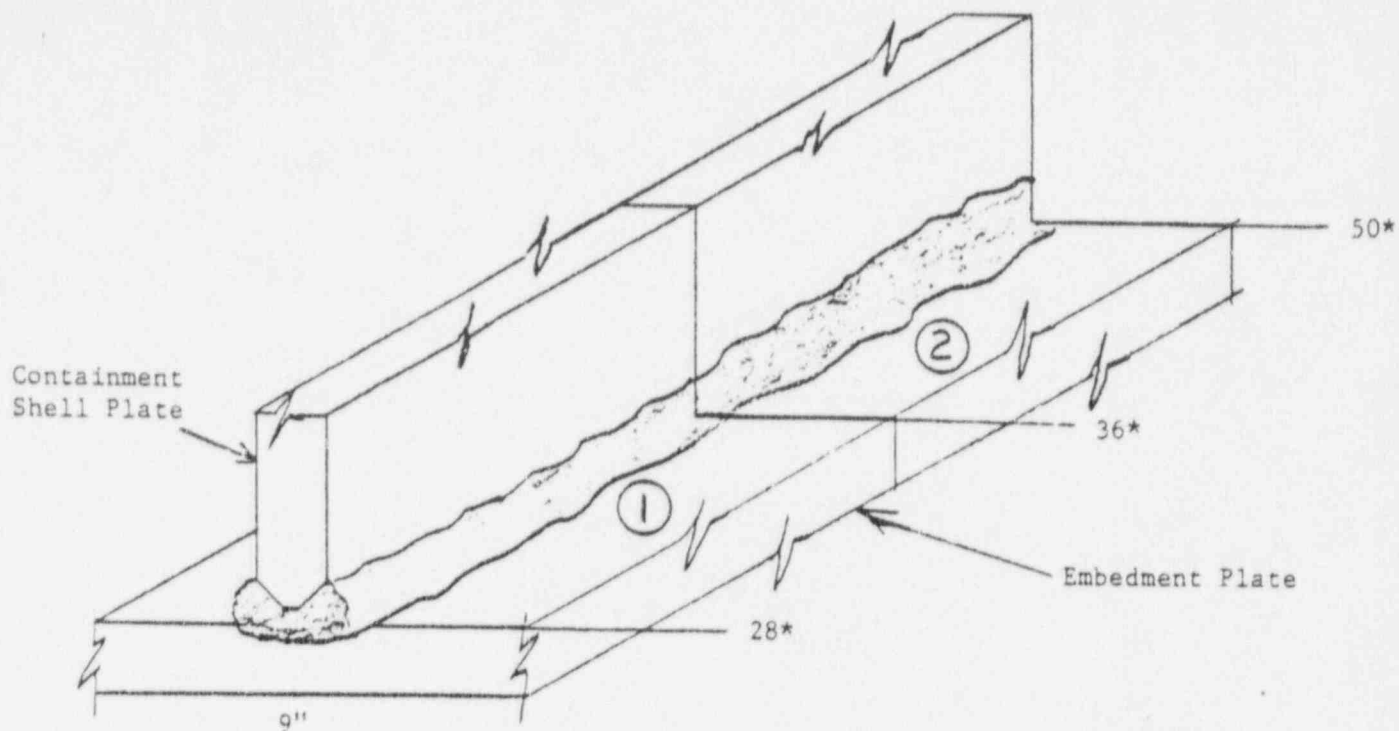
FIGURE 2 CONTAINMENT CORNER JUNCTION T-WELD SECTION
USED FOR METALLURGICAL INVESTIGATION

Sections representing the defective weld root area and sound weld were cut from a Unit 2 assembly (No. 3E30-1) for this investigation. The samples were sectioned as shown in Figure 2. Section 2 contained root area indications, and Section 1 had a sound weld based on ultrasonic examination. The following tests and examinations were performed for this investigation:

SECTION 1 - SECTION CONTAINING SOUND WELD USED FOR CHARPY
IMPACT TEST SPECIMENS.

SECTION 2 - SECTION CONTAINING CRACKED WELD USED FOR METALLOGRAPHY,
HARDNESS AND CHEMICAL ANALYSIS SPECIMENS.

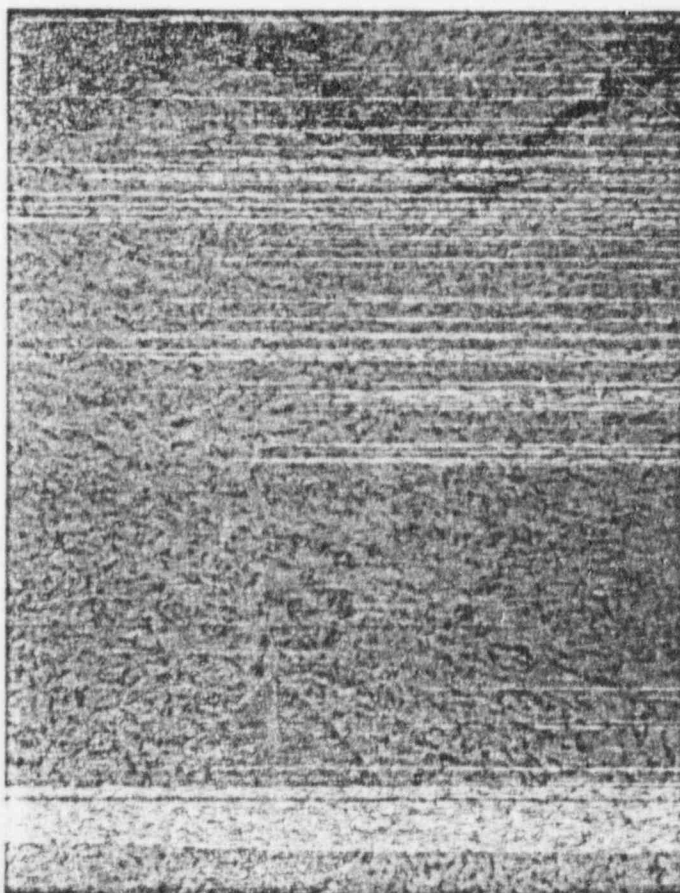
FIGURE 4B

WELD METAL MICROSTRUCTURE NEAR DEFECT. (THE
MICROSTRUCTURE CONSISTS OF BOUNDARY FERRITE,
ACICULAR FERRITE, AND CARBIDE.)

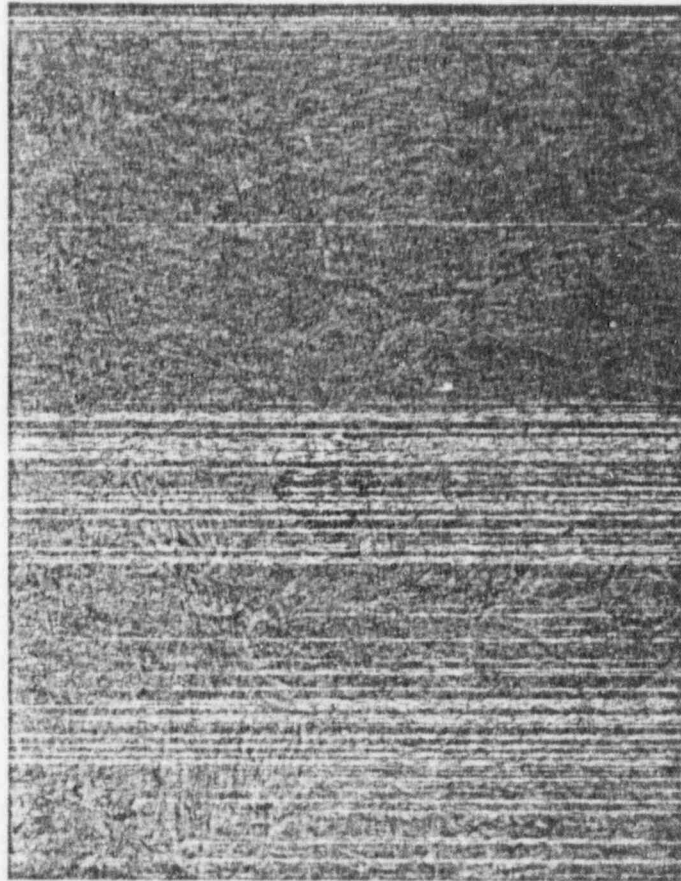
FIGURE 6

MICROSTRUCTURE OF HAZ ABOVE THE CENTER BEAD
IN CONTAINMENT SHELL PLATE. (THE MICROSTRUCTURE
SHOWS PRIOR AUSTENITIC GRAIN BOUNDARIES
SURROUNDING BAINITE COLONIES.)

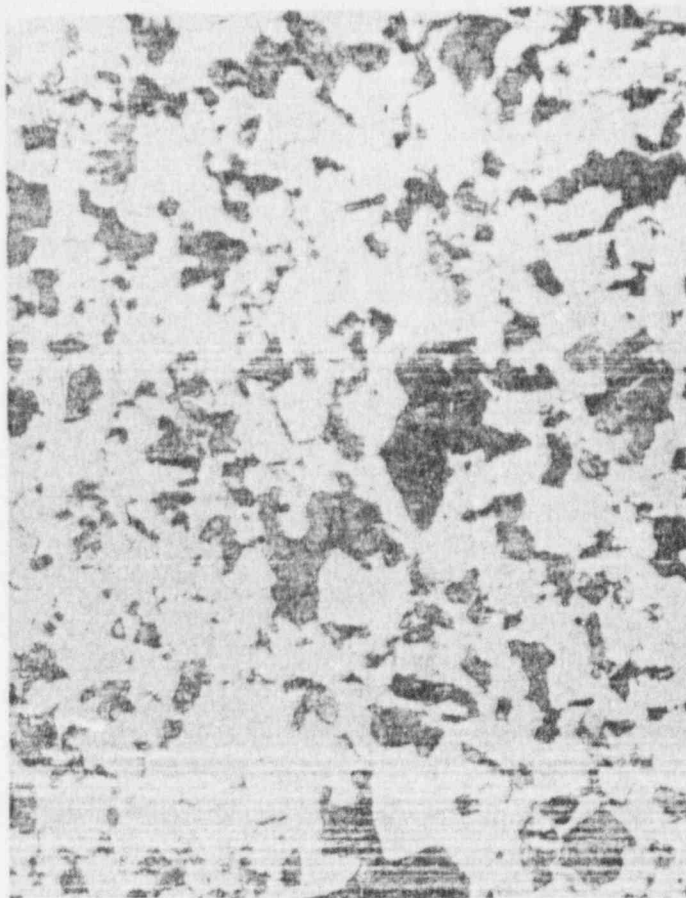
FIGURE 7A MICROSTRUCTURE OF CONTAINMENT SHELL PLATE
SHOWING FERRITE AND PEARLITE

Figure 3 shows a polished and etched cross-section specimen containing the defect in the root area. This specimen shows all weld beads. The SAW pass in the root area was deposited from both sides of the shell plate and forms a single large bead, approximately 1 inch deep by 1/2 inch wide with a centerline defect. This bead remelts and consumes part or all of SMAW bead. Figures 4A and 4B show the microstructure near the defect. The microstructure consists of boundary ferrite (light area), acicular ferrite, and carbides (dark etched) (References 1 and 2). Figure 5 shows the weld metal metallurgical structure away from the root, which is the same as the weld metal structure near the defect. Figure 6 shows the heat-affected zone in the shell plate. The structure consists of prior austenite grain boundaries surrounding bainite colonies. Figures 7A and 7B show the base metal structures which are ferrite (light areas) and pearlite (dark areas).

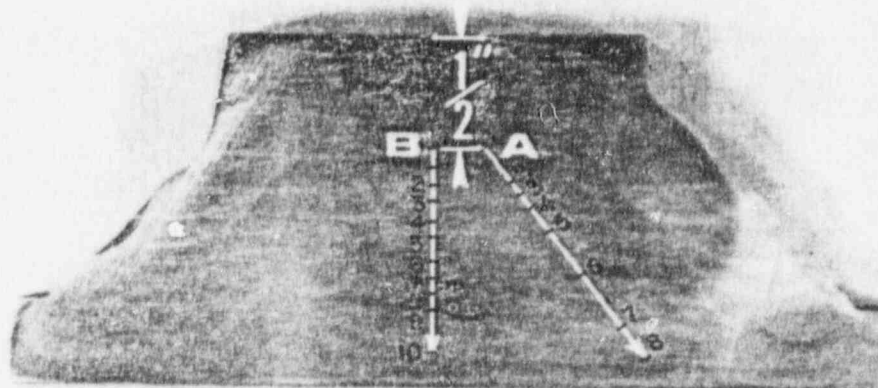
FIGURE 11 PHOTOGRAPH OF THE SPECIMEN SHOWING LOCATIONS OF MICROHARDNESS TESTS

Figure 11 shows the locations where microhardness readings were taken. Table 1 lists the results of the microhardness survey; the hardness values are within expected values in all areas.

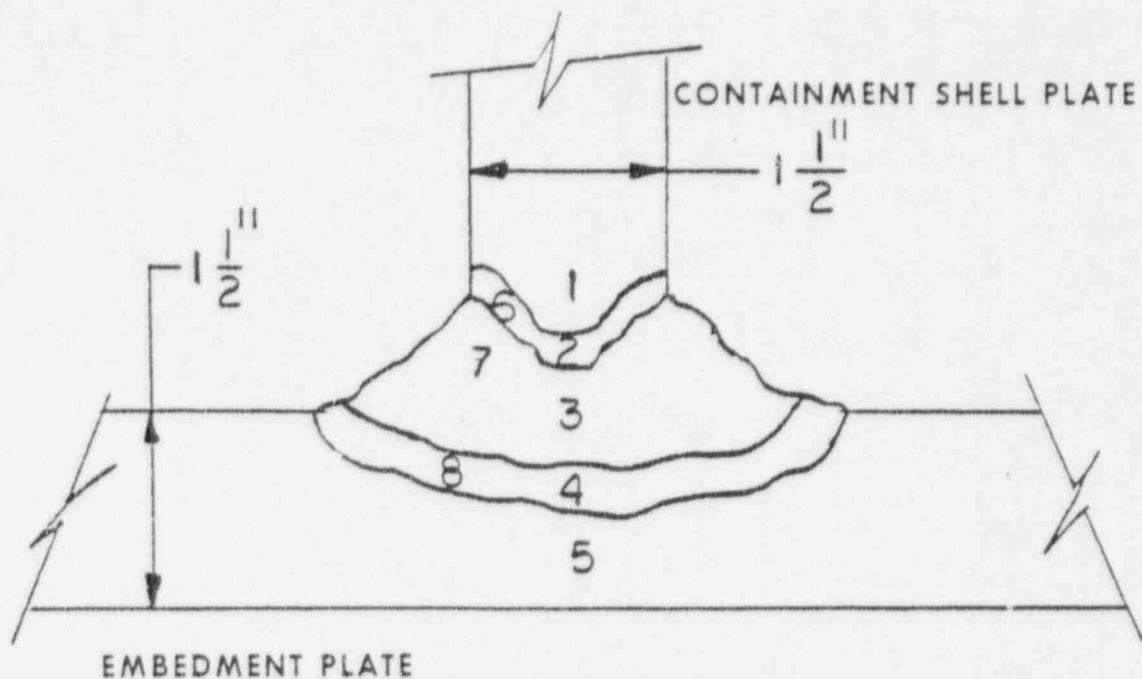
FIGURE 12 SKETCH IDENTIFYING LOCATIONS OF CHARPY V-NOTCH TEST SPECIMENS

Figure 12 shows locations at which Charpy-vee notch (Cv) impact specimens were taken. The Cv testing performed in the embedment plate was a through-thickness direction test. The specimens taken from the heat-affected zone (HAZ) were oriented in such a manner as to include as much of the HAZ as possible, as required by NE-4334.2. The results of Charpy tests are given in Table 2.

<u>LOCATION NO.</u>	<u>IDENTIFICATION</u>
1	BASE METAL - CONTAINMENT SHELL PLATE
2	HAZ - ABOVE SAW LARGE BEAD
3	WELD METAL - SAW LARGE BEAD
4	HAZ - BELOW SAW LARGE BEAD
5	BASE METAL - EMBEDMENT PLATE
6	HAZ - AWAY FROM ROOT IN SHELL PLATE
7	WELD METAL - AWAY FROM ROOT PLATE
8	HAZ - AWAY FROM ROOT IN EMBEDMENT PLATE
