LONG ISLAND LIGHTING COMPANY

(Shoreham Nuclear Power Station,
Unit 1)

PARTIAL INITIAL DECISION

ON EMERGENCY DIESEL GENERATORS

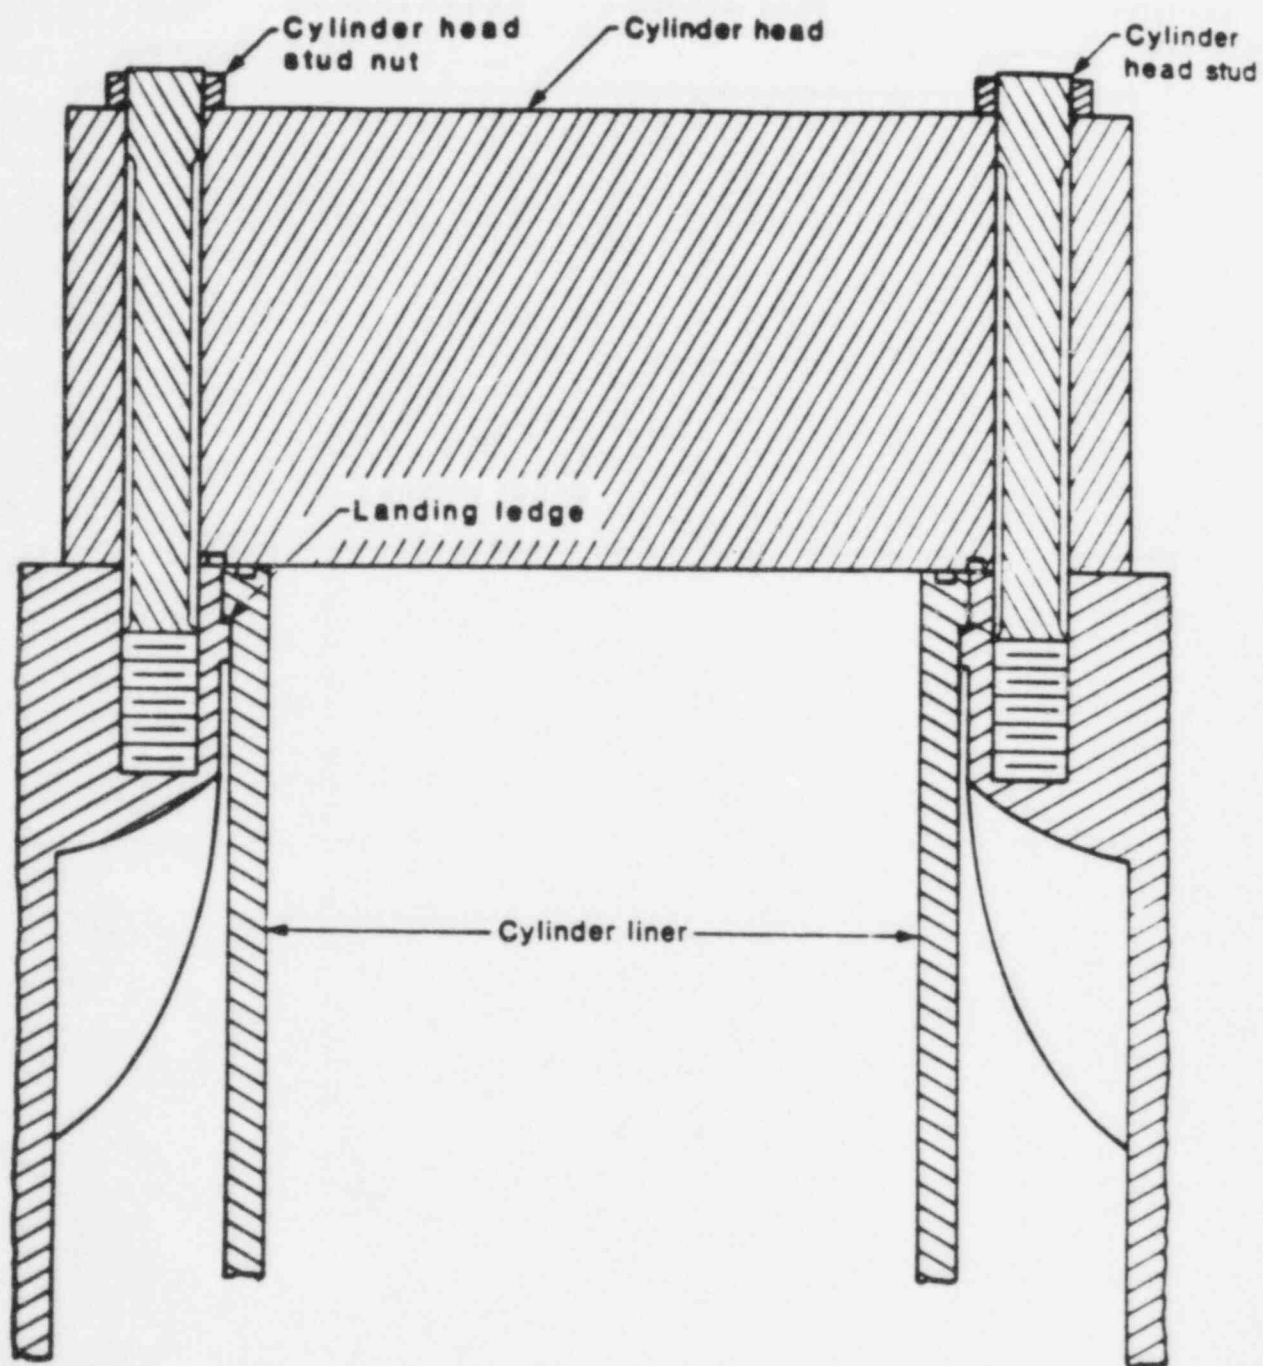
Figure 1.

B-3. The function of the cylinder blocks is to form the framework of the liquid-cooled engine, provide passage for coolant and support for the cylinder liners and cylinder heads and to restrain the forces generated by gas loads. McCarthy et al., ff. Tr. 24,372, at 8. The configuration for one cylinder liner and head is illustrated in LILCO Exhibit B-7 (Figure 1, attached), and plan views of block tops, showing
