Docket No. 50-346  
License No. NPF-3  
Serial No. 1-525  
May 15, 1985

On April 4, 1985, your office issued a Confirmatory Action Letter (CAL) (Log No. 1-1144) to Toledo Edison regarding the failed Control Rod Drive Mechanism (CRDM) Lead Screw Nut Leaf Spring on Davis-Besse Nuclear Power Station Unit No. 1. Toledo Edison provided its formal response on April 11, 1985, (Serial No. 1-512) which you found acceptable and in conformance with the CAL. Your letter of April 12, 1985 (Log No. 1-1151) documented this finding. In accordance with our commitment to provide a summary of the status of our activities which were planned or in progress at that time, we are pleased to provide the enclosed information.

EVALUATION OF  
CONTROL ROD DRIVE  
LEAF SPRING FAILURES  
AT DAVIS-BESSE

EXAMINATION OF CRDM  
LEAF SPRING AND FOREIGN DEBRIS  
SAMPLES REMOVED FROM DAVIS-BESSE 1

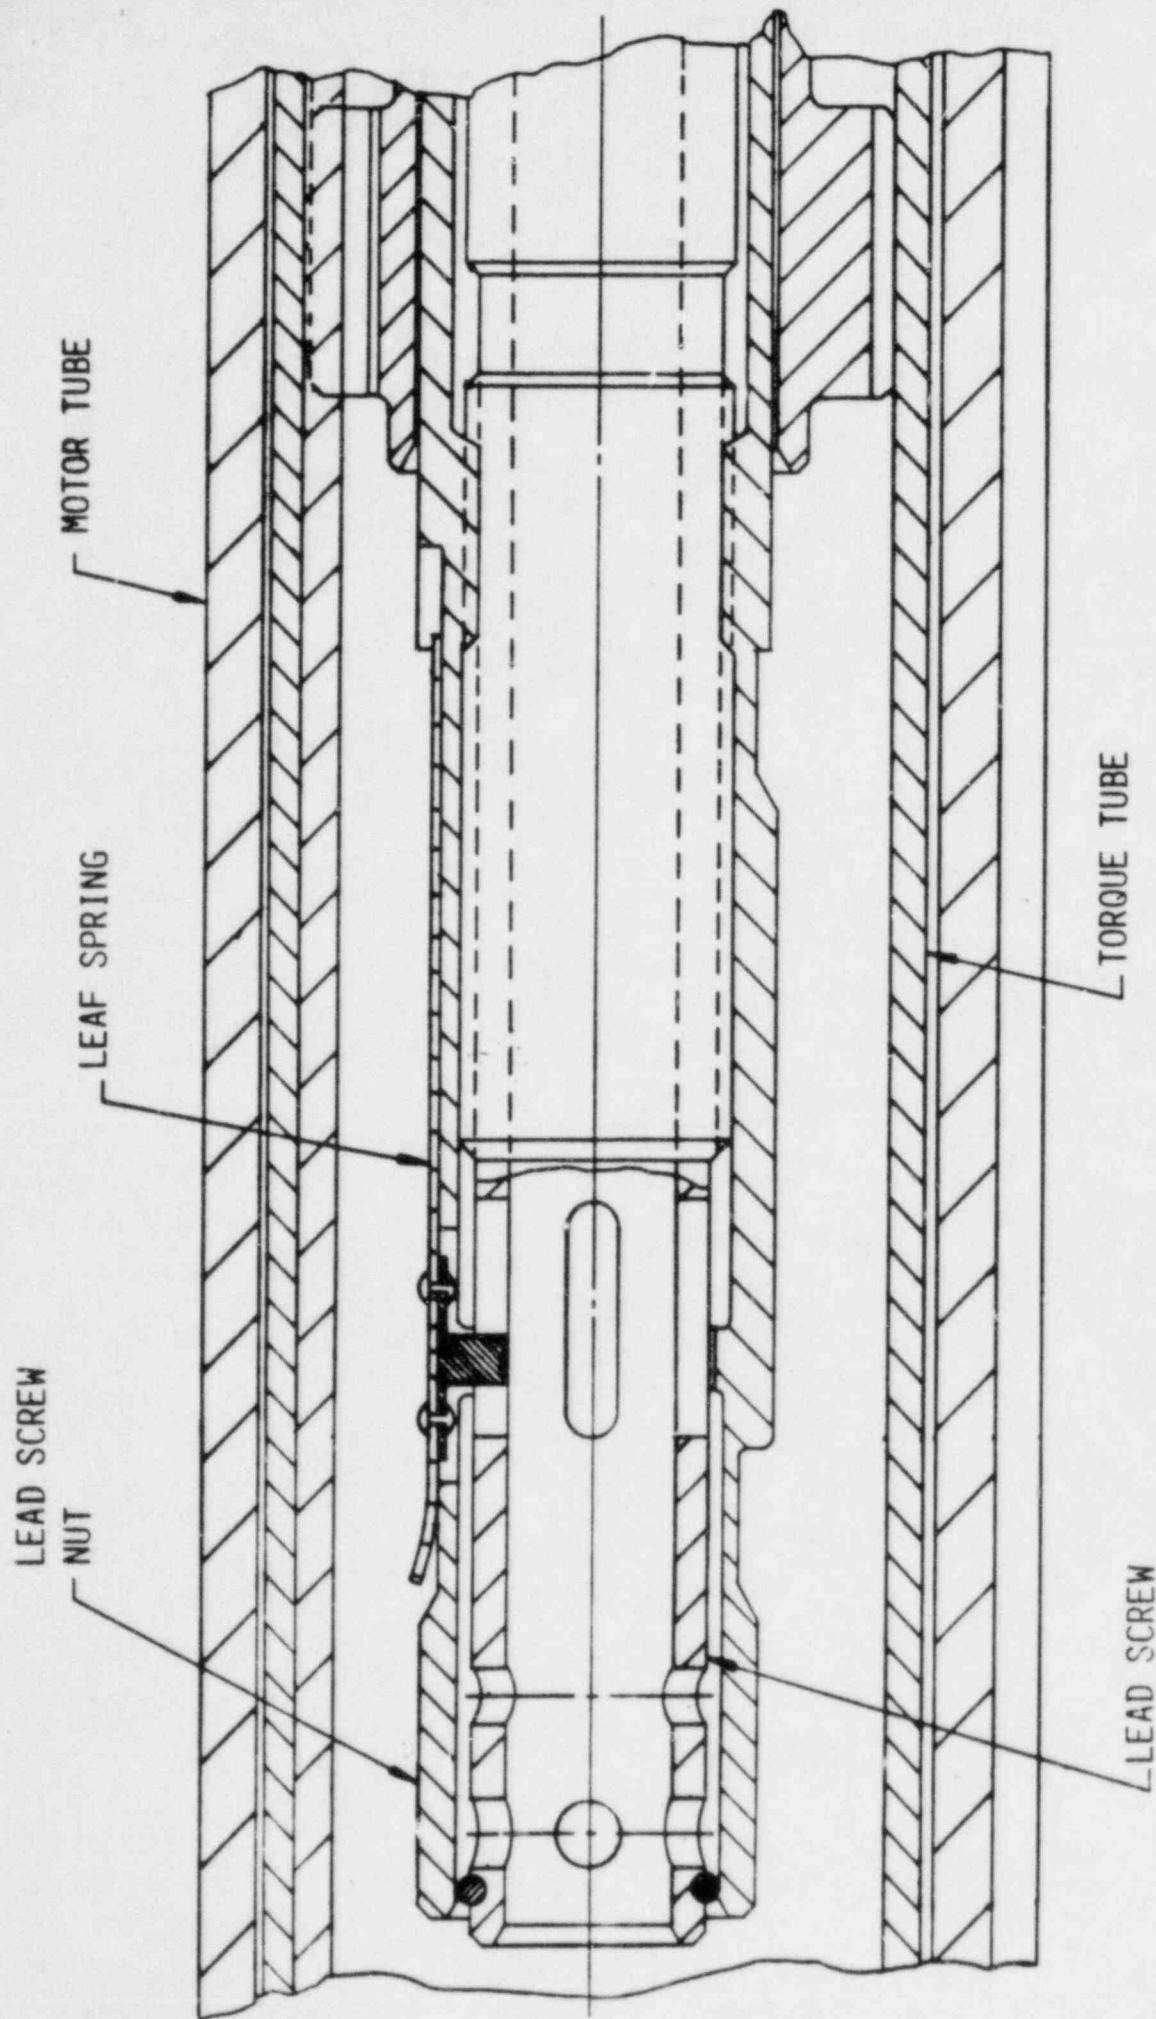
FIGURE 2  
CROSS SECTION OF LEAD SCREW AND LEAD SCREW NUT  
WITH LEAF SPRING IN LATCHED POSITION

Following removal of the drive, a preliminary inspection was performed at Davis Besse where a leaf spring was observed to be missing. The spring is used to retain the locking pin between the leadscrew extension and the leadscrew nut (See Figures 1 through 4 and Appendix A for details of CRDM operation). The drive was subsequently shipped to a Babcock & Wilcox facility at Parks Township, Pennsylvania where the drive was disassembled and some foreign material as well as the missing spring were found inside the drive. The foreign material and spring were then sent to the Babcock & Wilcox Research Center (LRC) in Lynchburg, Virginia for evaluation.

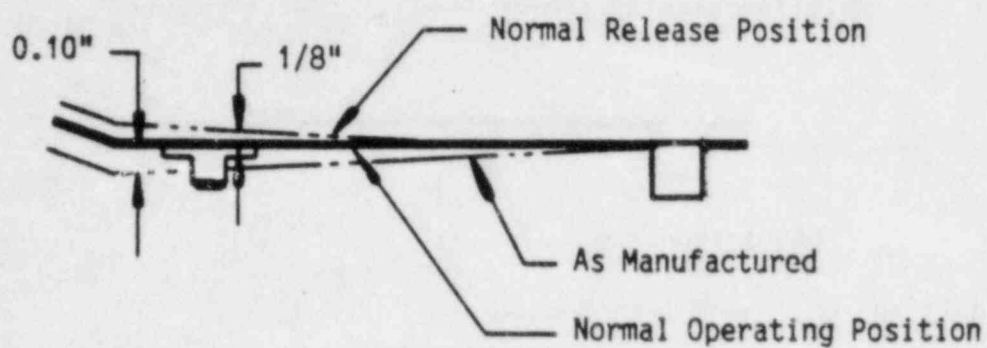
FIGURE 4-1A

- o Bending Out From the Center of the Nut (FIG 4-1A) - Since the spring is manufactured with an initial deformation, when it is mounted on the leadscrew nut, there is a preload and steady-state stress imposed. This stress is increased by the normal effort of lifting the pin out of the locking slot. Using a simple beam model, it is calculated that the steady state tensile stress is about 23,000 psi at the root of the spring (at the mounting flange). Additionally, the stress at the rivet hole closest to the base was calculated to be about 12,000 psi.

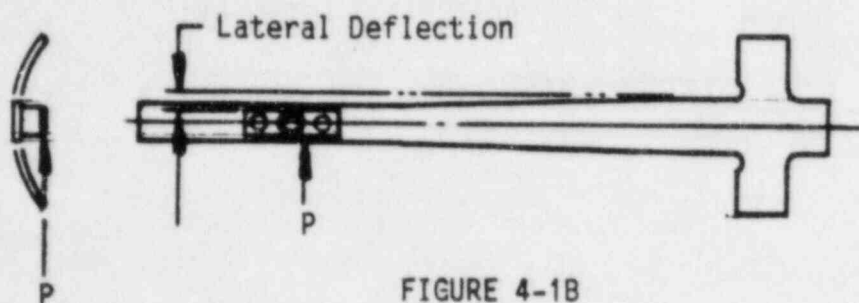
FIGURE 4-1B

- o Lateral Loads Imposed on the Locking Pin (FIG 4-1B) - It was recognized that the lateral clearances between the slots and the locking pins could result in a lateral and torsional stressing of the spring material, if the tolerances were stacked up wrong. Assuming these worst case tolerances, it was calculated that the lateral loads could produce stresses on the order of 77,000 psi when combined with the outward preload stresses of 29,000 psi. This situation would occur when the leadscrew uncoupling method was used and the relocking of this pin was being verified. This technique is no longer in use because of previous experiences with galling of the threaded interfaces.

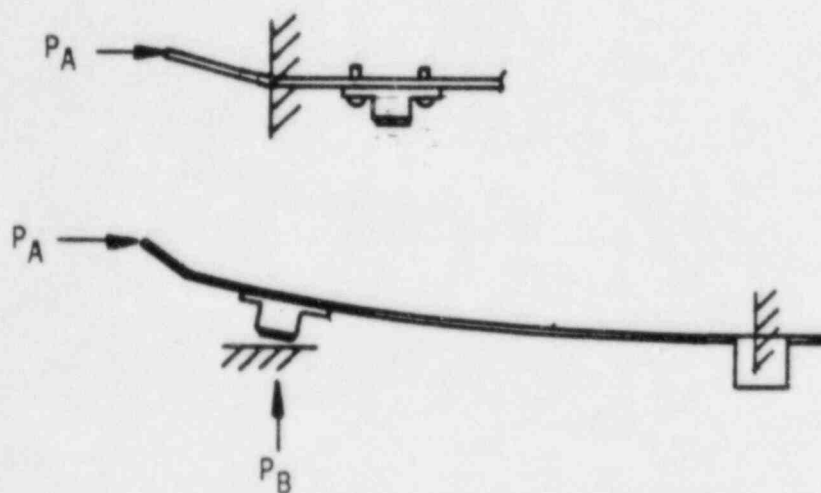
FIGURE 4-1C

- o End Loads Imposed on the Tip of the Spring (FIG 4-1C) - If an axial force was imposed on the end of the spring, the situation would be similar to column buckling with a significant amount of loading eccentricity imposed. Two models were considered, one looking at the bend at the spring-end only and the other with the spring held outward away from the re-inforcement of the leadscrew nut.

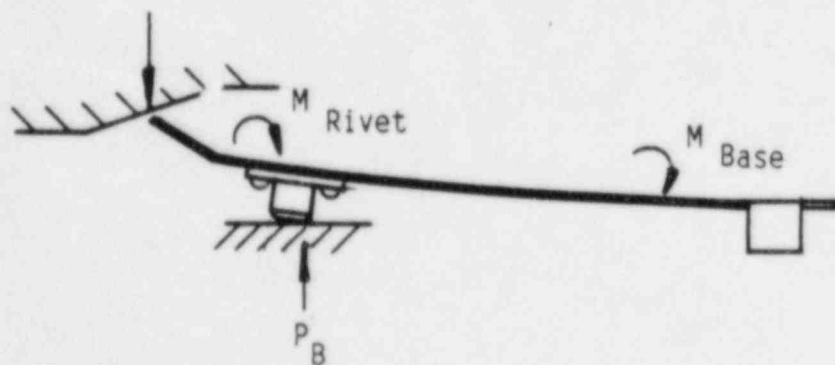
FIGURE 4-1D

- o Inward Tip Loadings on an Extended Spring (FIG 4-1D) - If the unlocked leaf spring were raised into the reduced diameter portion of the torque tube cap, and the top of the leadscrew then leaned in the direction of the spring, then the end would receive a horizontal loading. This loading, considering the available deflection of the leadscrew will result in a stress of 147,000 psi at the locking pin rivet holes. To accomplish this, the force required to tilt the leadscrew in that direction would be about 10-20 pounds.
