MEMORANDUM FOR: John J. Linehan
Uranium Recovery Licensing Branch

FROM: Terry Vandell
Uranium Recovery Licensing Branch

SUBJECT: REVIEW AND CONCLUSIONS REGARDING "SPECIAL REPORT ON
MONITOR WELL ANALYTICAL RESULTS," MARCH 25, 1981, FROM
OGLE PETROLEUM

BISON BASIN MINE
WELLFIELD LAYOUT
(R&D AREA)

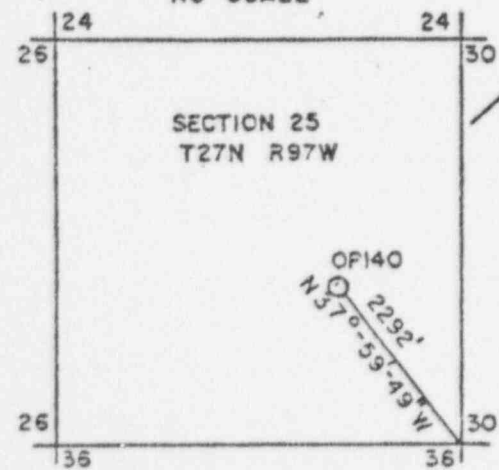
FIGURE 1

- (1) Two "minor" lateral excursions occurred at Ogle Petroleum's R&D well field in wells M-2 and M-4 (see attached Figure 1) where (a) well M-2 exceeded UCL's for Cl and $\text{CO}_3 + \text{H}_2\text{CO}_3$ by a maximum of = 15 ppm and = 118 ppm, respectively, and (b) well M-4 exceeded UCL's for Cl, $\text{CO}_3 + \text{H}_2\text{CO}_3$, and specific conductance by a maximum of = 63 ppm, = 118 ppm, and = 71 mhos/cm, respectively.
- (2) During the past month or two, well M-2 has been experiencing above-normal values for chloride and carbonate plus bicarbonate which were believed by Ogle to be caused by the normal outside sweep of the lixiviant during mining operations. An expanded outside sweep by the lixiviant was expected due to the increased injection capacity resulting from new injection wells being placed into operation in the southeast corner of the R&D well field.

The sudden increase over a two-week period in carbonate plus bicarbonate, chloride, and specific conductivity at well M-4 is believed by Ogle to have resulted from a typical horizontal excursion which was most likely caused by localized over-injection on the south side of the field well.
- (3) Control measures were implemented
 - (a) plant bleed increased,
 - (b) injection stopped and reduced and recovery increased, and
 - (c) fresh water injection into an ore zone control well 50 feet from M-2, to reverse the gradient towards the well field.
- (4) All parameters are below their UCL's for well M-4; and although Cl is still high, only $\text{CO}_3 + \text{H}_2\text{CO}_3$ exceeds its UCL at well M-2.

*new well
drilled
injected
from H₂C
well (1)
to reverse
excursion*

I believe that OPI has implemented very effective clean-up and control techniques and that they are and should continue on with their monitoring and reporting to us, as they have done, if another excursion occurs.
