SUBJECT: SUPPLEMENT TO NUPAC ENVIRALLOY HIC REPORT

EA-142 PROTOTYPE TEST

Supplement to
NUCLEAR PACKAGING, INC.
ENVIRALLOY
HIGH INTEGRITY CONTAINERS

Enviralloy 190 Cubic Foot Prototype Drop Test

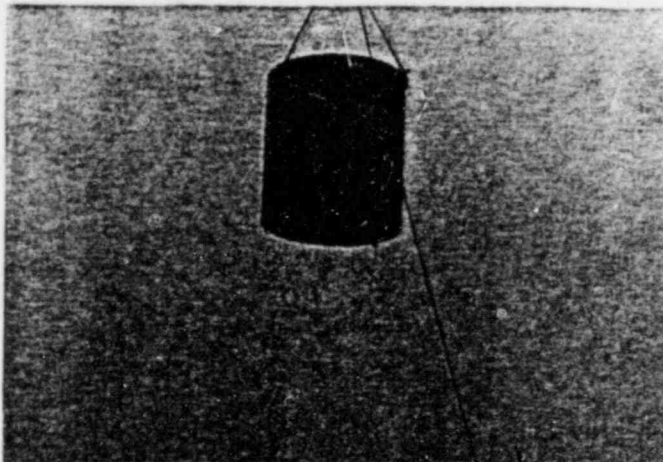
The container did not sustain any significant damage from any of the drops. The only damage that was sustained by the container was a slightly dented lift lug on the top due to the four foot drop on the top straight down, and some damage on the corners due to the four foot drop. The lifting lug was not bent or deformed sufficiently to prevent its use. The container was slightly bowed due to the corner drop on the four foot drop. Also the ends, top and bottom were plastically deflected from the corner drop. None of these deformations were in the excess of 1/2 inch. The container did not sustain any loss of contents as a result of any of these drops. The container was not damaged either on the outside or on any of the inside supports, such that it would prevent its use. The container was cleaned up after the drop and all welds were magnetic particle tested to detect any damage to the welds. No damage was detected.

Figure 16 Four Foot Top Down Drop
