1992 THERMAL SHIELD
INSPECTION AND REPAIR

OMAHA PUBLIC POWER DISTRICT
FORT CALHOUN STATION

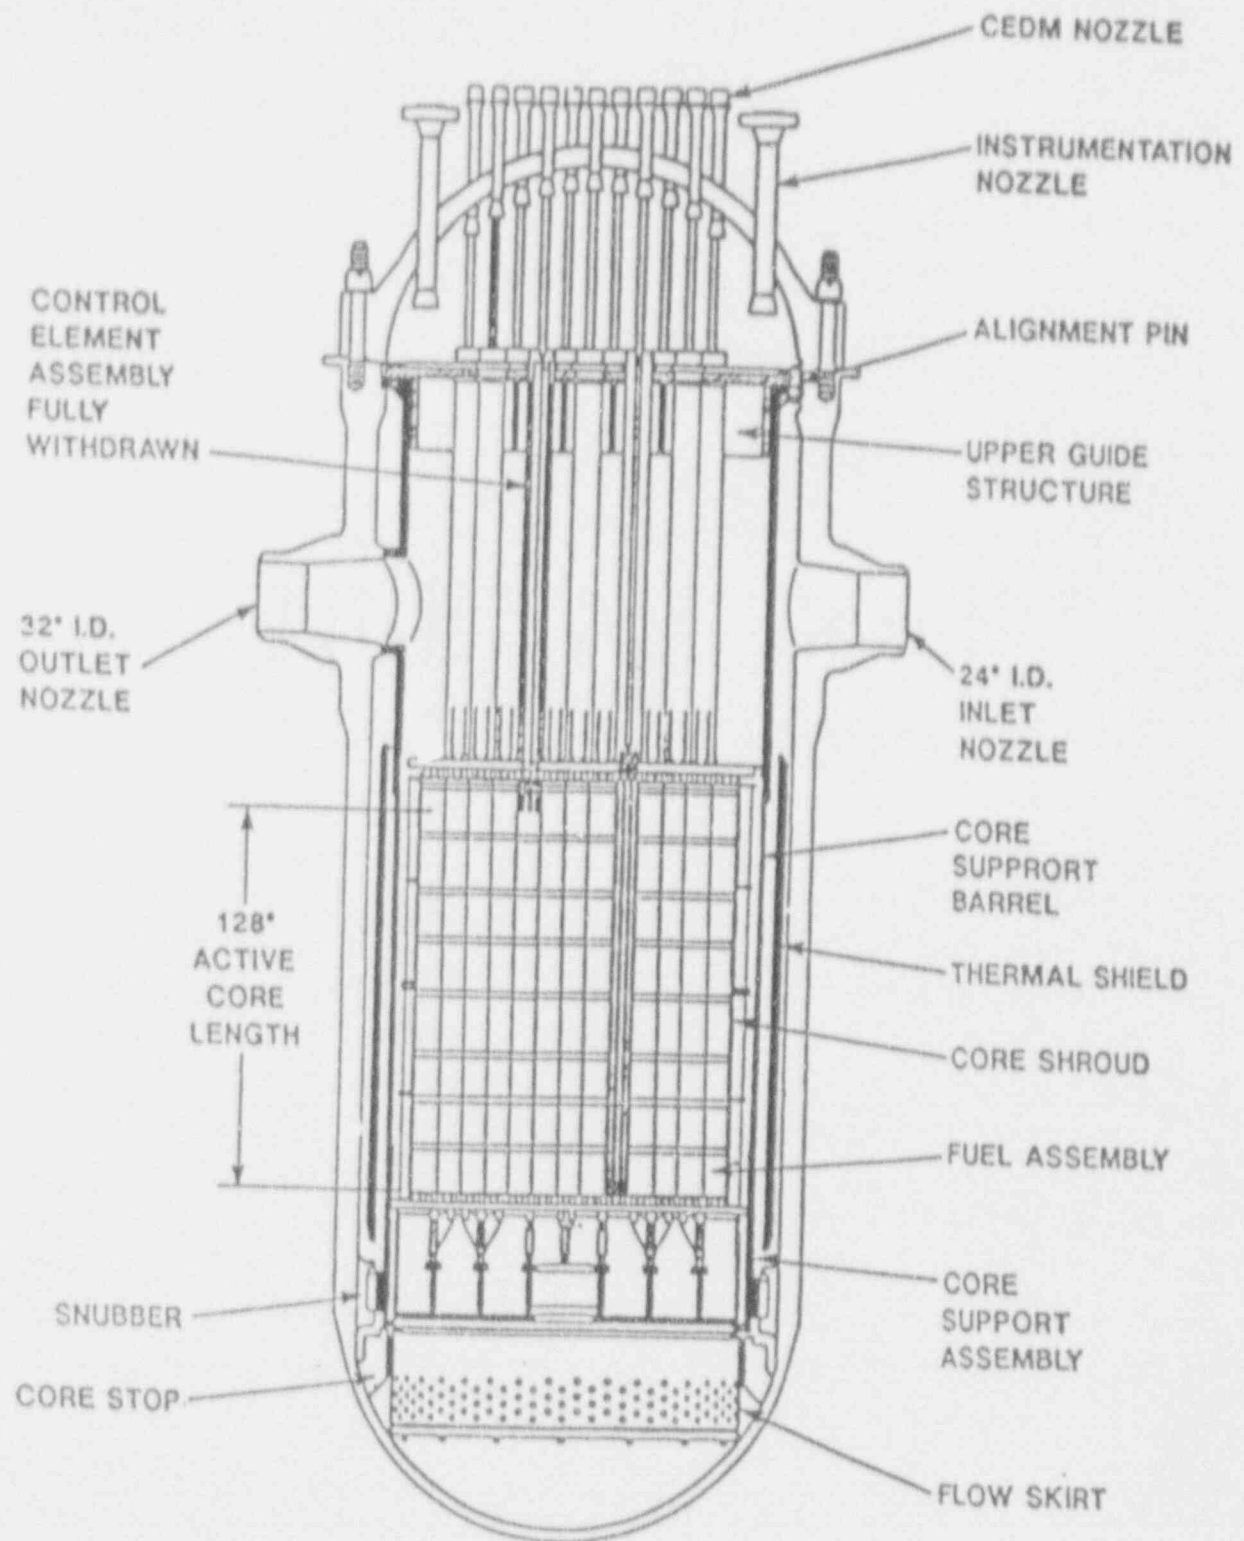
FIGURE 1
REACTOR INTERNAL ARRANGEMENT

The TS is a 3" thick, 304 stainless steel cylindrical structure with an inside diameter of 127" and a height of 164" (Figure 1). The thermal shield is vertically supported at the top by eight equally spaced support lugs welded to the outer periphery of the CSB. The TS lug support pins were fitted during assembly to position the TS on the support lugs. The main function of the lugs is to support the weight of the TS. The TS is positioned and constrained radially by a total of twenty-four (24) positioning pins. Eight of the positioning pins are located below the support lugs and the remaining positioning pins are located approximately 10" from the bottom of the TS. At the lower positioning pin locations, stellite wear surfaces are welded to the CSB as bearing surfaces for the positioning pins. There is no stellite on the core support barrel at the top pin locations. The positioning pins are threaded into the TS and were originally torqued to 250 ft-lbs (approximately 8,000 - 10,000 lbs preload) against the CSB, thus coupling the TS and CSB.

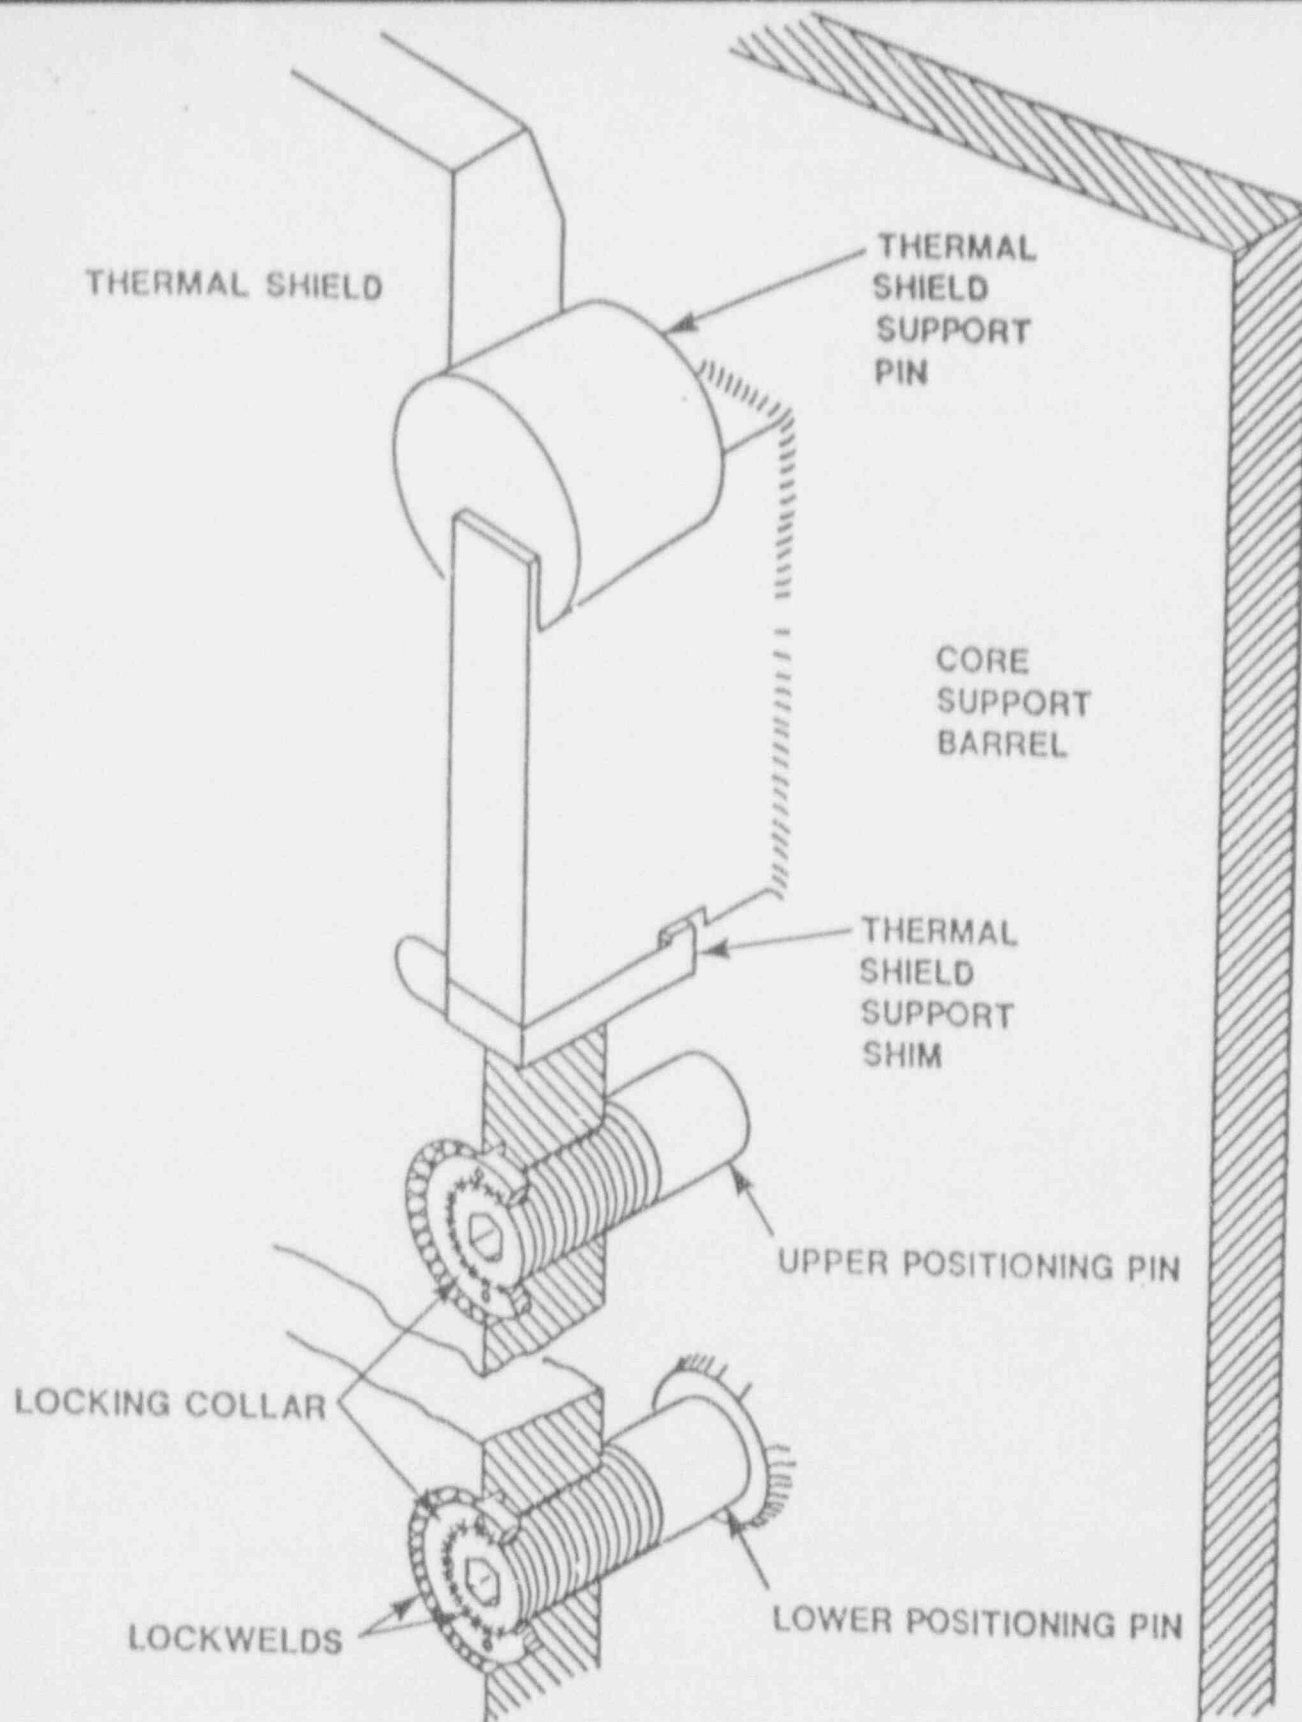
FIGURE 2
THERMAL SHIELD SUPPORT SYSTEM
ORIGINAL INSTALLATION

In the original configuration, locking collars were threaded on the positioning pins and torqued against the TS, thereby preloading the locking collars and positioning pins to the TS. The locking collars were then lockwelded to the positioning pins and the TS to prevent rotation and provide a means of capture (Figure 2). The replacement positioning pins and locking collars are installed and preloaded in a similar manner. However, the replacement locking collars are mechanically crimped to the positioning pins and TS to prevent rotation and provide a means of capture (Figure 3).
