Vicinity Property No. SLC 001

FINAL
THE RADIOLOGICAL AND ENGINEERING ASSESSMENT
AND FINAL DESIGN
FOR
SALT LAKE CITY PROPERTY
SL-001

April 3, 1985

PREPARED BY
MORRISON-KNUDSEN COMPANY, INC.

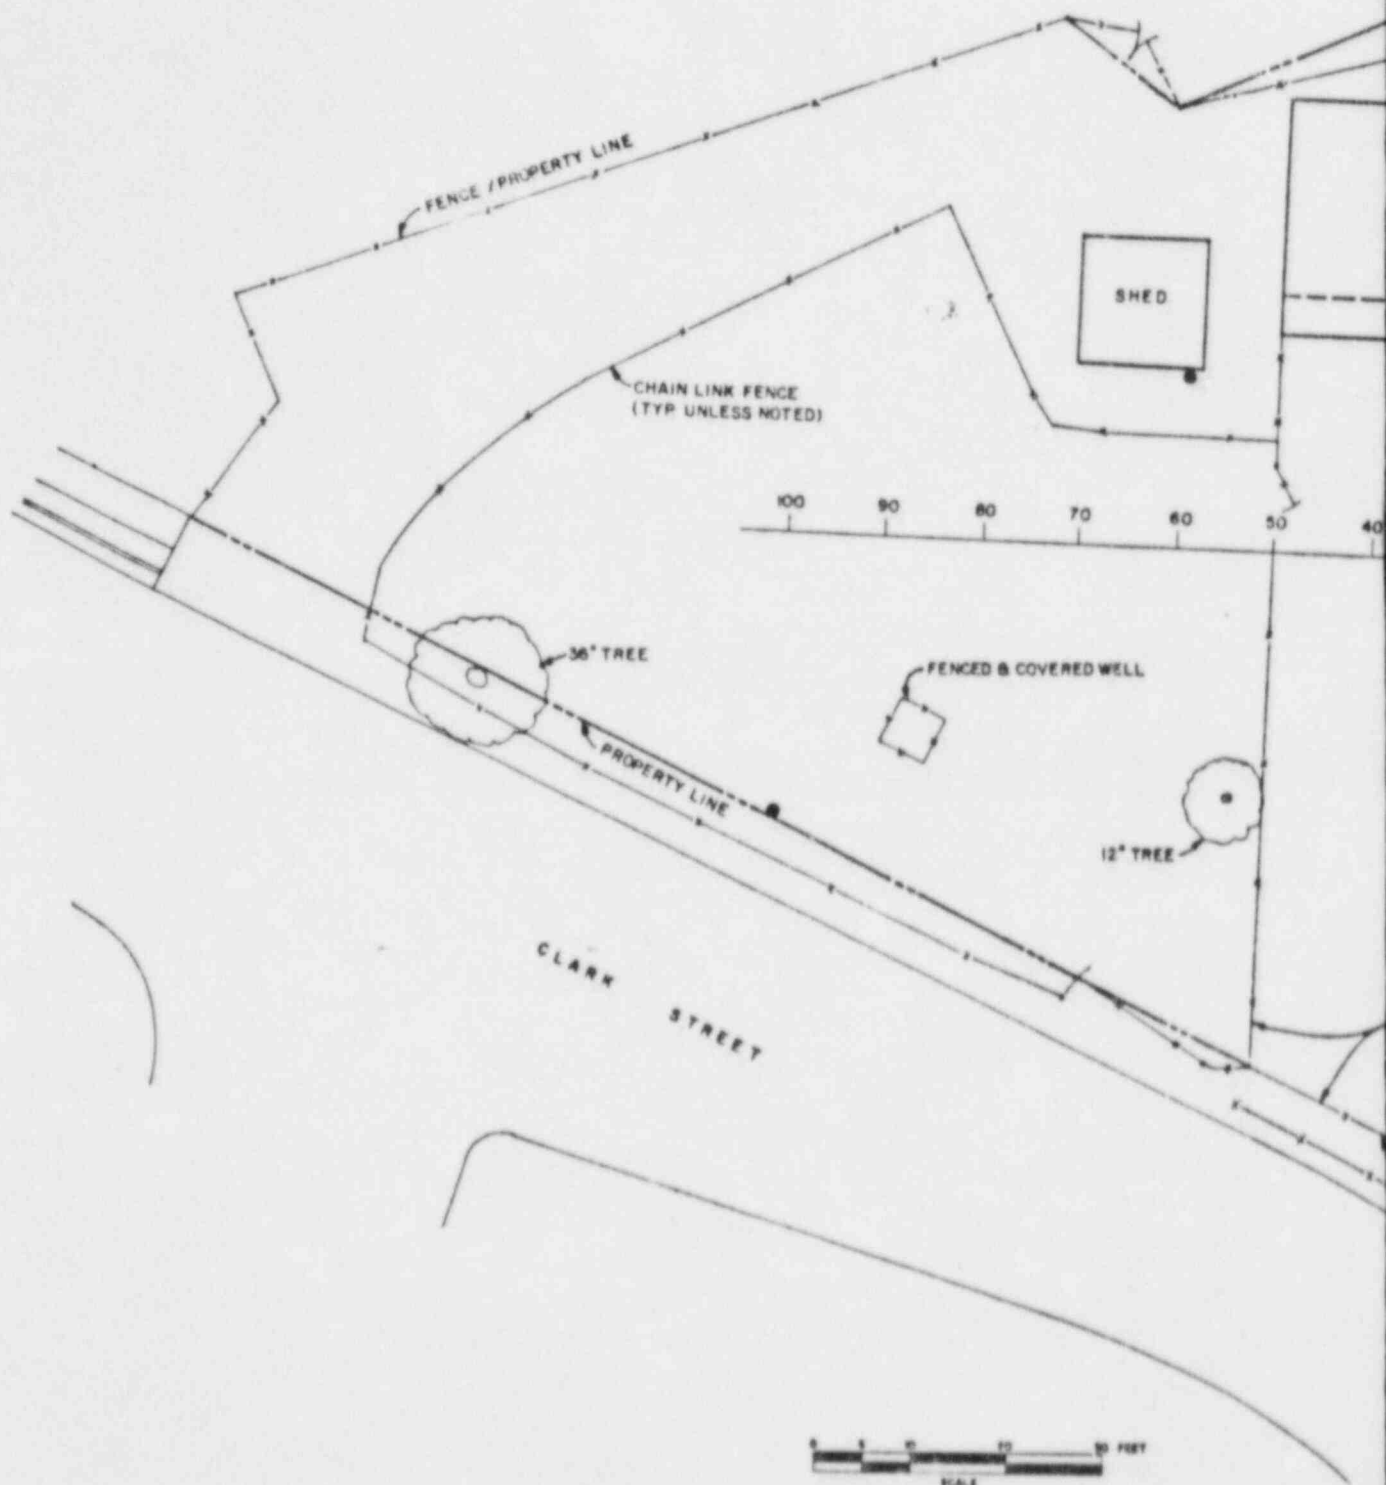
Contamination was found in 2 of the 16 outdoor holes augered. The location and depth of the contamination is described in Table 3.2 and is shown in Figure 3.1.

There is one area of contamination on SL-001. The area is identified as Area A on Figure 3.1 and corresponds to the area noted on the inclusion survey.
