Draft Radiological and Engineering Assessment

Vicinity Property No. SLC 092

THE RADIOLOGICAL AND ENGINEERING ASSESSMENT

SALT LAKE CITY PROPERTY

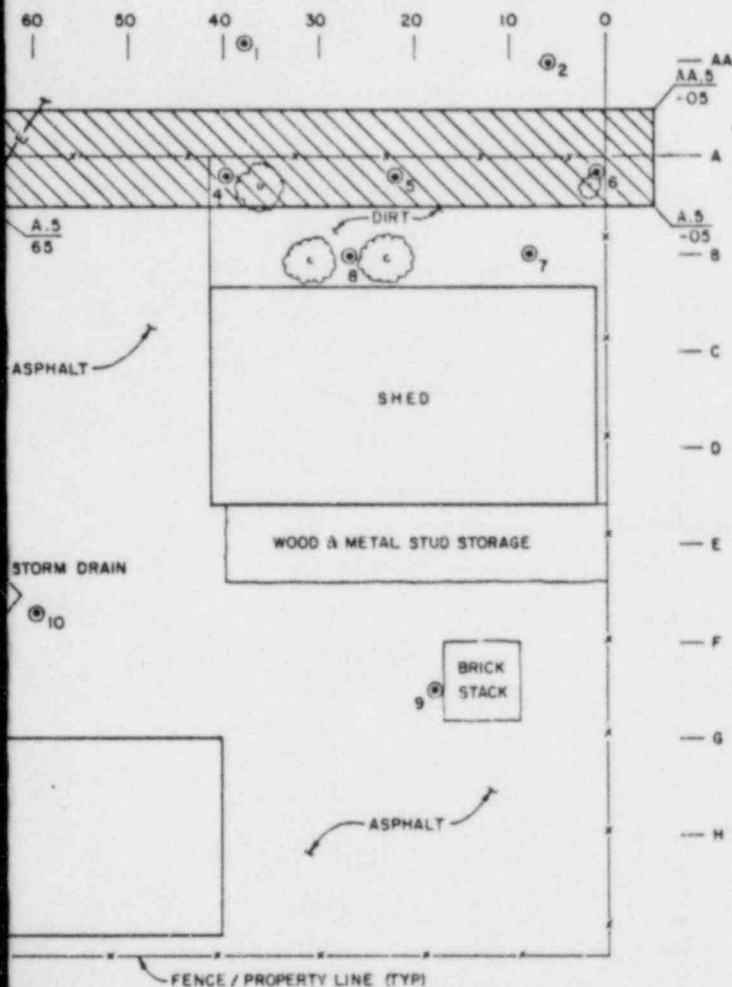
Contamination was found in 3 of the 13 outdoor holes augered. The location and depth of the contamination is described in Table 3.2 and is shown in Figure 3.1.
