APPLICANT: Northeast Nuclear Energy Company  
FACILITY: Millstone Nuclear Power Station, Unit 3  
SUBJECT: SUMMARY OF MILLSTONE 3 SEISMIC II/I MEETING

The purpose of this meeting was to discuss the non-seismic/seismic interaction program for Millstone 3.

**THE APPLICATION OF EXPERIENCE DATA  
TO SEISMIC INTERACTION AT THE  
MILLSTONE III NUCLEAR POWER PLANT**

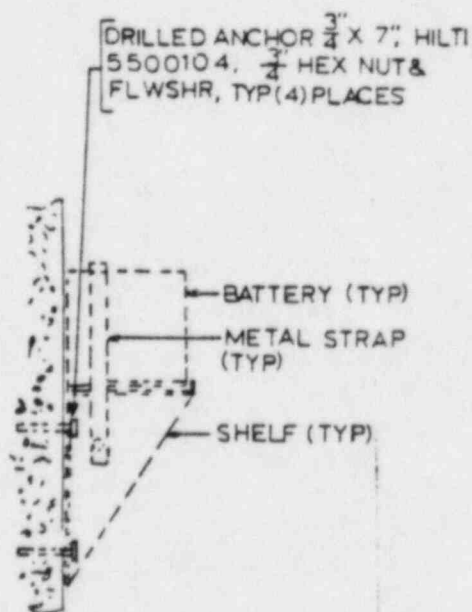
Figure No. 1

Resolution: Emergency lighting units will not become detached during a seismic event since adequate anchorage is provided. Subsequently, no functional impairment of nearby safety-related components will occur.

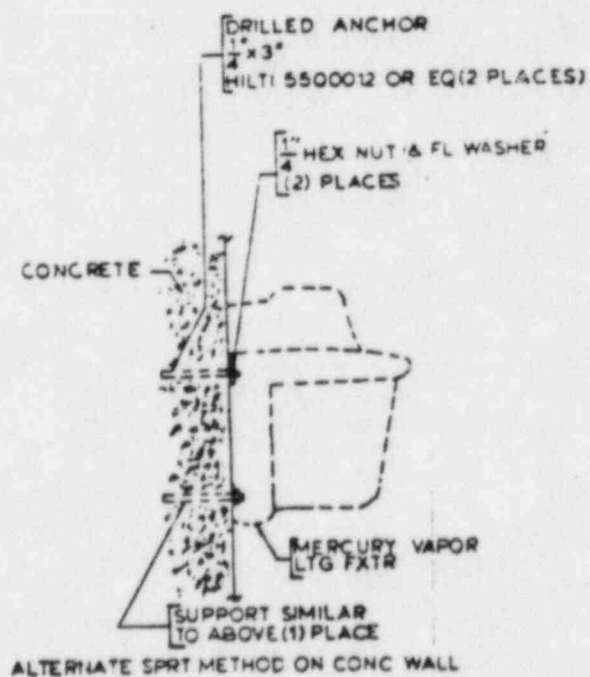
Figure No. 1

Resolution: Mercury vapor lighting units will not become detached during a seismic event since adequate anchorage is provided. Subsequently, no functional impairment of nearby safety-related components will occur.
