RADIOLOGIC AND ENGINEERING ASSESSMENT

DOE ID NO.: GJ-03999-RS
ADDRESS: 1930 Kennedy Avenue

JULY 1985

BENDIX FIELD ENGINEERING CORPORATION
P.O. Box 1569
Grand Junction, Colorado 81502

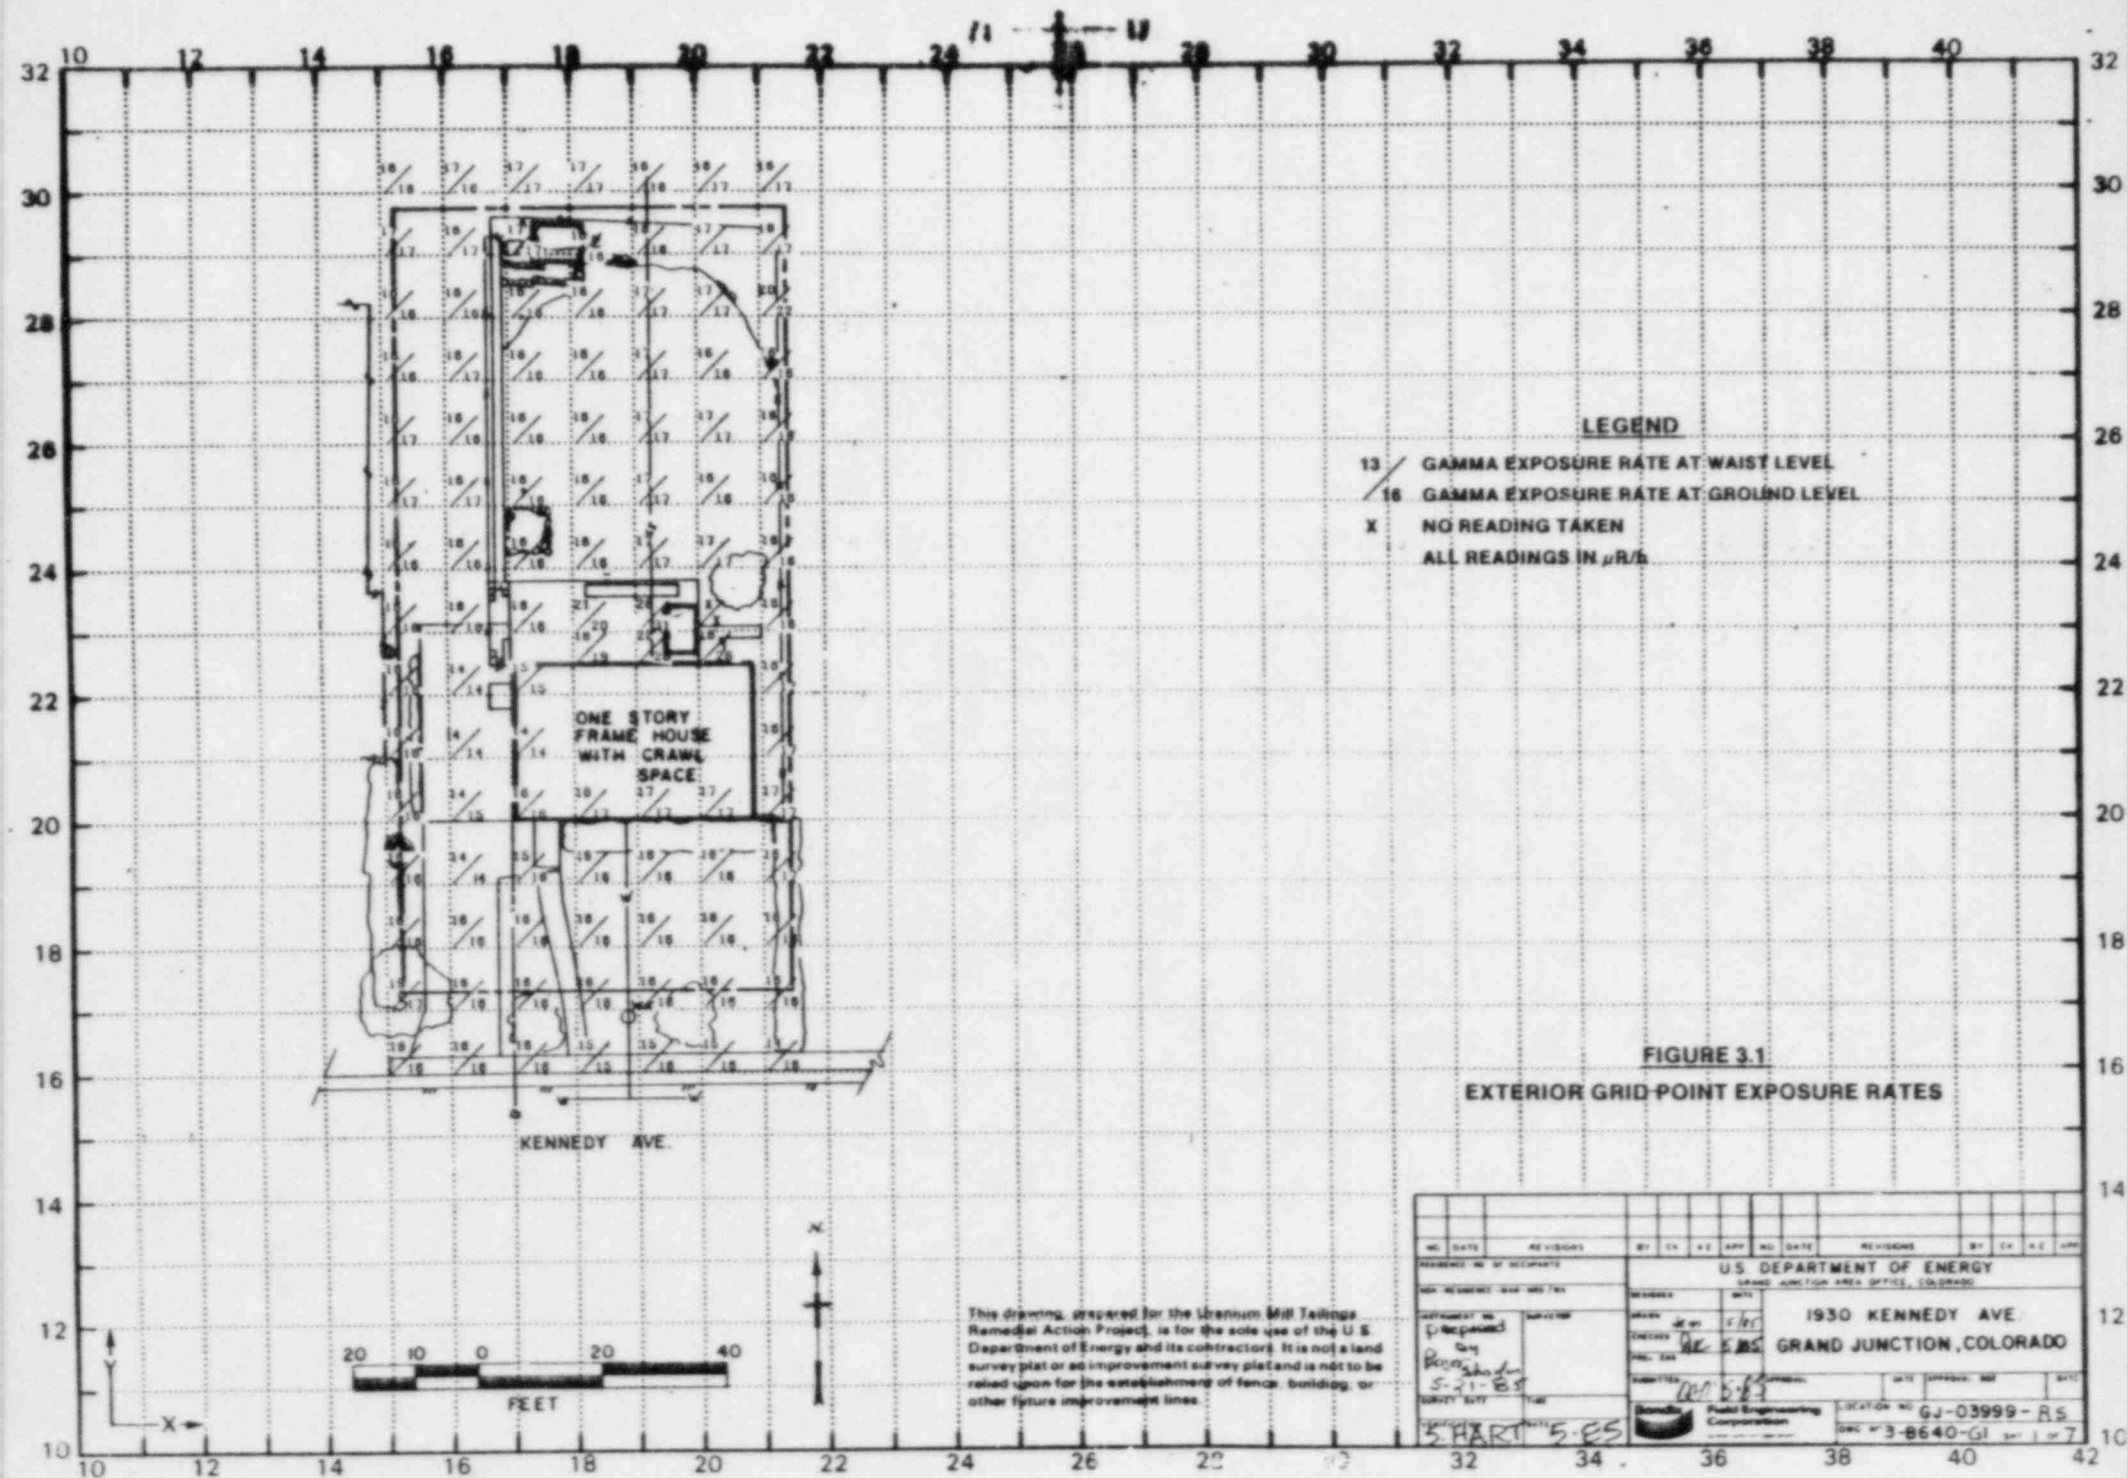
FIGURE 3.2
EXTERIOR GAMMA SCAN

Exterior radium-concentration measurements are presented in Appendix Table 3.1. Grid-point survey results are shown in Appendix Figure 3.1. Appendix Figure 3.2 presents the ranges of elevated gamma readings and indicates areas of possible contamination.

Contamination was found in the rock gardens and on the patio during our exterior gamma scan. In the rock garden north of the patio (grid block 190240), the source of our elevated reading was obvious. This source was identified as ore by D. Mackler. After removal of the ore, the cps readings dropped dramatically to a level close to background.
