**RADIOLOGIC AND ENGINEERING ASSESSMENT**

DOE ID NO.: GJ-03494-RS  
ADDRESS: 174 LITTLE PARK ROAD

JULY 1985

BENDIX FIELD ENGINEERING CORPORATION  
P.O. Box 1569  
Grand Junction, Colorado 81502

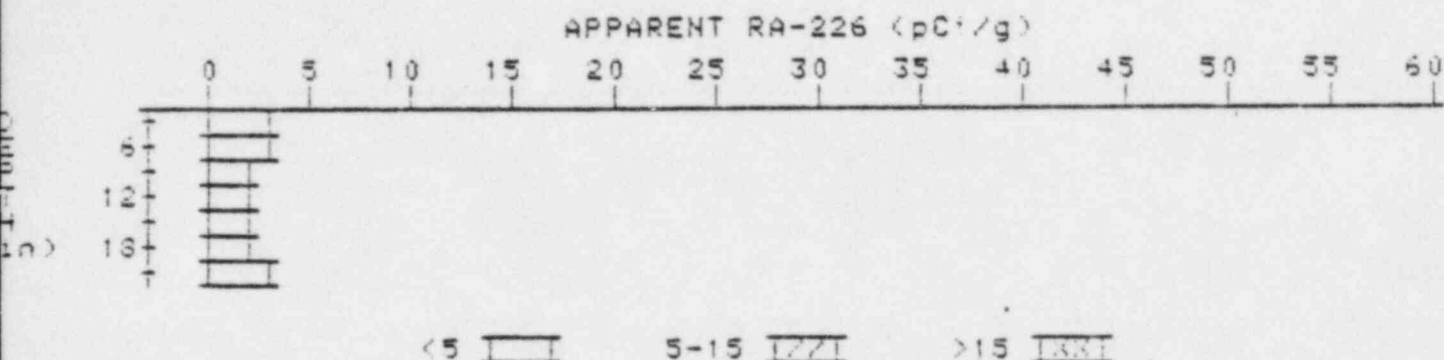
HOLE NUMBER: 4

Depth (in)	Apparent Radium-226 (pCi/g) Undeconvolved	Apparent Radium-226 (pCi/g) Deconvolved
3	2.5	2.5
6	2.5	2.9
9	2.3	1.9
12	2.3	2.3
15	2.3	2.1
18	2.4	2.2
21	2.6	2.6

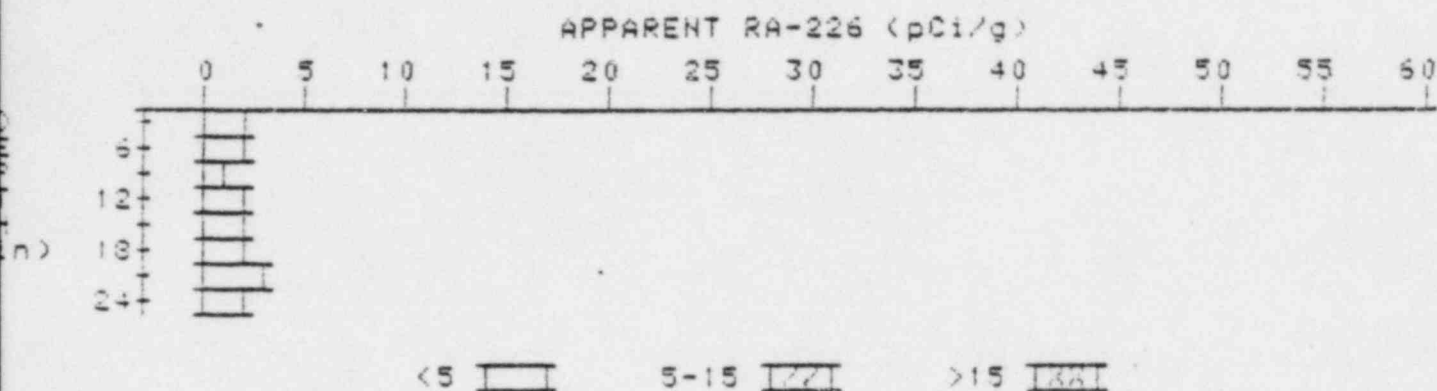
HOLE NUMBER: 5

Depth (in)	Apparent Radium-226 (pCi/g) Undeconvolved	Apparent Radium-226 (pCi/g) Deconvolved
3	1.5	1.5
6	1.6	1.6
9	1.6	1.4
12	1.7	1.7
15	1.8	1.8
18	1.9	1.5
21	2.2	2.6
24	2.3	2.3

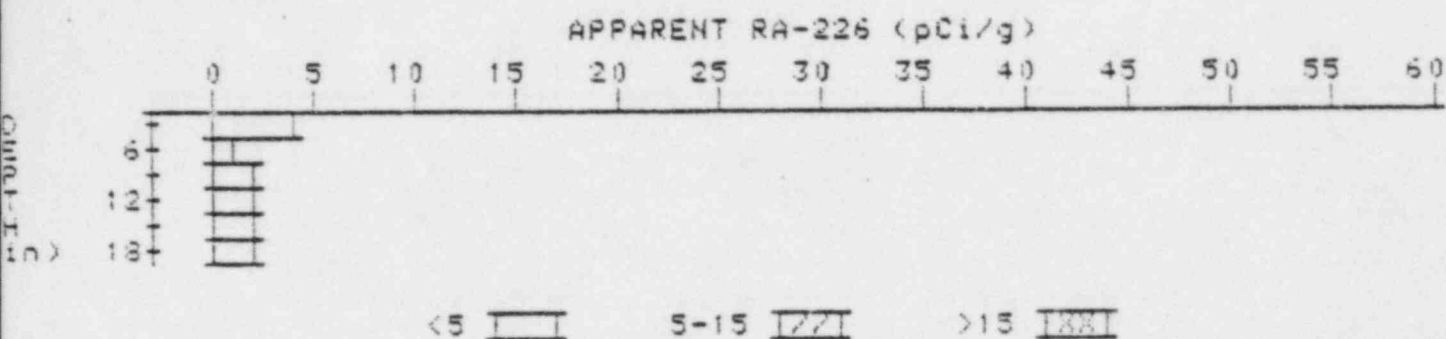
HOLE NUMBER: 6

Depth (in)	Apparent Radium-226 (pCi/g) Undeconvolved	Apparent Radium-226 (pCi/g) Deconvolved
3	3.8	3.8
6	2.7	1.5
9	2.3	1.9
12	2.1	1.6
15	2.2	2.4
18	2.2	2.2

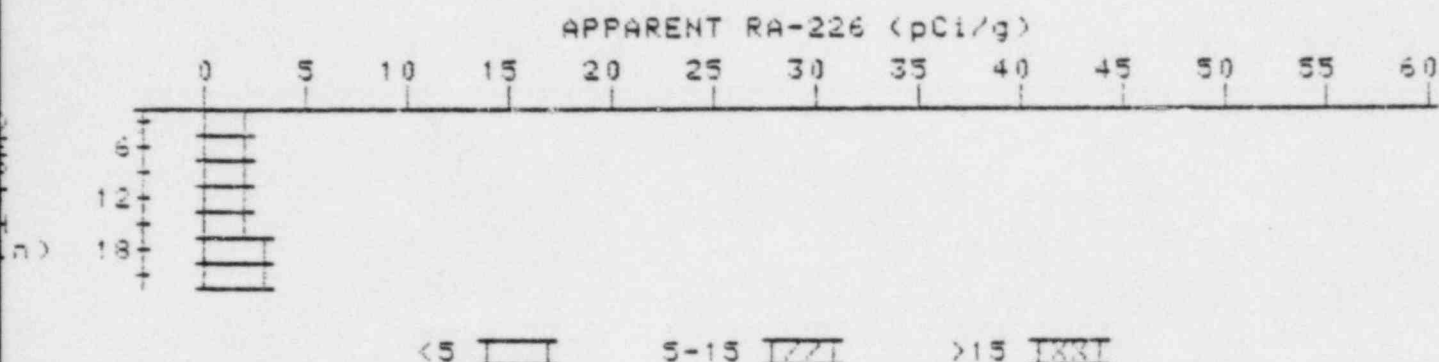
HOLE NUMBER: 7

Depth (in)	Apparent Radium-226 (pCi/g) Undeconvolved	Apparent Radium-226 (pCi/g) Deconvolved
3	1.8	1.8
6	1.9	1.9
9	2.0	2.0
12	2.1	1.7
15	2.4	2.4
18	2.7	2.9
21 ✓	2.9	2.9

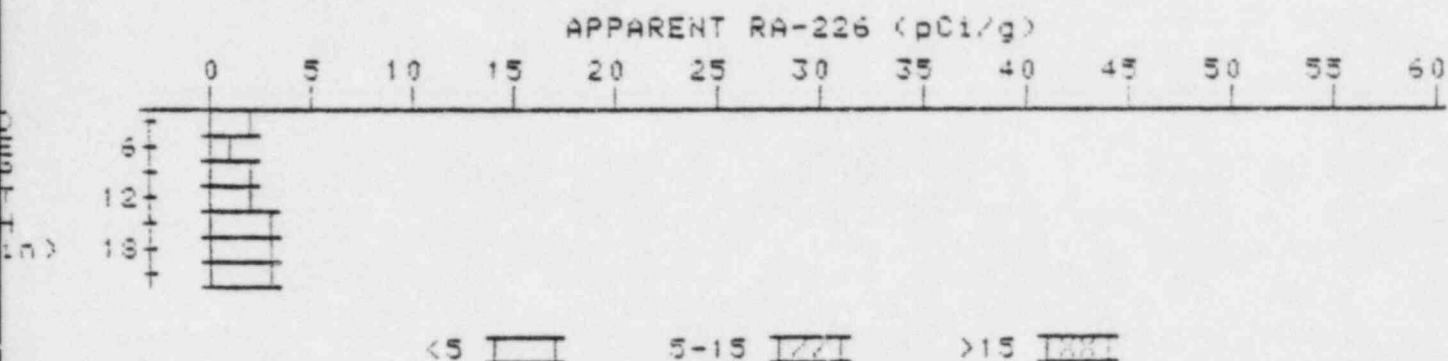
HOLE NUMBER: 8

Depth (in)	Apparent Radium-226 (pCi/g)	Apparent Radium-226 (pCi/g)
	Undeconvolved	Deconvolved
3	1.7	1.7
6	1.8	1.4
9	2.1	2.3
12	2.3	2.1
15	2.6	3.0
18	2.7	2.7
21	2.8	2.8

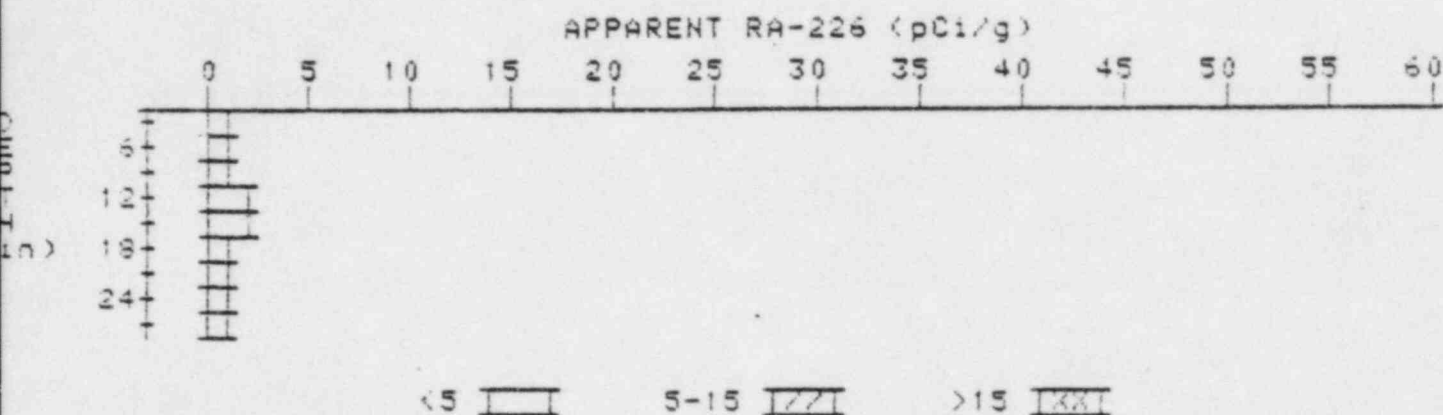
PROPERTY NUMBER: GJ-03494-RS  
HOLE NUMBER: 10  
LOCATION: 440392

Depth (in)	Apparent Radium-226 (pCi/g) Undeconvolved	Apparent Radium-226 (pCi/g) Deconvolved
3	1.4	1.4
6	1.4	1.4
9	1.4	1.2
12	1.5	1.7
15	1.5	1.7
18	1.4	1.4
21	1.3	1.3
24	1.2	1.0
27	1.2	1.2

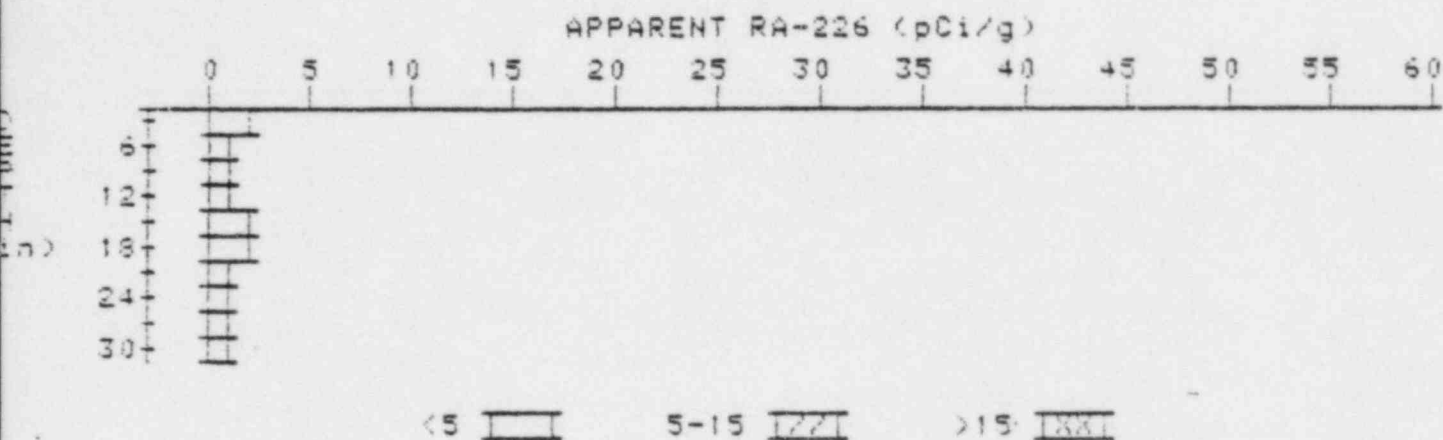
HOLE NUMBER: 17

Depth (in)	Apparent Radium-226 (pCi/g) Undeconvolved	Apparent Radium-226 (pCi/g) Deconvolved
3	1.5	1.5
6	1.4	1.4
9	1.3	.9
12	1.4	1.2
15	1.6	2.0
18	1.6	1.3
21	1.5	1.5
24	1.4	1.2
27	1.4	1.4
30	1.4	1.4

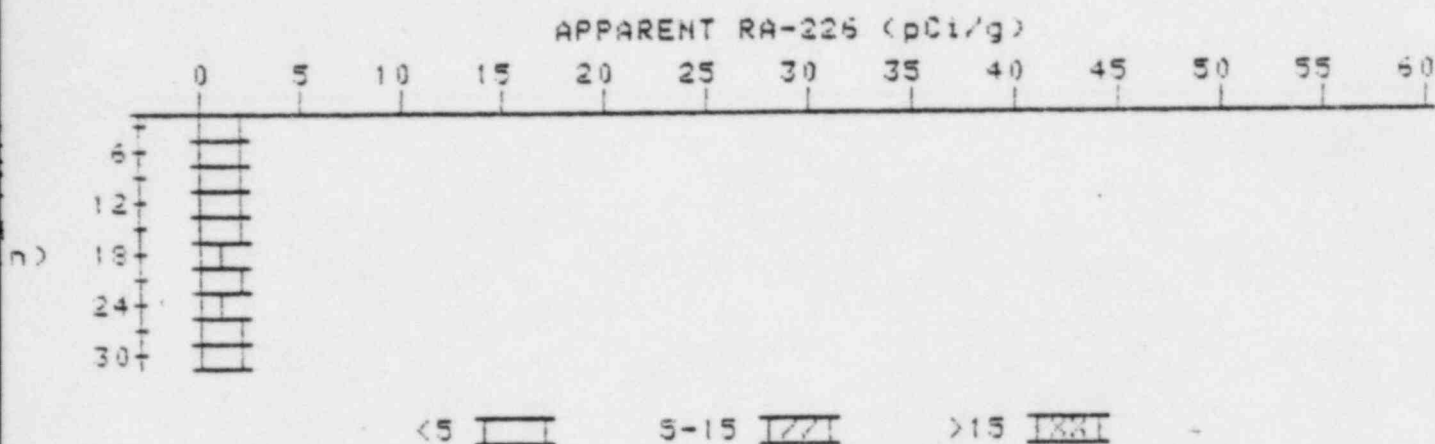
HOLE NUMBER: 18

Depth (in)	Apparent Radium-226 (pCi/g) Undeconvolved	Apparent Radium-226 (pCi/g) Deconvolved
3	1.7	1.7
6	1.7	1.7
9	1.7	1.7
12	1.7	1.7
15	1.7	1.9
18	1.6	1.2
21	1.7	2.1
24	1.6	1.4
27	1.6	1.8
30	1.5	1.5

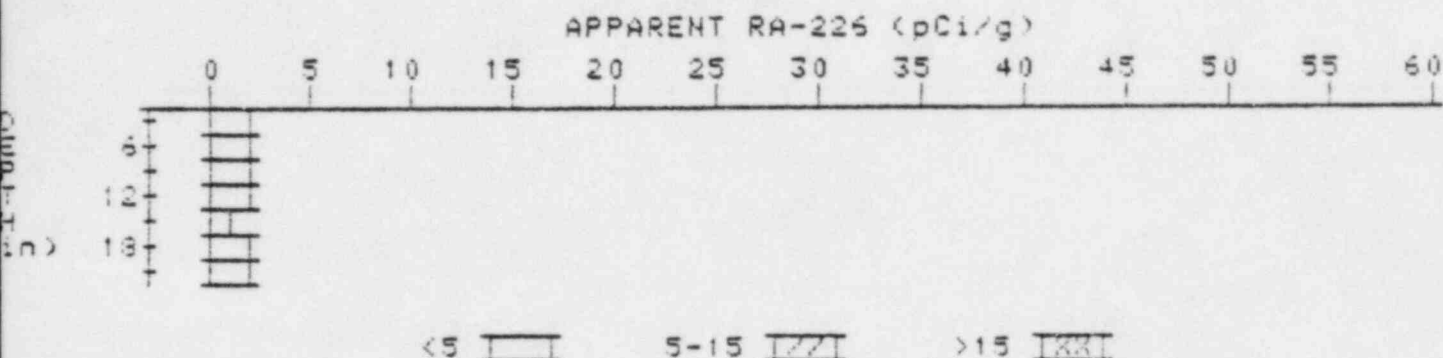
HOLE NUMBER: 19 ✓

Depth (in)	Apparent Radium-226 (pCi/g) Undeconvolved	Apparent Radium-226 (pCi/g) Deconvolved
3	2.1	2.1
6	2.0	2.0
9	1.9	2.1
12	1.7	1.7
15	1.5	1.1
18	1.5	1.5
21	1.5	1.5
