Modified to Fit Waterford Unit #3

Concrete Phase I Construction

POP-N-713
USE OF DISCREPANCY REPORTS

WATERFORD III SES
ANALYSIS OF CRACKS AND WATER SEEPAGE
IN FOUNDATION MAT
LOUISIANA POWER & LIGHT COMPANY
REPORT NO. 8304-1
SEPTEMBER 19, 1983

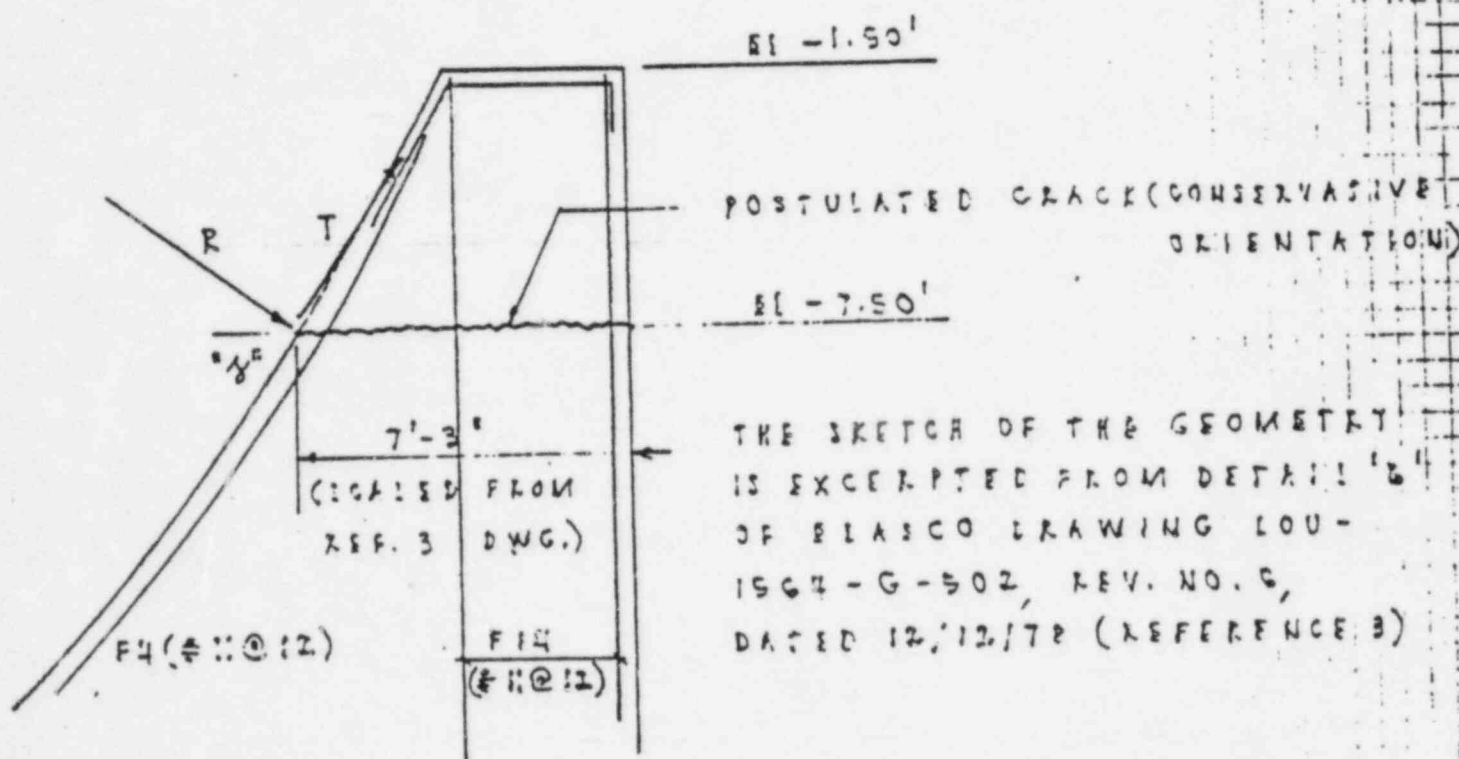
USING THE MAGNITUDES OF THE REACTION FORCES T , R COMPUTED ON PAGE 4, DETERMINE WHETHER THE UNDERLYING REINFORCED CONCRETE IS STRUCTURALLY ADEQUATE.

THE SKETCH OF THE GEOMETRY IS EXCERPTED FROM DETAIL 'B' OF BLASCO DRAWING LOU-1564-G-502, REV. NO. 6, DATED 12/12/78 (REFERENCE 3)

SINCE T , R ARE COMPUTED AS STRESS OF N-S AND E-W DLR, AND SINCE THE RESPECTIVE BEARING POINTS ARE 90° APART, REDUCE THESE FORCES BY $\sqrt{2}$.

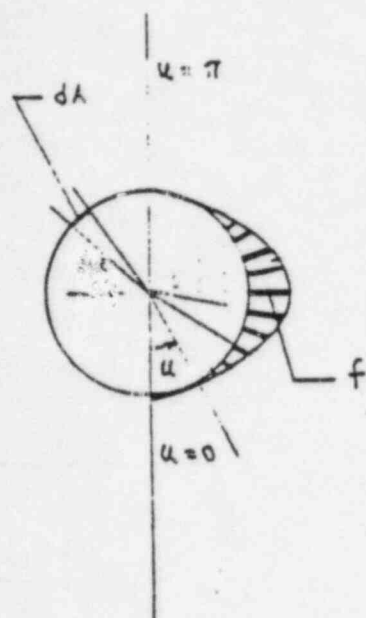
ASSUME THAT $H = 14414 \text{ k}$ IS THE RESULTANT OF THE SINUSOIDALLY DISTRIBUTED FORCE SHOWN ON THE LEFT.

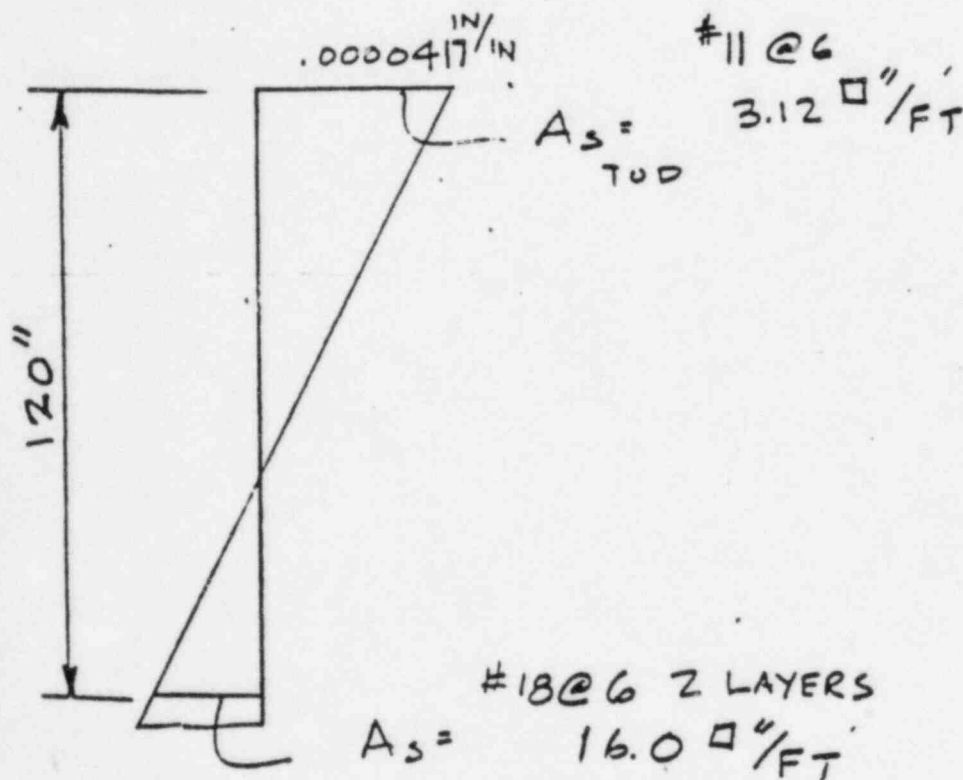
NEGLECT CONCRETE IN TENSION & COMPRESSION,
 REASONABLE SINCE BOTT STL \gg TOP STL

PROJECT WATERFORD 3 SES
 CLIENT LP&L
 SUBJECT CRACK WIDTH

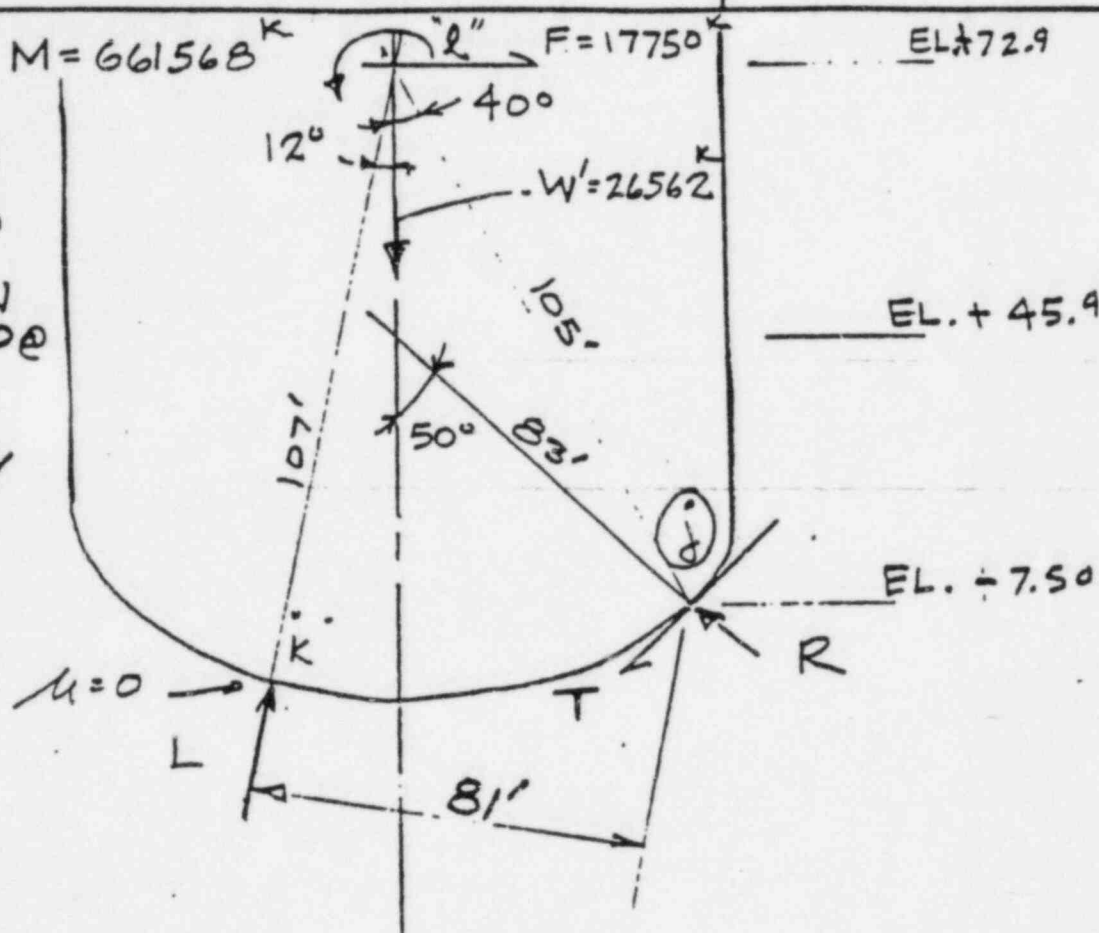
IF STEEL
 VESSEL WAS
 MOVED HORIZ.
 WITHOUT
 TIPPING, TWO
 POINTS OF
 CONTACT CAN
 BE IDEALIZED @
 "j" & "k".

PT K IS
 CONSERVATIVELY
 ASSUMED AS
 FRICTIONLESS

$$\begin{aligned} \textcircled{1} \quad \sum M_j &= -M + 81L + F \cos 40^\circ (105) - W' \sin 40^\circ (105) = 0 \\ &= -661568 + 81L + 1,427,715 - 1,792,741 = 0 \\ &L = 12674 \end{aligned}$$
