LICENSEE: Northeast Nuclear Energy Company
FACILITY: Millstone Nuclear Power Station, Unit No. 2
SUBJECT: SUMMARY OF MEETING WITH NORTHEAST NUCLEAR ENERGY COMPANY
CONCERNING EDDY CURRENT TEST (ECT) RESULTS ON MILLSTONE UNIT 2

MILLSTONE NUCLEAR POWER STATION, UNIT NO. 2

STEAM GENERATOR CHEMICAL CLEANING

STEAM GENERATOR TUBE INSPECTIONS

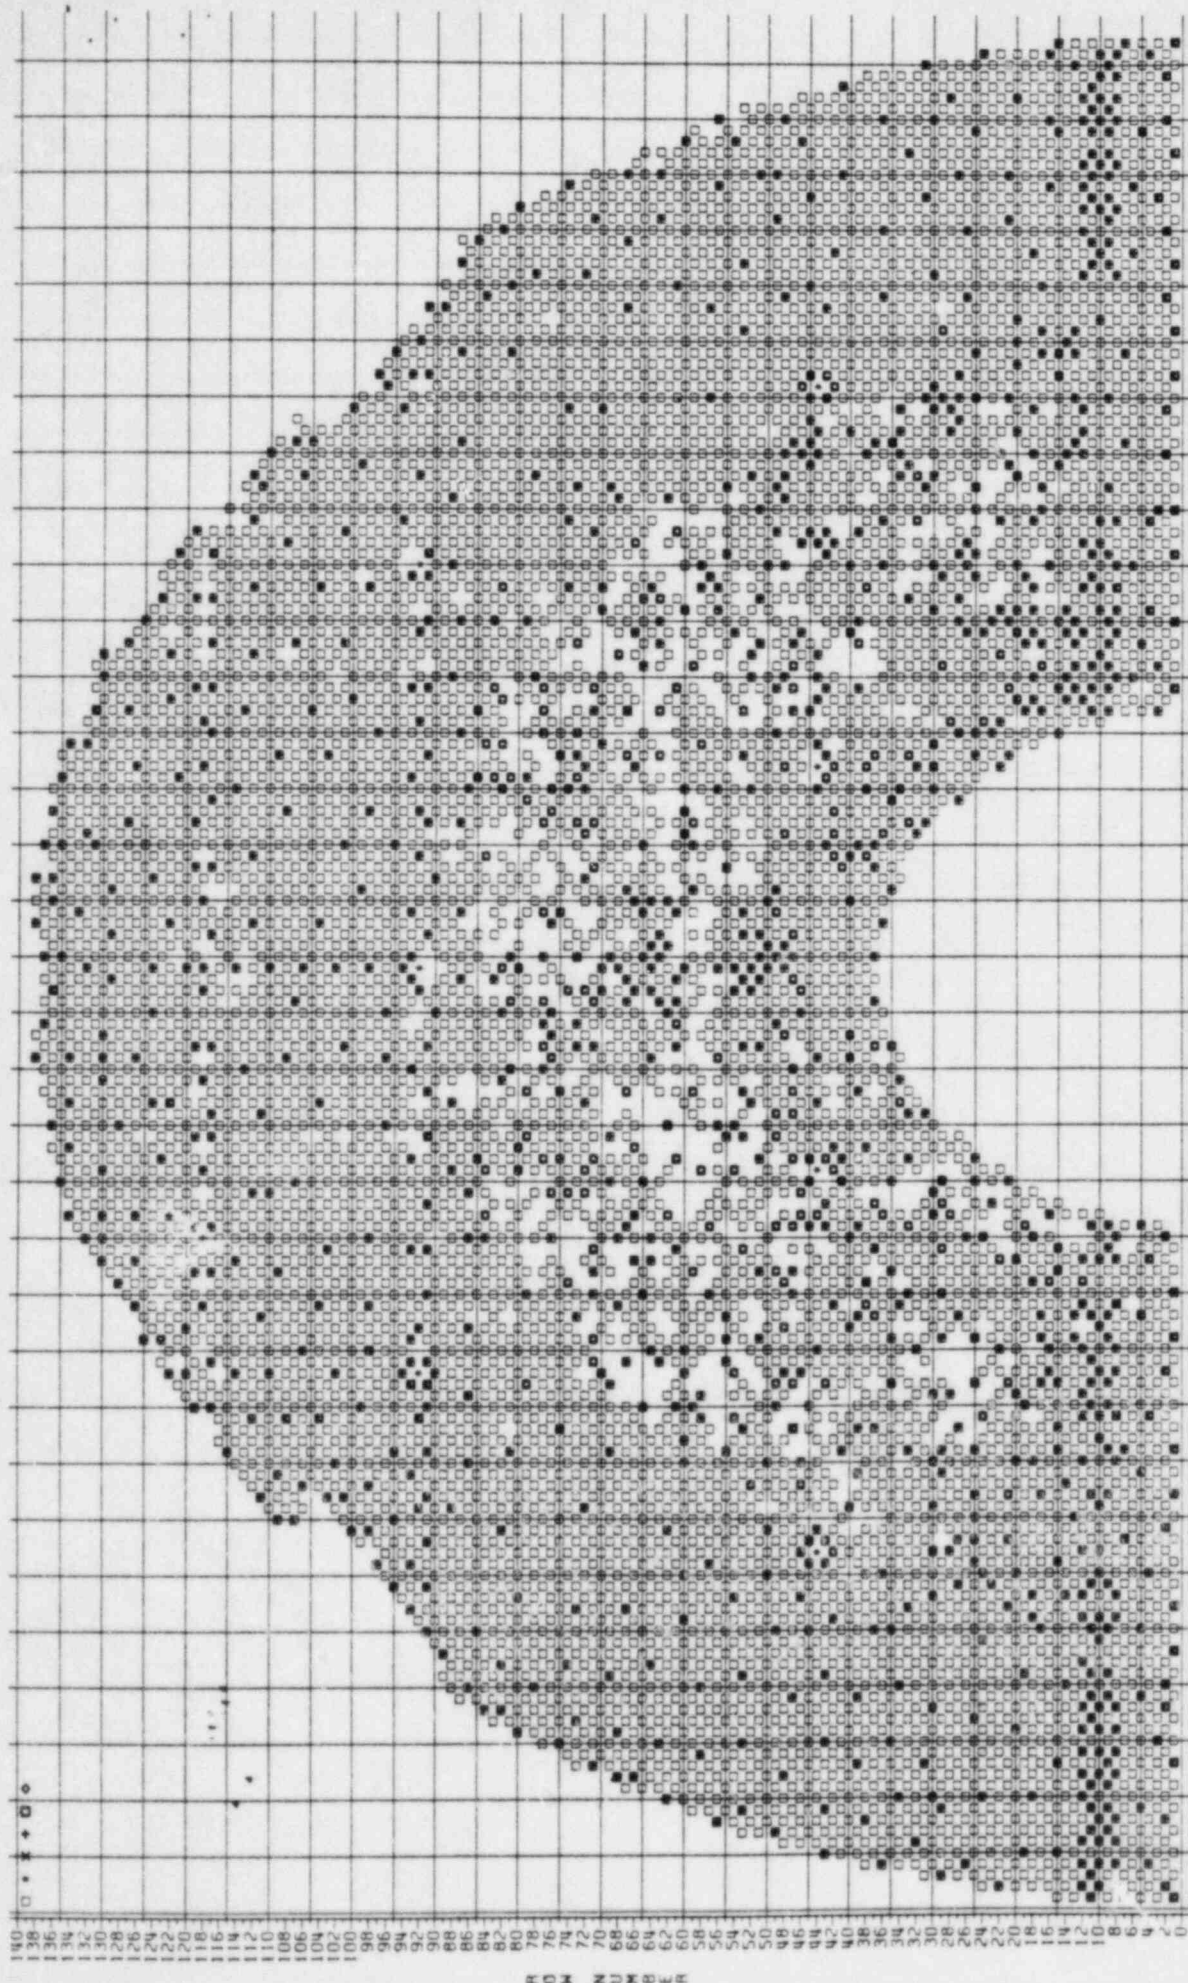
FOR MP2 STEAM GENERATOR #1, 1985 OUTAGE

<u>DESCRIPTION</u>	<u>STEAM GENERATOR 1</u>		<u>TOTAL</u>
	<u>COLD SIDE</u>	<u>HOT SIDE</u>	
1. DEFECTS \geq 40 PERCENT	1101	154	1255
2. DISTORTED INDICATIONS	14	392	<u>406</u>
			1661

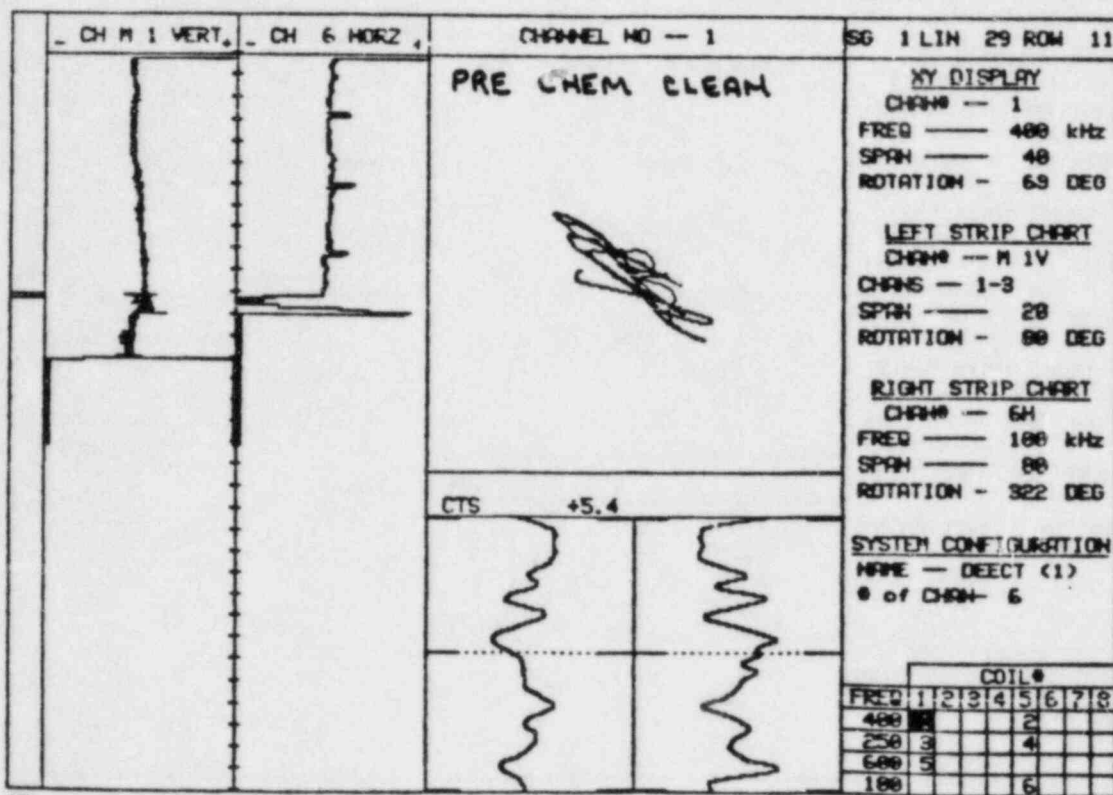
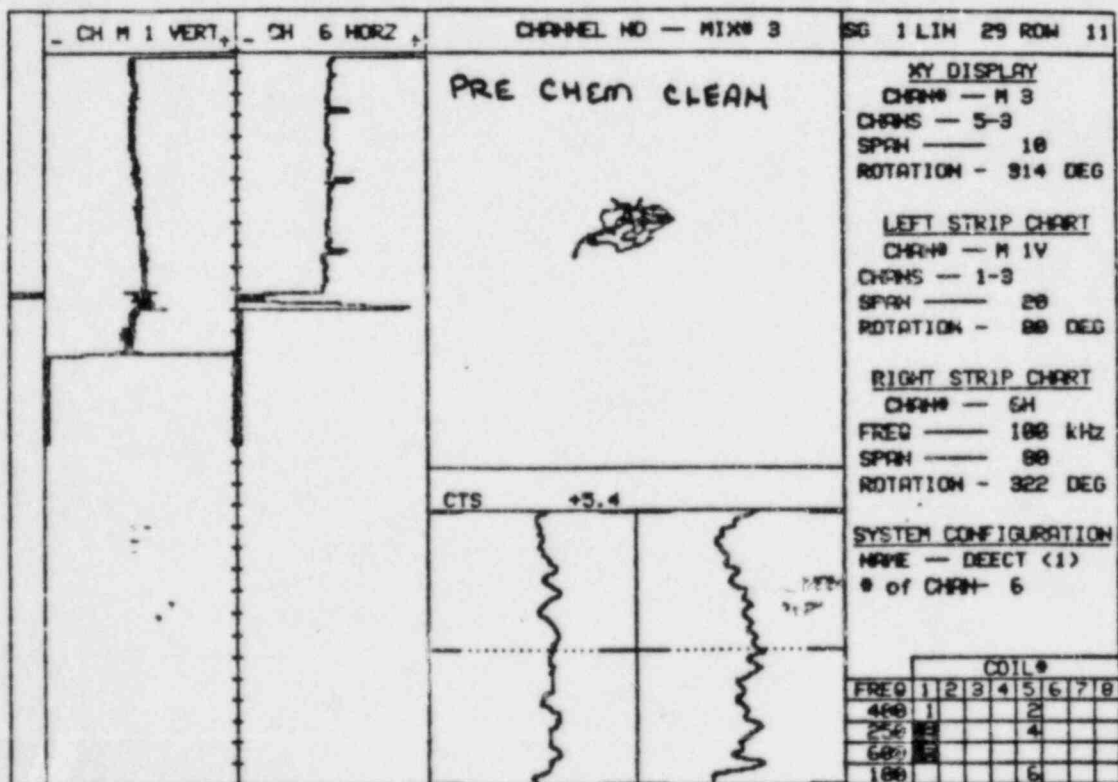
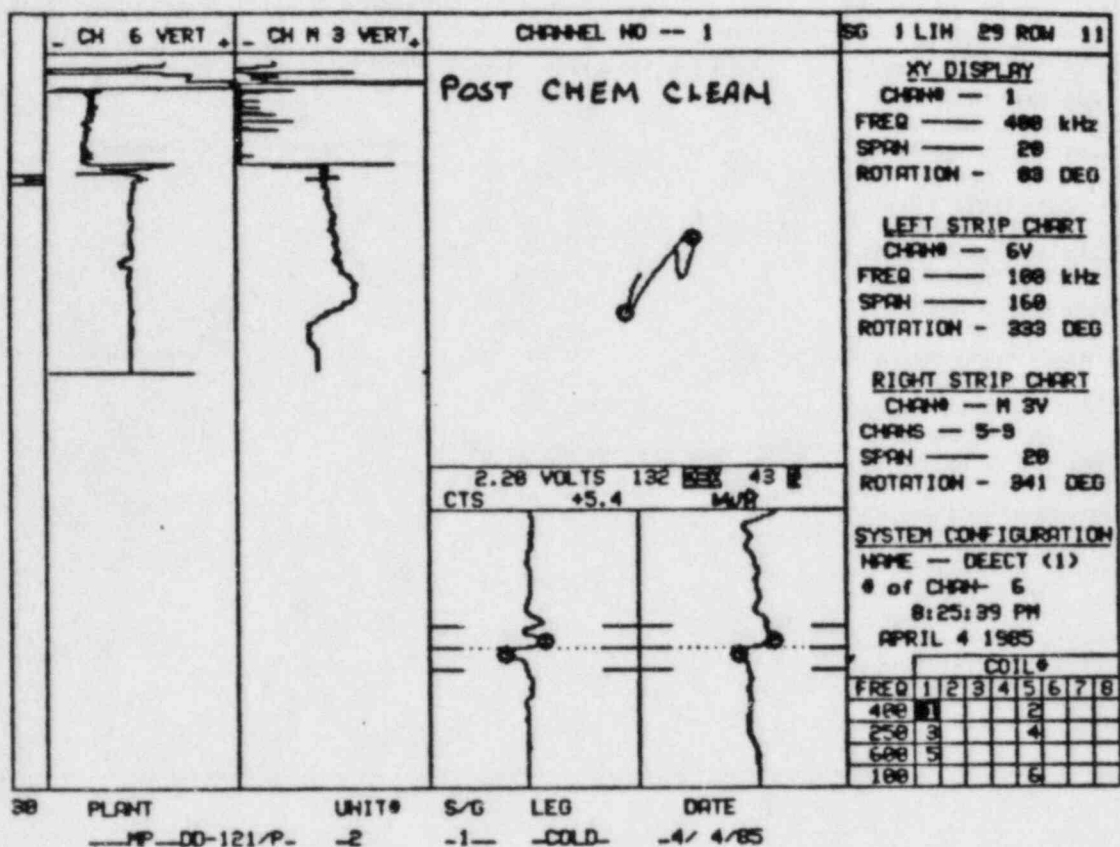
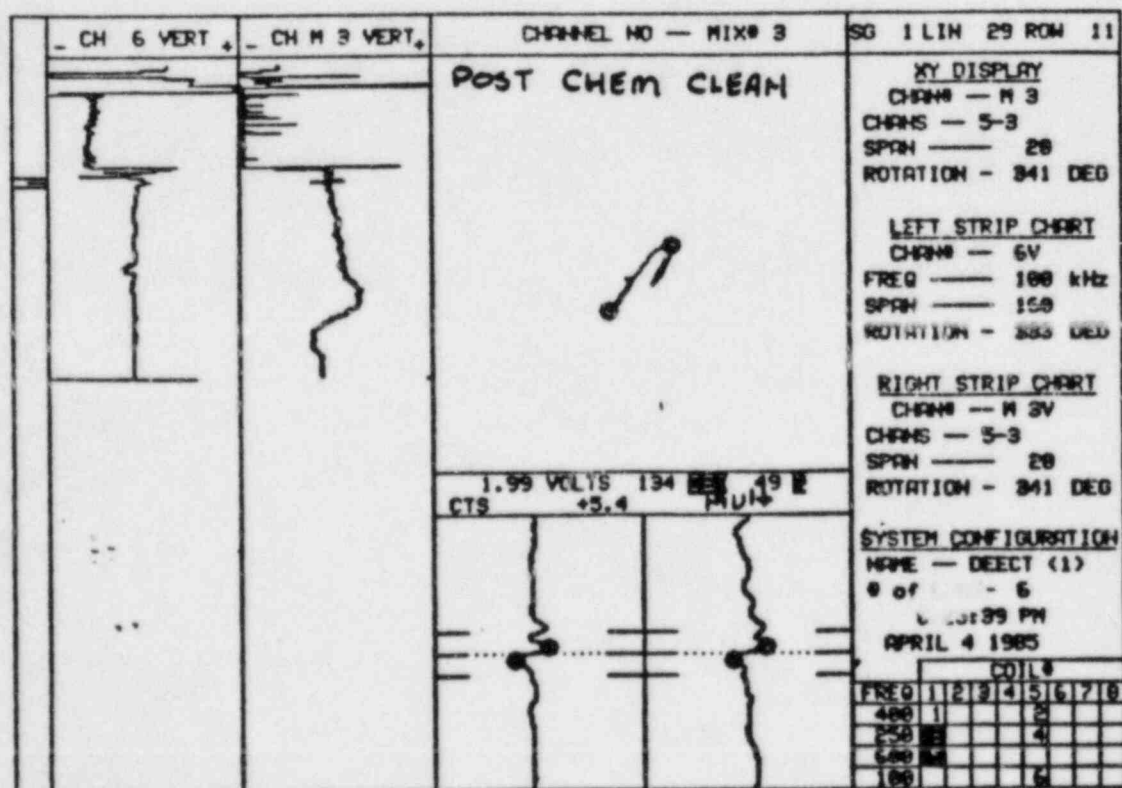
REASON FOR NEWLY DETECTED DEFECTS
AFTER CHEMICAL CLEANING

- o STRONG ELECTRONIC NOISE (COPPER) GREATLY REDUCED BY CHEMICAL CLEANING (COPPER REMOVAL)
- o INCREASED EDDY CURRENT SIGNAL RESPONSE FROM COPPER REMOVAL (SHOWN IN LABORATORY).
- o NEW FLAWS SMALL IN VOLUME, BELOW ECT THRESHOLD OF DETECTABILITY IN PRESENCE OF COPPER
- o LARGER PROBE DIAMETER AFTER CLEANING
