RADIOLOGIC AND ENGINEERING ASSESSMENT

DOE ID NO.: GJ-10103-RS
ADDRESS: 133 GUNNISON AVENUE

JUNE 1985

BENDIX FIELD ENGINEERING CORPORATION
P.O. Box 1569
Grand Junction, Colorado 81502

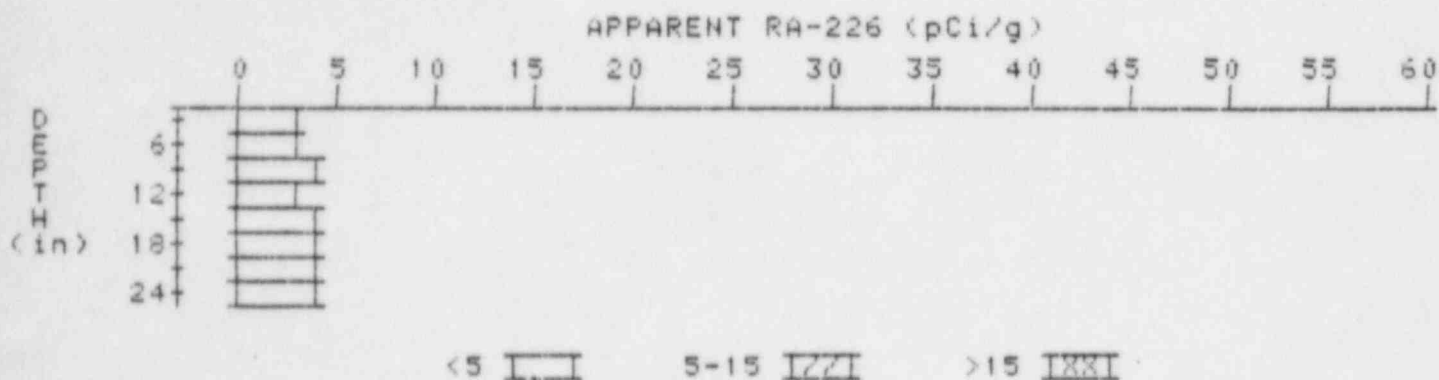
HOLE NUMBER: 1

Depth (in)	Apparent Radium-226 (pCi/g) Undeconvolved	Apparent Radium-226 (pCi/g) Deconvolved
3	2.8	2.8
6	3.2	3.4
9	3.5	3.9
12	3.6	3.4
15	3.8	4.2
18	3.8	3.6
21	3.9	4.3
24	3.8	3.8

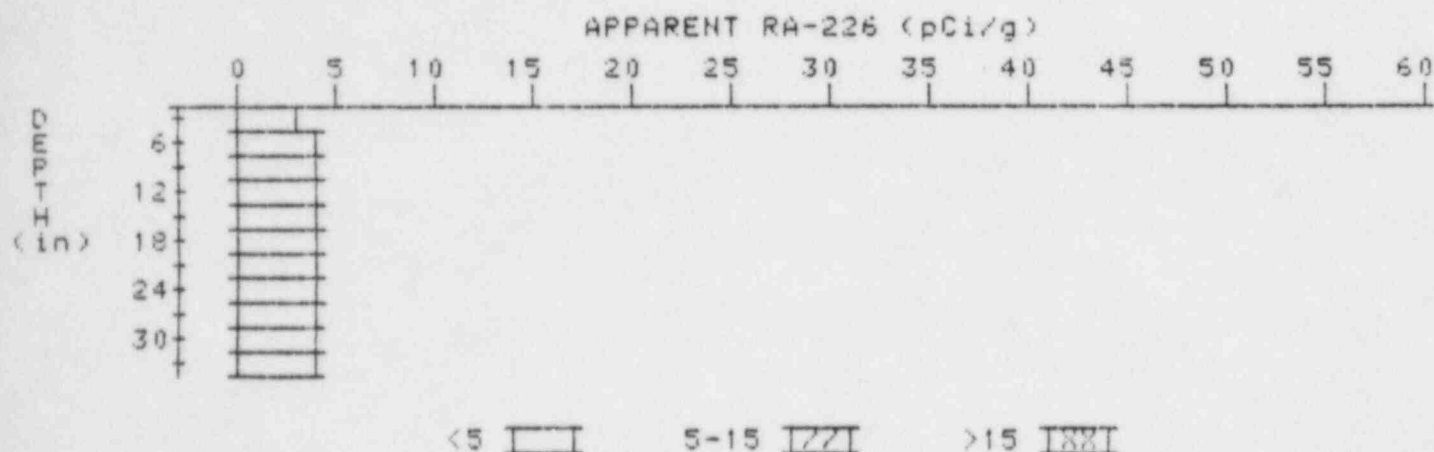
HOLE NUMBER: 2

Depth (in)	Apparent Radium-226 (pCi/g) Undeconvolved	Apparent Radium-226 (pCi/g) Deconvolved
3	3.2	3.2
6	3.6	3.8
9	3.9	4.3
12	4.0	4.0
15	4.1	4.5
18	4.0	4.0
21	3.9	3.7
24	3.9	3.9
27	3.9	3.7
30	4.0	4.2
33	4.0	4.0

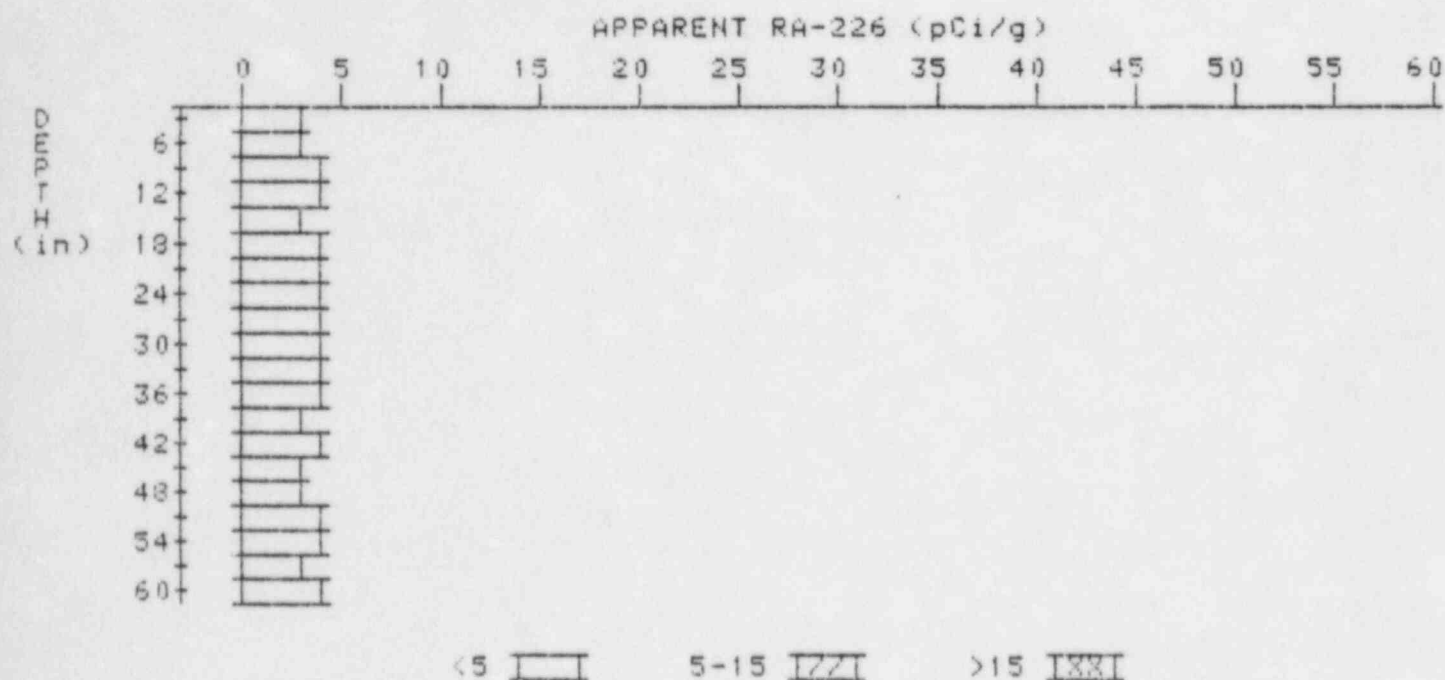
HOLE NUMBER: 6

Depth (in)	Apparent Radium-226 (pCi/g) Undeconvolved	Apparent Radium-226 (pCi/g) Deconvolved
3	3.1	3.1
6	3.3	3.3
9	3.5	3.7
12	3.6	3.8
15	3.6	3.4
18	3.7	3.7
21	3.8	3.8
24	3.9	4.3
27	3.8	3.6
30	3.8	3.8
33	3.8	4.0
36	3.7	3.9
39	3.5	3.0
42	3.6	4.0
45	3.8	3.3
48	3.8	3.1
51	3.7	3.9
54	3.8	4.2

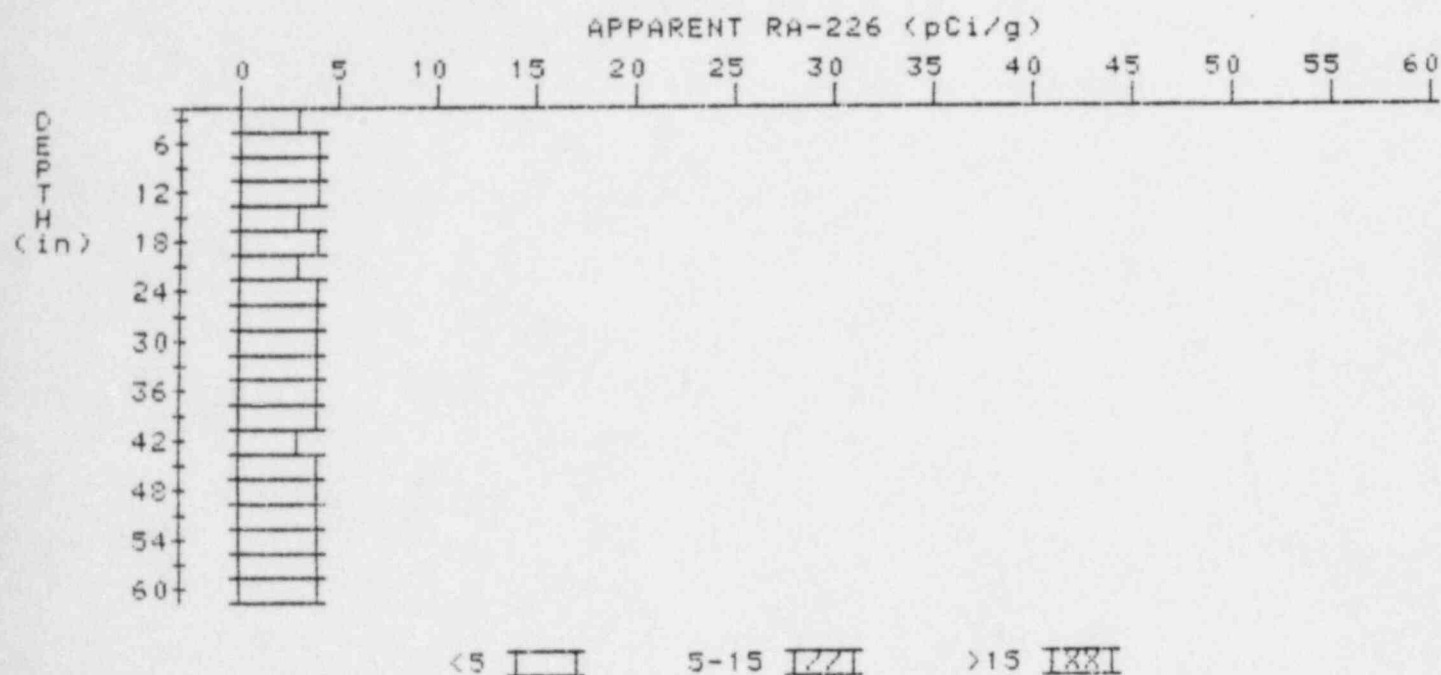
PROPERTY NUMBER: GJ-10103-RS
HOLE NUMBER: 15
LOCATION: 220270

Depth (in)	Apparent Radium-226 (pCi/g) Undeconvolved	Apparent Radium-226 (pCi/g) Deconvolved
3	3.2	3.2
6	3.4	3.6
9	3.5	3.7
12	3.5	3.5
15	3.5	3.3
18	3.6	3.8
21	3.6	3.4
24	3.7	3.9
27	3.7	3.5
30	3.8	4.0
33	3.8	3.6
36	3.9	4.1
39	3.9	4.1
42	3.8	3.4
45	3.9	4.1
48	3.9	3.9
51	3.9	3.7
54	4.0	4.0

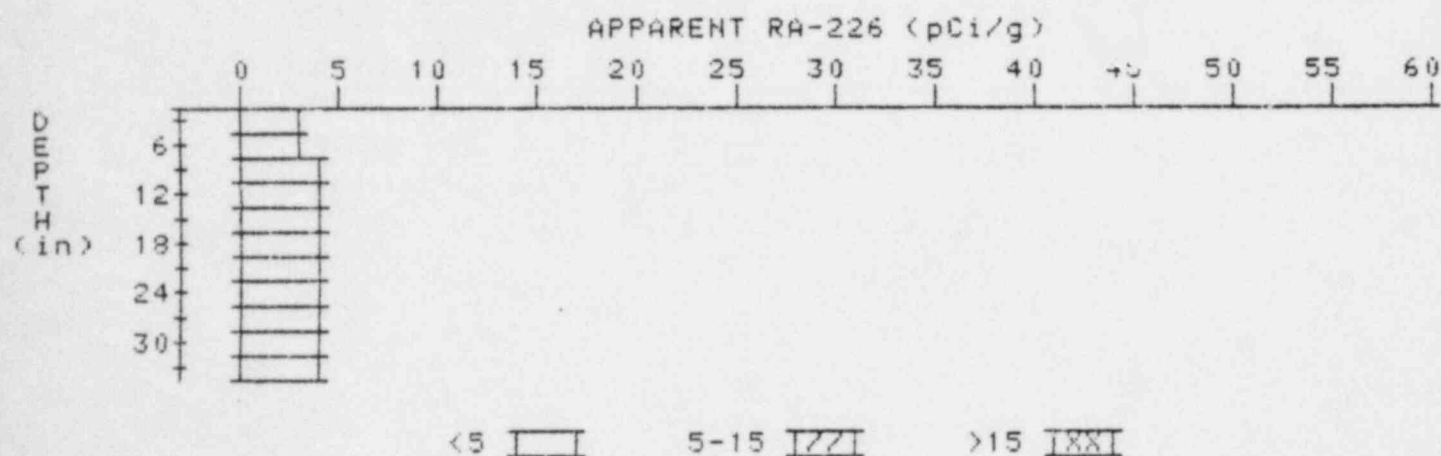
HOLE NUMBER: 18

Depth (in)	Apparent Radium-226 (pCi/g) Undeconvolved	Apparent Radium-226 (pCi/g) Deconvolved
3	3.2	3.2
6	3.4	3.4
9	3.6	3.8
12	3.7	3.9
15	3.7	3.7
18	3.7	3.7
21	3.7	3.5
24	3.8	3.8
27	3.9	4.1
30	3.9	3.9
33	3.9	3.9
