RADIOLOGIC AND ENGINEERING ASSESSMENT

DOE ID NO.: GJ-10653-RS
ADDRESS: 631 OURAY AVENUE

JUNE 1985

BENDIX FIELD ENGINEERING CORPORATION
P.O. Box 1569
Grand Junction, Colorado 81502

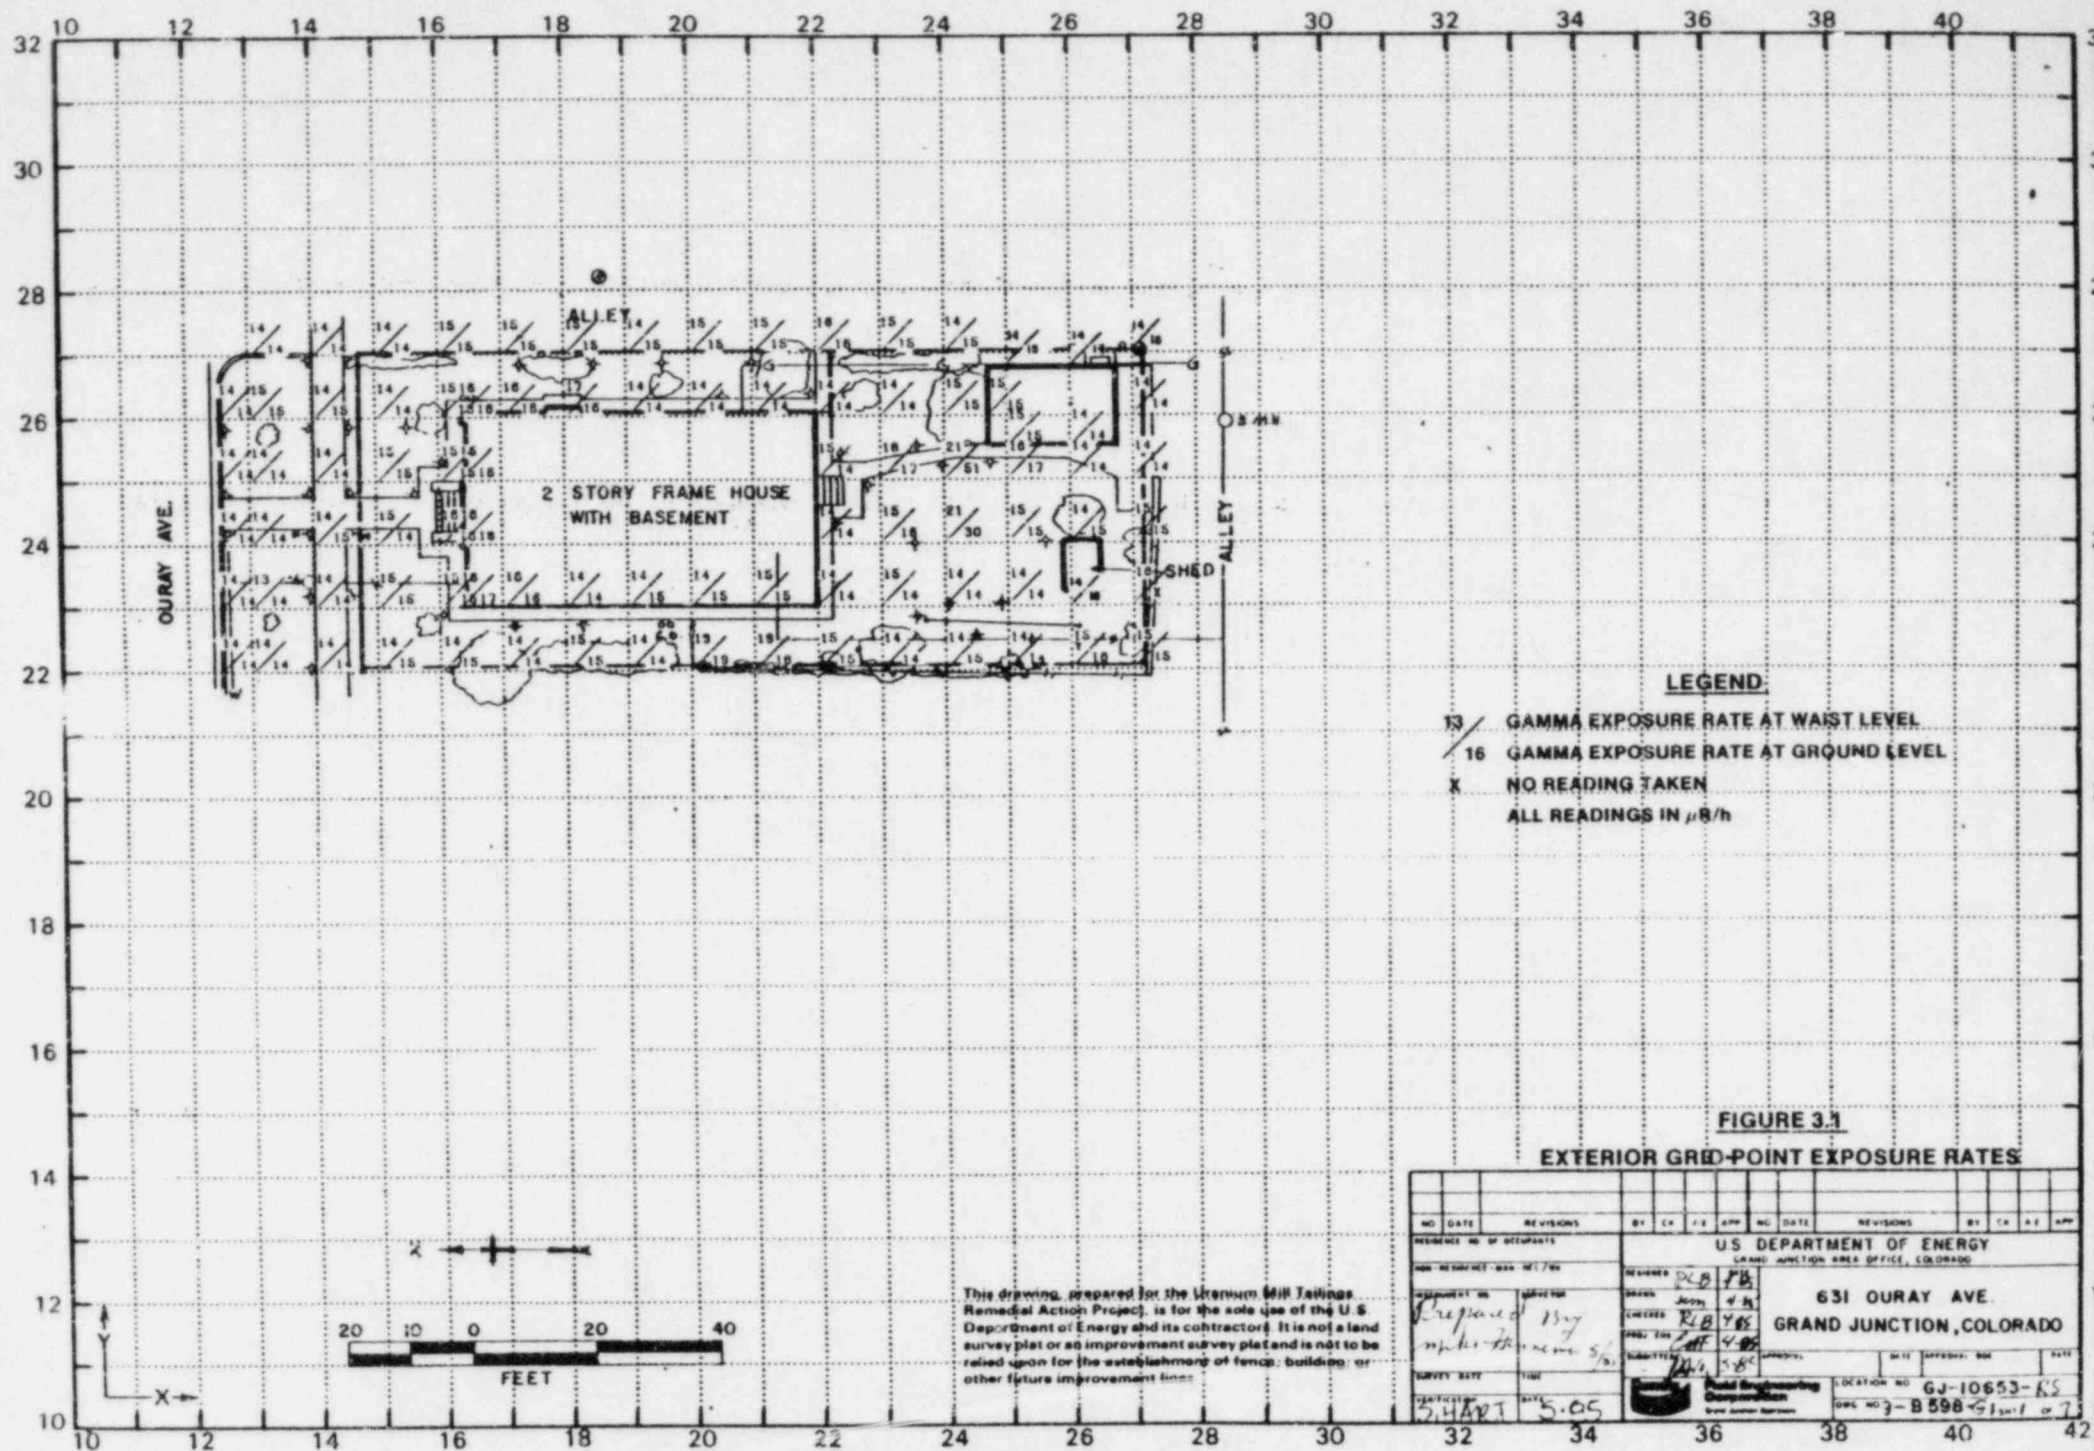
Shine from a contaminated concrete pad on the adjacent property is the cause of elevated gamma readings on grid-points 200220 and 210220.

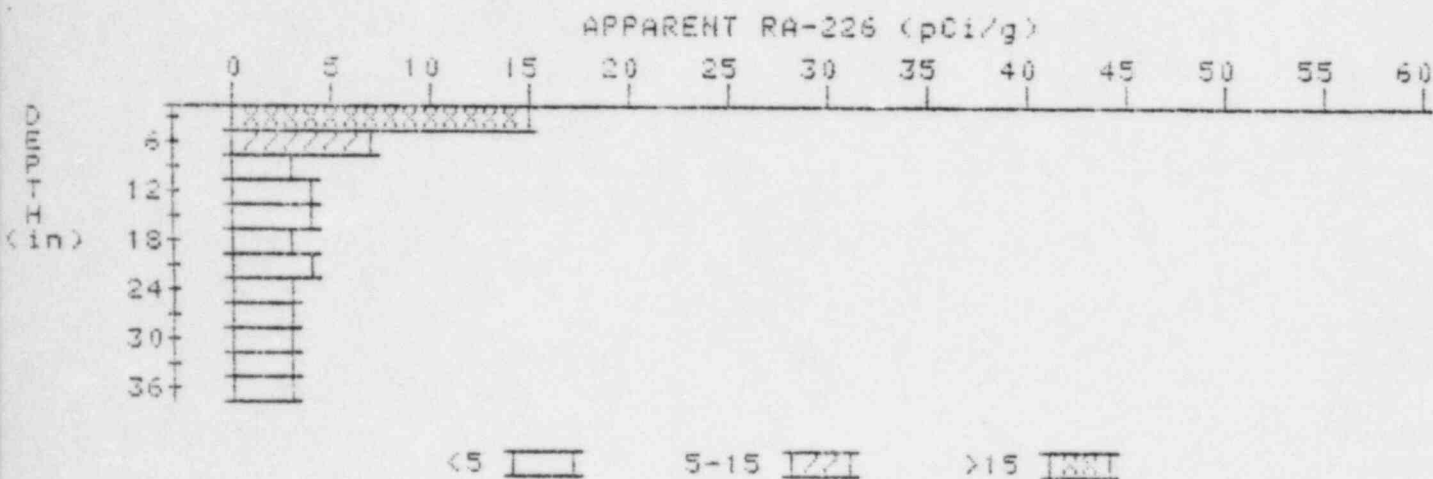
PROPERTY NUMBER: GJ-10553-R3
HOLE NUMBER: 12
LOCATION: 240248

Depth (in)	Apparent Radium-226 (pCi/g) Undeconvolved	Apparent Radium-226 (pCi/g) Deconvolved
3	15.2	15.2
6	10.1	7.1
9	6.7	3.5
12	3.1	3.5
15	4.4	4.0
18	3.9	3.4
21	3.7	3.9
24	3.4	3.2
27	3.2	3.0
30	3.1	3.1
33	3.0	3.0
36	2.9	2.9
