RADIOLOGIC AND ENGINEERING ASSESSMENT

DOE ID NO.: GJ-11585-RS
ADDRESS: 2010 ELM AVENUE

JUNE 1985

BENDIX FIELD ENGINEERING CORPORATION
P.O. Box 1569
Grand Junction, Colorado 81502

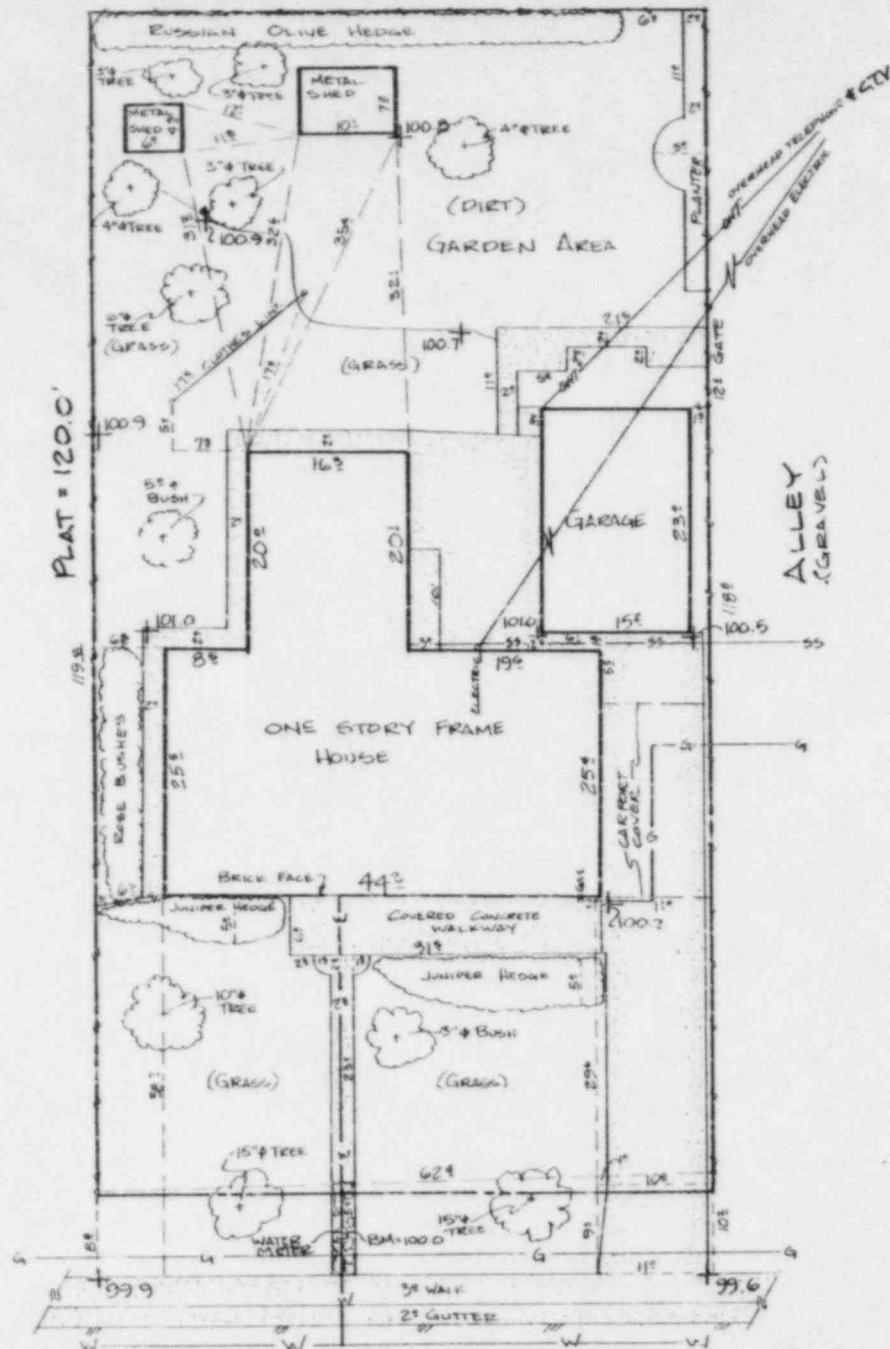
FIGURE 2.2 SITE PLAN

The front yard is well landscaped. Structures, utilities, landscaping, and other special features of this property are included in Appendix Figure 2.2.
