RADIOLOGIC AND ENGINEERING ASSESSMENT

DOE ID NO.: GJ-11061-RS  
ADDRESS: 419 BELFORD AVENUE

JUNE 1985

BENDIX FIELD ENGINEERING CORPORATION  
P.O. Box 1569  
Grand Junction, Colorado 81502

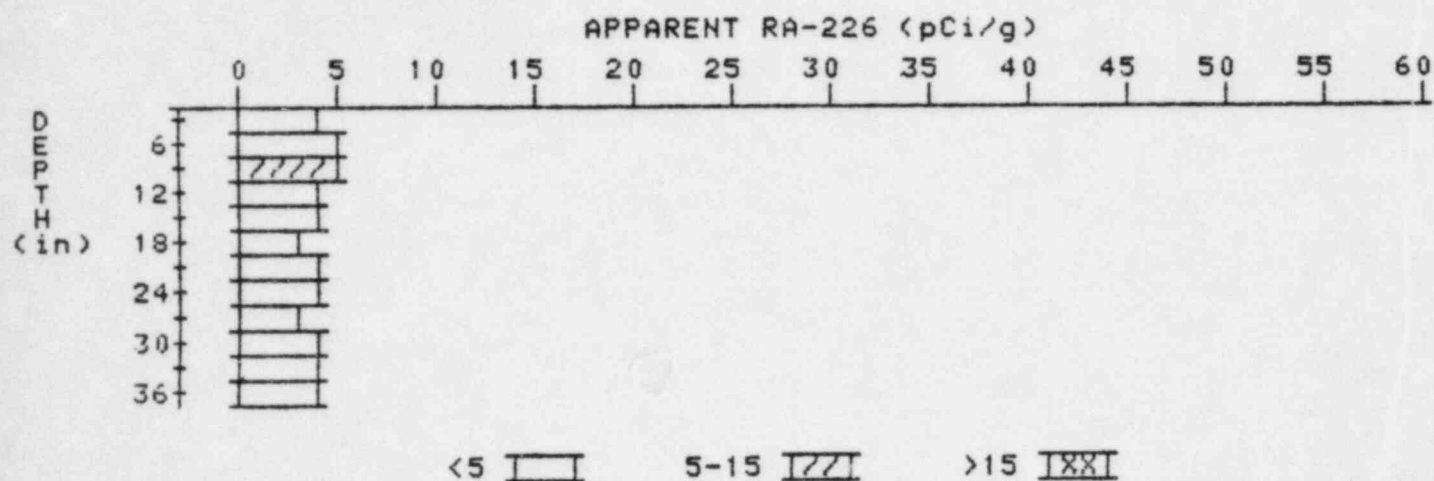
HOLE NUMBER: 3

Depth (in)	Apparent Radium-226 (pCi/g) Undeconvolved	Apparent Radium-226 (pCi/g) Deconvolved
3	4.1	4.1
6	4.4	4.8
9	4.5	5.2
12	4.2	4.0
15	4.0	4.0
18	3.8	3.4
21	3.8	3.6
24	3.9	4.3
27	3.8	3.4
30	3.9	3.9
33	4.0	4.0
36	4.1	4.1

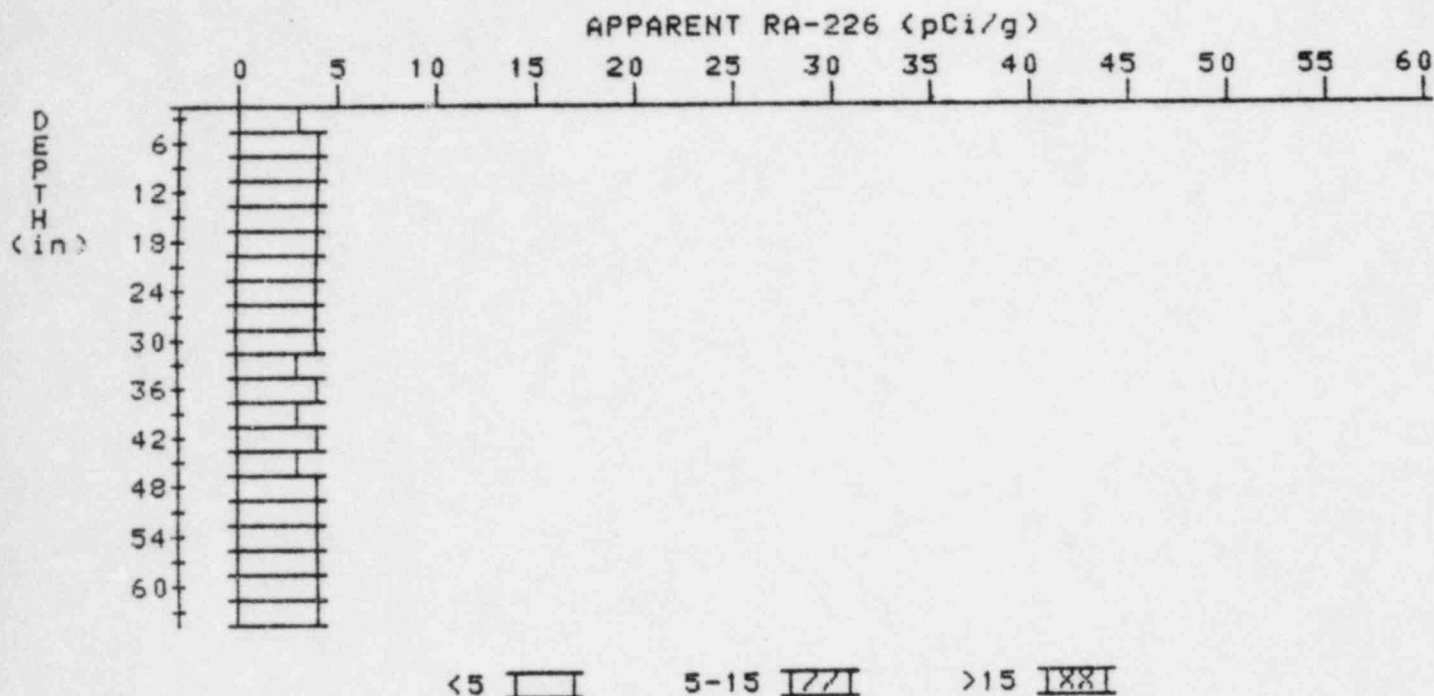
HOLE NUMBER: 5

Depth (in)	Apparent Radium-226 (pCi/g) Undeconvolved	Apparent Radium-226 (pCi/g) Deconvolved
3	2.8	2.8
6	3.2	3.6
9	3.4	3.6
12	3.5	3.5
15	3.6	3.8
18	3.6	3.6
21	3.6	3.6
24	3.6	3.6
27	3.6	3.6
30	3.6	3.8
33	3.5	3.1
36	3.6	4.0
39	3.5	3.1
42	3.6	3.8
45	3.6	3.2
48	3.8	4.0
51	3.9	4.1

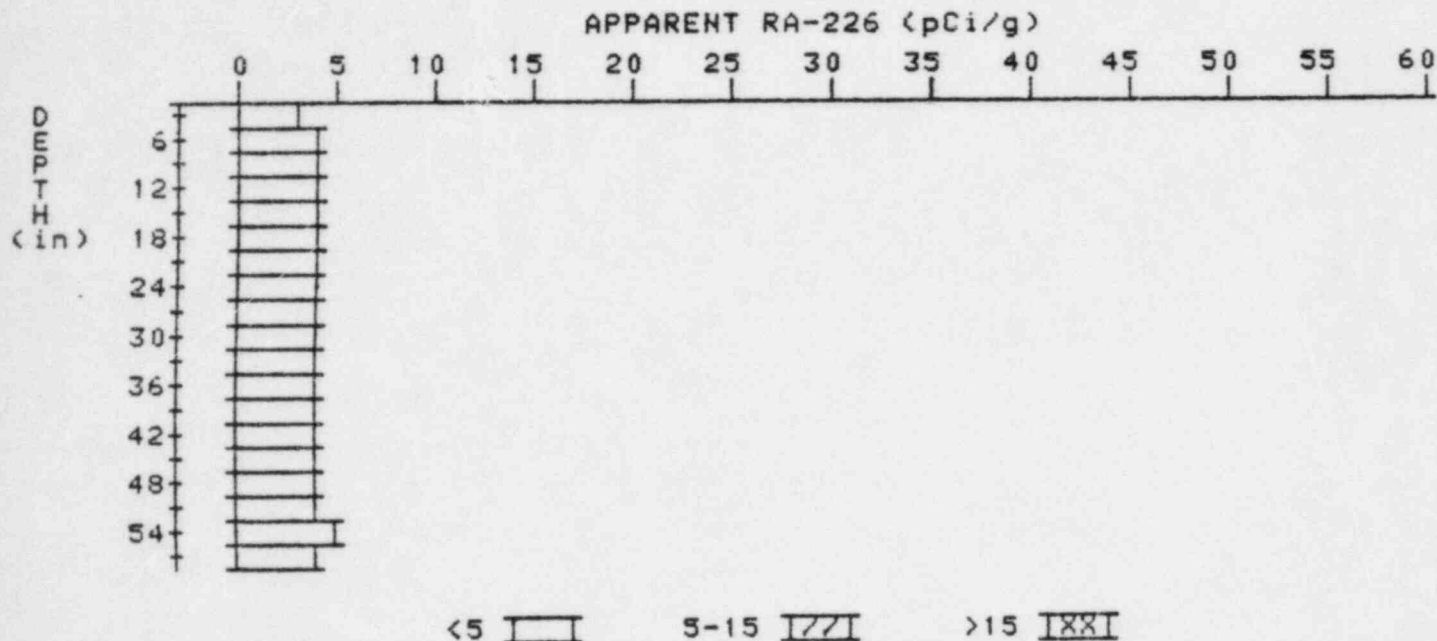
HOLE NUMBER: 6

Depth (in)	Apparent Radium-226 (pCi/g) Undeconvolved	Apparent Radium-226 (pCi/g) Deconvolved
3	3.1	3.1
6	3.4	3.6
9	3.6	3.8
12	3.7	3.9
15	3.7	3.5
18	3.8	4.2
21	3.7	3.5
24	3.7	3.7
27	3.7	3.7
30	3.7	3.7
33	3.7	3.5
36	3.8	3.6
39	4.0	4.2
42	4.1	4.1
45	4.2	4.4
48	4.2	4.2
51	4.2	4.0
54	4.3	4.7

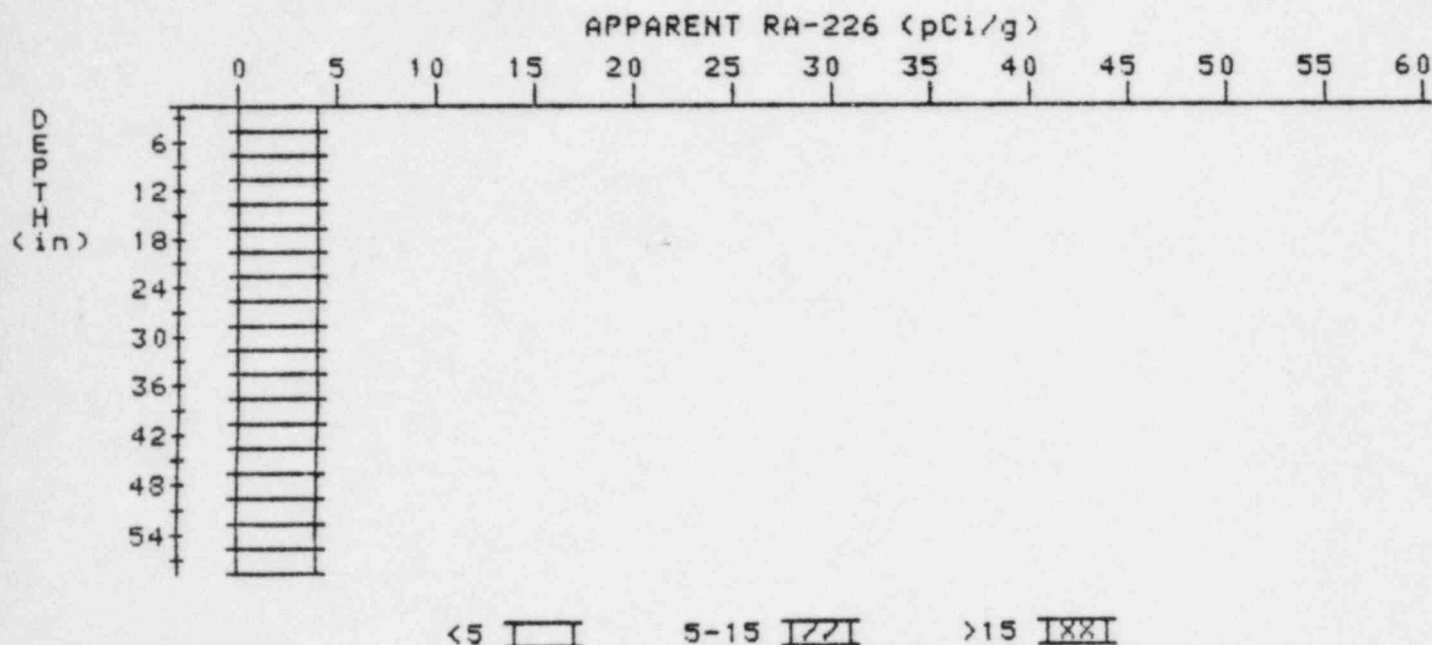
HOLE NUMBER: 7

Depth (in)	Apparent Radium-226 (pCi/g) Undeconvolved	Apparent Radium-226 (pCi/g) Deconvolved
3	3.5	3.5
6	3.7	3.7
9	3.9	4.3
12	3.9	3.9
15	3.9	4.1
18	3.8	3.6
21	3.8	3.8
24	3.8	3.8
27	3.8	3.6
30	3.9	4.3
33	3.8	3.6
36	3.8	3.8
39	3.8	3.8
42	3.8	3.8
45	3.8	3.8
48	3.8	4.0
51	3.7	3.5
54	3.7	3.7

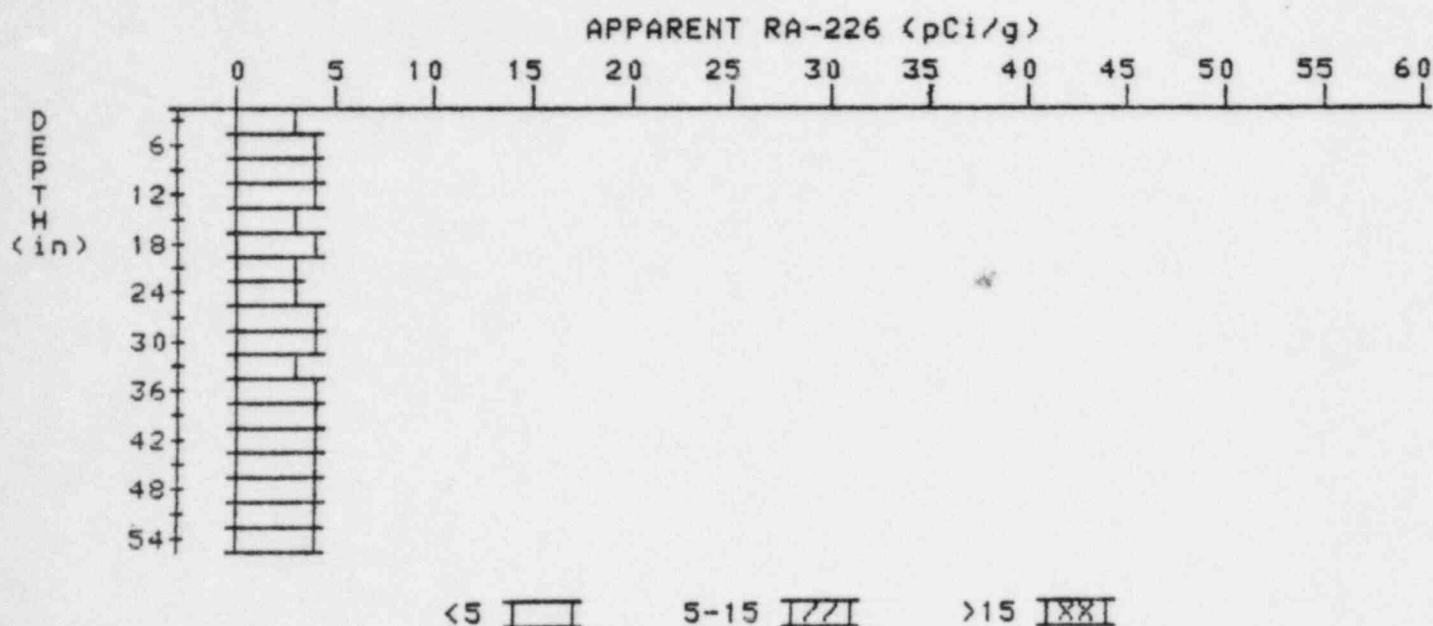
HOLE NUMBER: 9

Depth (in)	Apparent Radium-226 (pCi/g) Undeconvolved	Apparent Radium-226 (pCi/g) Deconvolved
3	3.2	3.2
6	3.5	3.9
9	3.6	3.8
12	3.6	3.6
15	3.6	3.4
18	3.7	4.1
21	3.6	3.4
24	3.6	3.4
27	3.7	3.7
30	3.8	4.3
33	3.6	3.1
36	3.7	3.9
39	3.7	3.5
42	3.8	4.0
45	3.8	3.6
48	3.9	3.9
51	4.0	4.4
54	3.9	3.9

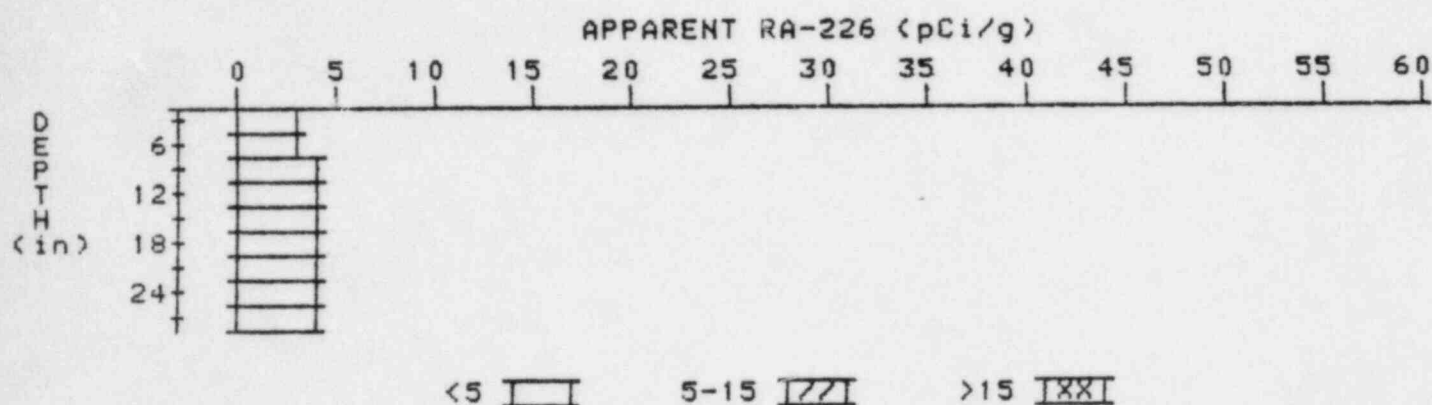
HOLE NUMBER: 11

Depth (in)	Apparent Radium-226 (pCi/g) Undeconvolved	Apparent Radium-226 (pCi/g) Deconvolved
3	3.1	3.1
6	3.4	3.4
9	3.7	4.1
12	3.8	3.8
15	3.9	4.1
18	3.9	3.7
21	4.0	4.2
24	4.0	4.2
27	3.9	3.9

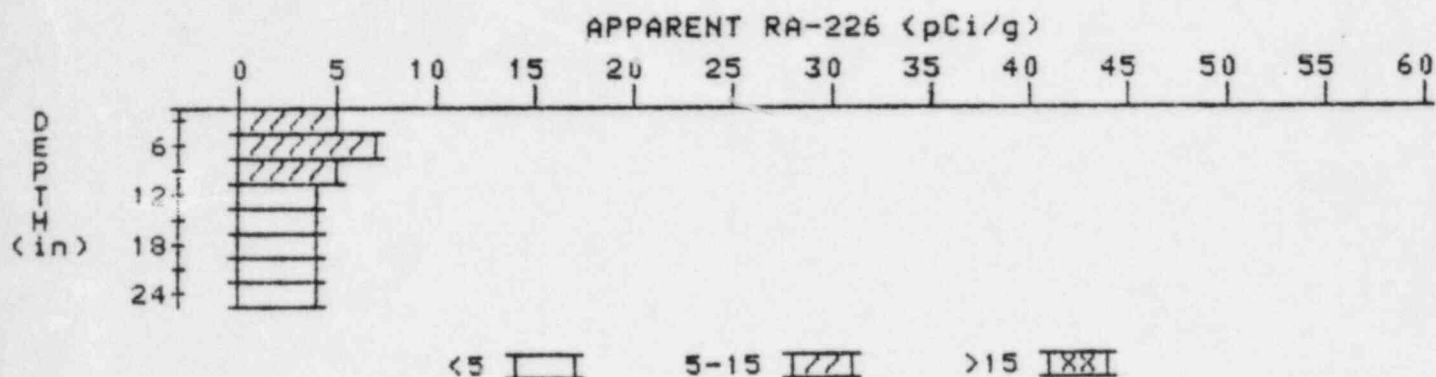
HOLE NUMBER: 12

Depth (in)	Apparent Radium-226 (pCi/g) Undeconvolved	Apparent Radium-226 (pCi/g) Deconvolved
3	5.0	5.0
6	5.3	6.5
9	4.9	5.1
12	4.4	3.9
15	4.2	4.0
18	4.1	4.1
21	4.0	3.8
24	4.0	4.0
