RADIOLOGIC AND ENGINEERING ASSESSMENT

DOE ID NO.: GJ-00713-MR  
ADDRESS: 1535 ELM AVENUE

JUNE 1985

BENDIX FIELD ENGINEERING CORPORATION  
P.O. Box 1569  
Grand Junction, Colorado 81502

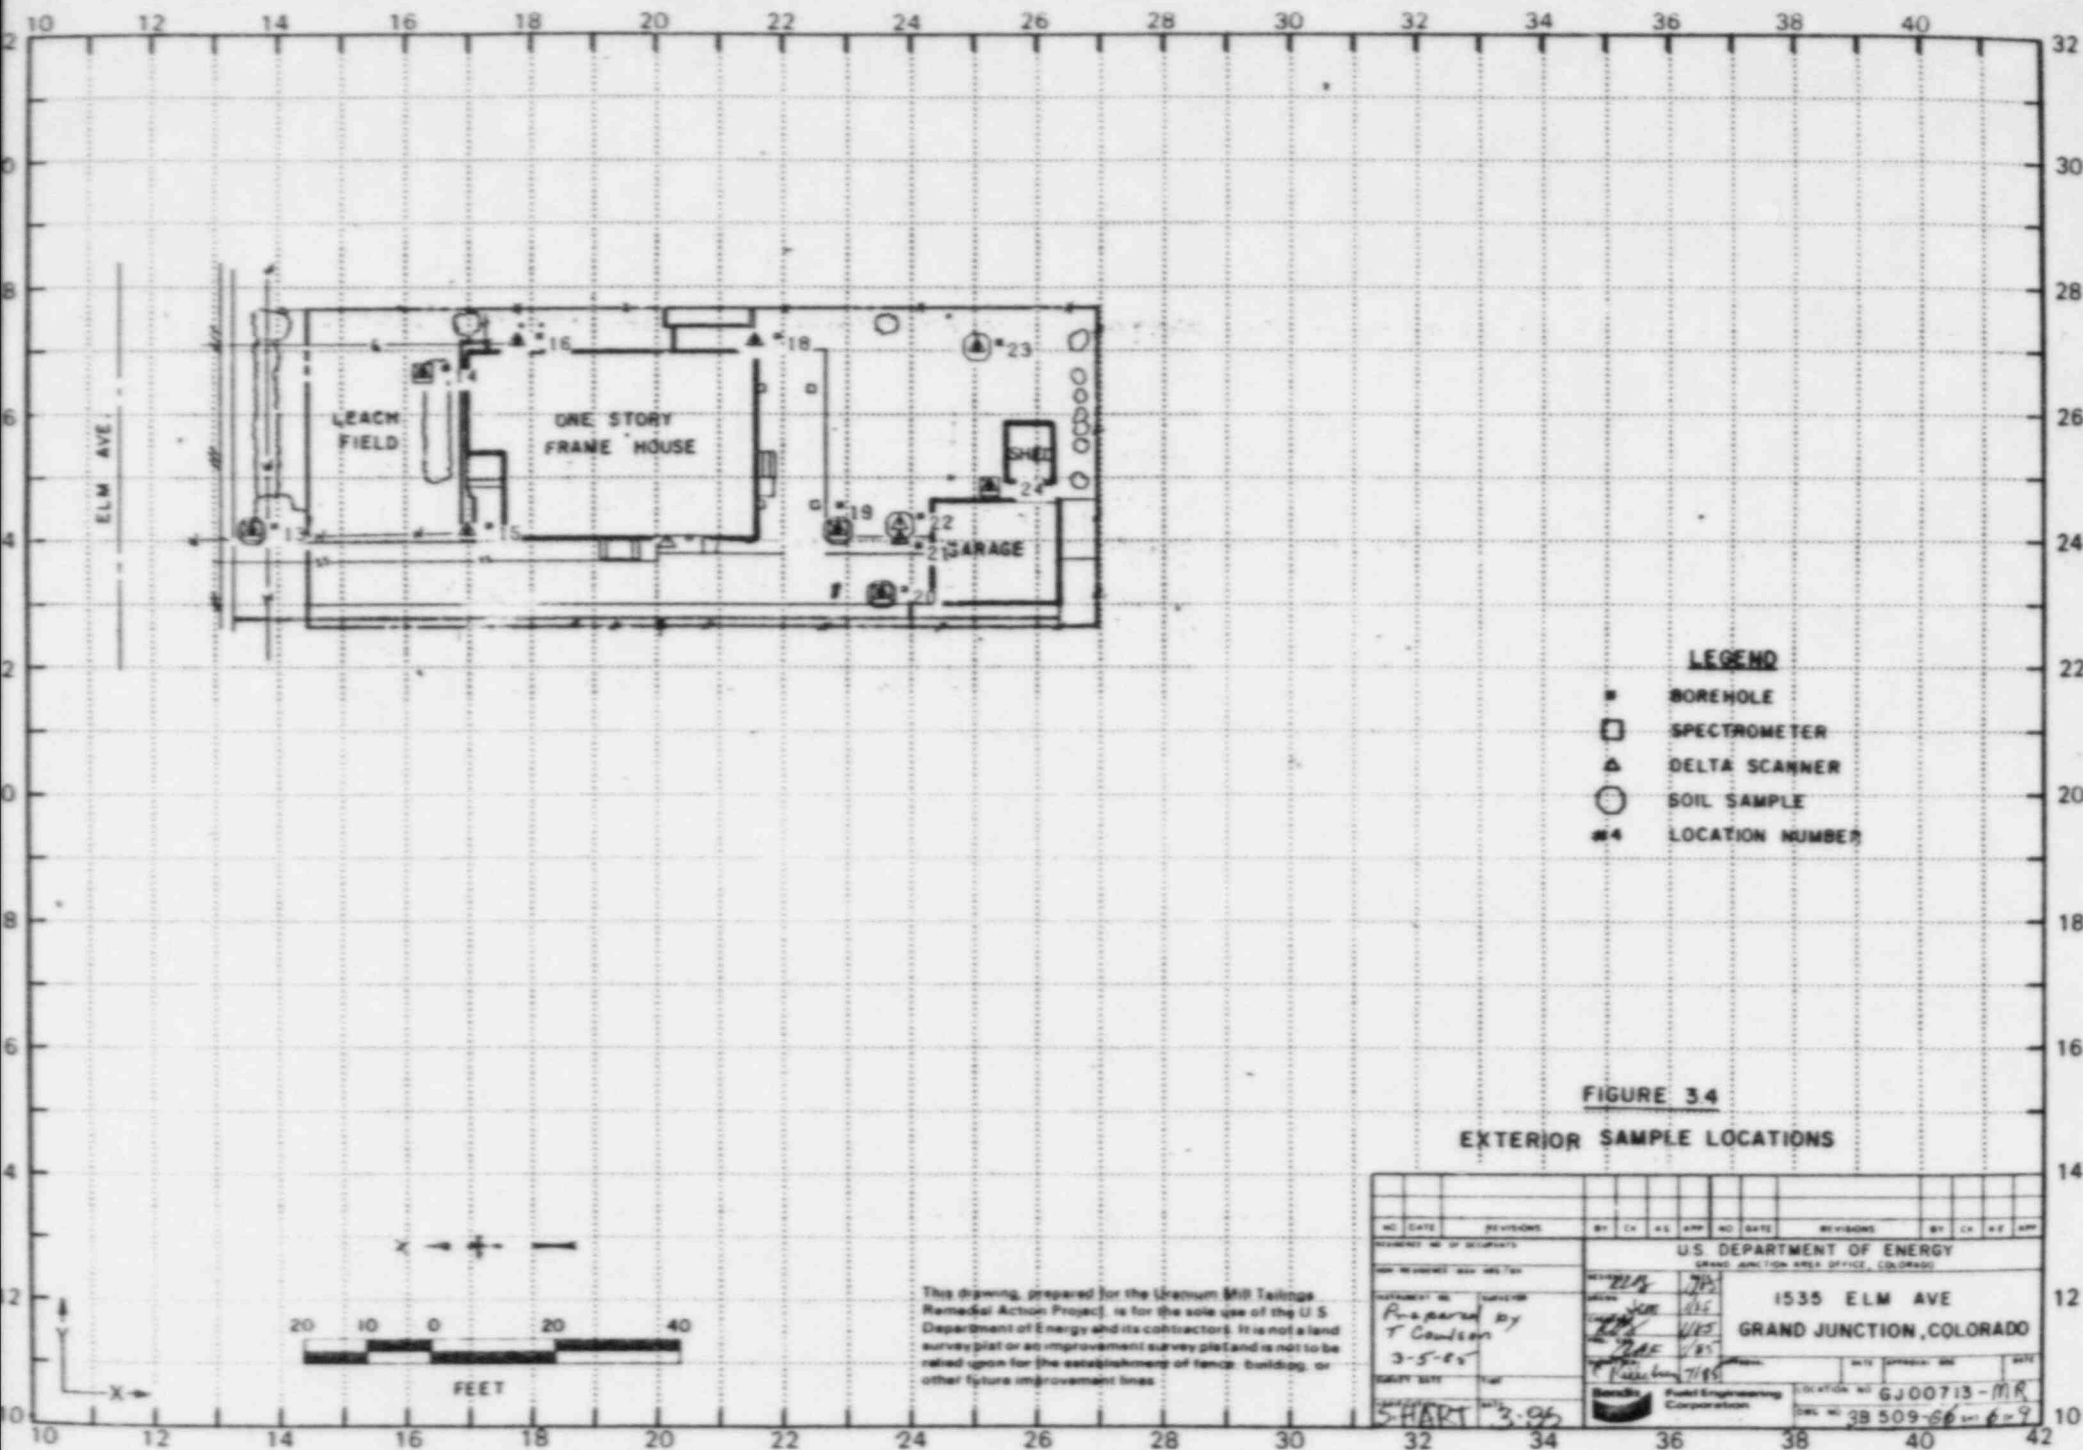
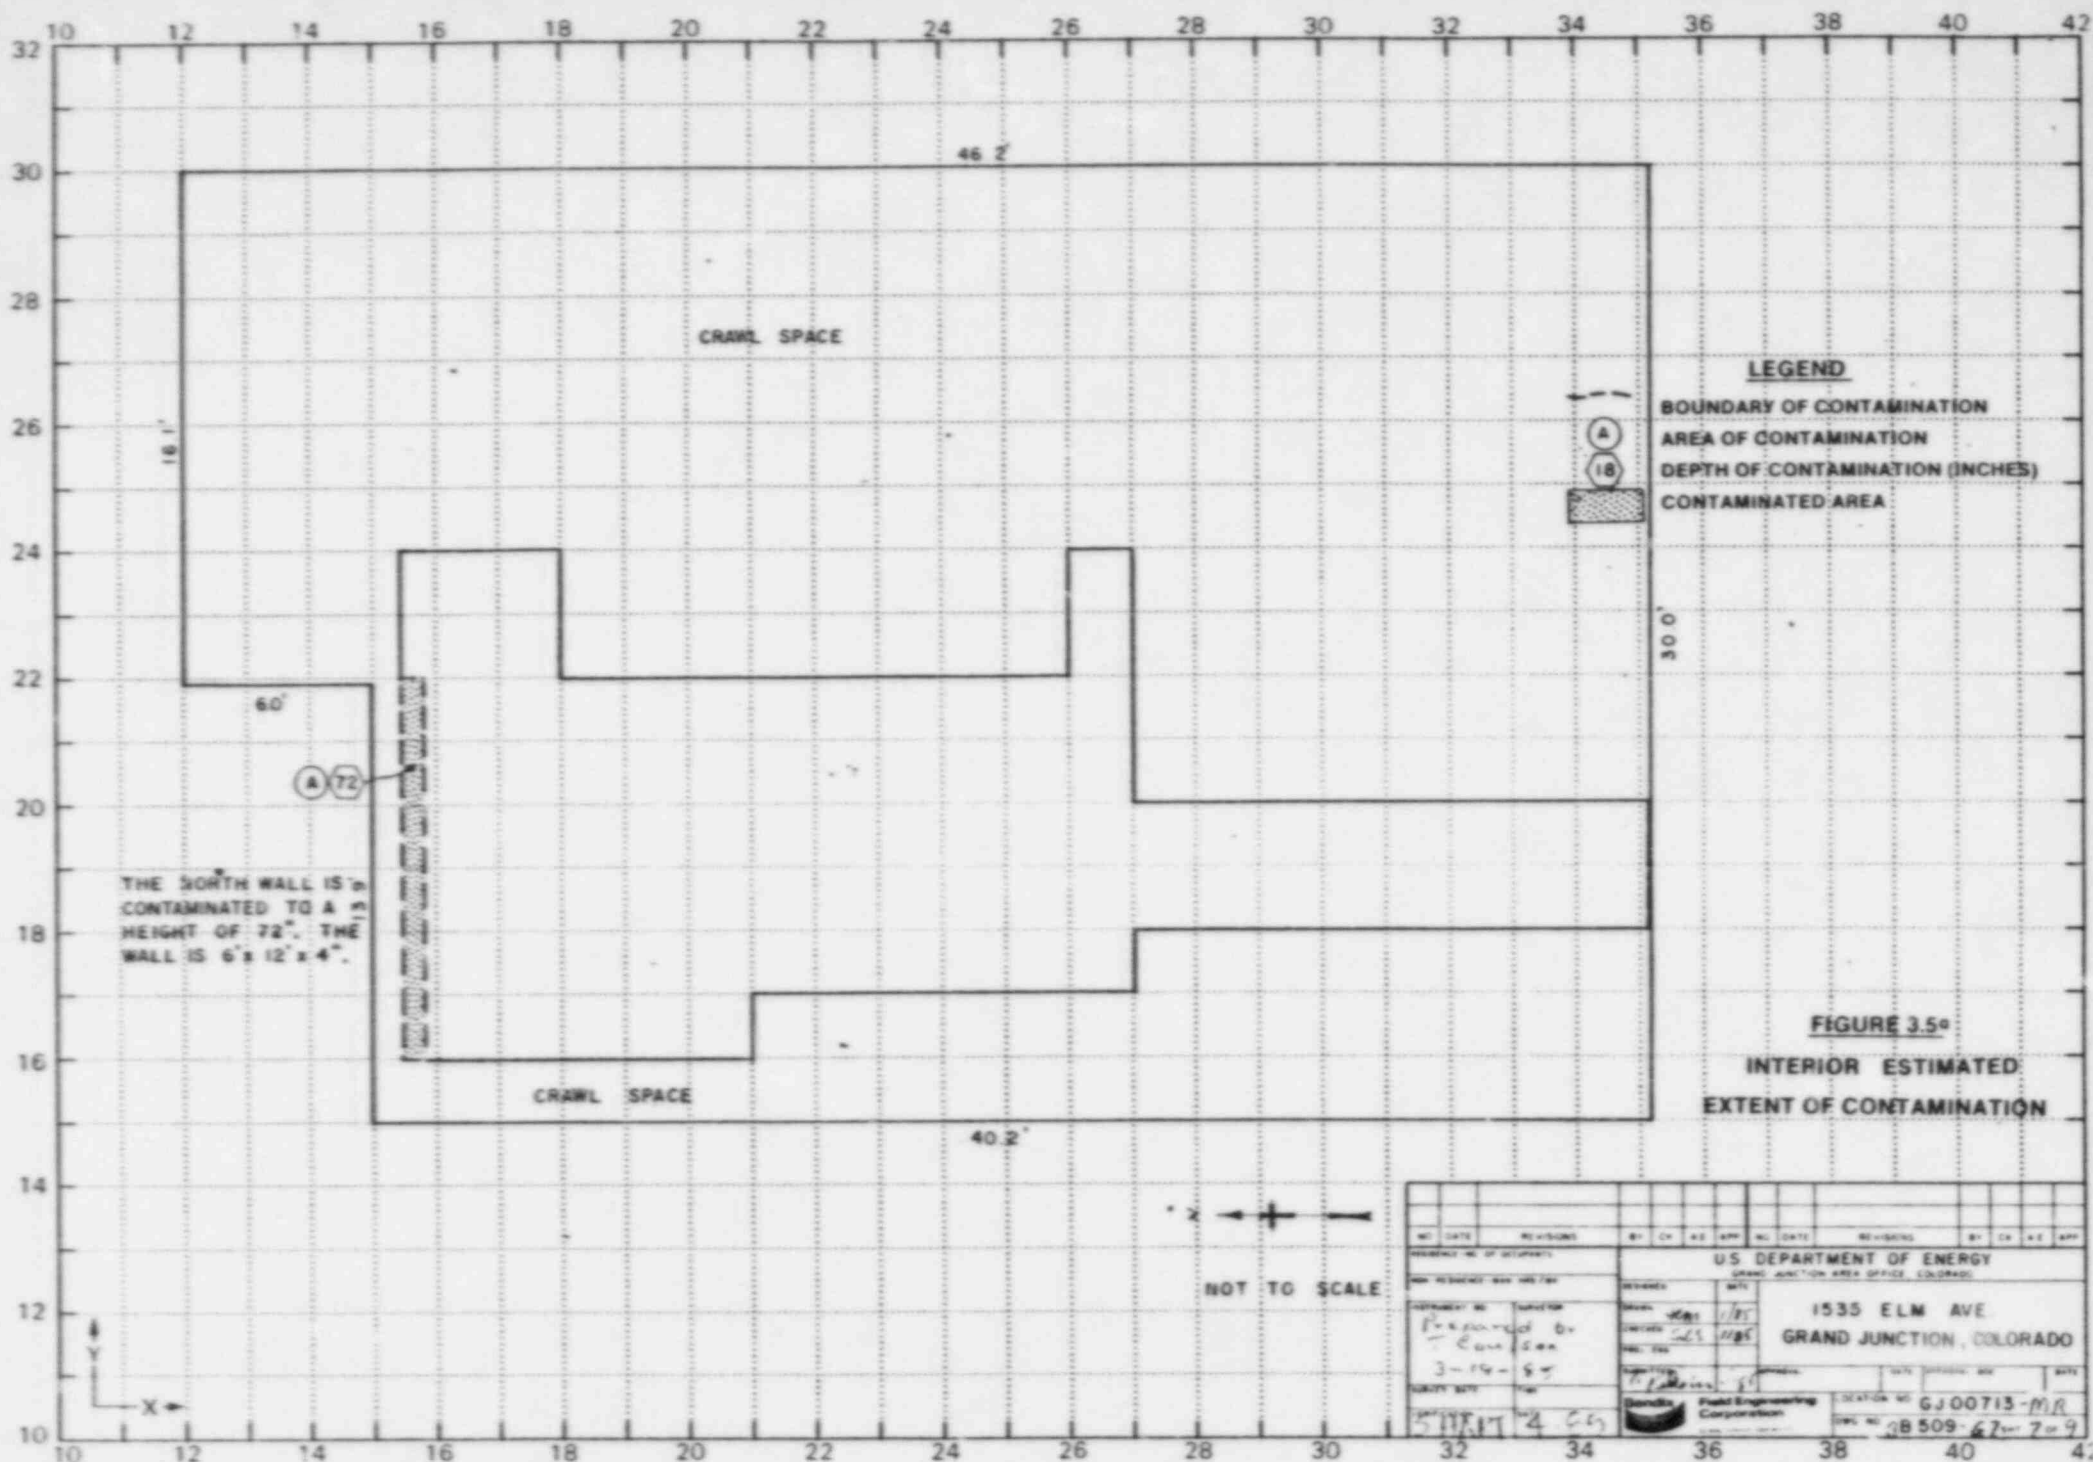
**FIGURE 3.5c**

Appendix Figures 3.5a, 3.5b, and 3.5c show identified areas and estimated depths of contamination on this property, based on assessments of all measurements taken. As noted in these figures, areas recommended for remedial action that contain identified residual radioactive materials are:

- (AREA A) The concrete wall at the north side of the basement is contaminated. The wall is approximately 72 inches high, 144 inches wide, and 4 inches thick. This area is not recommended for remedial action because the EPA Standards for gamma or RDC are not exceeded.
- (AREA B) The 4-inch-thick concrete floor pad in the garage is contaminated (approximately 320 sf).
- (AREA C) A portion of the 4-inch-thick concrete driveway and sidewalk slabs is contaminated. The fill material beneath the concrete is also contaminated. The total depth of contamination is 10 inches (approximately 209 sf).
- (AREA D) The lawn adjacent to the driveway is contaminated to a depth of 6 inches (approximately 60 sf).
- (AREA E) An isolated section of concrete on the north edge of the property is contaminated. The concrete is 3 inches thick (approximately 16 sf).

**EXTERIOR ESTIMATED EXTENT OF CONTAMINATION**

The recommended remedial action for this property, DOE ID No. GJ-00713-MR, includes removal of select areas identified as containing radioactive material (as discussed in Section 3.5 and shown in Appendix Figures 3.5b and 3.5c) and transport of removed material to the disposal site.
