Draft Radiological and Engineering Assessment

Vicinity Property No. DUR 048

THE RADIOLOGICAL AND ENGINEERING ASSESSMENT

DURANGO PROPERTY

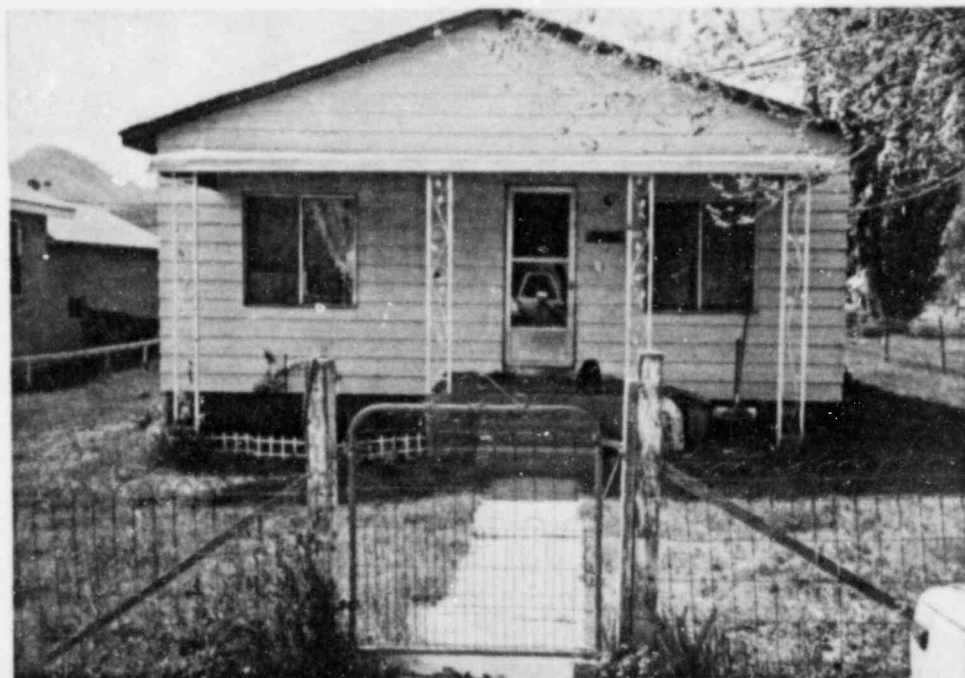
Front of House Looking West

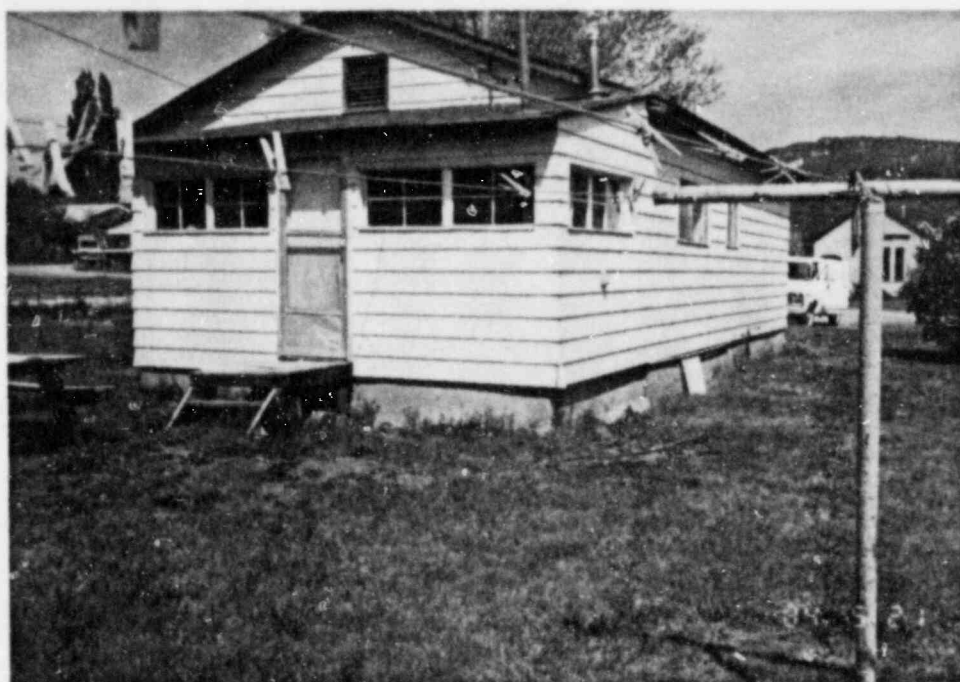
Rear of House Looking Northeast

Area A consists of the area directly in back of the house, under the rear addition to the house, and in the crawl space under the house. The frame house addition will have to be removed in order to gain access to the materials, but the tailings which are in the crawl space under the house itself can be removed without further damage to the structure. Because of the looseness of the tailings, it was not possible to maintain a borehole for logging; the estimated depth is 42 inches under the porch, and 6-24 inches in the crawl space.

- RETAIN AND STORE APPLIANCES AND MISCELLANEOUS ITEMS. PROVISIONS TO BE MADE FOR WATER HEATER SERVICE TO REMAIN DURING CONSTRUCTION.
- DEMOLISH AND REMOVE HOUSE ADDITION AS PER DRAWING DU-048-021.
- EXCAVATE AREA "A" TO A DEPTH OF 42 INCHES.
- HAND EXCAVATE AREA "A₁" TO A DEPTH OF 24 INCHES. TEMPORARY STRUCTURE SUPPORT WILL BE NEEDED DURING EXCAVATION PHASE.
- BACKFILL AREA "A₁" WITH COMMON BACKFILL AND TOP WITH 6 INCHES OF STRUCTURAL FILL.
- CONSTRUCT NEW HOUSE ADDITION AS PER DEMOLITION AND RESTORATION DRAWING DU-048-021.
- REPLACE APPLIANCES TO PREVIOUS LOCATIONS.
- BACKFILL REMAINING AREA "A" WITH COMMON BACKFILL AND TOP WITH 6 INCHES OF TOPSOIL IN LAWN AREA AND SOD.

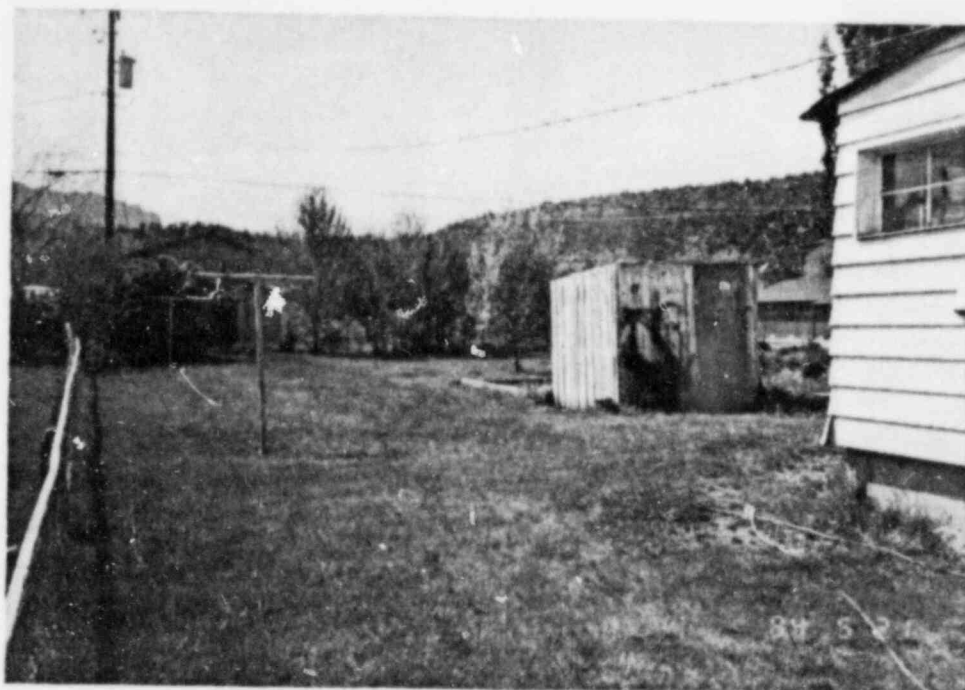
Rear of Yard Looking Northwest

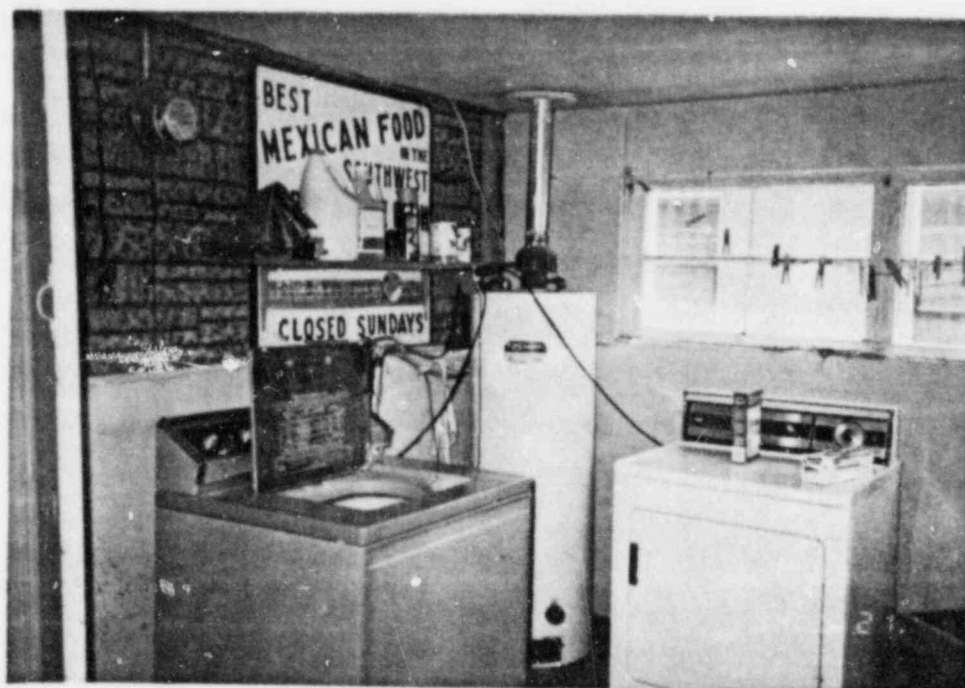
Utility Room Looking Southeast

- o Remove and store washing appliances and miscellaneous items. Temporarily relocate gas water heater so as to maintain service to the residence during construction. Replace washing appliances, miscellaneous items and water heater when construction has been completed.
- o Demolish and remove room addition and concrete front porch.
- o Excavate areas of contamination to the limits and depths illustrated in Figure 4.1.
- o Backfill excavated areas with common fill and to with:
 - (1) Topsoil and sod in lawn areas.
 - (2) Structural fill in concrete areas.
 - (3) Gravel in graveled areas.
- o Reconstruct room addition and concrete front porch as shown in Figure 4.2.
