Meeting Title: Brief by ITT on Loss of Indium - 1992 Source
Therapy Administration at Indiana
Regional Cancer Center, Indiana, PA
November 16, 1992

Title: BRIEFING BY IIT ON LOSS OF IRIIDIUM-192
SOURCE AND THERAPY MISADMINISTRATION AT
INDIANA REGIONAL CANCER CENTER, INDIANA,
PA., NOVEMBER 16, 1992

Date: FEBRUARY 8, 1993

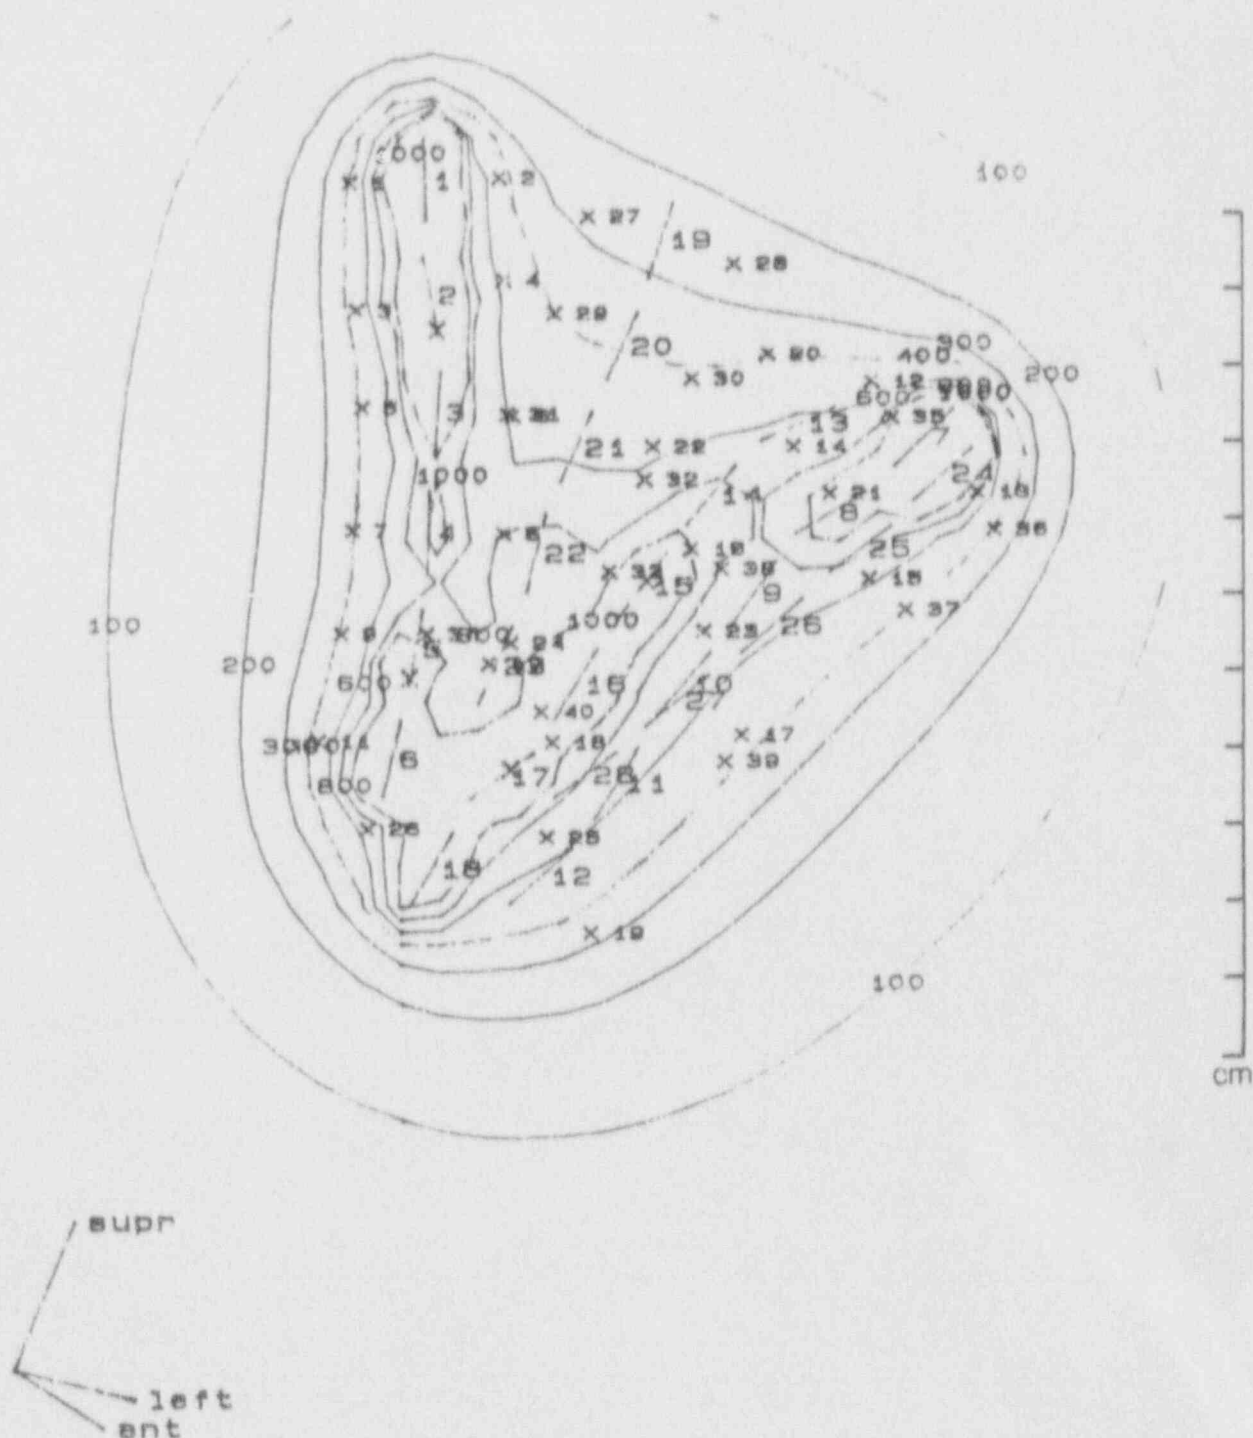
Figure 2.1 Isodose Graph for Initial High Dose Rate Patient Treatment Plan

On November 16, 1992, before the patient was treated, Medical Physicist A generated an Omnitron HDR dosimetry drawing with 40 dosimetric points (Figure 2.1). The calculated source strength upon initiating the treatment was $1.56 \text{ E}+11 \text{ Bq}$ (4.219 Ci). The dwell time calculations for the five implanted catheters were generated by computer (Figure 2.2). On November 16, 1992, at 9:35 a.m., the implanted catheters were connected to the HDR afterloader connecting catheters* and patient treatment was initiated. Difficulties were encountered during the source wire insertion into implanted Catheter 5, and Physician A directed termination of treatment without treating the patient through implanted Catheter 5. The patient was disconnected from the HDR afterloader (Figures 2.3 and 2.4). After the patient was removed from the treatment room, one loose catheter was removed, and the other four catheters were left in the patient for subsequent treatments.

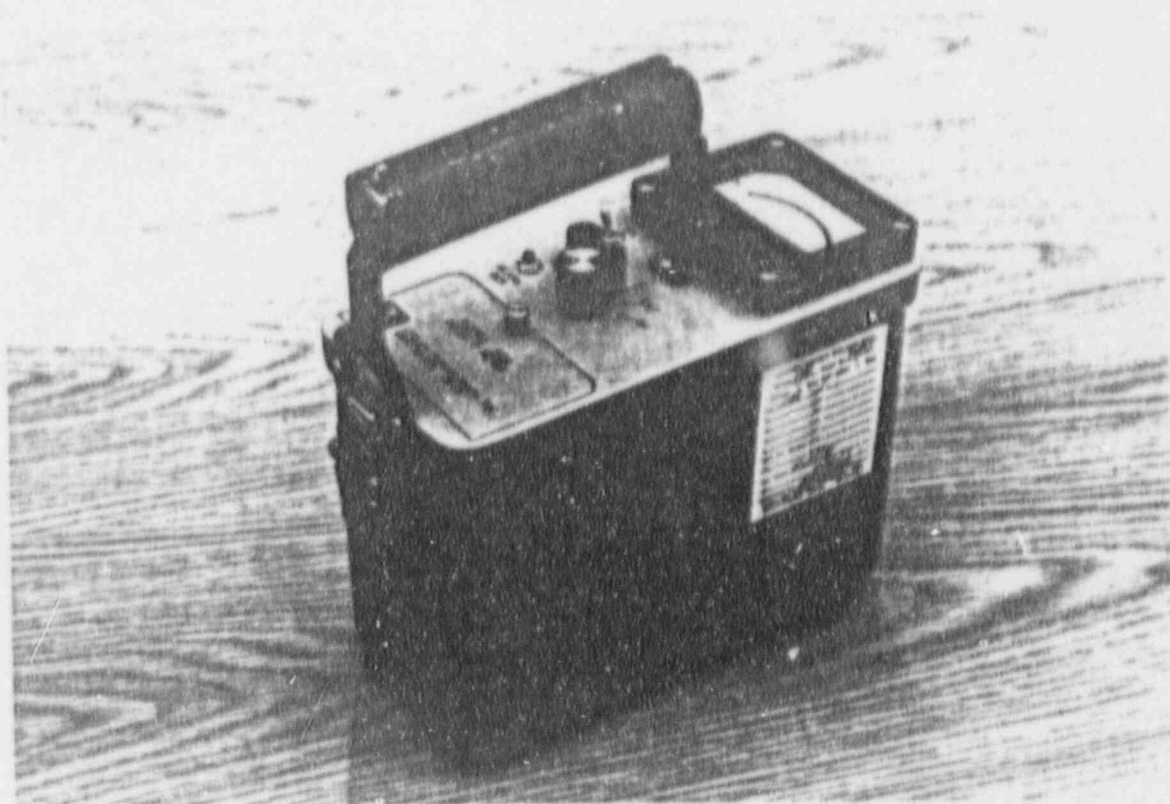
Figure 2.16 Survey Meter Used at BFI - Warren

After identifying the possible cause of the radiation alarms, both the Plant Manager and the Supervisor began to look for the source with their portable survey meters (Figure 2.16) outside of the parked trailers (Figure 2.17). When they came within approximately 121.9 meters (400 feet) of the trailer, both portable survey meters immediately alarmed and registered at their highest levels over 5 μ Sv (500 μ rem) per hour.

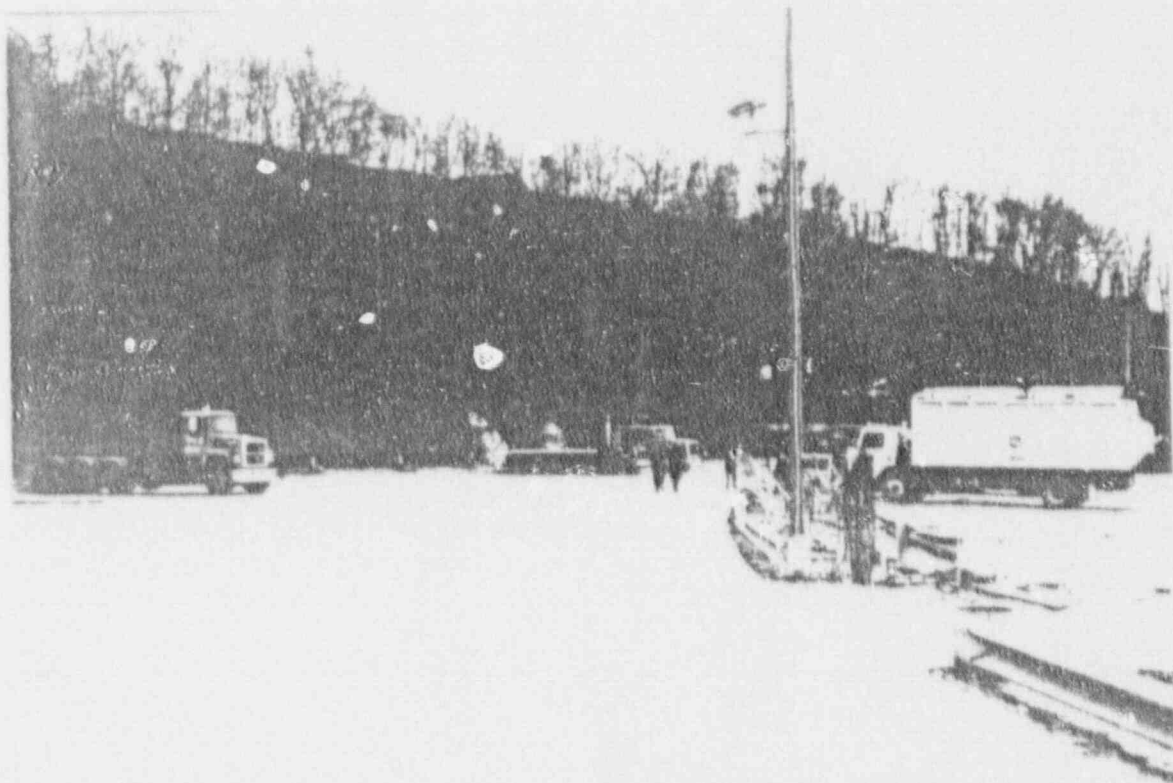
Figure 2.18 BFI Truck Parking Lot, Carnegie, Pennsylvania

BFI Driver C arrived at BFI-Carnegie. Because it was growing late, the driver unhooked and parked the trailer in a back lot where it remained for the rest of the weekend in a fenced, secured area (Figure 2.18).

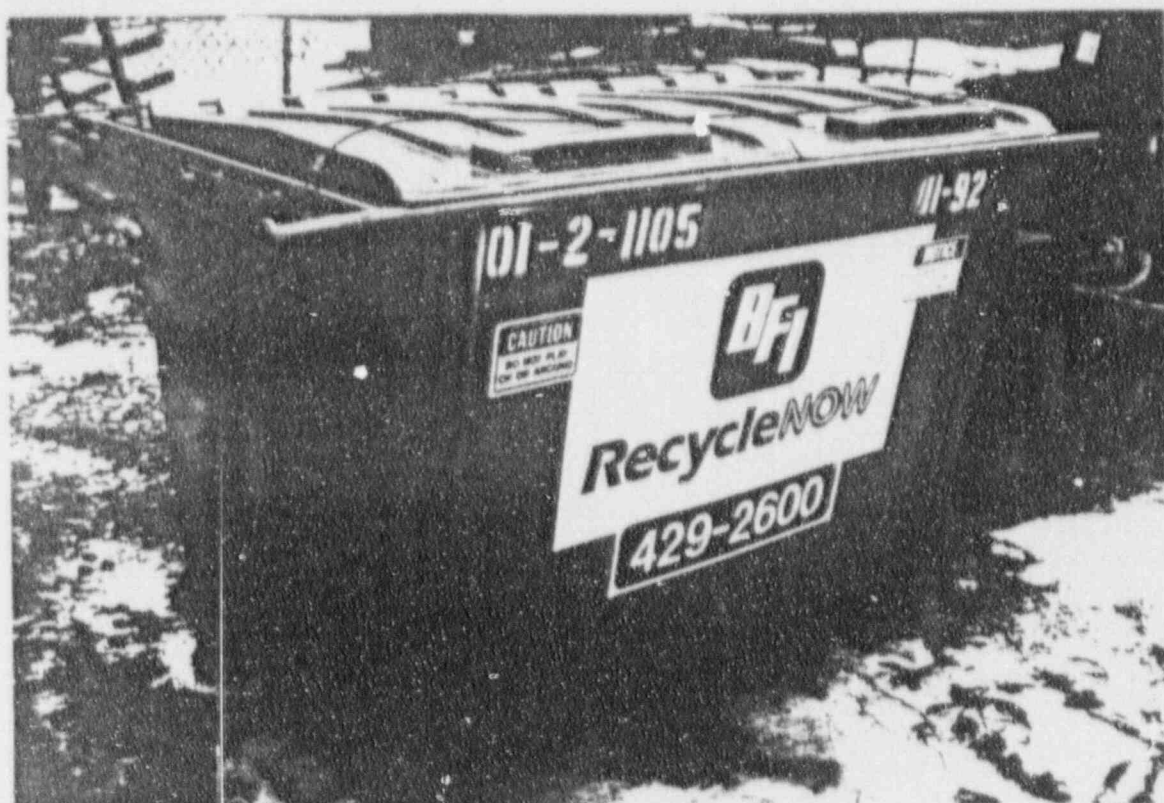
Figure 2.20 BFI Locking Recycle Container

- 3:00 p.m. One of the two safety technicians found a portion of a prescription in the waste that had an individual's name on it. With this information, they sealed up the box, placed it in a green recycle container (Figures 2.20 and 2.21), and locked it. They returned to their office with this information and began calling the list of facilities from which waste was picked up on November 25, 1992.

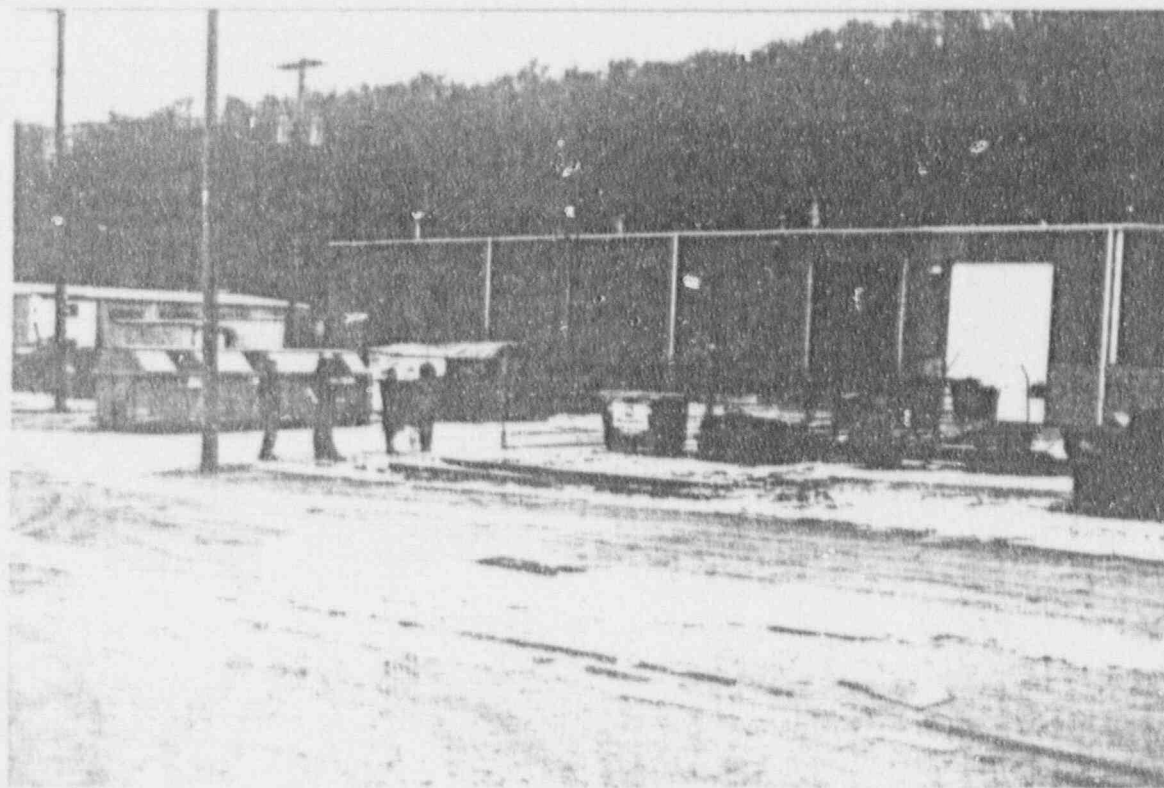
Figure 2.22 Location of Radioactive Source Recycle Container at BFI - Carnegie

Upon approaching the green recycle container (Figure 2.22), Safety Technician A unlocked it and stood approximately 2 meters (6.6 feet) away with a portable survey meter turned on. Medical Physicist A also had a portable survey meter and noted that the radiation reading at about 1.5 to 1.8 meters (5 to 6 feet) away from the container was above 7.8 mR (780 mrem) per hour.

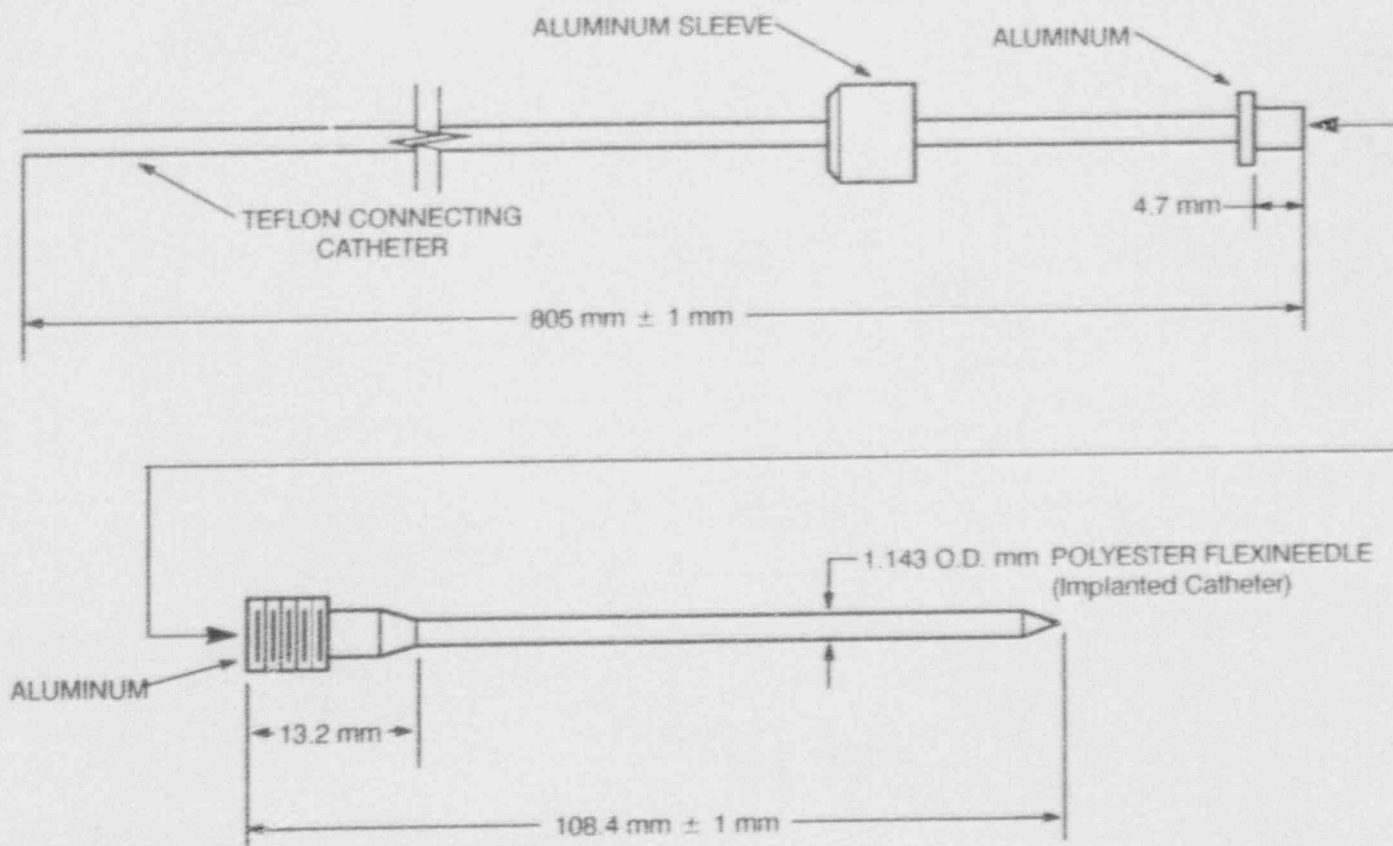
Figure 3.8 Connecting Catheter and Flexineedle Unassembled

In the HDR treatment of November 16, 1992, at IRCC, five 80-cm connecting catheters were used. Each of the catheters was made of teflon tubing with aluminum coupling hardware. The nominal coupled length of the inside lumen of the 10-cm flexineedle connected to an 80-cm coupling catheter is 90.34 cm plus or minus 0.2 cm. Figure 3.8 represents a schematic of this arrangement.

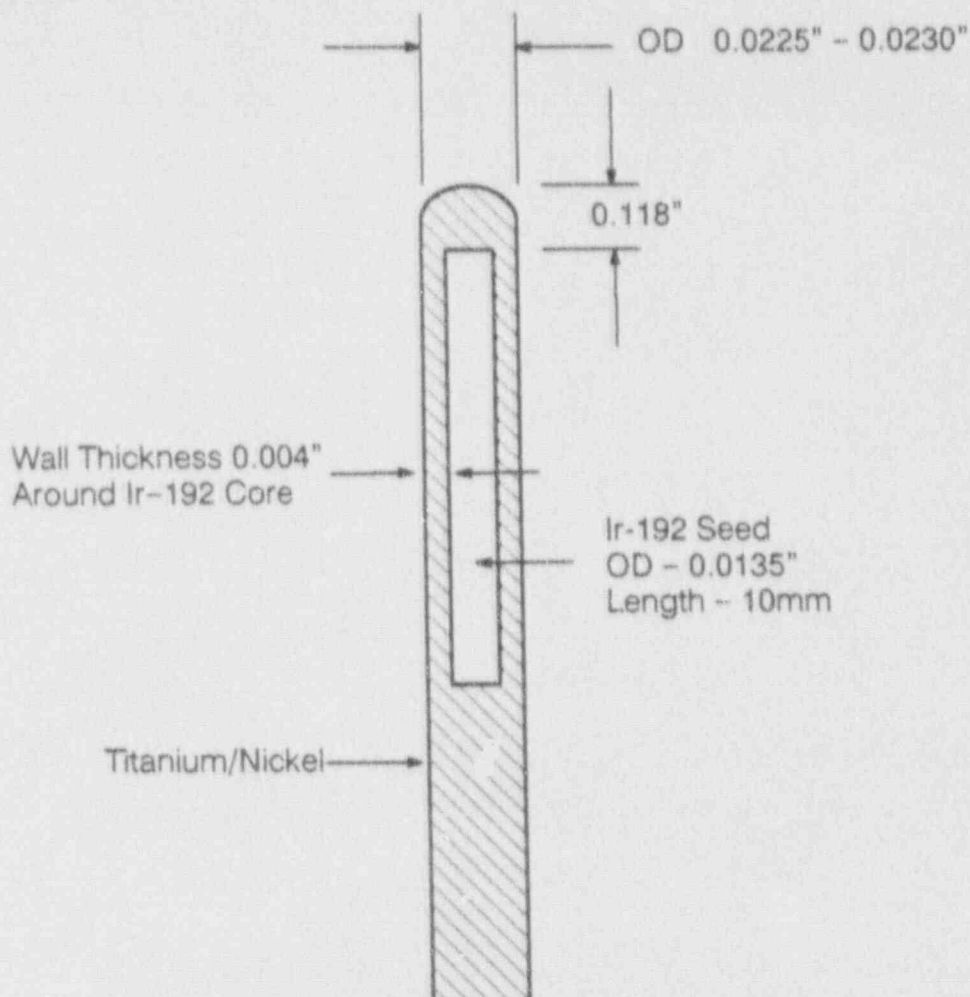
**Ir-192 Seed in Titanium/Nickel
Model #SL -777**

Ir-192 Seed in Titanium/Nickel

An Ir-192 Seed is encapsulated firmly inside a solid titanium/nickel wire.
The overall length of the Ir-192 Seed is 10mm

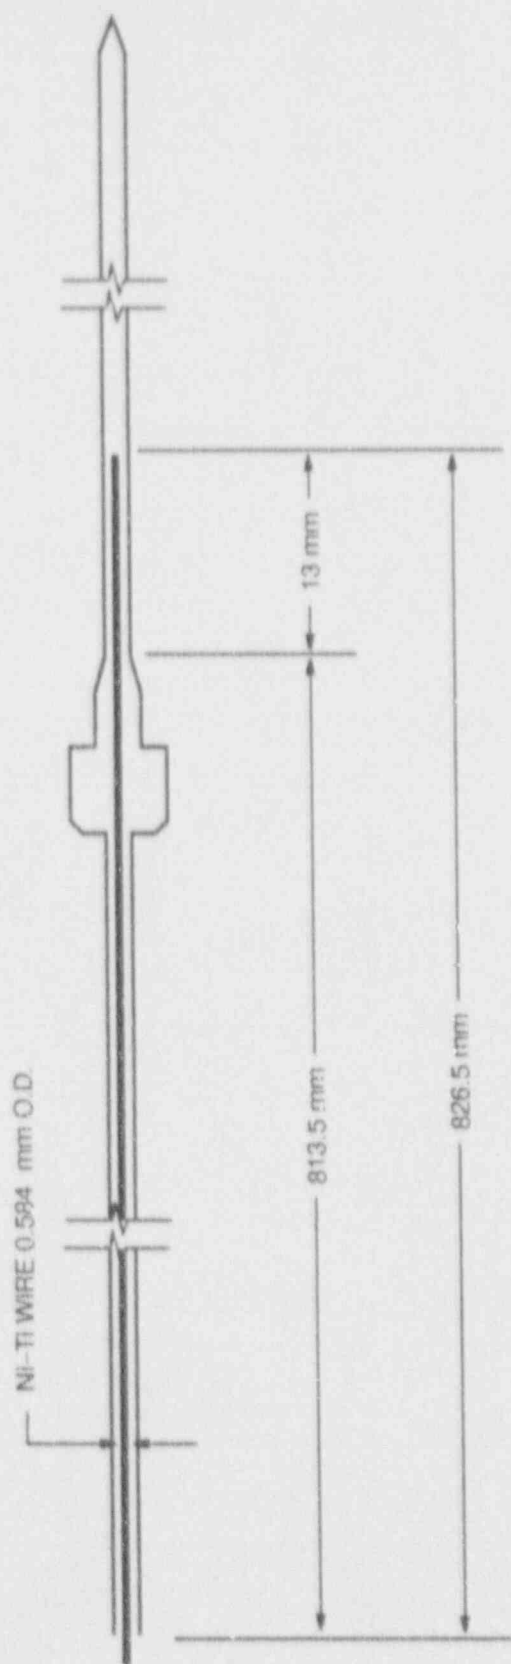
Figure 4.3 Connecting Catheter and Flexineedle-Assembled

- **Area 5—Inside the flexineedle connector:** A polyester tube containing a stainless steel tip was pressed into a threaded aluminum fitting to form the flexineedle. Because the break occurred near the bottom of the source-wire cavity and a constriction error occurred at 82.4 cm, the tip of the source would have had to be placed approximately 13 mm past the end of the fitting. (See Figures 3.8 and 4.3). The fitting supplies support to the wire, and when the wire is bent and retracting, places a stress point on the wire. The team was unable to examine the fitting for wear.

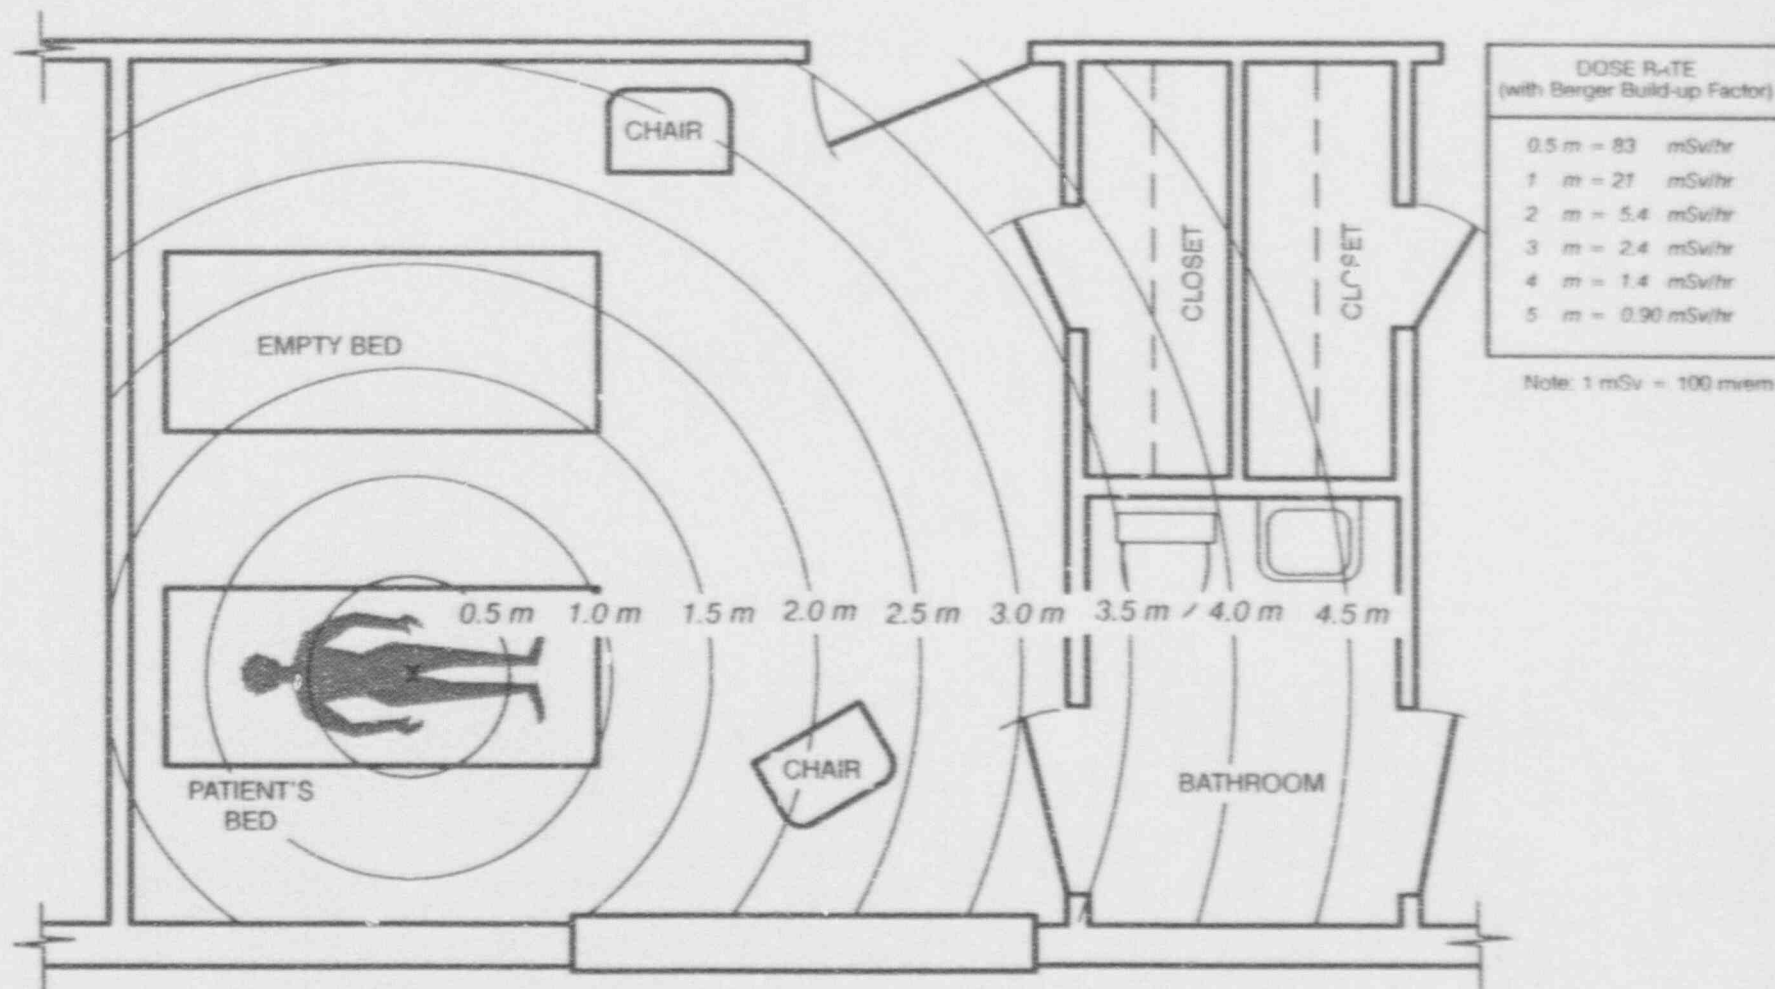
Figure 6.3 Diagram of Room 4B at the Scenery Hill Manor Nursing Home Showing Isodose Curves from the Iridium-192 Source on November 16, 1992

Figure 6.3 is a diagram of the dose rates at different distances for individuals who may have been in contact with Patient A from November 16 through 20, 1992.

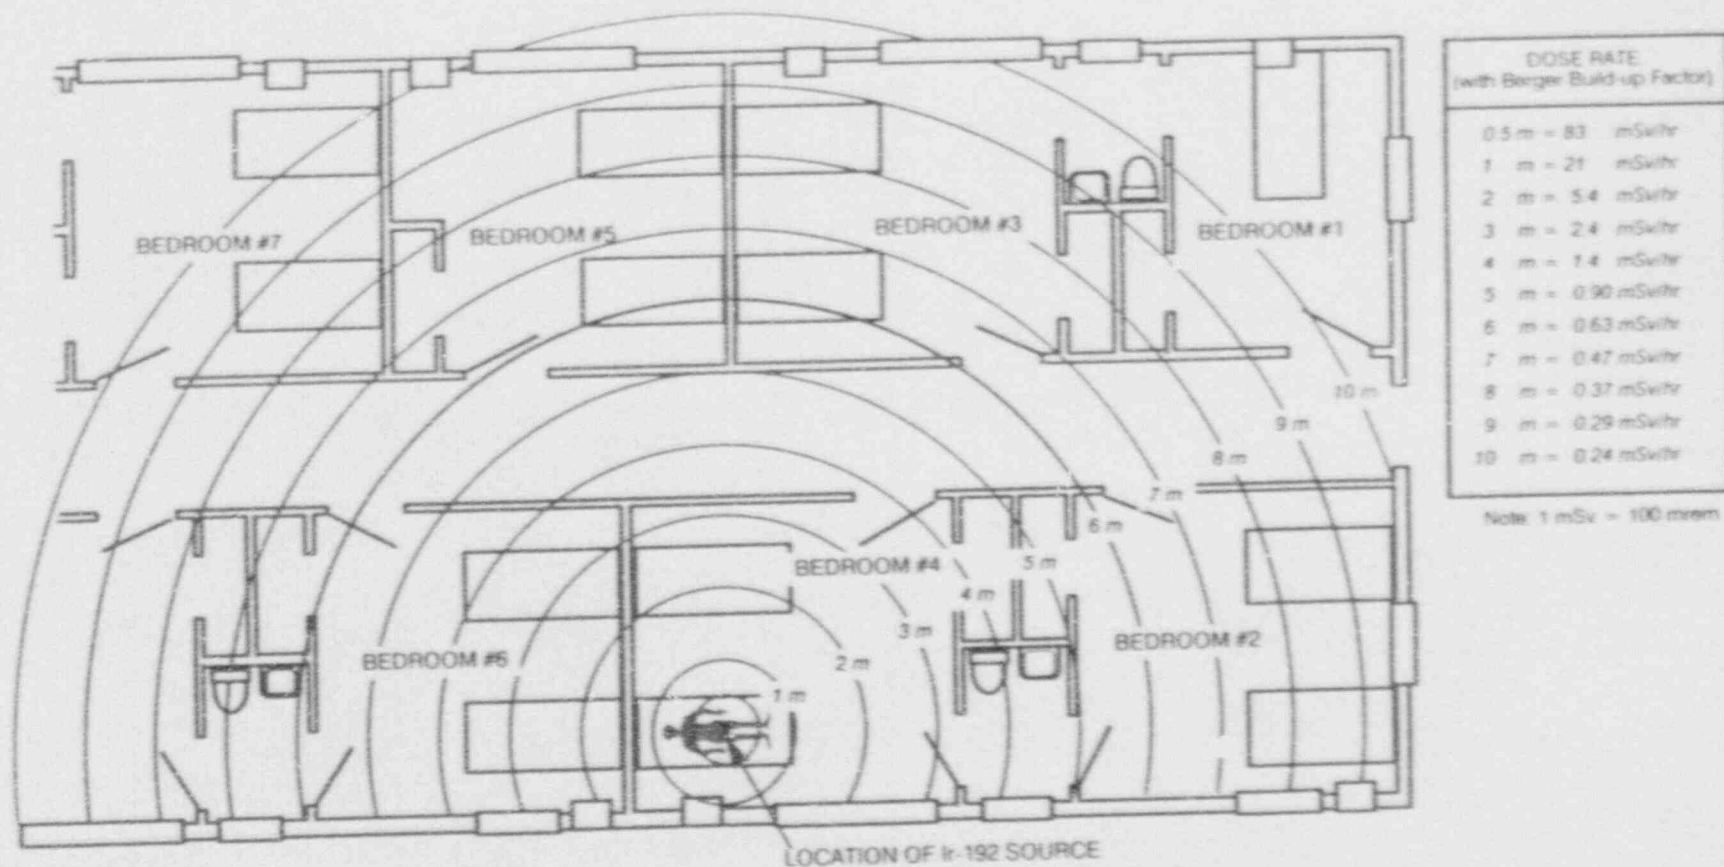
Figure 6.4 Diagram of the SHM Nursing Home Soiled Utility Room Showing Isodose Curves from the Iridium-192 Source on November 20, 1992

- **Maintenance Man** was estimated to have been 0.4 to 0.5 meters (15.8 to 19.7 inches) away from the source when moving the red-bag waste from the inside soiled utility room (next to Room 9) to the outside waste storage room on November 20, 1992. Figure 6.4 shows the soiled utility room illustrating isodose curves from the iridium-192 source on November 20, 1992. The amount of time estimated to walk from the inside soiled utility room to the outside waste storage area, and then to place the red-bag waste in a BFI carton was approximately 5 minutes.

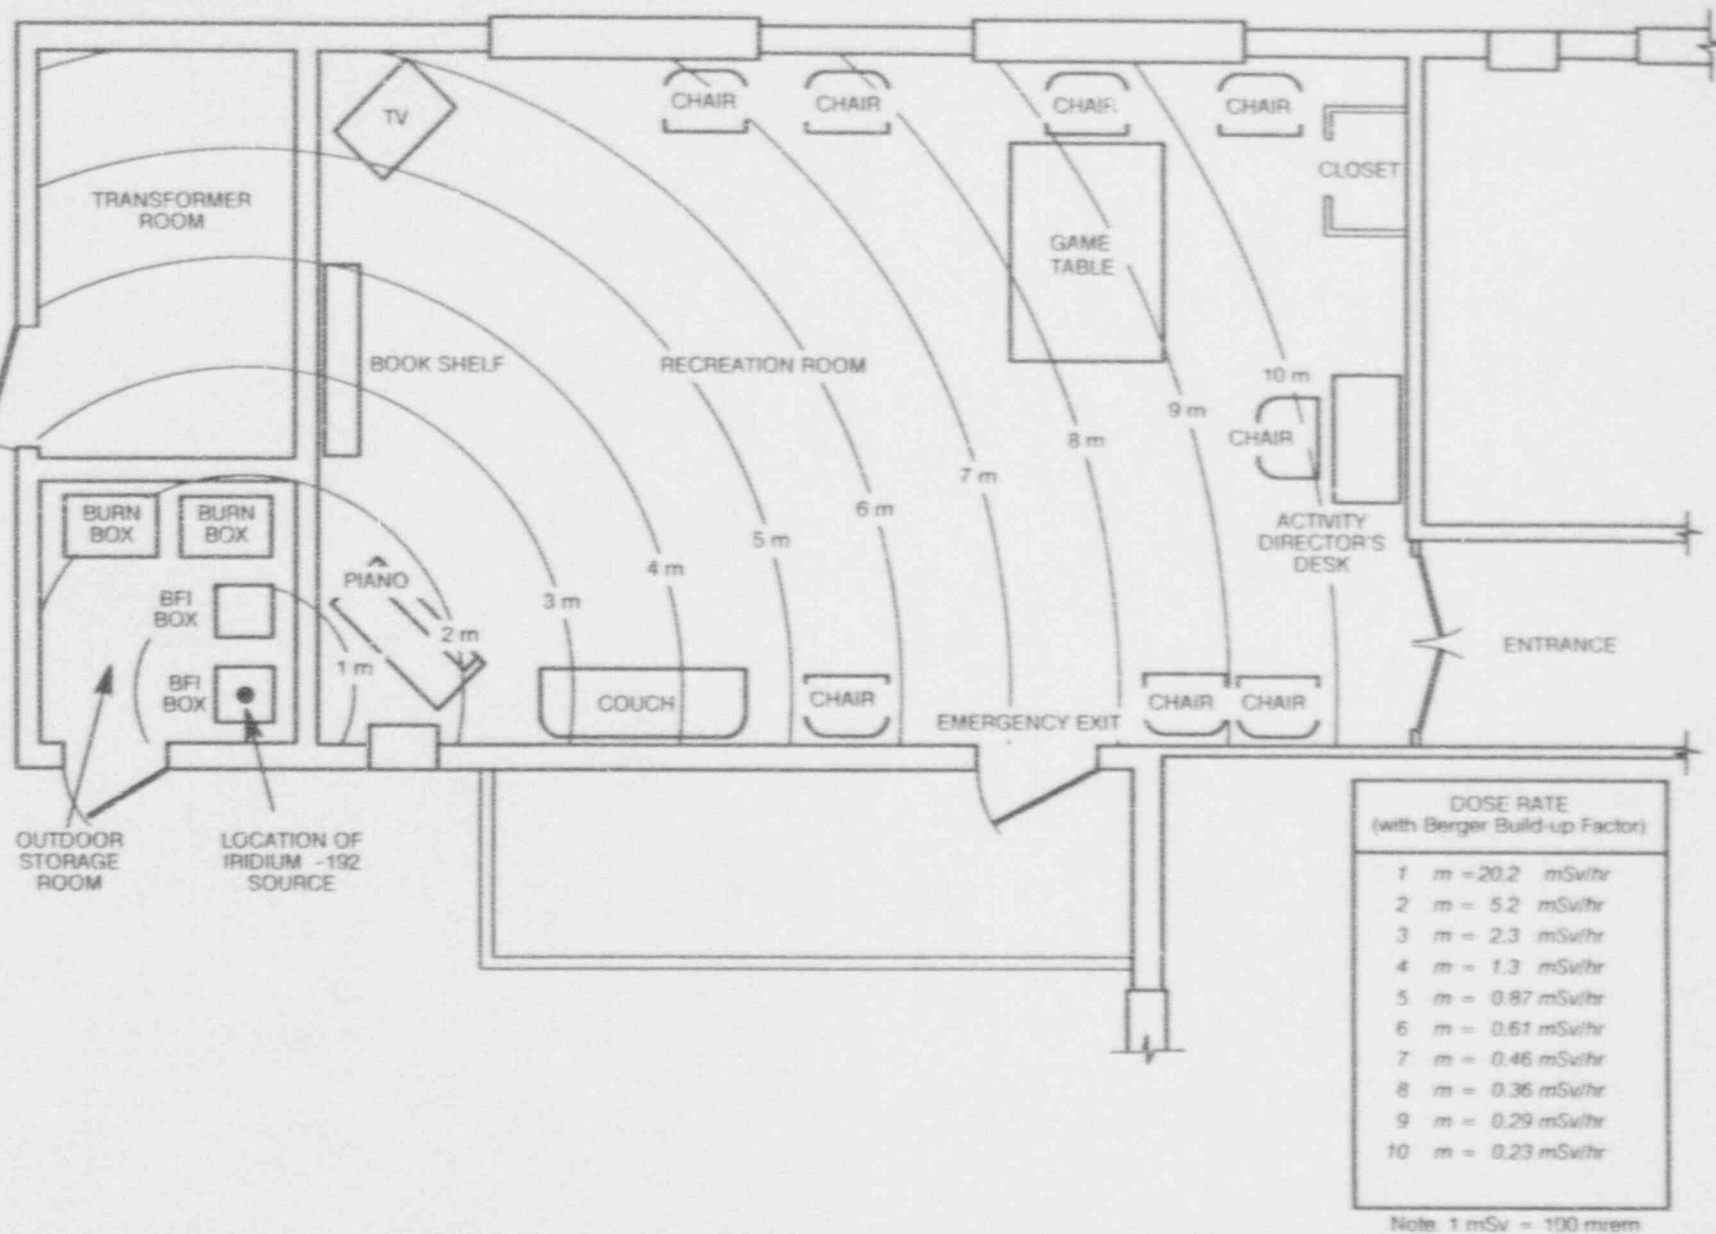
Figure 6.5 Diagram of Rooms Adjacent to Patient Room 4B Showing 1-Meter Isodose Curves from the Iridium-192 Source on November 16, 1992

The team estimated doses for several of the residents that were known to have been exposed to the source for the entire period of November 16, 1992, 11 a.m., through November 20, 1992, 6:15 a.m., (91.25 hours total) while the source remained inside Patient A. Isodose curves for the rooms adjacent to Patient A are shown in Figure 6.5. These estimated doses are summarized in Table 6.11. All of the residents listed in Table 6.11 except Residents K and M participated in several activities in the Recreation Room during November 20 through 25, 1992.

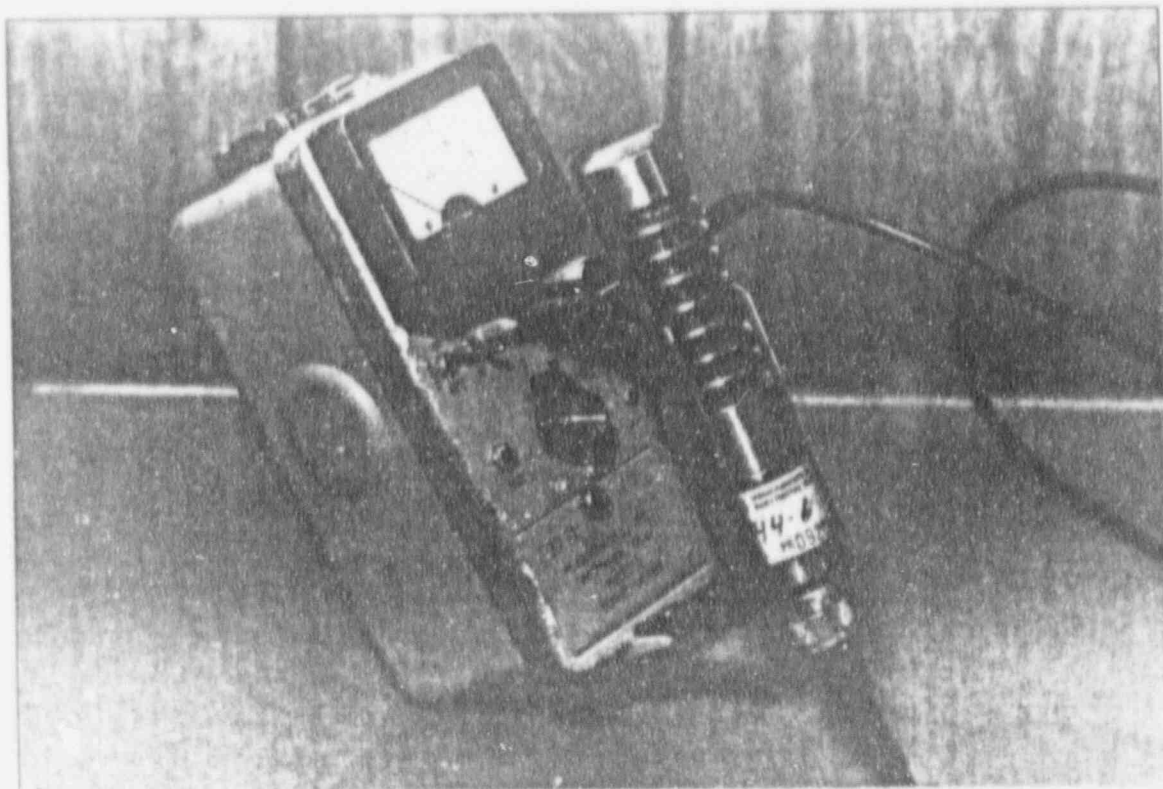
Figure 6.6 Detailed Diagram of the Scenery Hill Manor Nursing Home Recreation Room Showing Isodose Curves from the Iridium-192 Source Located in the Outside Storage Room from November 20 to 25, 1992

The SHM nursing home provides medical care and, in addition, a recreation room that offers residents a variety of diversions from which to choose; therefore, many of the residents in the home occupy the recreation room daily. On the basis of an interview with the Activities Director, who was responsible for developing and coordinating all activities at the SHM nursing home, and a review of the activities calendar for November 1992; the team developed Table 6.12 that describes the number of activities, the approximate number of residents in the Recreation Room for each activity, the estimated distance the residents were from the outside waste storage room (where the source was later stored), estimated total dose range for each resident that participated in each activity, and the total collective dose for each activity in the Recreation Room. Figure 6.6 shows the isodose curves for the Recreation Room for the iridium-192 source while located in the outside storage room from November 20 through 25, 1992.
