Draft Radiological and Engineering Assessment

Vicinity Property No. DUR 027

THE RADIOLOGICAL AND ENGINEERING ASSESSMENT

February 6, 1985

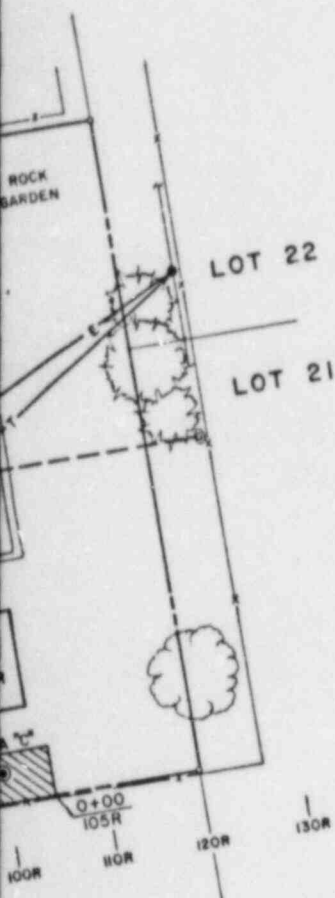
Contamination was found in 9 of the 16 outdoor holes augered. The location and depth of the contamination is described in Table 3.2 and is shown in Figure 3.1.

No contamination was found in any of the 8 crawl space holes. The location and activity of these holes are described in Table 3.3, and the locations are shown in Figure 3.1.
