Draft Radiological and Engineering Assessment

Vicinity Property No. DUR 024

DURANGO PROPERTY

February 5, 1985

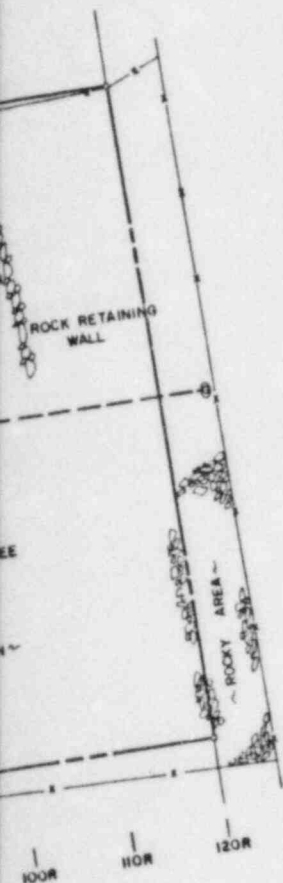
Contamination was found in 7 of the 10 outdoor holes augered. The location and depth of the contamination is described in Table 3.2 and is shown in Figure 3.1.

The possibility that contamination could be underneath the house was investigated by digging four holes, one on each side of the house, and then augering an angled hole underneath the house. These holes are shown in Figure 3.1. One hole was dug at the point where the main water line and the sewer line enter the house. No contamination was found in any of these holes. It is concluded that no contamination is found underneath the house on this property.
