THE INTERIM EQUIPMENT AND PROCEDURES AT
BROWNS FERRY TO DETECT WATER IN THE SCRAM DISCHARGE VOLUME

OFFICE FOR ANALYSIS AND EVALUATION OF

September 1980

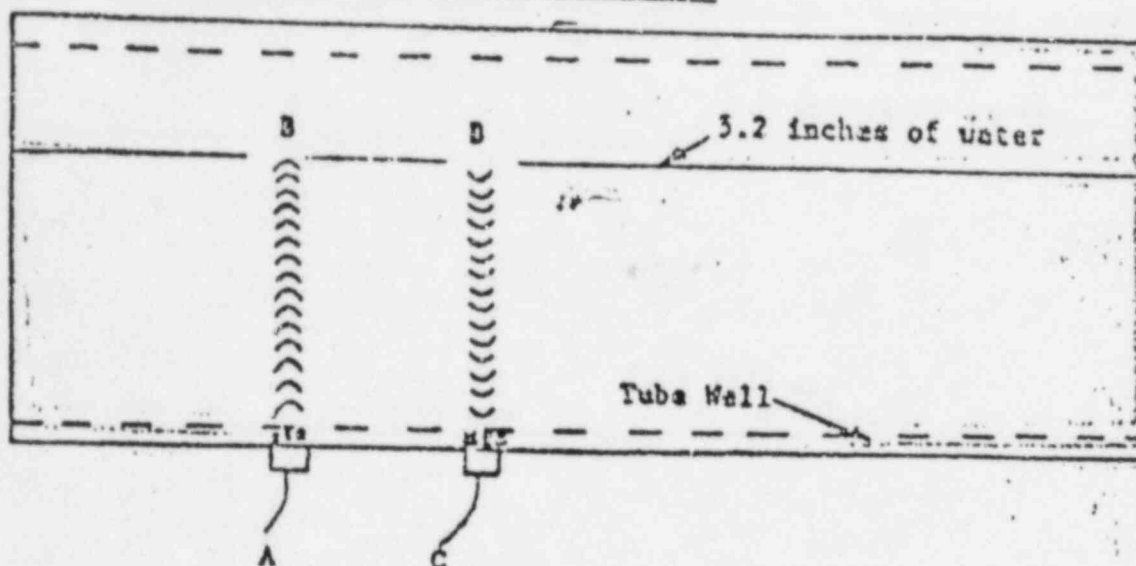
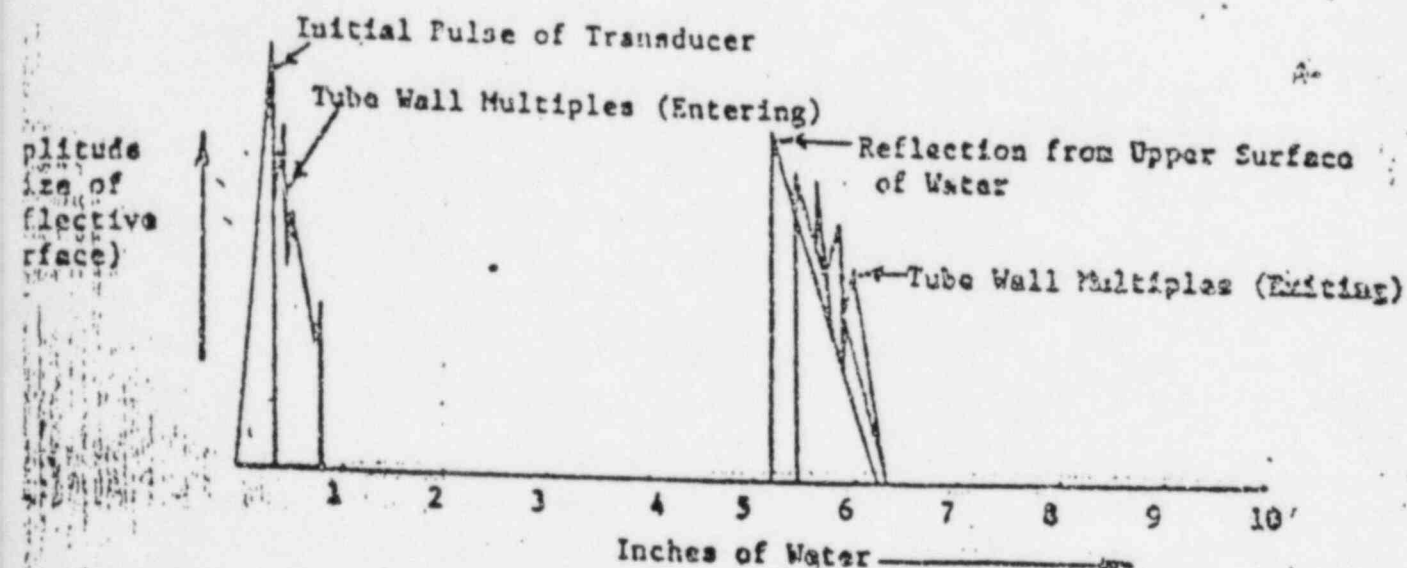
Figure 4 Pulse Echo CRT Display

The pulse-echo technique of depth measurement is used and is illustrated in Figure 4. The top illustration shows a cross section of the SDV pipe on which the transducers are mounted. The bottom illustration shows the CRT display arising from this situation. Since sound travels one-fourth the speed in water as in steel, the reflection from the inner tube wall is received very quickly following the initial pulse. This is shown on the left hand side of the CRT display in Figure 4. Multiple reflections are seen on the CRT because of sound reflections between the inner and outer diameter of the pipe. These show a decreasing amplitude and die out rapidly.

The time scale on the CRT is adjusted to read the depth of the water in the header in terms of horizontal divisions on the CRT screen. As shown in Figure 4, a total of ten horizontal divisions are used on the CRT display. The sweep time and the horizontal centering of the CRT are adjusted so that the sixth division on the screen corresponds to a water depth of 6 inches while the first division on the screen corresponds to a water depth of one inch. Thus, the CRT displays water depth directly. If no water is present, only the echo from the i.d. of the pipe is displayed on the CRT screen at a position below the one inch mark.

At this point, a short discussion of the capability and reliability of the UT system will be presented. As stated in Section 2, the UT system includes a CRT display of the return echo. This is shown in Figure 4. As stated earlier, an echo is received from the i.d. of the pipe and is displayed on the CRT as the left most peak. The presence of this so-called "reference pulse" is interpreted by the inspector performing the calibration as verification of the operability of the transducer which is being monitored. The calibration technique also requires that the UT system be connected to a separate transducer to detect a known depth of water in a standard pipe. These surveillance and calibration procedures are performed once each shift by a level two QC inspector who has extensive training in UT techniques. We believe that because of the presence of the "reference pulse" and the high level of training of the level two QC personnel who performed the surveillance and calibration of this instrument, any degradation of the operation of the UT system due to heat, vibration, radiation or other failure mode would be discovered during the scheduled surveillance. It is recognized that during the period of 8 hours between surveillance of the UT system, it would be possible for equipment failure to go undetected. However, because of the unlikelihood of a rapid water inflow with an accompanying need to scram occurring during the same period of the equipment failure (except for the degraded air case), this surveillance interval is judged to be adequate.
