**RADIOLOGIC AND ENGINEERING ASSESSMENT**

DOE ID NO.: GJ-10775-RS  
ADDRESS: 522-1/2 MORNING GLORY LANE

JUNE 1985

URANIUM MILL TAILINGS REMEDIAL ACTION PROJECT OFFICE

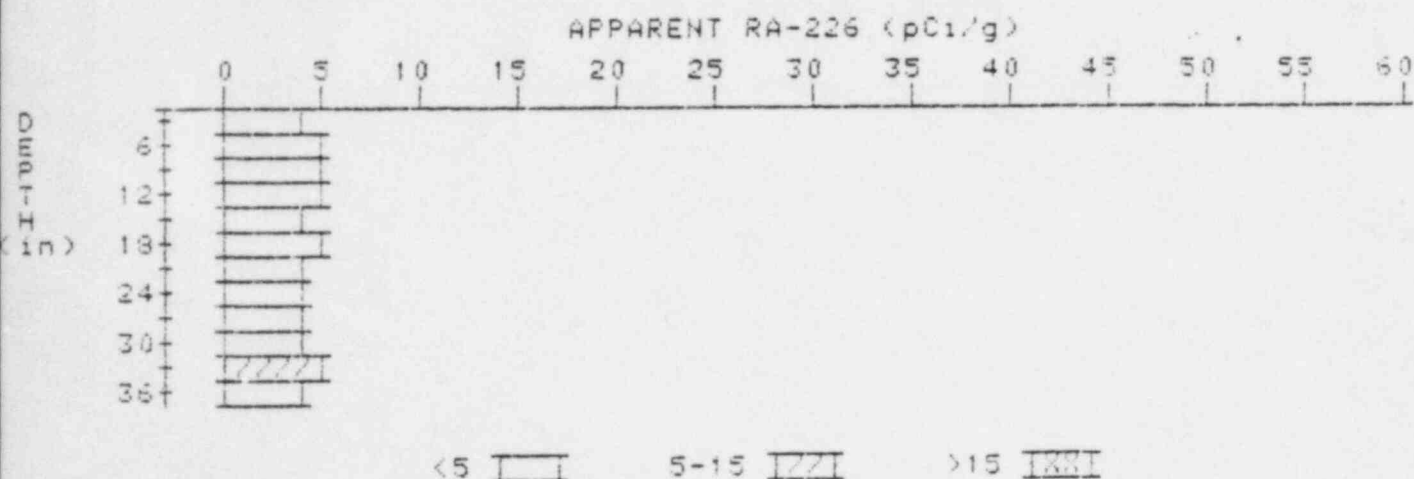
HOLE NUMBER: 1

Depth (in)	Apparent Radium-226 (pCi/g) Undeconvolved	Apparent Radium-226 (pCi/g) Deconvolved
3	4.0	4.0
6	4.3	4.7
9	4.4	4.6
12	4.4	4.6
15	4.3	3.9
18	4.4	4.8
21	4.3	4.3
24	4.2	4.0
27	4.2	4.2
30	4.2	3.8
33	4.4	5.1
36	4.2	4.2

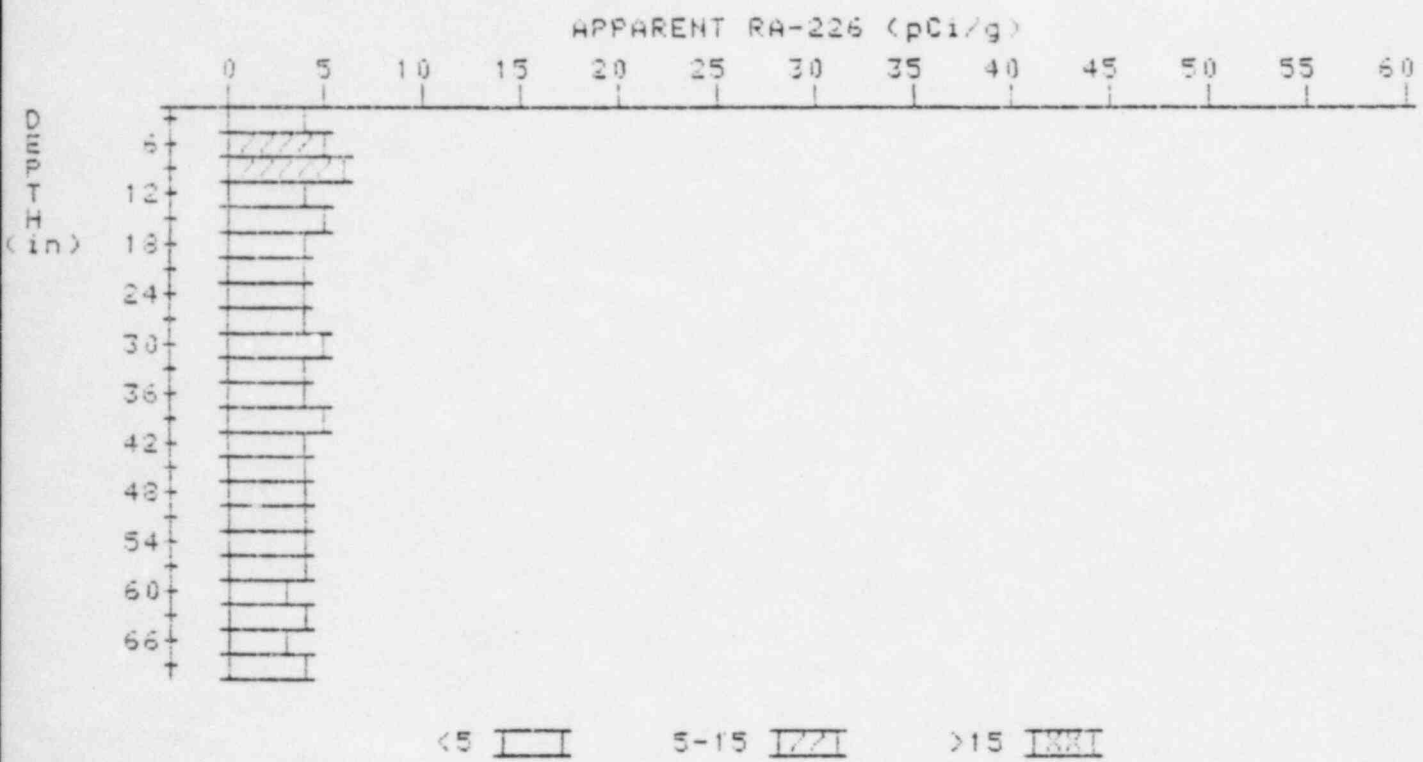
PROPERTY NUMBER: GJ-10775-RS  
HOLE NUMBER: 2  
LOCATION: 163255

Depth (in)	Apparent Radium-226 (pCi/g) Undeconvolved	Apparent Radium-226 (pCi/g) Deconvolved
3	4.1	4.1
6	4.7	5.4
9	4.9	5.6
12	4.6	4.2
15	4.5	4.5
18	4.4	4.4
21	4.3	4.3
24	4.2	4.2
27	4.1	3.7
30	4.2	4.6
33	4.1	3.7
36	4.2	4.4
39	4.2	4.6
42	4.0	3.6
45	3.9	3.5

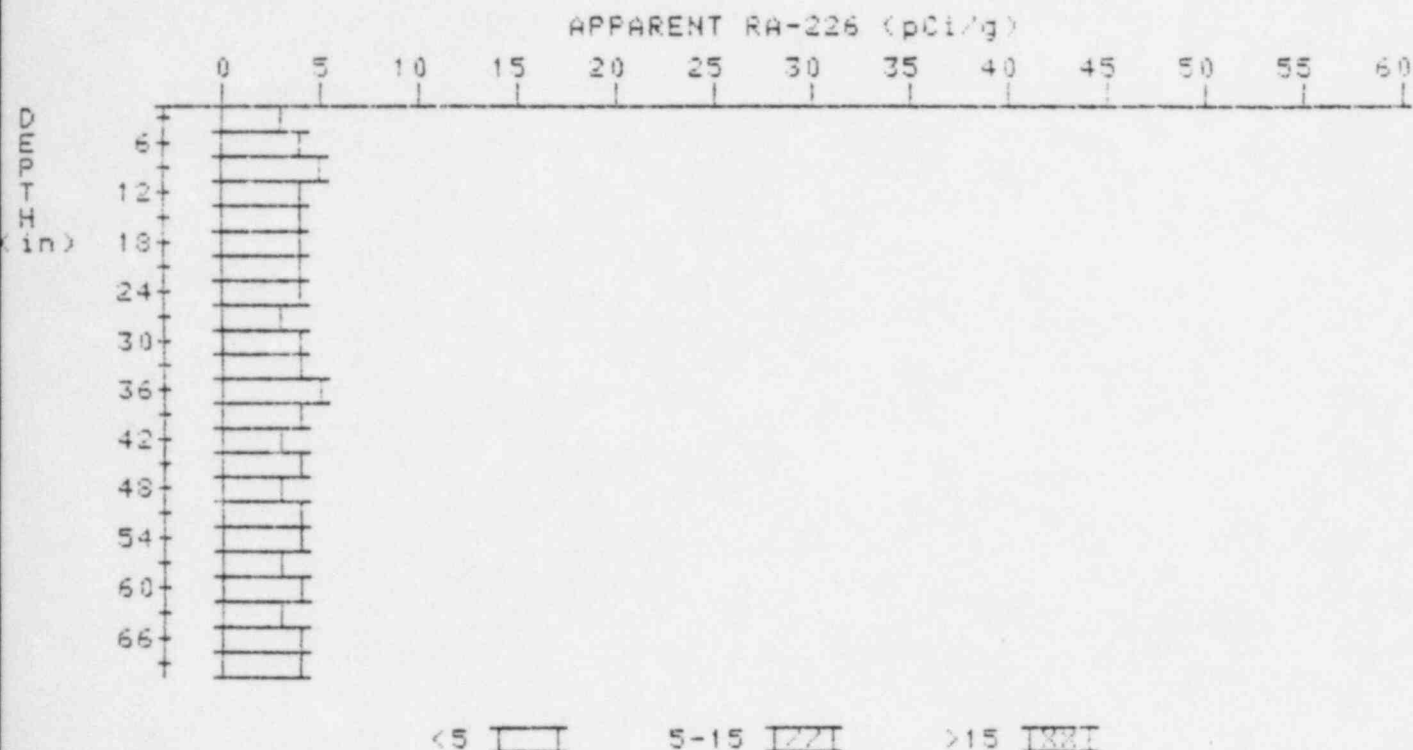
HOLE NUMBER: 6

Depth (in)	Apparent Radium-226 (pCi/g)	Apparent Radium-226 (pCi/g)
	Undeconvolved	Deconvolved
3	3.3	3.3
6	3.7	3.9
9	4.0	4.7
12	3.9	3.7
15	3.9	4.1
18	3.8	3.6
21	3.8	3.8
24	3.8	4.0
27	3.7	3.8
30	3.8	3.8
33	3.9	3.9
36	4.0	4.6
39	3.8	3.8
42	3.6	3.1
45	3.7	4.1

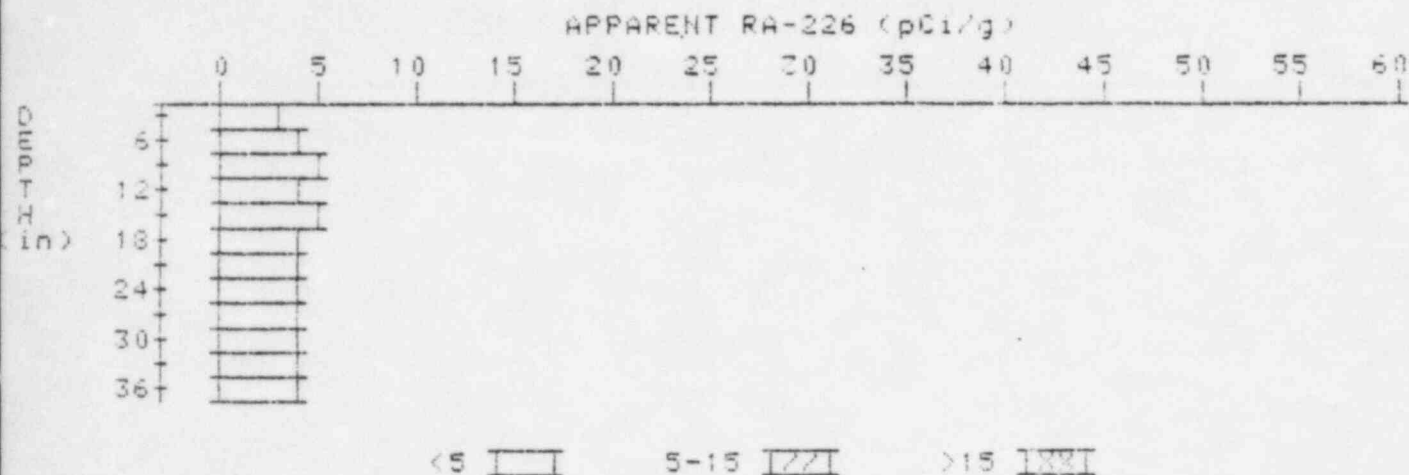
HOLE NUMBER: 7

Depth (in)	Apparent Radium-226 (pCi/g) Undeconvolved	Apparent Radium-226 (pCi/g) Deconvolved
3	3.1	3.1
6	3.6	3.6
9	4.0	4.5
12	4.1	4.1
15	4.2	4.6
18	4.1	3.9
21	4.1	4.3
24	4.0	3.8
27	4.0	3.8
30	4.1	4.3
33	4.1	4.1
36	4.1	4.1

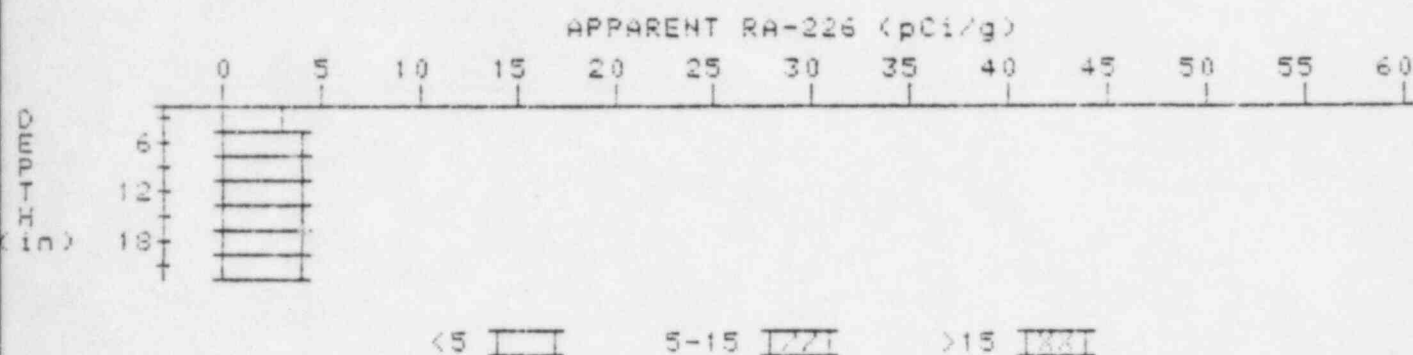
HOLE NUMBER: 9

Depth (in)	Apparent Radium-226 (pCi/g) Undeconvolved	Apparent Radium-226 (pCi/g) Deconvolved
3	3.0	3.0
6	3.4	3.6
9	3.7	3.9
12	3.9	4.1
15	4.0	4.2
18	4.0	4.0
21	4.0	4.0

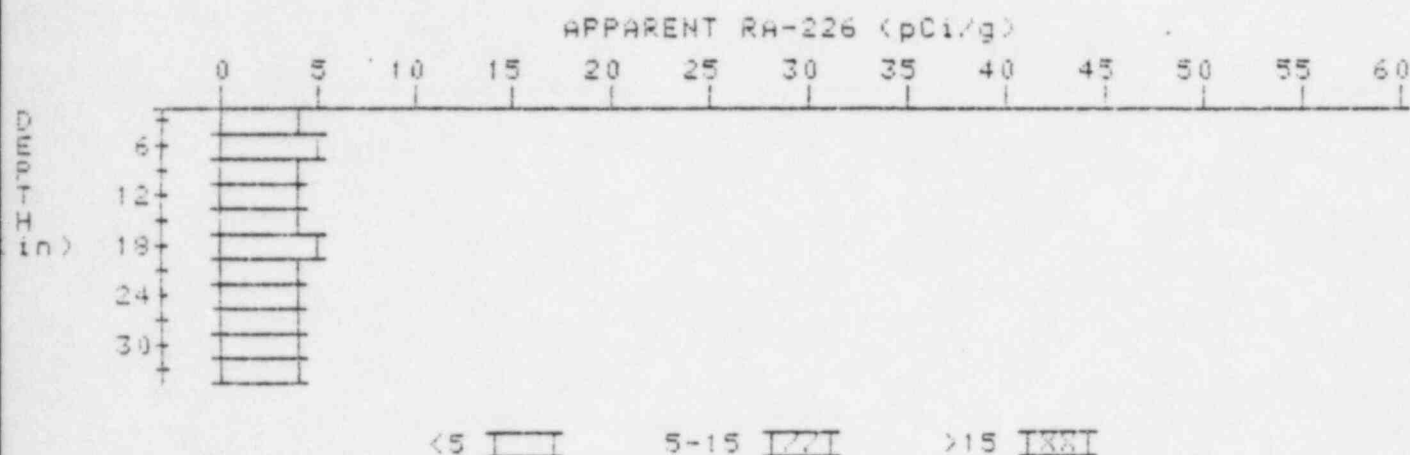
HOLE NUMBER: 10

Depth (in)	Apparent Radium-226 (pCi/g)	Apparent Radium-226 (pCi/g)
	Undeconvolved	Deconvolved
3	3.7	3.7
6	4.0	4.5
9	4.0	3.8
12	4.1	4.1
15	4.2	4.2
18	4.3	4.8
21	4.1	3.7
24	4.1	3.9
27	4.2	4.2
30	4.3	4.5
33	4.3	4.3
