RADIOLOGIC AND ENGINEERING ASSESSMENT

DOE ID NO.: GJ-10751-RS
ADDRESS: 444 HILL AVENUE

JUNE 1985

BENDIX FIELD ENGINEERING CORPORATION
P.O. Box 1569
Grand Junction, Colorado 81502

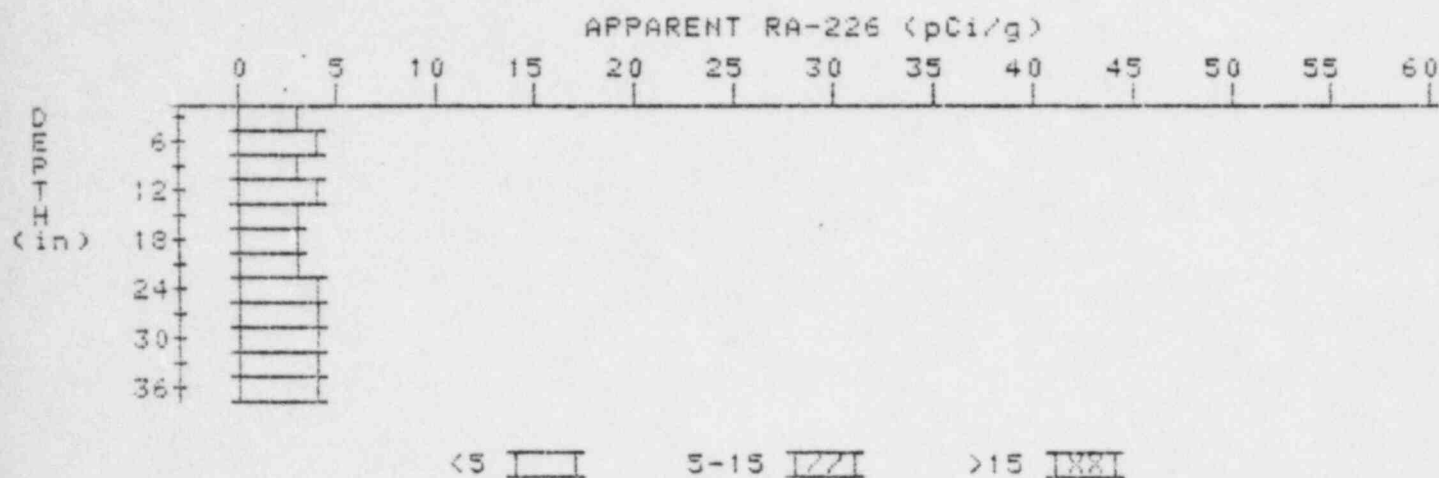
HOLE NUMBER: 1

Depth (in)	Apparent Radium-226 (pCi/g) Undeconvolved	Apparent Radium-226 (pCi/g) Deconvolved
3	2.9	2.9
6	3.2	3.6
9	3.3	3.3
12	3.4	3.6
15	3.4	3.4
18	3.4	3.2
21	3.5	3.3
24	3.7	3.9
27	3.8	3.8
30	3.9	3.9
33	4.0	4.2
36	4.0	4.0

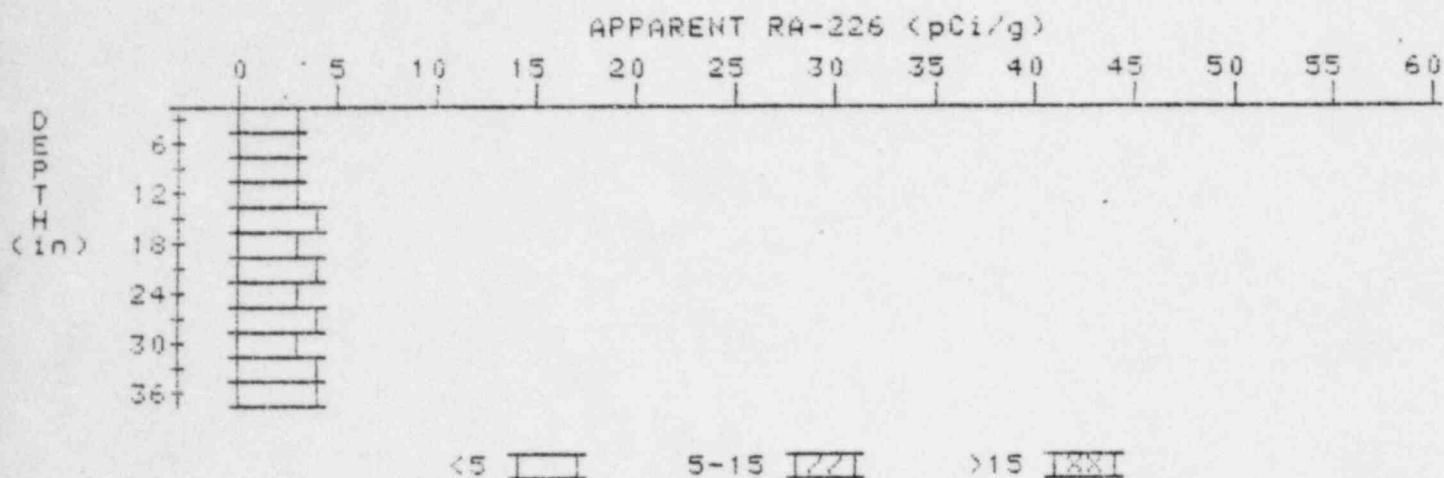
HOLE NUMBER: 2

Depth (in)	Apparent Radium-226 (pCi/g) Undeconvolved	Apparent Radium-226 (pCi/g) Deconvolved
3	2.8	2.8
6	3.1	3.5
9	3.2	3.2
12	3.3	3.3
15	3.4	3.8
18	3.3	2.9
21	3.4	3.6
24	3.4	3.2
27	3.5	3.7
30	3.5	3.3
33	3.6	3.8
36	3.6	3.6

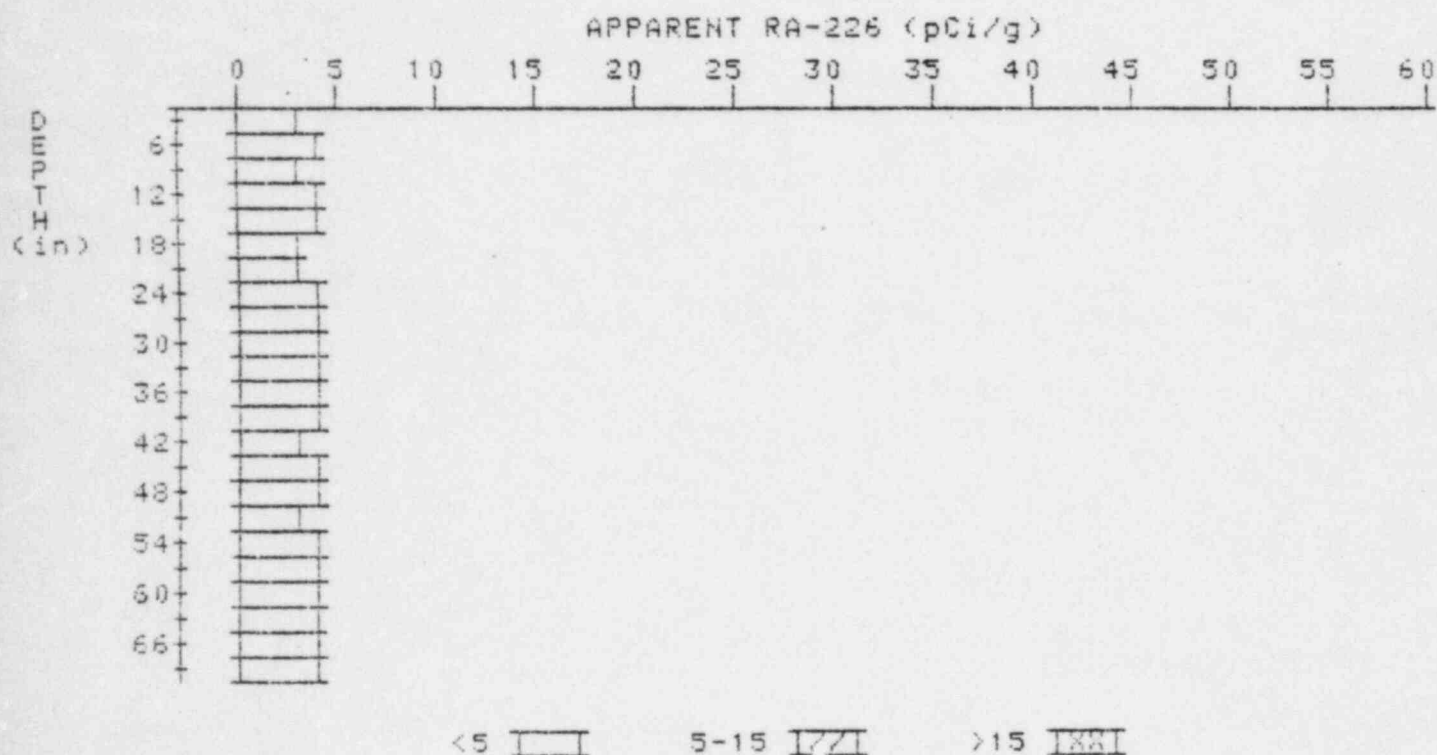
HOLE NUMBER: 4

Depth (in)	Apparent Radium-226 (pCi/g) Undeconvolved	Apparent Radium-226 (pCi/g) Deconvolved
3	3.4	3.4
6	3.5	3.7
9	3.5	3.3
12	3.6	3.8
15	3.6	3.8
18	3.5	3.1
21	3.6	3.4
24	3.8	4.2
27	3.8	3.6
30	3.9	4.1
33	3.9	3.9
36	3.9	3.9
39	3.9	4.3
42	3.7	3.3
45	3.7	3.5

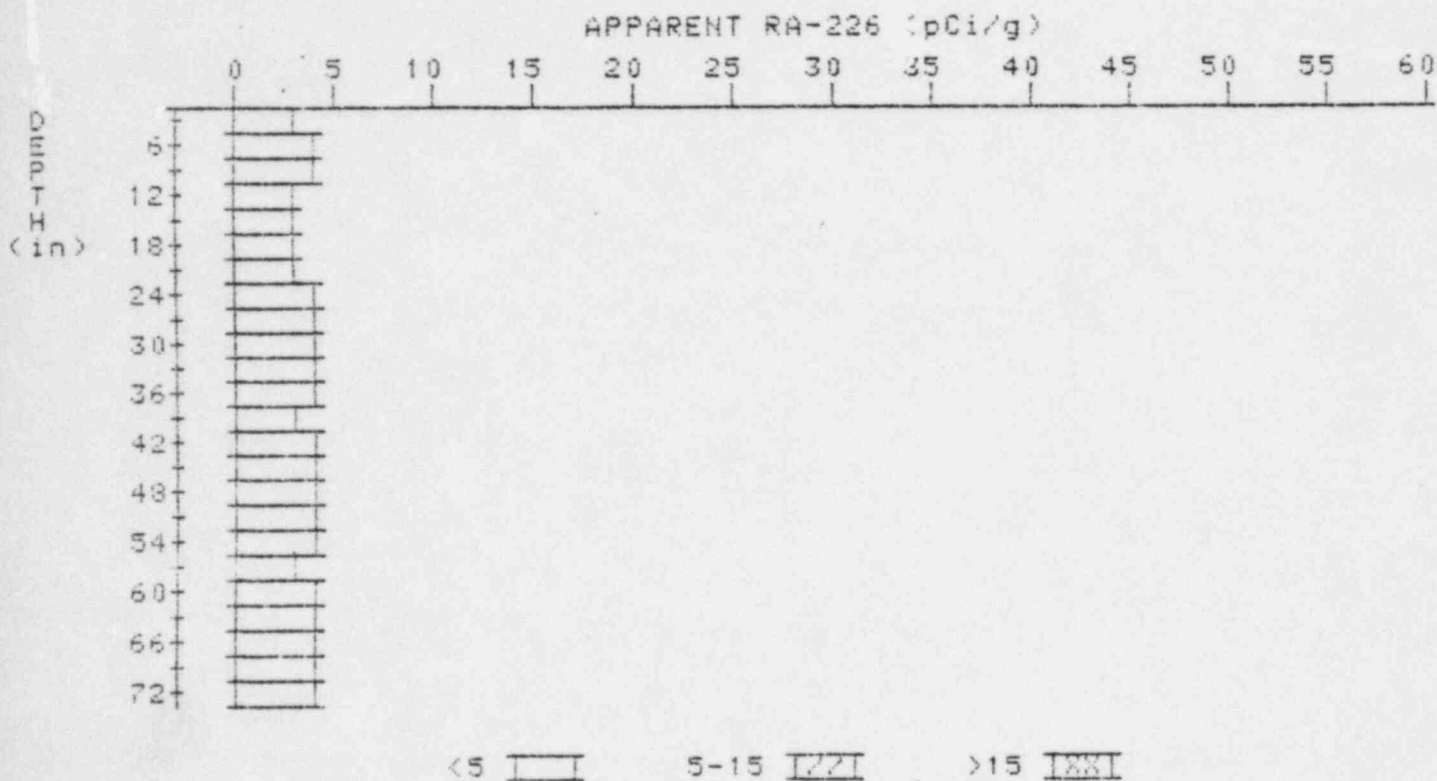
HOLE NUMBER: 5

Depth (in)	Apparent Radium-226 (pCi/g) Undeconvolved	Apparent Radium-226 (pCi/g) Deconvolved
3	3.1	3.1
6	3.4	3.9
9	3.4	3.6
12	3.3	3.1
15	3.3	3.3
18	3.3	3.1
21	3.4	3.4
24	3.5	3.5
27	3.6	3.6
30	3.7	3.7
33	3.8	3.8
36	3.9	4.4
39	3.7	3.3
42	3.7	3.7
45	3.7	3.7

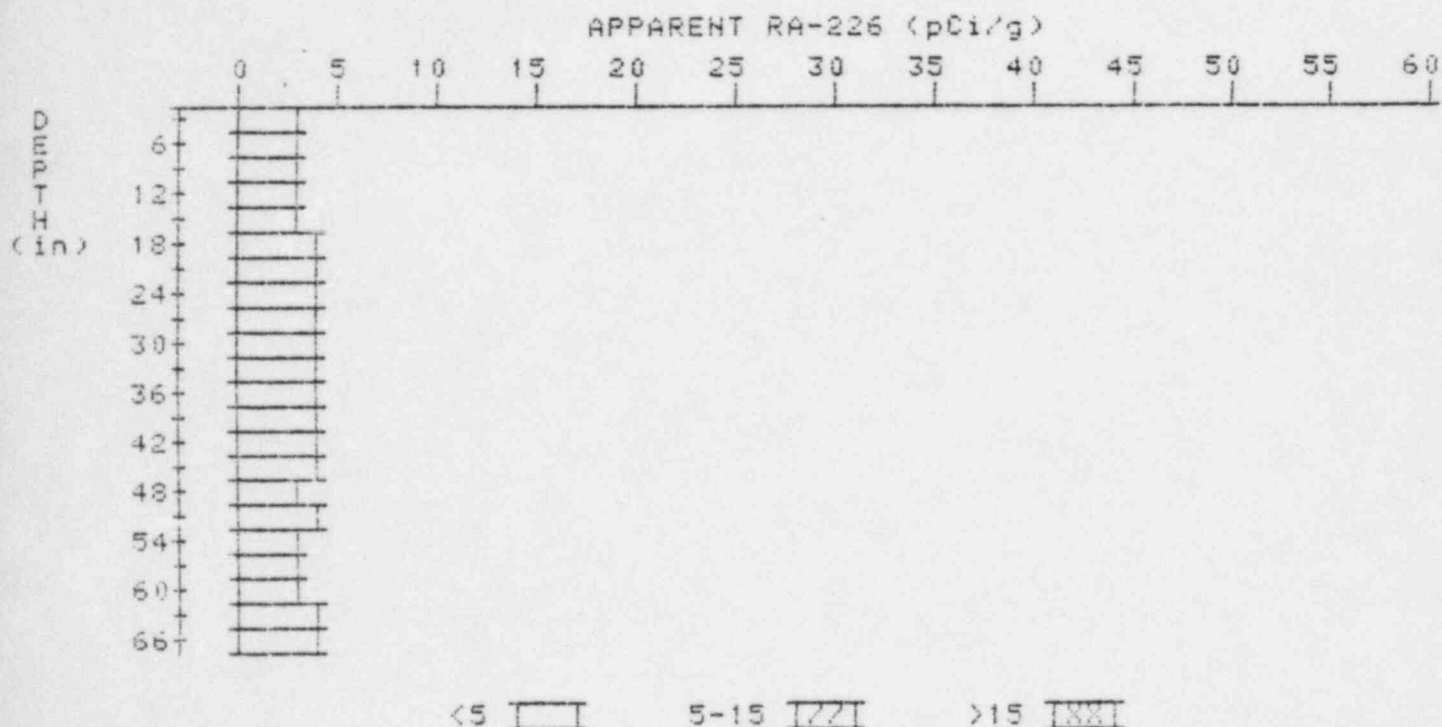
HOLE NUMBER: 6

Depth (in)	Apparent Radium-226 (pCi/g) Undeconvolved	Apparent Radium-226 (pCi/g) Deconvolved
3	3.0	3.0
6	3.2	3.4
9	3.3	3.5
12	3.3	3.1
15	3.4	3.4
18	3.5	3.5
21	3.6	3.6
24	3.7	3.7
27	3.7	3.7
30	3.7	3.7
33	3.9	4.1
36	3.9	4.1
39	3.8	3.8
42	3.7	3.7
45	3.6	3.6
48	3.5	3.3

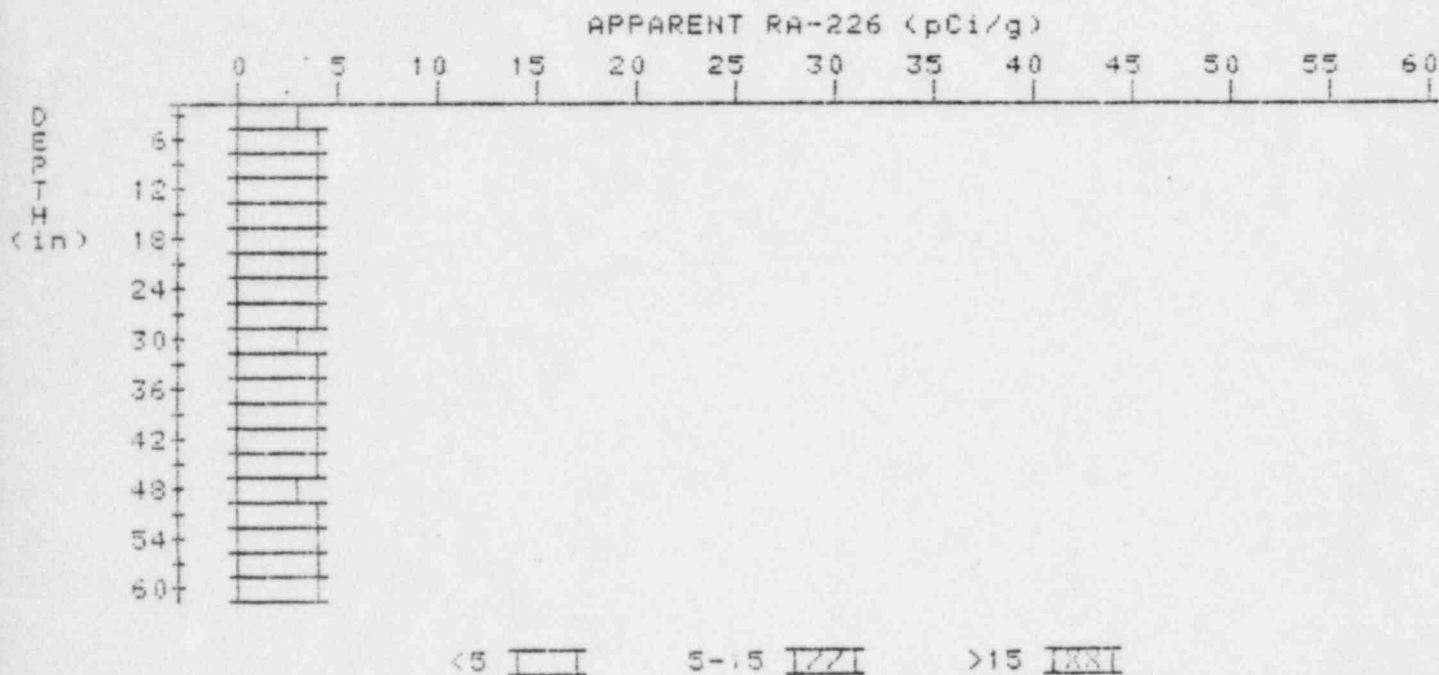
HOLE NUMBER: 7

Depth (in)	Apparent Radium-226 (pCi/g) Undeconvolved	Apparent Radium-226 (pCi/g) Deconvolved
3	3.4	3.4
6	3.7	4.2
9	3.7	3.7
12	3.7	3.5
15	3.8	4.0
18	3.8	4.0
21	3.7	3.3
24	3.7	3.7
27	3.7	3.9
30	3.6	3.2
33	3.7	3.3
36	3.7	3.3
39	3.8	4.0
42	3.8	3.6
45	3.9	4.4
48	3.7	3.3
51	3.7	3.7
54	3.7	3.9

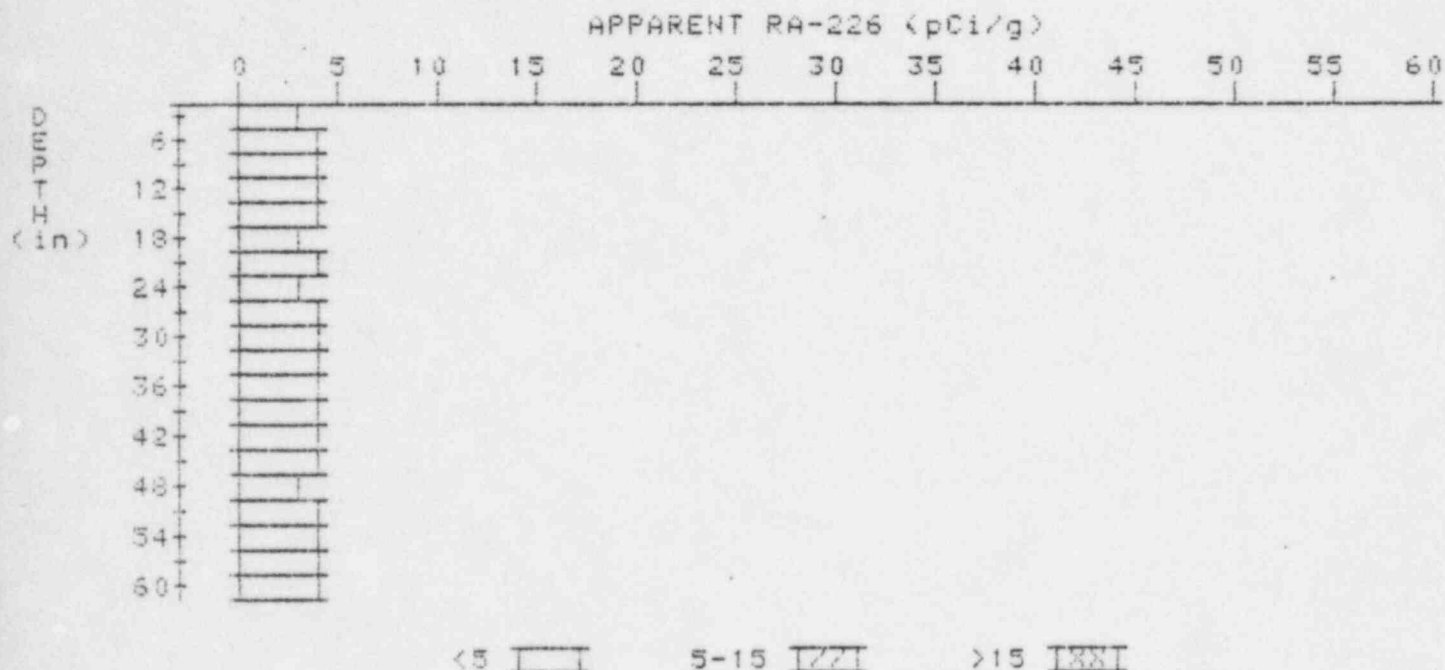
HOLE NUMBER: 8

Depth (in)	Apparent Radium-226 (pCi/g) Undeconvolved	Apparent Radium-226 (pCi/g) Deconvolved
3	3.2	3.2
6	3.5	3.9
9	3.6	3.6
12	3.7	3.9
15	3.7	3.9
18	3.6	3.4
21	3.6	3.6
24	3.6	3.4
27	3.7	3.9
30	3.7	3.5
33	3.8	4.0
36	3.8	3.6
39	3.9	4.3
42	3.8	3.8
45	3.7	3.7
48	3.6	3.4
51	3.6	3.6
54	3.6	3.6
