RADIOLOGIC AND ENGINEERING ASSESSMENT

DOE ID NO.: GJ-10759-RS
ADDRESS: 545 HILL AVENUE

JUNE 1985

BENDIX FIELD ENGINEERING CORPORATION
P.O. Box 1569
Grand Junction, Colorado 81502

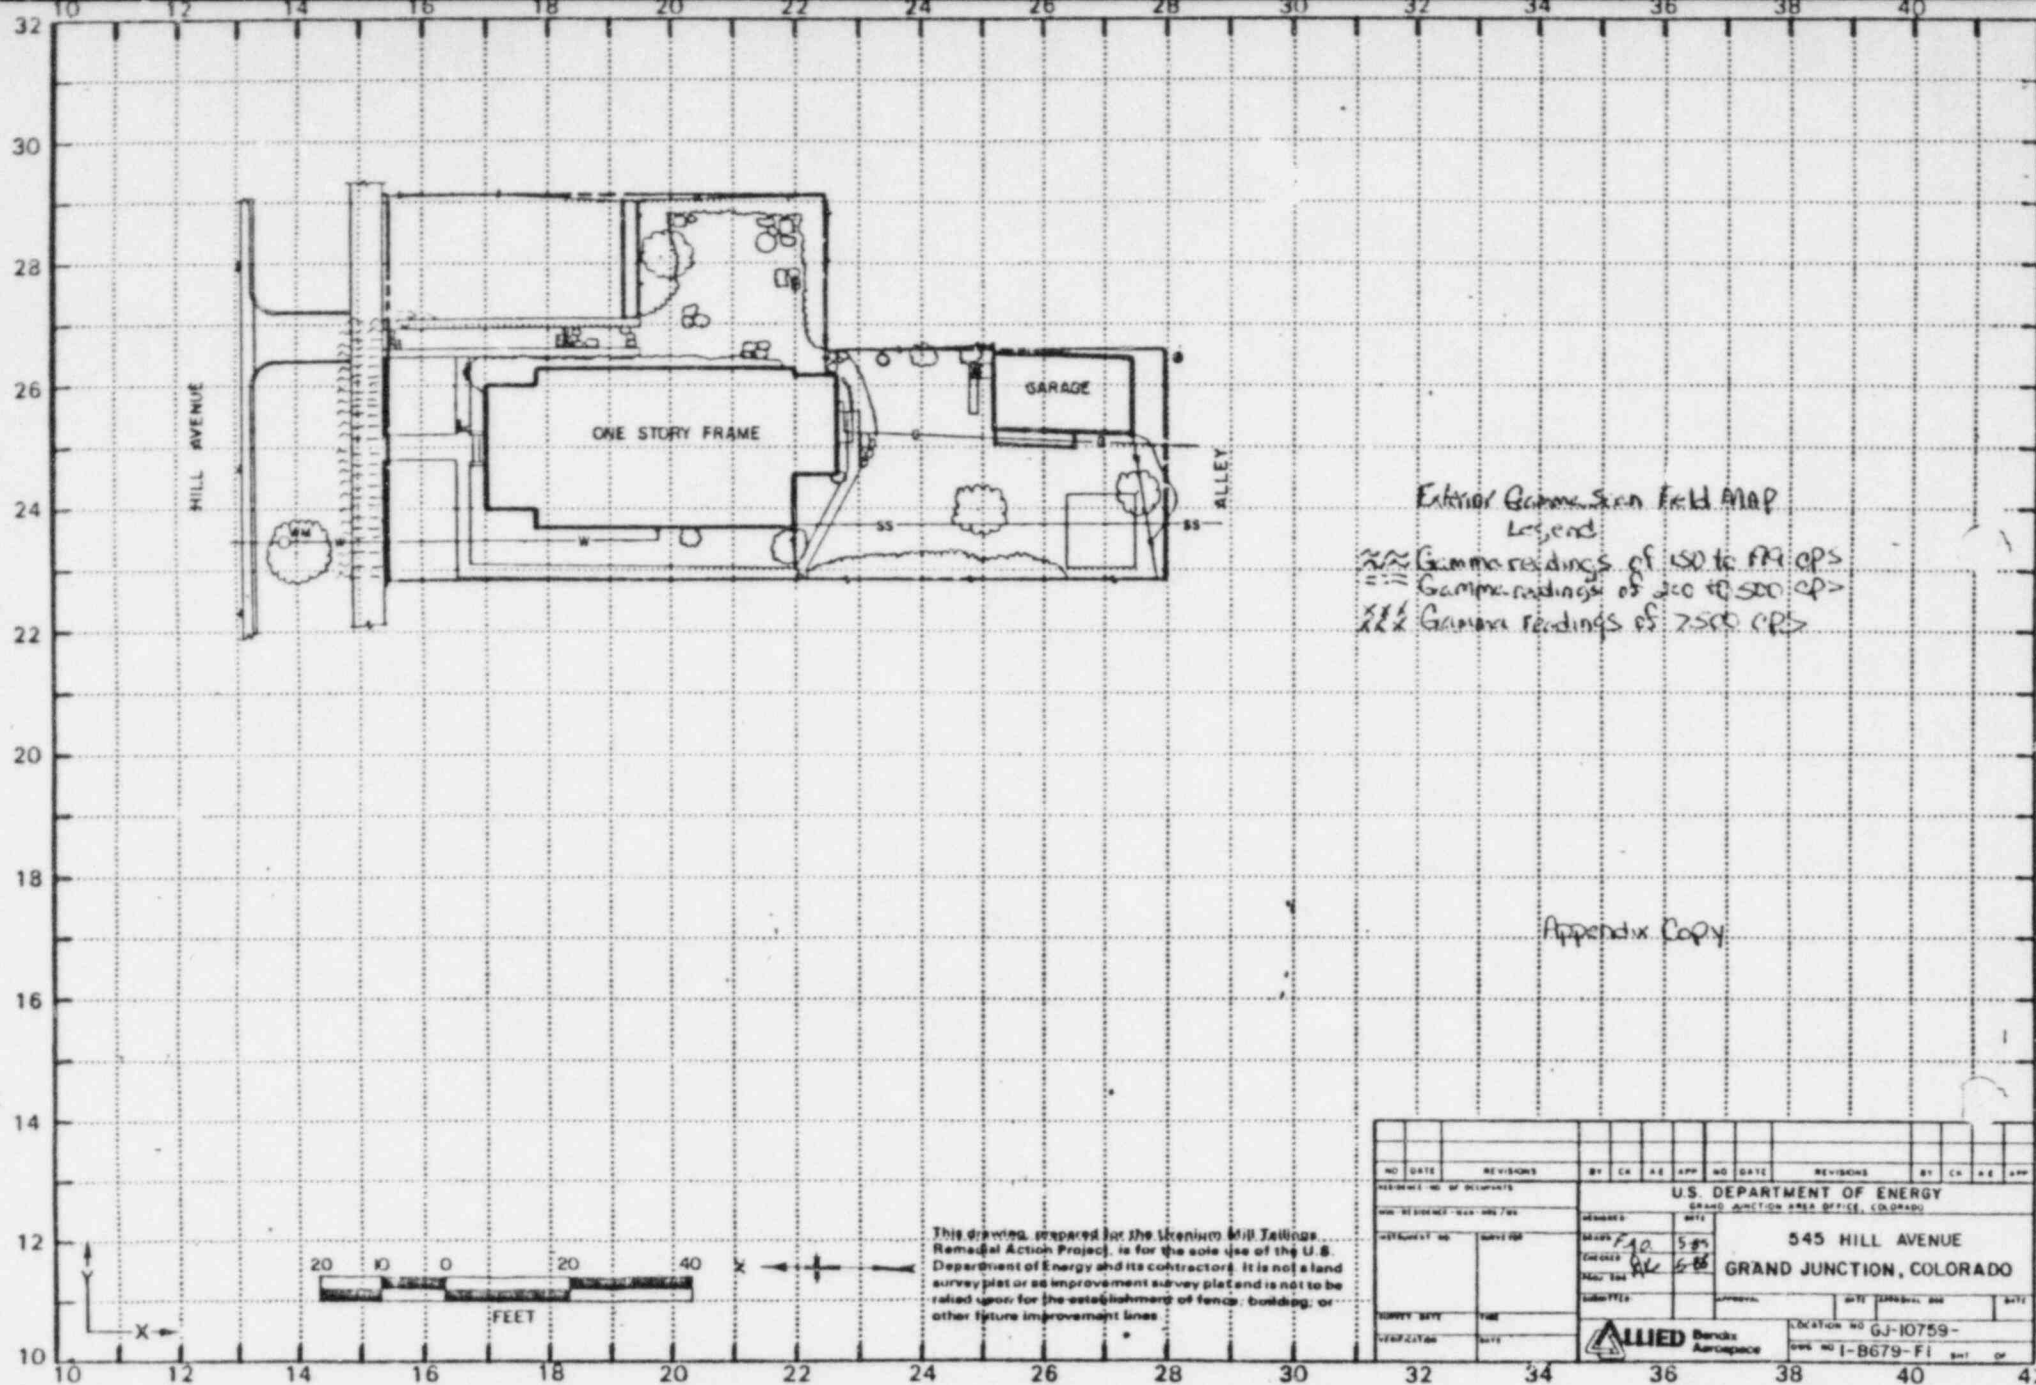
HOG = 42 uR/h

Contamination was located in the city sidewalk, after a survey was conducted.

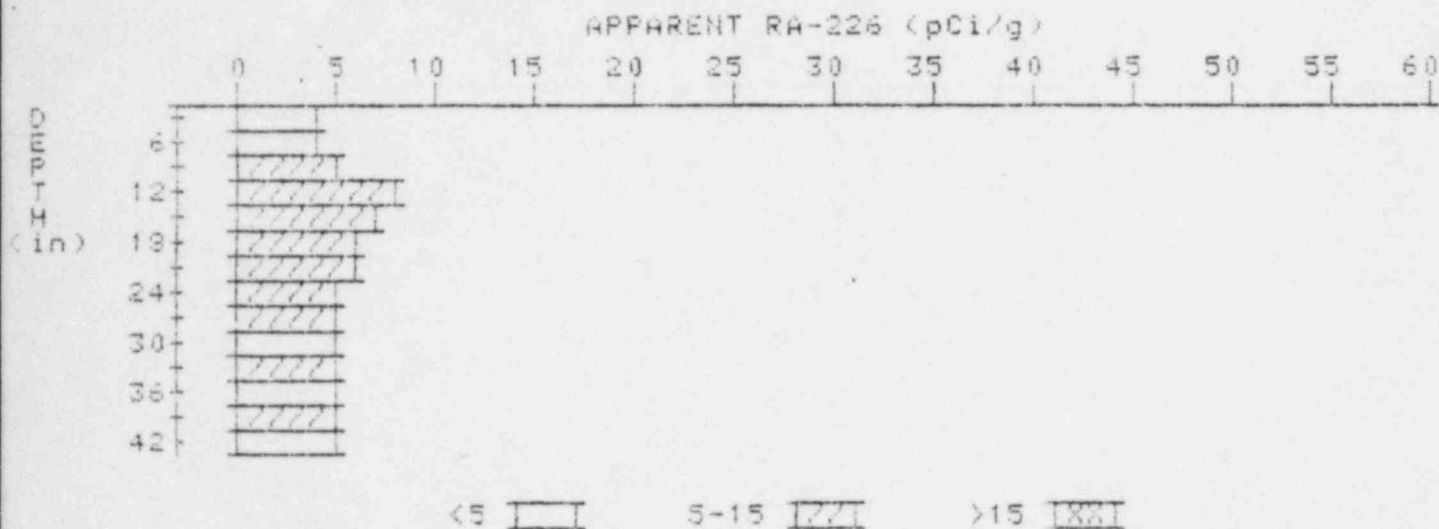
LOCATION: 155246

Depth (in)	Apparent Radium-226 (pCi/g) Undeconvolved	Apparent Radium-226 (pCi/g) Deconvolved
=====		
3	3.6	3.6
6	4.4	4.2
9	5.3	5.3
12	6.2	7.6
15	6.3	6.8
18	6.1	6.3
21	5.8	6.0
24	5.4	5.0
27	5.2	5.2
30	5.0	4.6
33	5.0	5.2
36	4.9	4.7
39	4.9	5.3
42	4.7	4.7

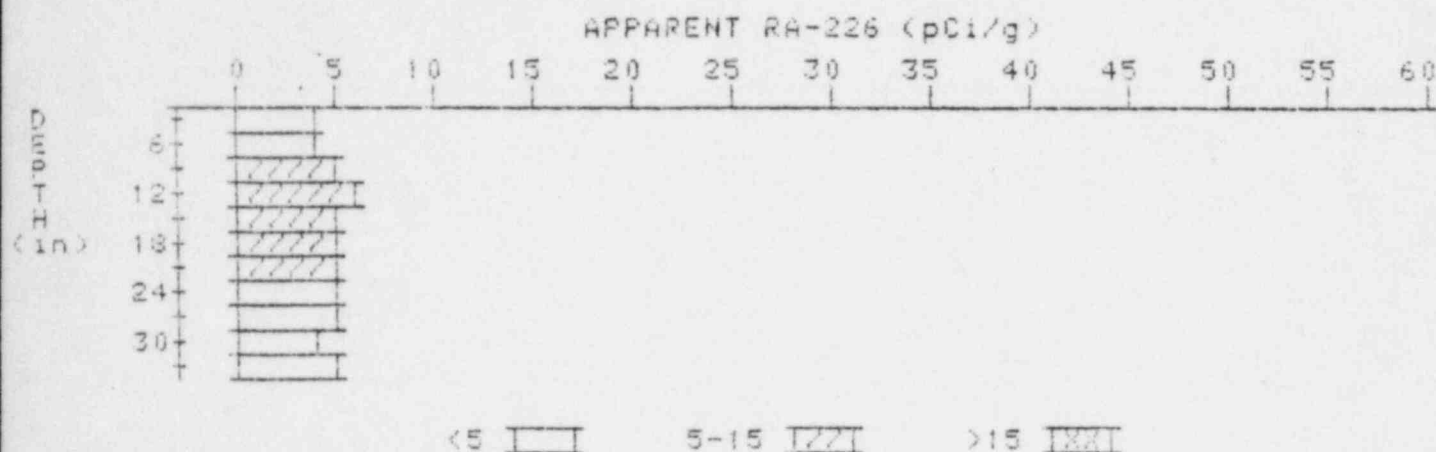
PROPERTY NUMBER: GJ-10759-RS
HOLE NUMBER: 7
LOCATION: 155256

Depth (in)	Apparent Radium-226 (pCi/g) Undeconvolved	Apparent Radium-226 (pCi/g) Deconvolved
3	3.6	3.6
6	4.3	4.5
9	4.9	5.4
12	5.2	5.7
15	5.2	5.4
18	5.1	5.1
21	5.0	5.2
24	4.8	4.6
27	4.7	4.9
30	4.5	4.1
33	4.5	4.5

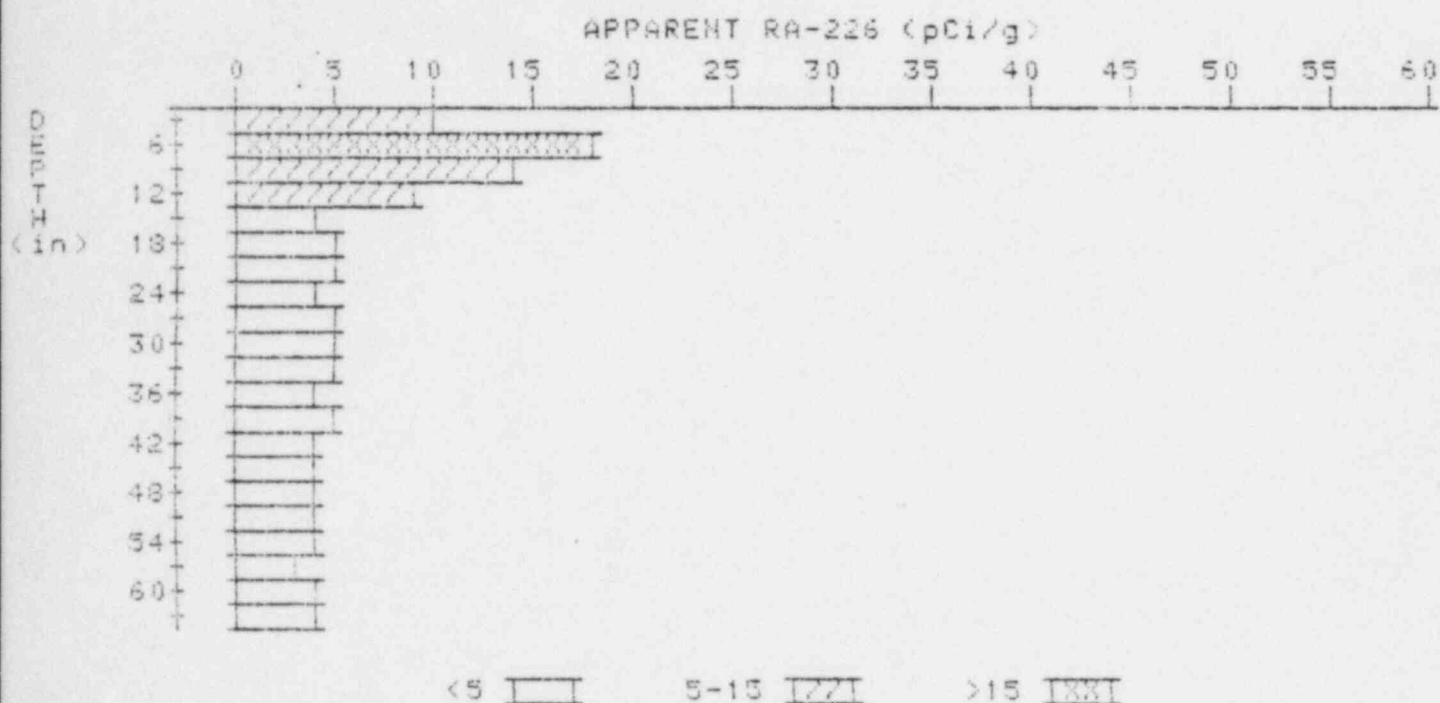
PROPERTY NUMBER: GJ-10759-RS
HOLE NUMBER: 8
LOCATION: 155264

Depth (in)	Apparent Radium-226 (pCi/g) Undeconvolved	Apparent Radium-226 (pCi/g) Deconvolved
3	9.5	9.5
6	12.0	17.9
9	11.2	14.0
12	8.8	8.6
15	6.5	4.0
18	5.6	4.9
21	5.1	4.7
24	4.8	4.4
27	4.7	4.7
30	4.6	4.6
33	4.5	4.5
36	4.4	4.2
39	4.4	4.6
42	4.3	4.3
45	4.2	4.4
48	4.0	3.8
51	3.9	4.1

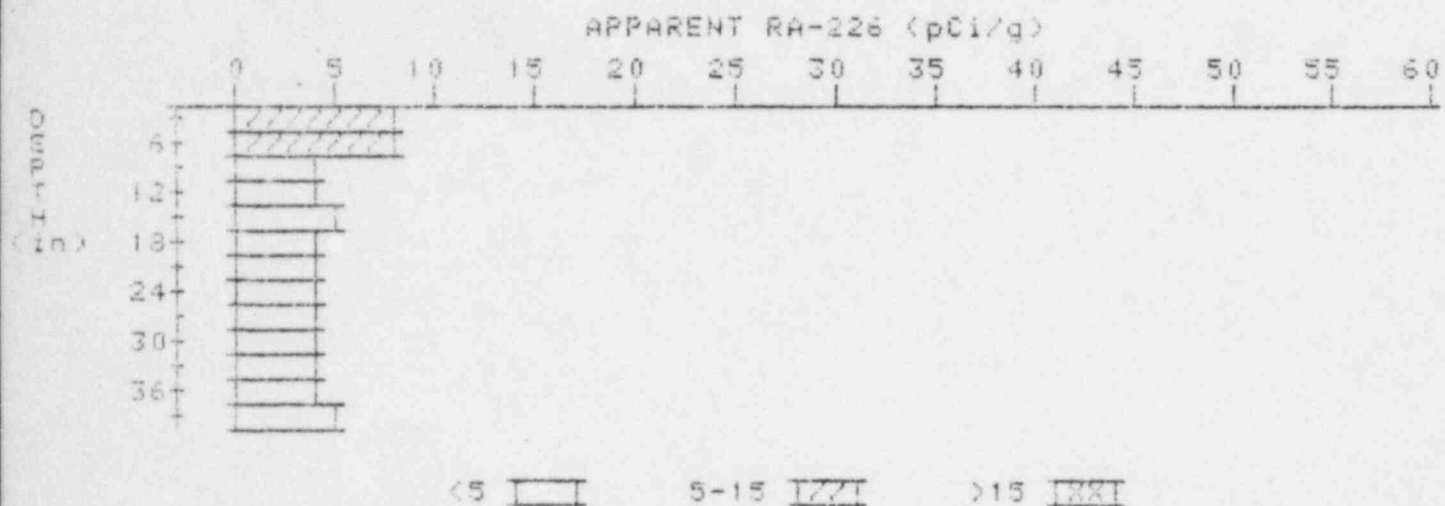
PROPERTY NUMBER: GJ-10759-RS
HOLE NUMBER: 9
LOCATION: 155270

Depth (in)	Apparent Radium-226 (pCi/g) Undeconvolved	Apparent Radium-226 (pCi/g) Deconvolved
3	8.2	8.2
6	7.1	7.8
9	5.6	4.4
12	4.9	3.9
15	4.5	4.5
18	4.2	3.8
21	4.1	4.1
24	4.0	3.6
27	4.1	4.1
30	4.2	4.2
33	4.3	4.3
36	4.4	4.4
39	4.5	4.5

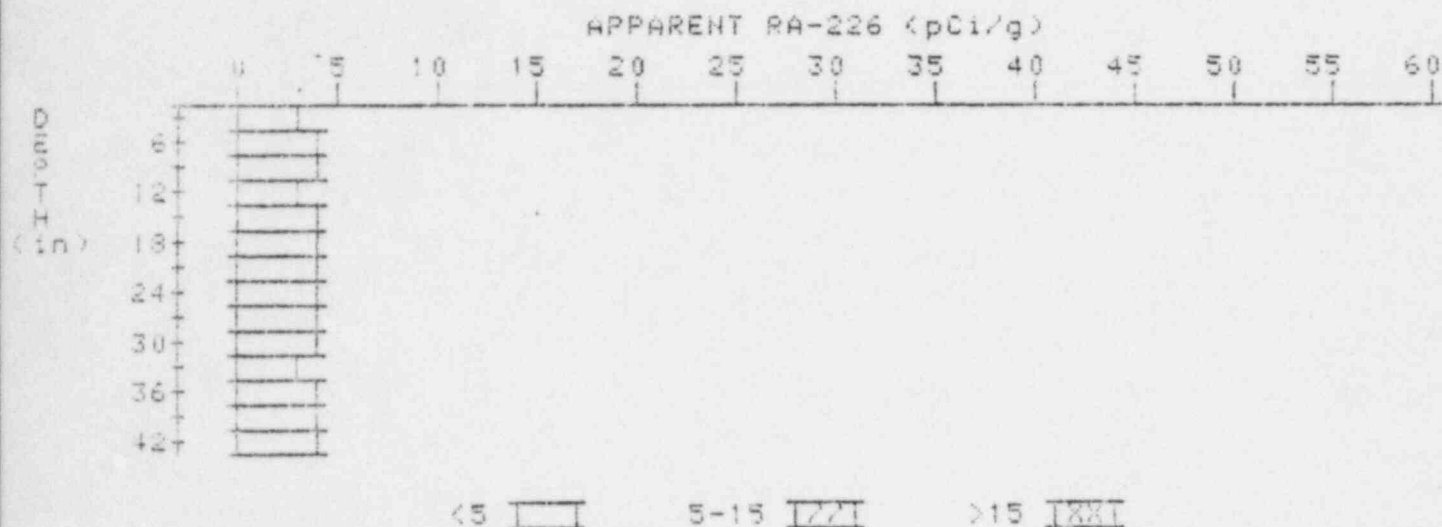
PROPERTY NUMBER: GJ-10759-R8
HOLE NUMBER: 11
LOCATION: 185236

Depth (in)	Apparent Radium-226 (pCi/g) Undeconvolved	Apparent Radium-226 (pCi/g) Deconvolved
3	3.1	3.1
6	3.4	3.8
9	3.5	3.7
12	3.5	3.1
15	3.7	4.1
18	3.7	3.5
21	3.8	4.0
24	3.8	3.8
27	3.8	3.6
30	3.9	4.3
33	3.8	3.4
36	3.9	4.1
39	3.9	3.9
42	3.9	3.9

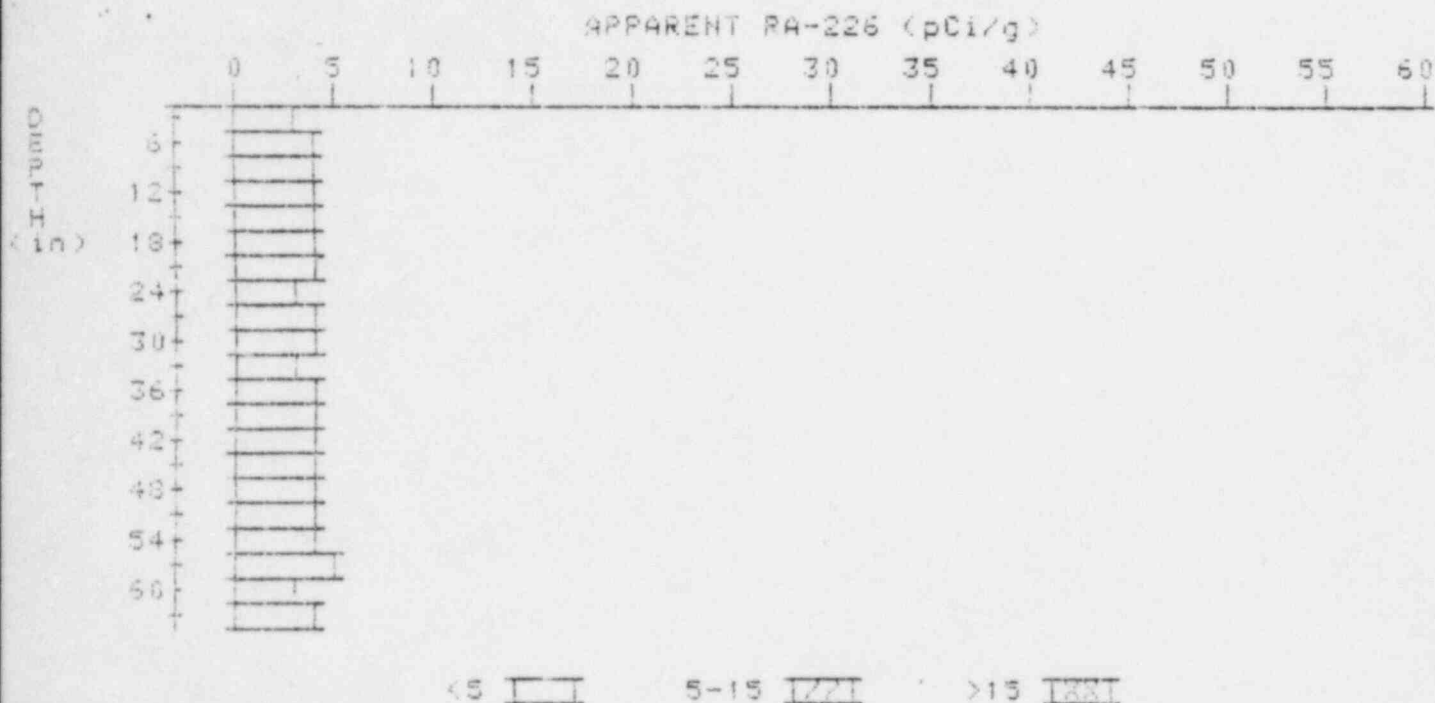
PROPERTY NUMBER: GJ-10759-RS
HOLE NUMBER: 12
LOCATION: 230240

Depth (in)	Apparent Radium-226 (pCi/g) Undeconvolved	Apparent Radium-226 (pCi/g) Deconvolved
3	2.7	2.7
6	3.3	3.7
9	3.7	4.1
12	3.9	4.4
15	3.9	3.6
18	3.9	4.0
21	3.7	3.7
24	3.6	3.2
27	3.7	3.6
30	3.7	3.9
33	3.6	3.2
36	3.7	3.6
39	3.9	4.1
42	4.0	4.2
45	4.0	3.0
48	4.1	4.6
51	4.1	4.3

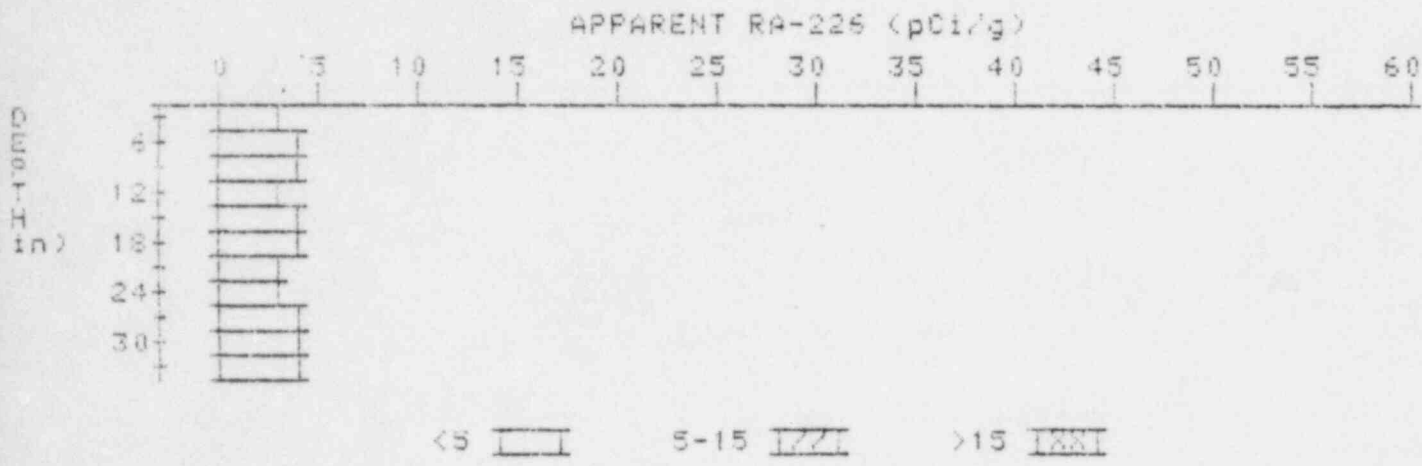
PROPERTY NUMBER: GJ-10759-RS
HOLE NUMBER: 14
LOCATION: 265245

Depth (in)	Apparent Radium-226 (pCi/g) Undeconvolved	Apparent Radium-226 (pCi/g) Deconvolved
3	3.1	3.1
6	3.4	3.3
9	3.5	3.7
12	3.5	3.3
15	3.6	3.3
18	3.6	3.3
21	3.5	3.1
24	3.6	3.4
27	3.8	4.2
30	3.8	3.6
33	3.9	3.9
