RADIOLOGIC AND ENGINEERING ASSESSMENT

DOE ID NO.: GJ-04396-RS
ADDRESS: 2654 SACOMA COURT

JUNE 1985

BENDIX FIELD ENGINEERING CORPORATION
P.O. Box 1569
Grand Junction, Colorado 81502

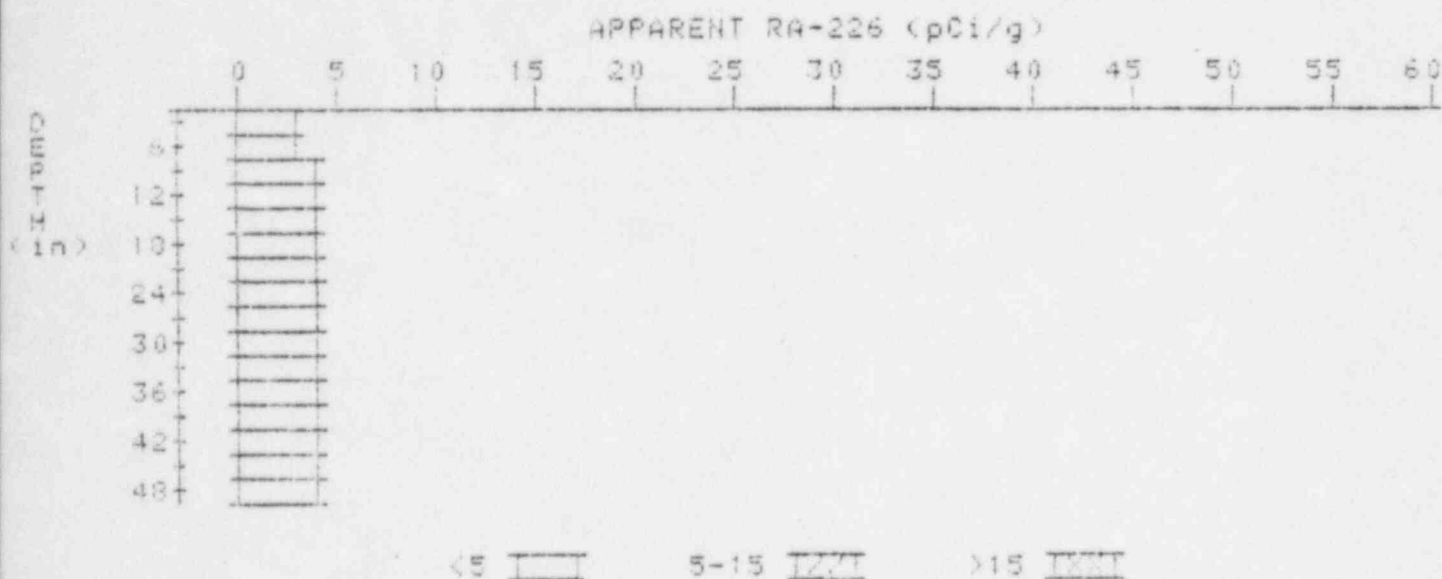
PROPERTY NUMBER: GJ-04396-R3
HOLE NUMBER: 5
LOCATION: 205280

An old septic system was located in the north yard, Location 205280.
No contamination was found in this area.
