RADIOLOGIC AND ENGINEERING ASSESSMENT

DOE ID NO.: GJ-06194-CS  
ADDRESS: 908 NORTH 1ST STREET

JUNE 1985

BENDIX FIELD ENGINEERING CORPORATION  
P.O. Box 1569  
Grand Junction, Colorado 81502

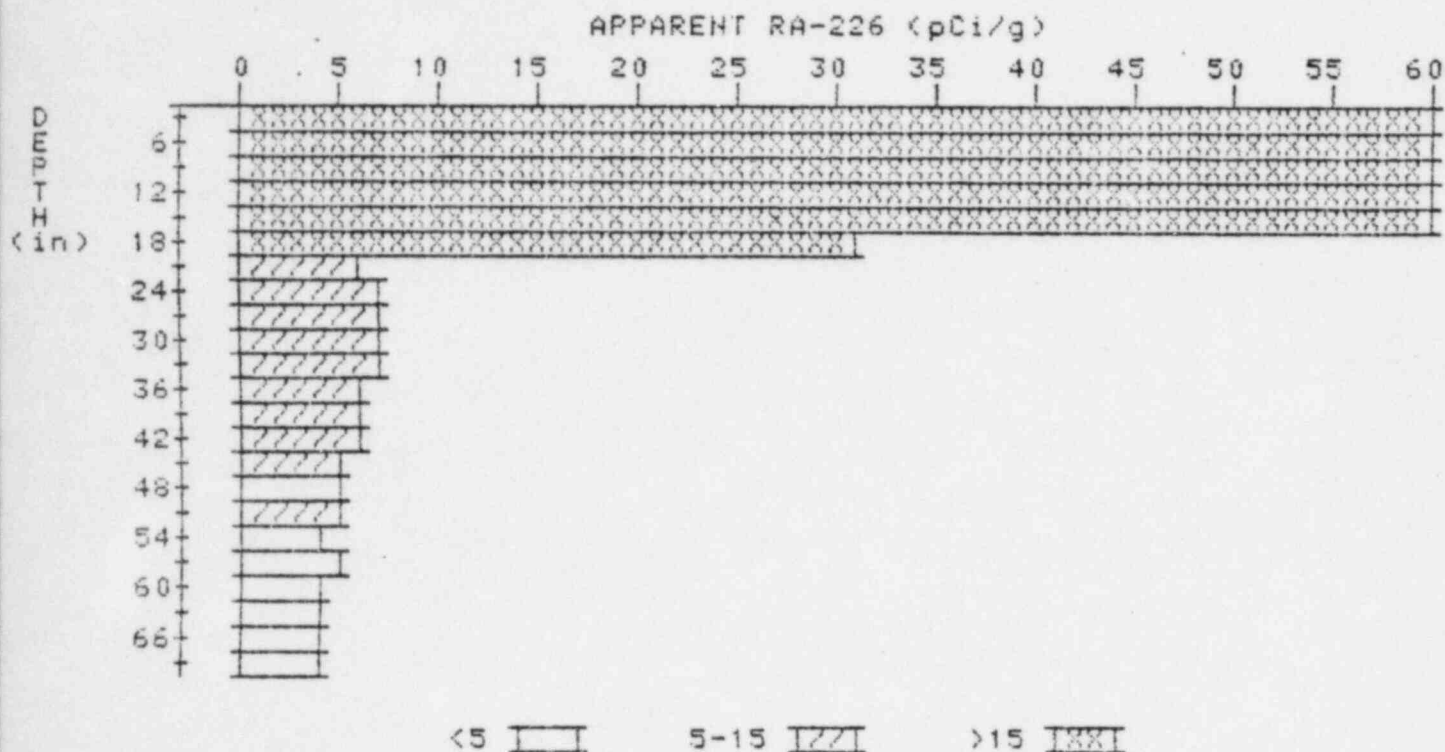
HOLE NUMBER: 1

Depth (in)	Apparent Radium-226 (pCi/g) Undeconvolved	Apparent Radium-226 (pCi/g) Deconvolved
3	59.7	59.7
6	93.8	137.9
9	103.1	141.0
12	91.1	114.7
15	65.8	63.8
18	41.6	30.9
21	23.4	6.0
24	15.0	7.4
27	10.9	7.3
30	8.8	7.4
33	7.5	6.6
36	6.7	6.3
39	6.1	5.7
42	5.7	5.7
45	5.3	5.1

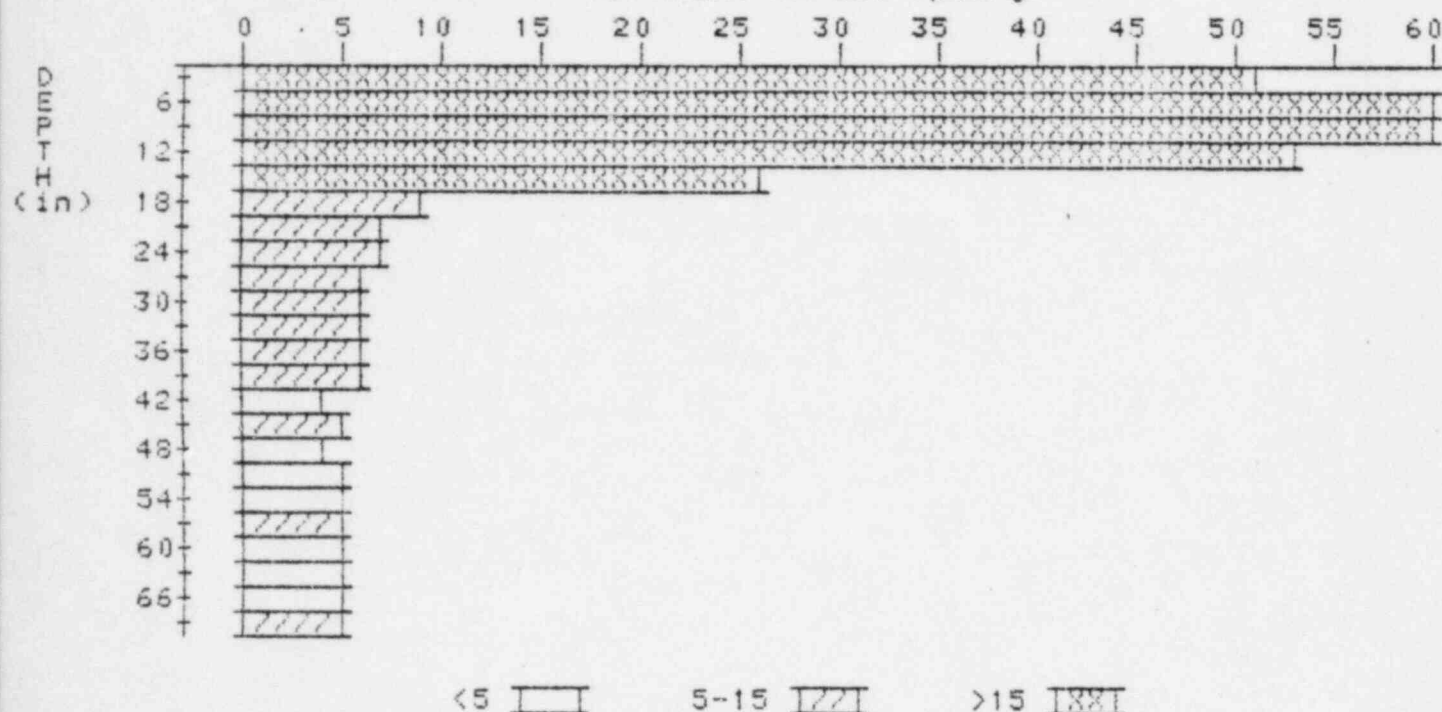
LOCATION: 187228

Depth (in)	Apparent Radium-226 (pCi/g) Undeconvolved	Apparent Radium-226 (pCi/g) Deconvolved
3	50.9	50.9
6	78.0	139.7
9	70.4	88.5
12	52.6	53.3
15	34.4	26.4
18	20.7	9.1
21	13.5	7.1
24	9.9	7.1
27	7.9	5.9
30	7.0	6.5
33	6.4	5.9
36	6.1	6.3
39	5.7	5.9
42	5.2	4.5
45	5.1	5.5

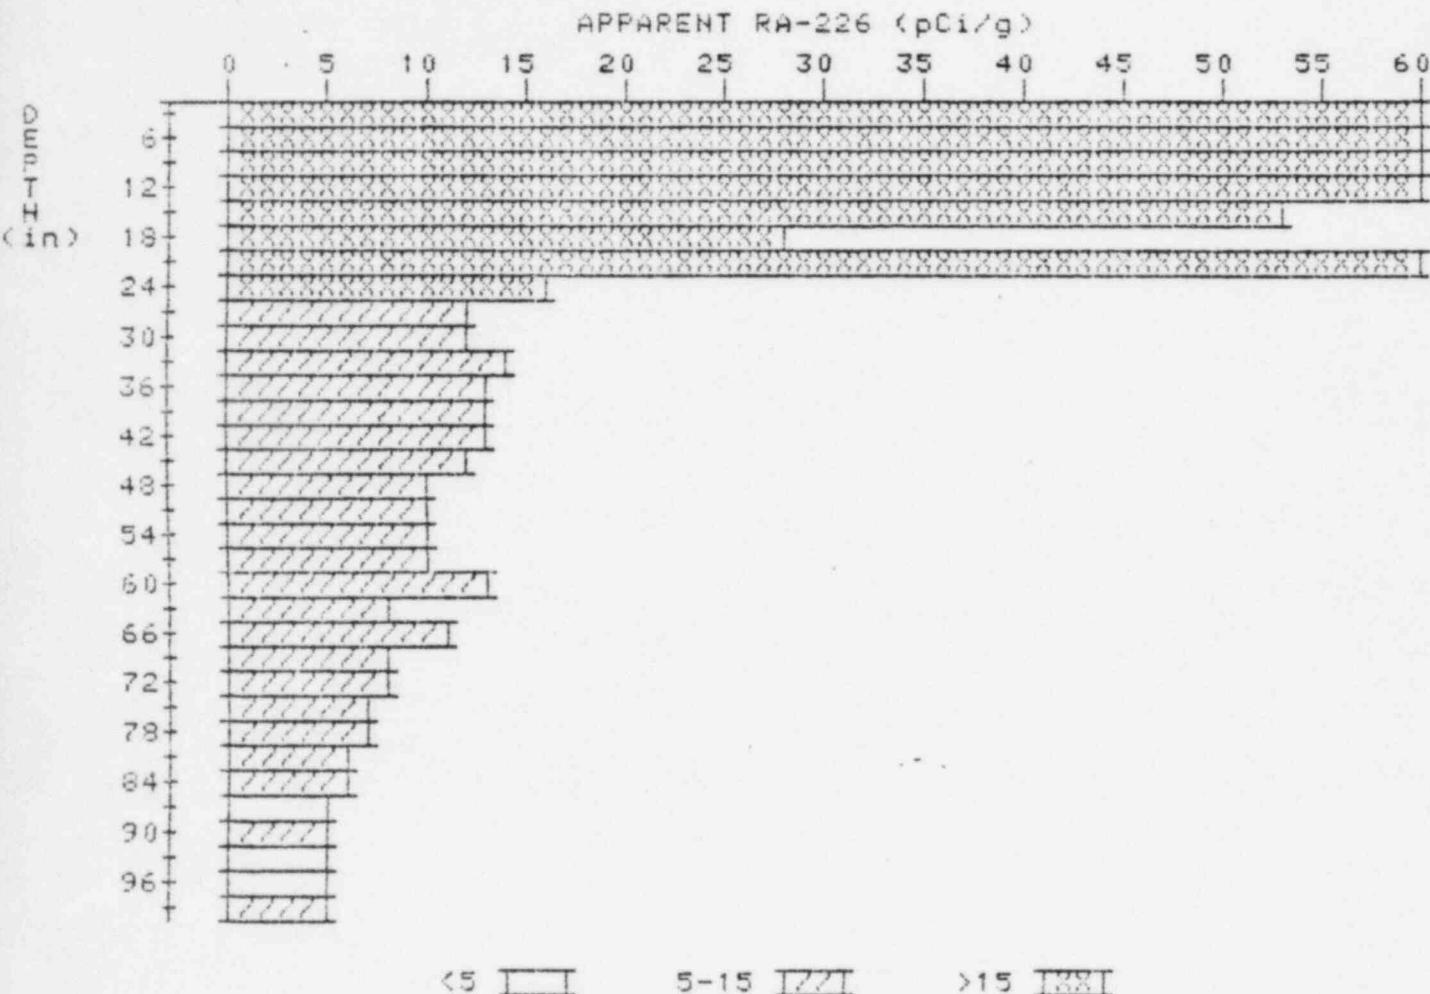
PROPERTY NUMBER: GJ-06194-CS  
HOLE NUMBER: 5  
LOCATION: 197227

Depth (in)	Apparent Radium-226 (pCi/g) Undeconvolved	Apparent Radium-226 (pCi/g) Deconvolved
3	78.8	78.8
6	109.7	151.1
9	117.3	158.4
12	101.8	121.0
15	75.5	53.5
18	61.6	27.6
21	66.8	124.8
24	39.4	15.8

27	25.3	12.0
30	18.7	11.8
33	16.0	11.0
36	14.4	11.3
39	13.4	13.0
42	12.6	12.6
45	11.8	12.2
48	10.8	9.7
51	10.4	10.0
54	10.2	9.8
57	10.2	9.8
60	10.4	12.5
63	9.4	7.8
66	9.3	10.5
69	8.5	8.1
72	7.9	7.9
75	7.3	7.1
78	6.8	7.0
81	6.2	6.0
84	5.7	5.5
87	5.3	4.8
90	5.2	5.4
93	5.0	4.6
96	5.0	4.6
99	5.2	5.2

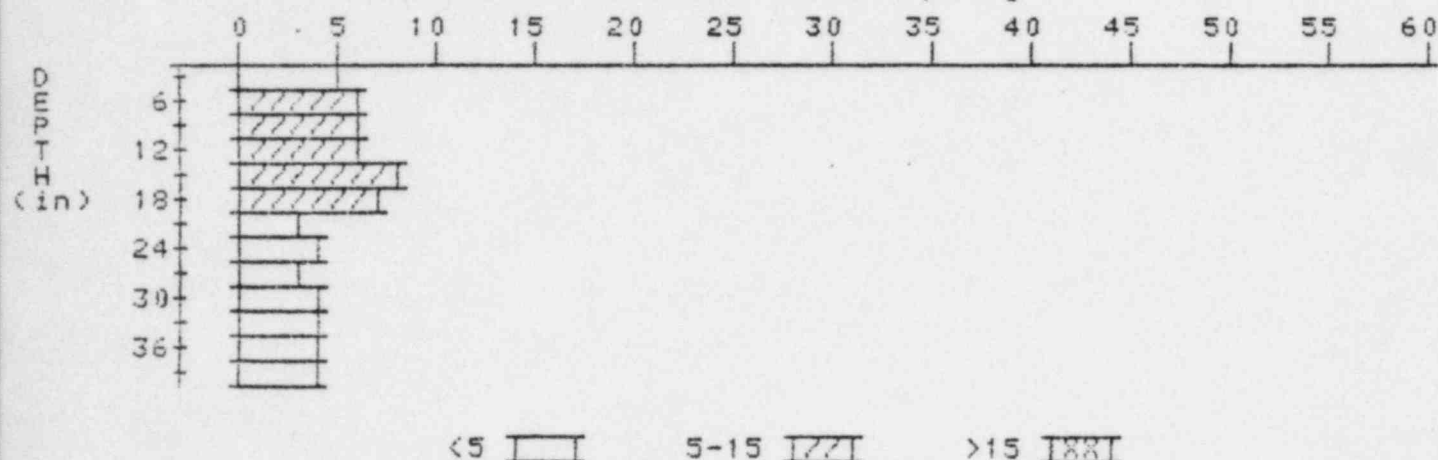
LOCATION: 201262

Depth (in)	Apparent Radium-226 (pCi/g) Undeconvolved	Apparent Radium-226 (pCi/g) Deconvolved
3	4.5	4.5
6	5.5	6.4
9	6.0	6.4
12	6.3	6.3
15	6.6	8.4
18	5.9	6.8
21	4.7	3.5
24	4.2	4.0
27	3.8	3.1
30	3.8	4.0
33	3.7	3.5
36	3.7	3.9
39	3.6	3.6

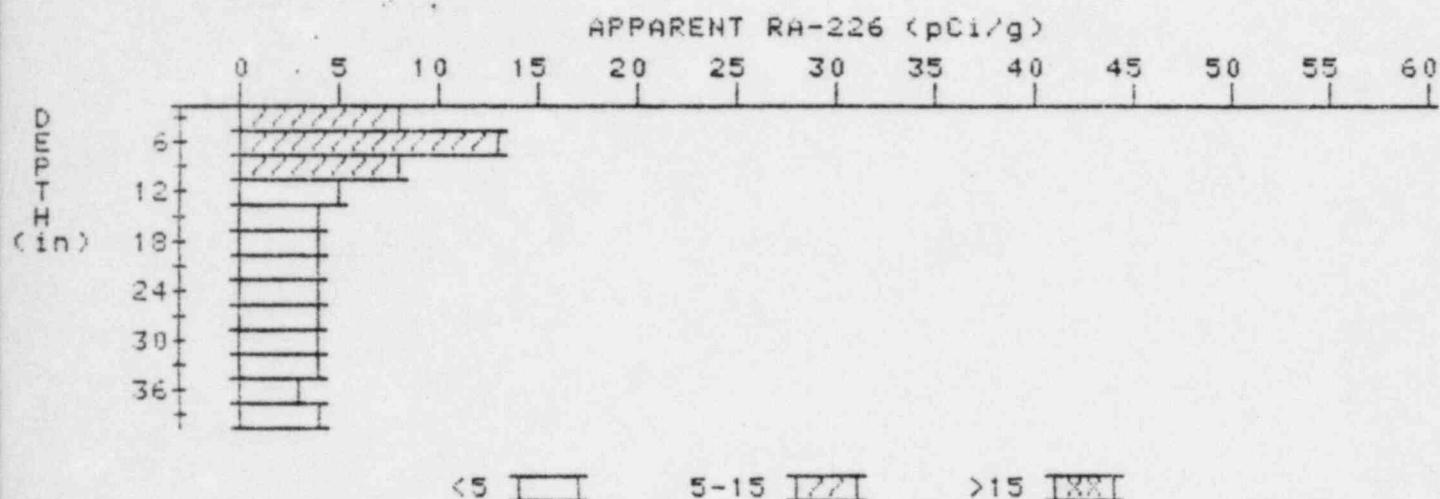
PROPERTY NUMBER: GJ-06194-CS  
HOLE NUMBER: 11  
LOCATION: 216275

Depth (in)	Apparent Radium-226 (pCi/g) Undeconvolved	Apparent Radium-226 (pCi/g) Deconvolved
3	7.9	7.9
6	9.0	13.3
9	7.7	8.4
12	6.0	4.9
15	4.9	4.0
18	4.3	3.6
21	4.1	4.1
24	3.9	3.7
27	3.8	3.6
30	3.8	3.8
33	3.8	4.2
36	3.6	3.1
39	3.7	3.7

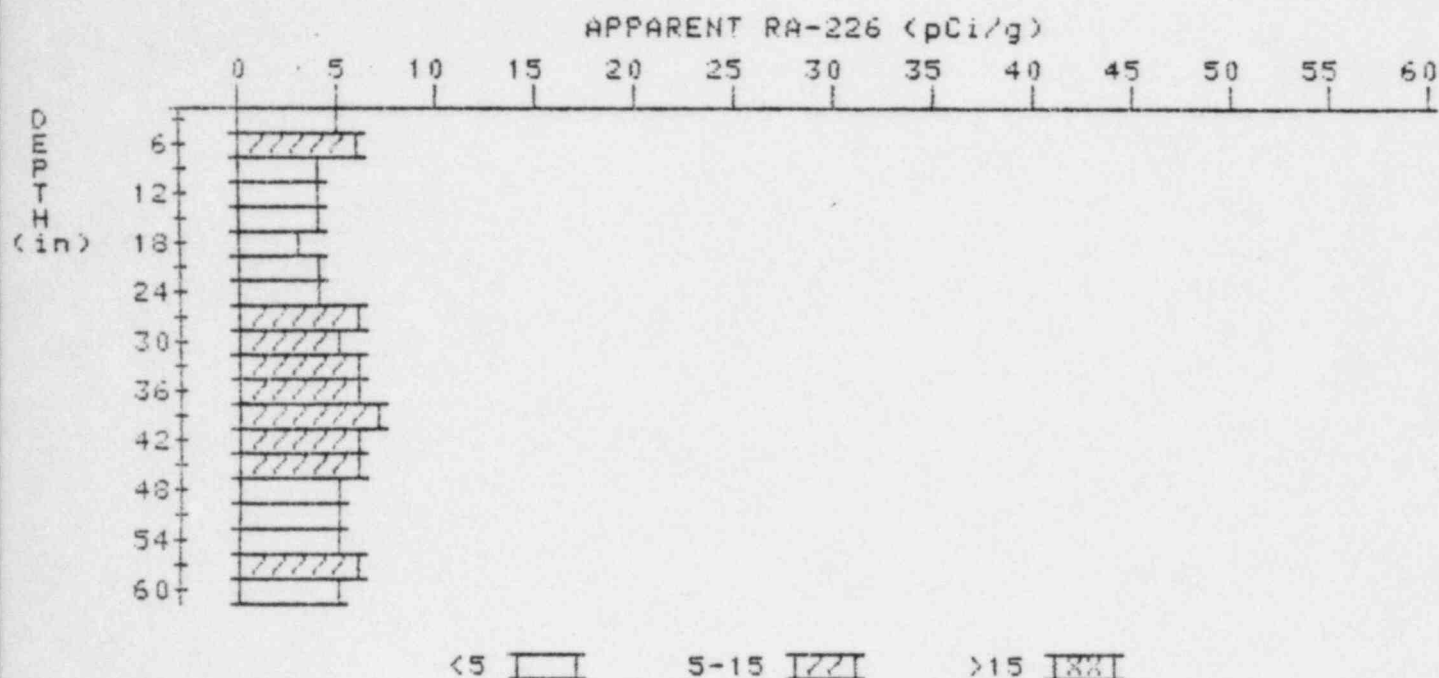
PROPERTY NUMBER: GJ-06194-CS  
HOLE NUMBER: 13  
LOCATION: 220228

1. The foundation information will only be taken if contamination is found. The interior survey showed negative readings, therefore, there will not be a final map in the assessment for the interior.
2. Borehole 13 was questionable and a note at the bottom of the final Radiologic and Engineering Assessment (REA) will read: "The areas underneath the sidewalks should be closely monitored for deeper contamination during remedial action."
3. The south sidewalk appears to be represented by the rest of the sidewalk and the core there would not have been necessary.

Depth (in)	Apparent Radium-226 (pCi/g) Undeconvolved	Apparent Radium-226 (pCi/g) Deconvolved
3	4.6	4.6
6	4.9	6.3
9	4.4	4.0
12	4.1	3.7
15	4.0	4.0
18	3.9	3.2
21	4.2	4.4
24	4.4	3.5
27	5.1	5.8
30	5.4	5.4
33	5.7	5.7
36	6.0	6.2
39	6.2	7.1
42	5.9	5.9
45	5.6	5.8
48	5.2	4.8
51	5.0	4.8
54	4.9	4.5
