RADIOLOGIC AND ENGINEERING ASSESSMENT

DOE ID NO.: GJ-00069-RS
ADDRESS: 1733 NORTH 17TH STREET

JUNE 1985

BENDIX FIELD ENGINEERING CORPORATION
P.O. Box 1569
Grand Junction, Colorado 81502

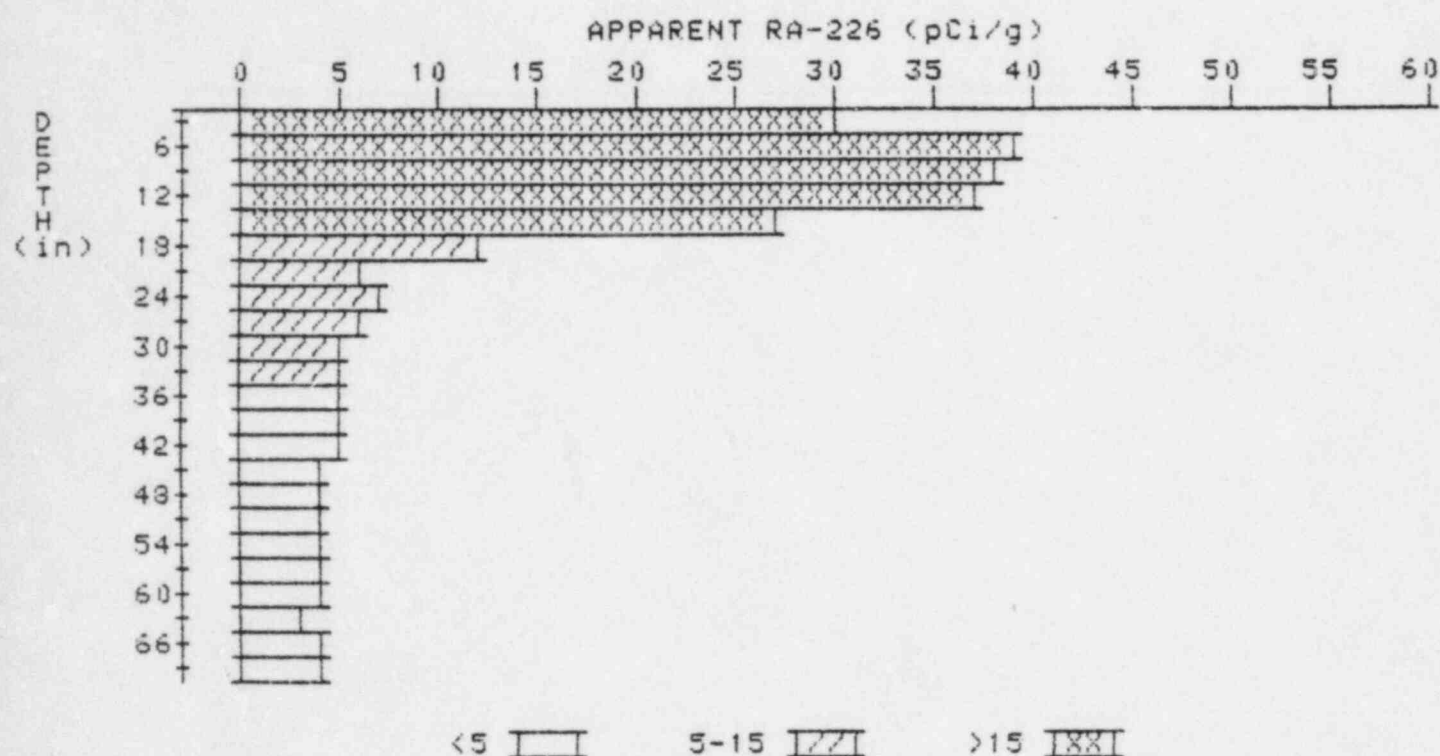
HOLE NUMBER: 4

LOCATION: 145225

Depth (in)	Apparent Radium-226 (pCi/g) Undeconvolved	Apparent Radium-226 (pCi/g) Deconvolved
3	30.0	30.0
6	33.2	38.7
9	33.3	38.5
12	30.5	36.5
15	24.3	27.0
18	16.6	12.3
21	11.3	6.5
24	8.7	6.7
27	7.2	6.5
30	6.1	5.2
33	5.5	5.3
36	5.0	4.6
39	4.7	4.5
42	4.5	4.5
45	4.3	4.3

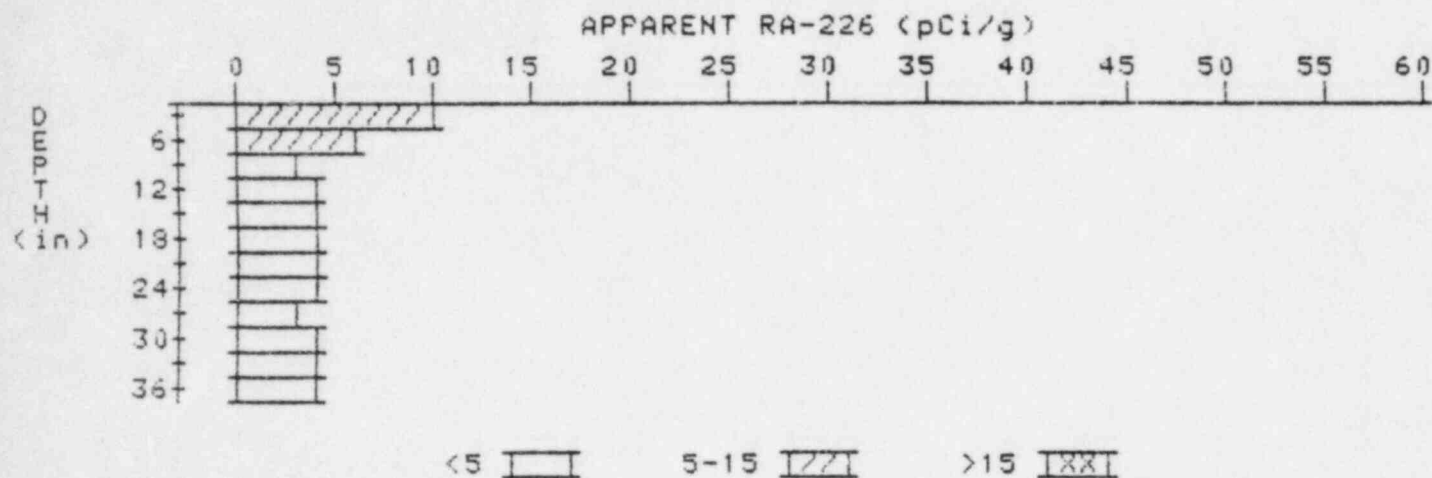
HOLE NUMBER: 8

LOCATION: 162243

Depth (in)	Apparent Radium-226 (pCi/g) Undeconvolved	Apparent Radium-226 (pCi/g) Deconvolved
3	10.2	10.2
6	7.3	5.7
9	5.3	3.2
12	4.5	3.8
15	4.1	3.6
18	4.0	4.0
21	3.9	3.9
24	3.8	3.8
27	3.7	3.3
30	3.8	4.0
33	3.8	4.0
36	3.7	3.7

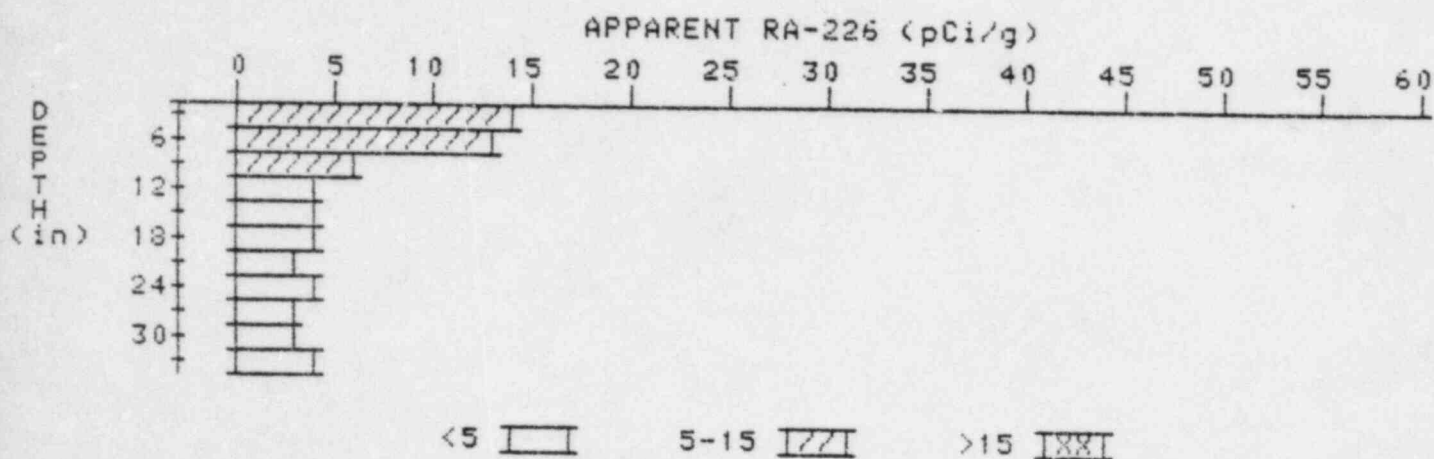
PROPERTY NUMBER: GJ-00069-RS
 HOLE NUMBER: 18
 LOCATION: 198236

Depth (in)	Apparent Radium-226 (pCi/g) Undeconvolved	Apparent Radium-226 (pCi/g) Deconvolved
3	14.3	14.3
6	11.6	13.2
9	8.0	5.7
12	5.7	3.6
15	4.6	3.5
18	4.1	3.7
21	3.8	3.4
24	3.7	3.7
27	3.6	3.4
30	3.6	3.4
33	3.7	3.7

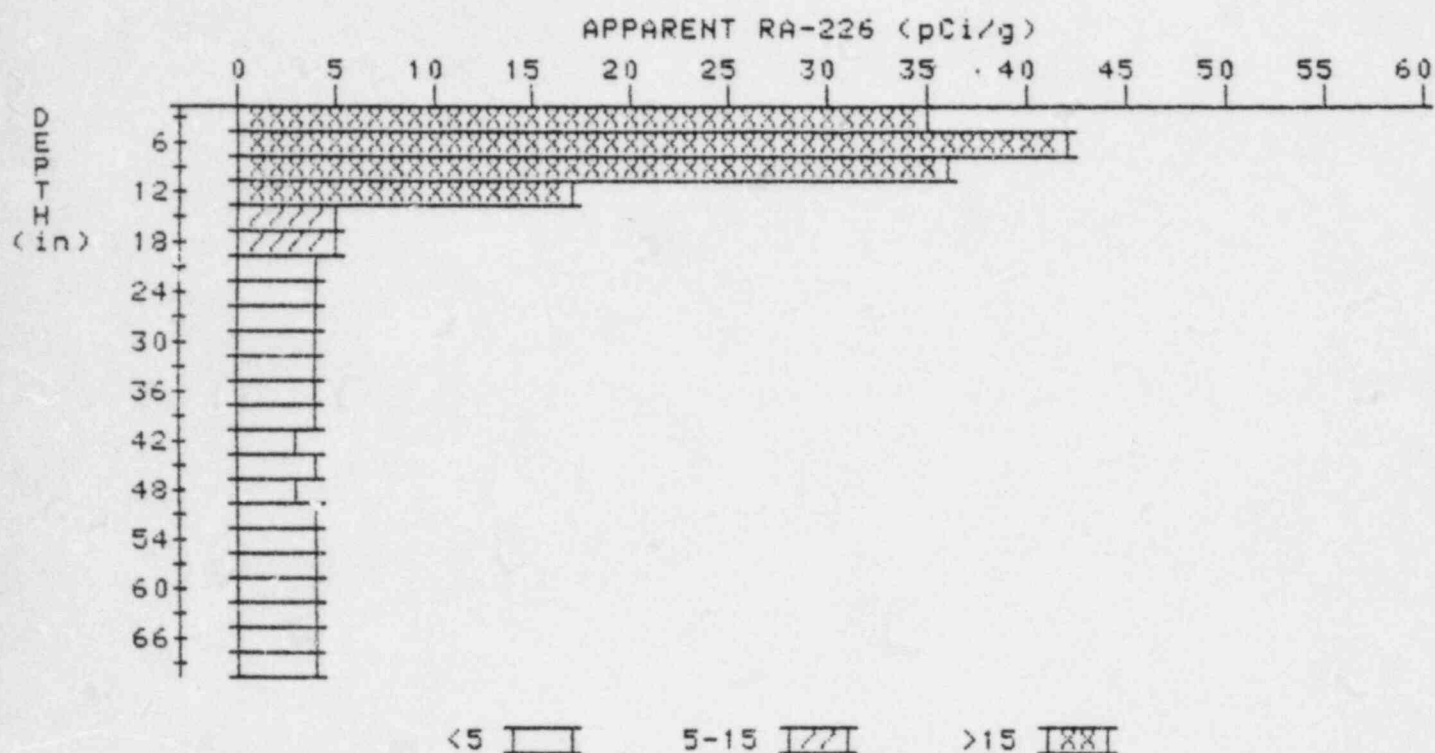
HOLE NUMBER: 22

LOCATION: 211219

Depth (in)	Apparent Radium-226 (pCi/g) Undeconvolved	Apparent Radium-226 (pCi/g) Deconvolved
3	35.4	35.4
6	34.4	41.9
9	29.2	36.5
12	19.9	17.1
15	12.2	5.4
18	3.3	5.1
21	6.2	4.4
24	5.1	4.0
27	4.6	4.2
30	4.3	4.3
33	4.0	3.6
36	3.9	4.1
39	3.7	3.5
42	3.6	3.2
45	3.7	4.1

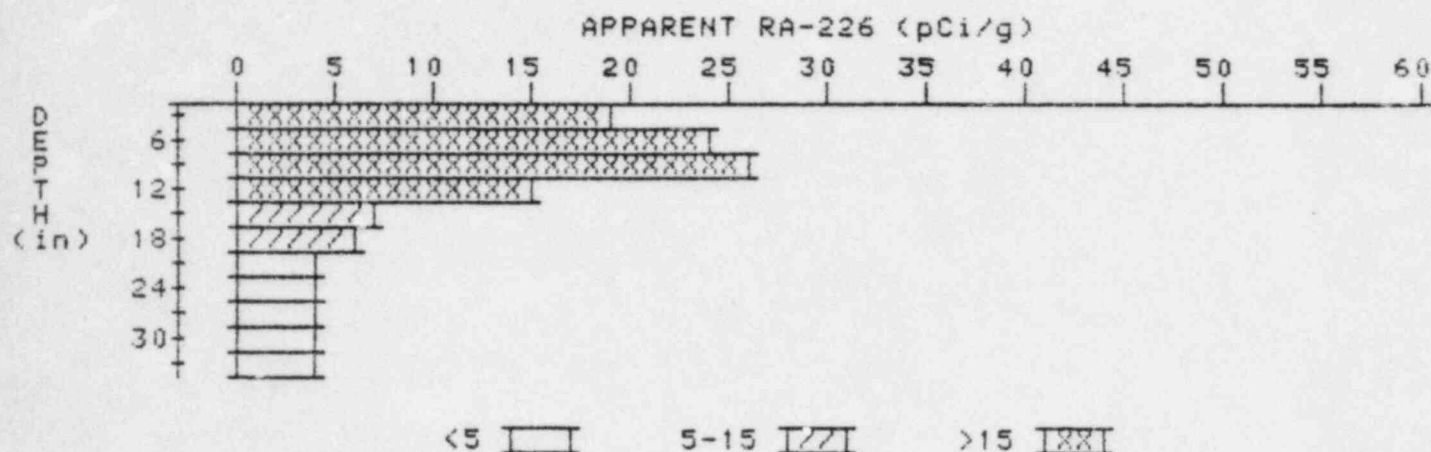
PROPERTY NUMBER: GJ-00069-RS
HOLE NUMBER: 23
LOCATION: 220253

Depth (in)	Apparent Radium-226 (pCi/g) Undeconvolved	Apparent Radium-226 (pCi/g) Deconvolved
3	18.7	18.7
6	20.2	24.5
9	19.3	25.5
12	14.9	15.1
15	10.4	7.4
18	7.6	5.6
21	5.9	4.5
24	5.0	4.3
27	4.5	4.0
30	4.3	4.1
33	4.2	4.2

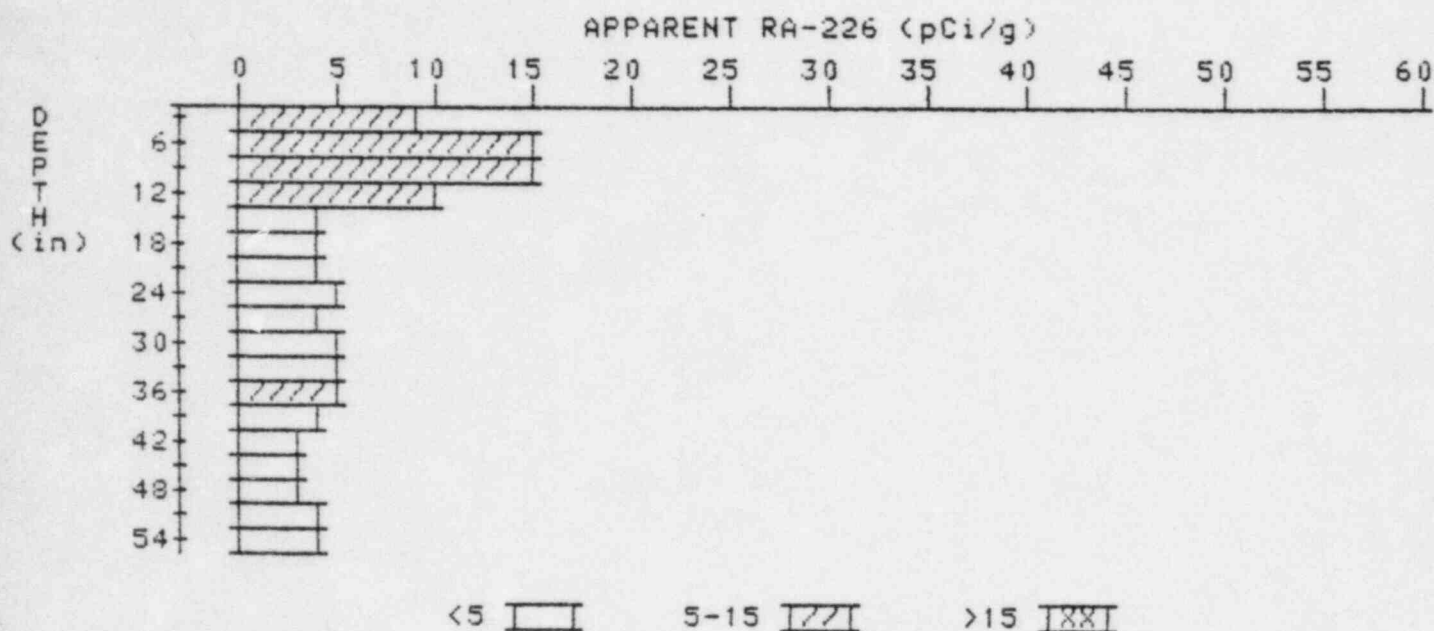
PROPERTY NUMBER: GJ-00069-RS
HOLE NUMBER: 24
LOCATION: 226243

1. Depth of contamination at auger hole at 226243 (previously #16) was changed to 15 inches.
2. A borehole in the driveway was not possible. Mr. Kappel said he dug this area out about 20 inches and filled it in with river gravel. He did not want the large rocks brought up to the surface. You might correct team leader notes to indicate 20 inches removed instead of 12.
3. A delta reading was taken under the garage foundation on the west end. There was no contamination. The south half is inaccessible. The owner believes the garage was built when the house was (about 40 years ago).

Depth (in)	Apparent Radium-226 (pCi/g) Undeconvolved	Apparent Radium-226 (pCi/g) Deconvolved
3	9.3	9.3
6	11.2	14.8
9	11.1	14.7
12	9.0	9.7
15	6.5	4.4
18	5.2	4.0
21	4.6	3.7
24	4.5	4.5
27	4.4	4.0
30	4.5	4.7
33	4.5	4.5
36	4.5	5.0
39	4.2	4.4
42	3.8	3.4
45	3.6	3.4
48	3.5	3.3
51	3.5	3.5
54	3.5	3.5
