UNITED STATES OF AMERICA
NUCLEAR REGULATORY COMMISSION

BEFORE THE FACT-FINDING TASK FORCE

RE: Davis-Besse Event of June 9, 1985

This report documents the review of data from previous unit trips, the 6/9/85 trip, AFPT testing, and other utility overspeed trips to determine possible causes of the overspeed trips which occurred at Davis-Besse on 6/9/85. Based on this review, this report presents hypothesized causes of the observed overspeed.

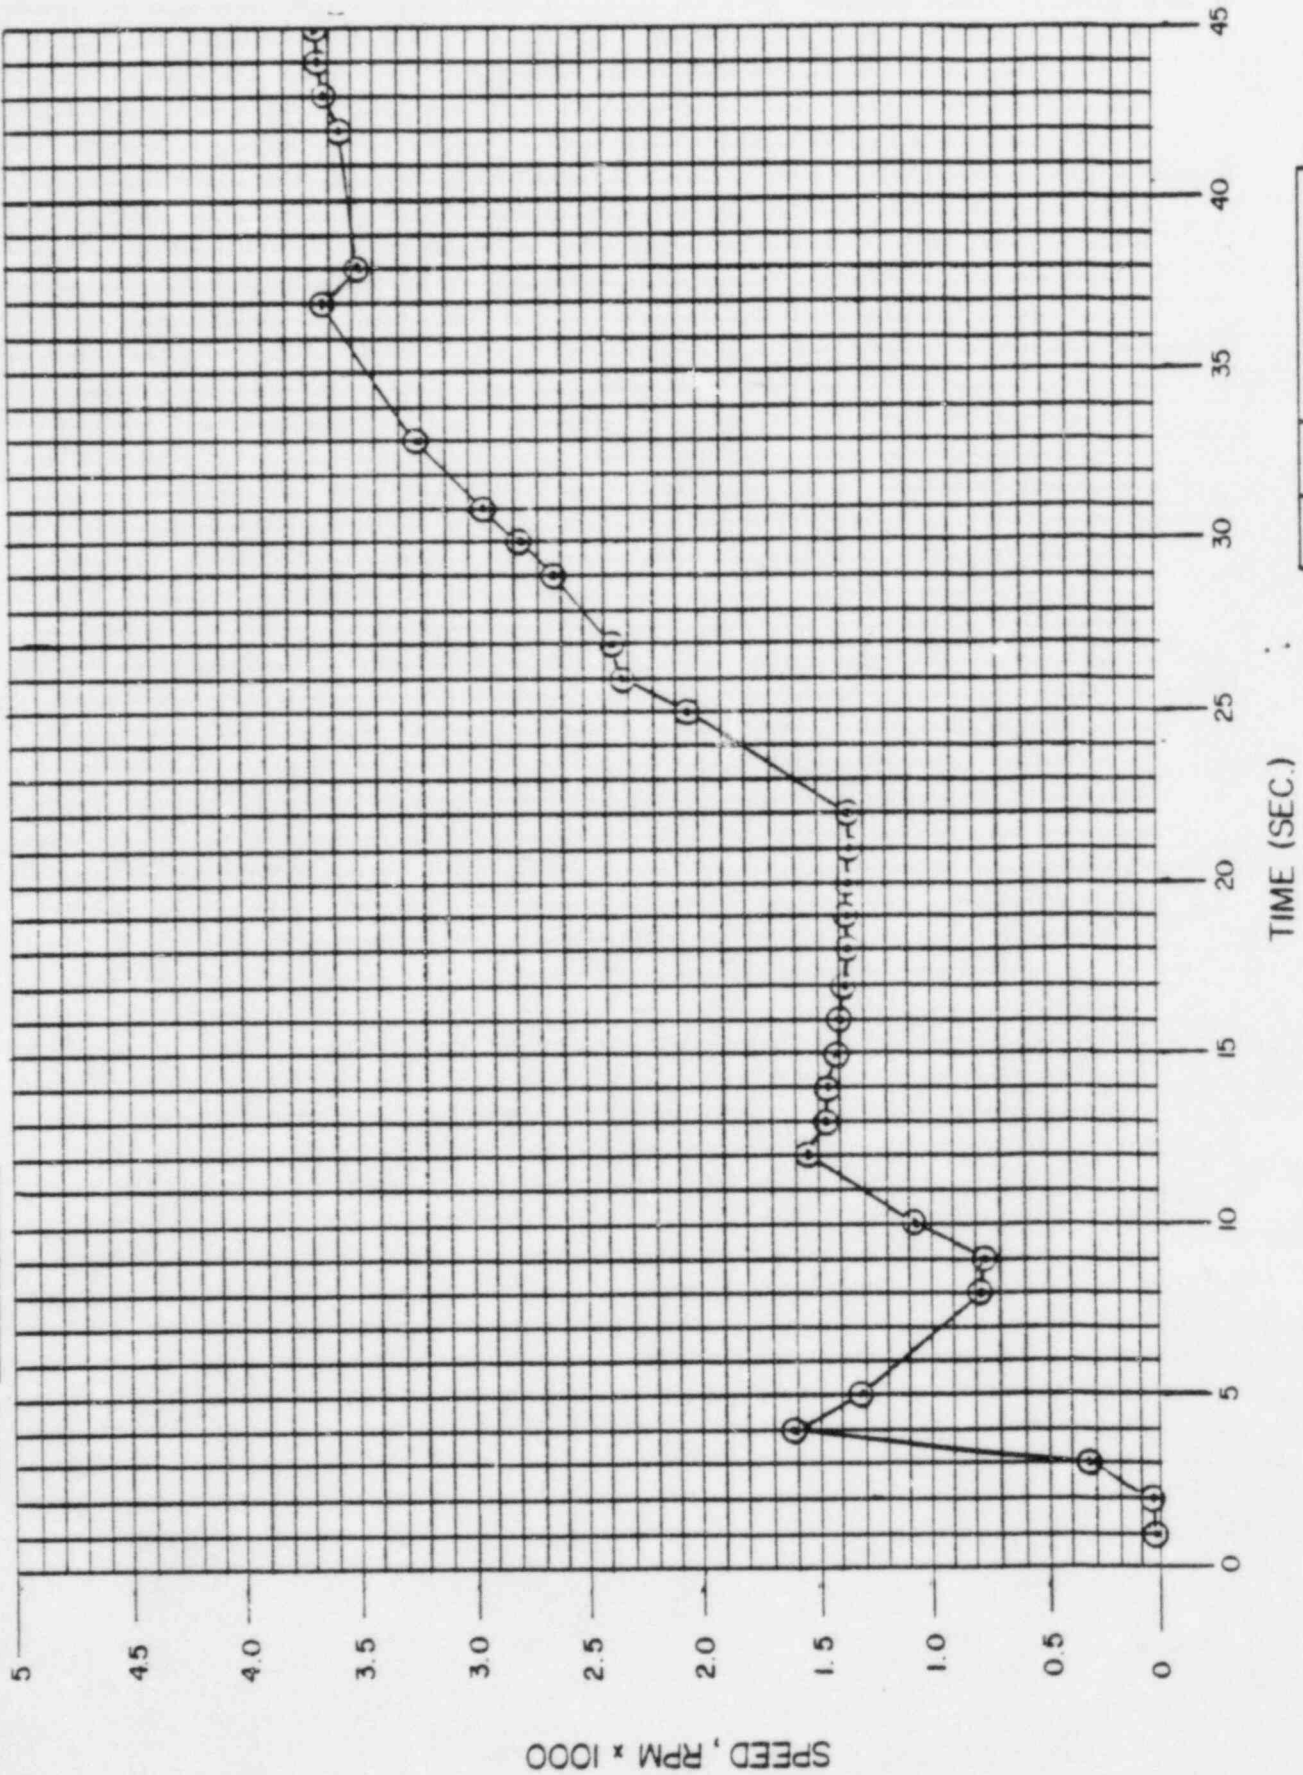
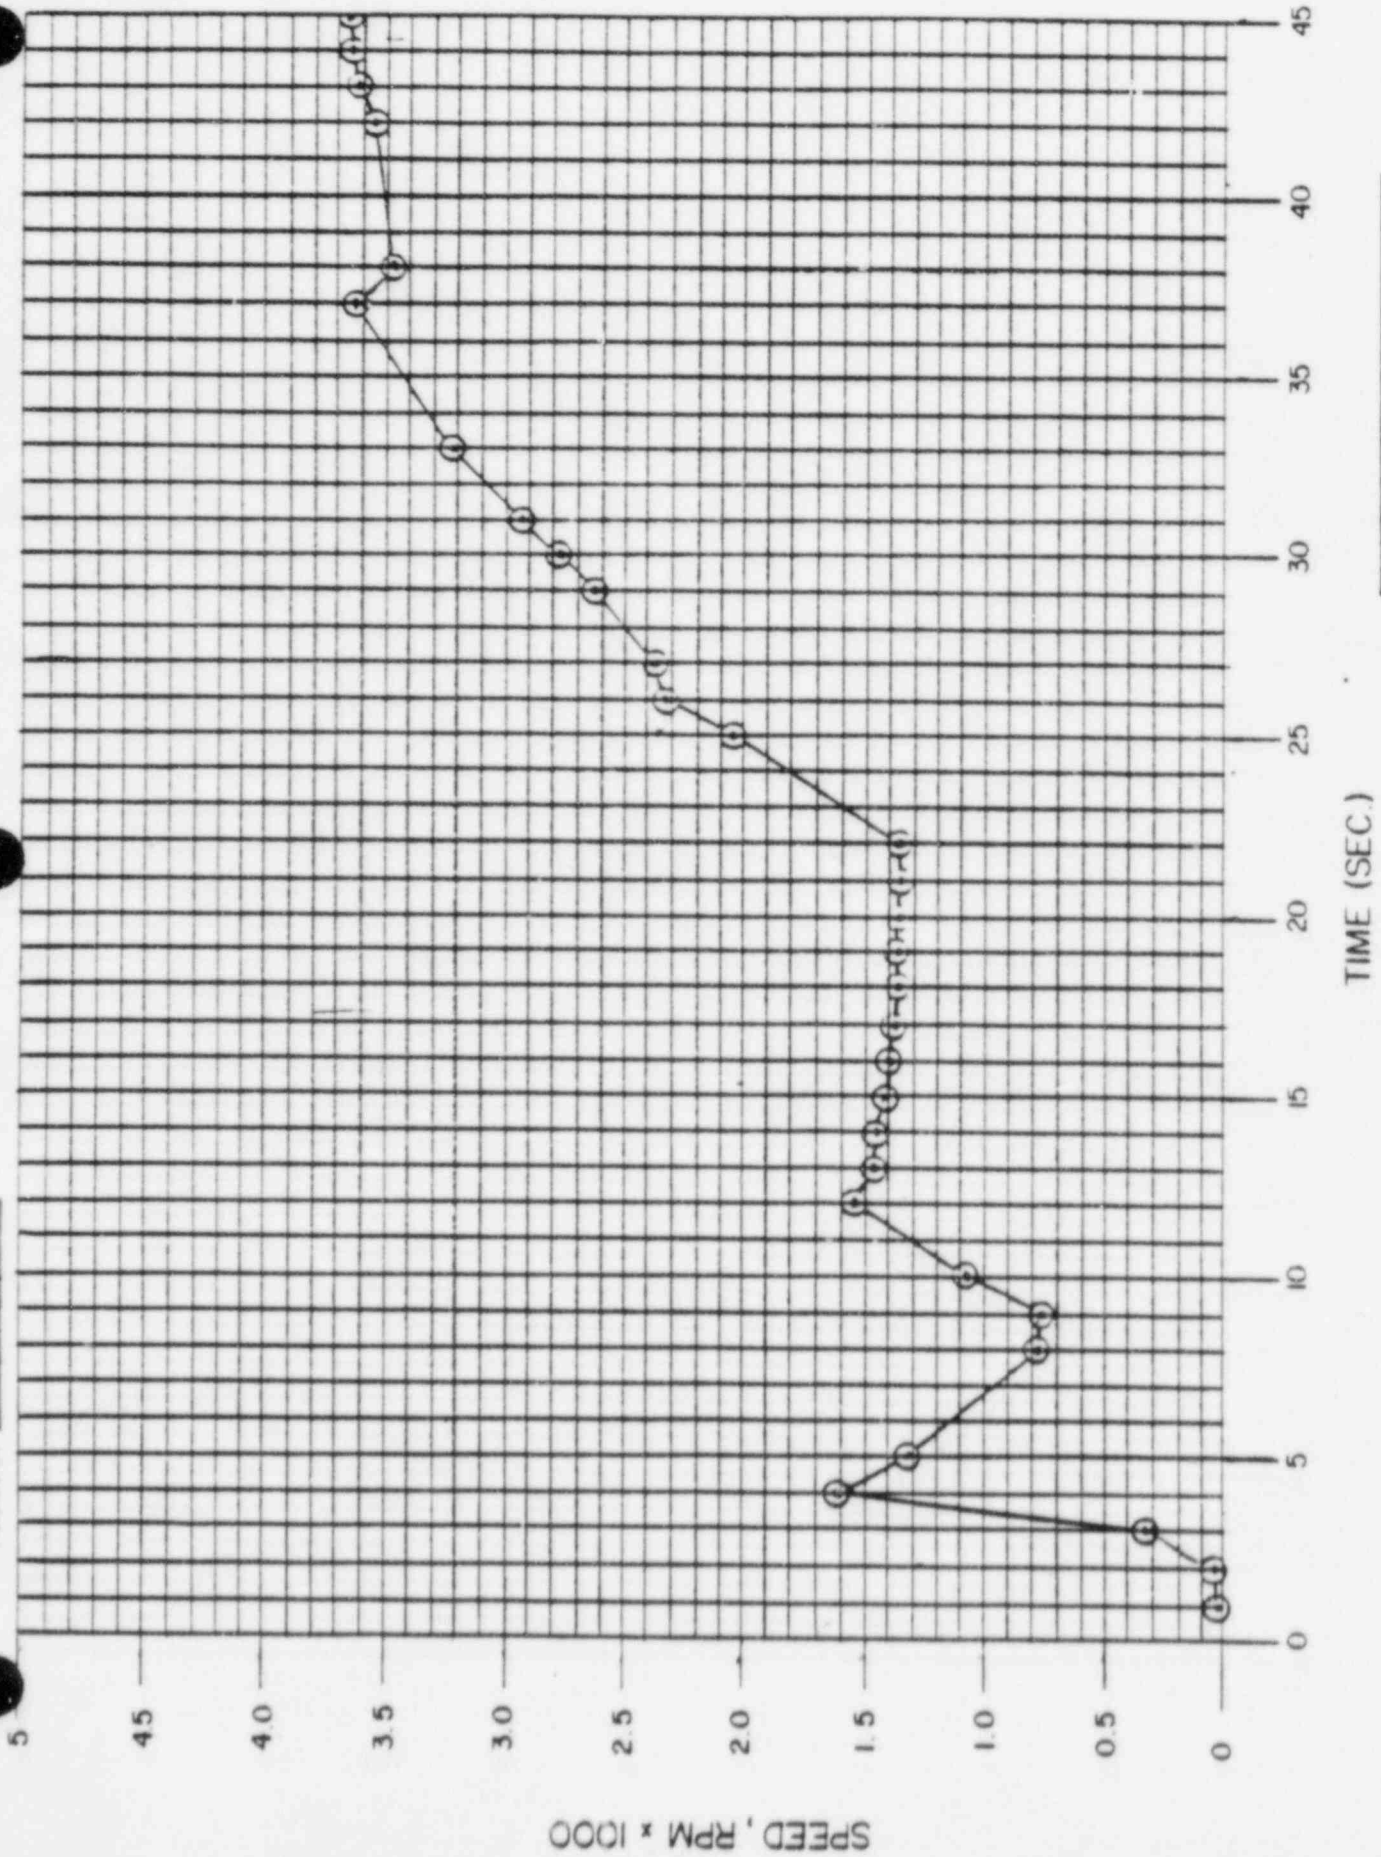
Figure 4

the steam supply valve (MS 107) from SG #2 to AFPT #2 and opened the cross connect valve MS 107A to supply steam to AFPT #2 from SG #1. This switch of steam supply occurred 21 seconds (12:37:55) after both AFPTs had been started via MS 106 and MS 107. A review of the speed vs. time characteristics (see Figures 4 and 5 of Attachment 2), show that AFPT #2 experienced a decrease of approximately 1000 RPM at sixteen (16) seconds after the SFRCS low pressure trip. This speed decrease may be attributed to excessive water being picked up from the MS 107A line and being carried to the turbine.

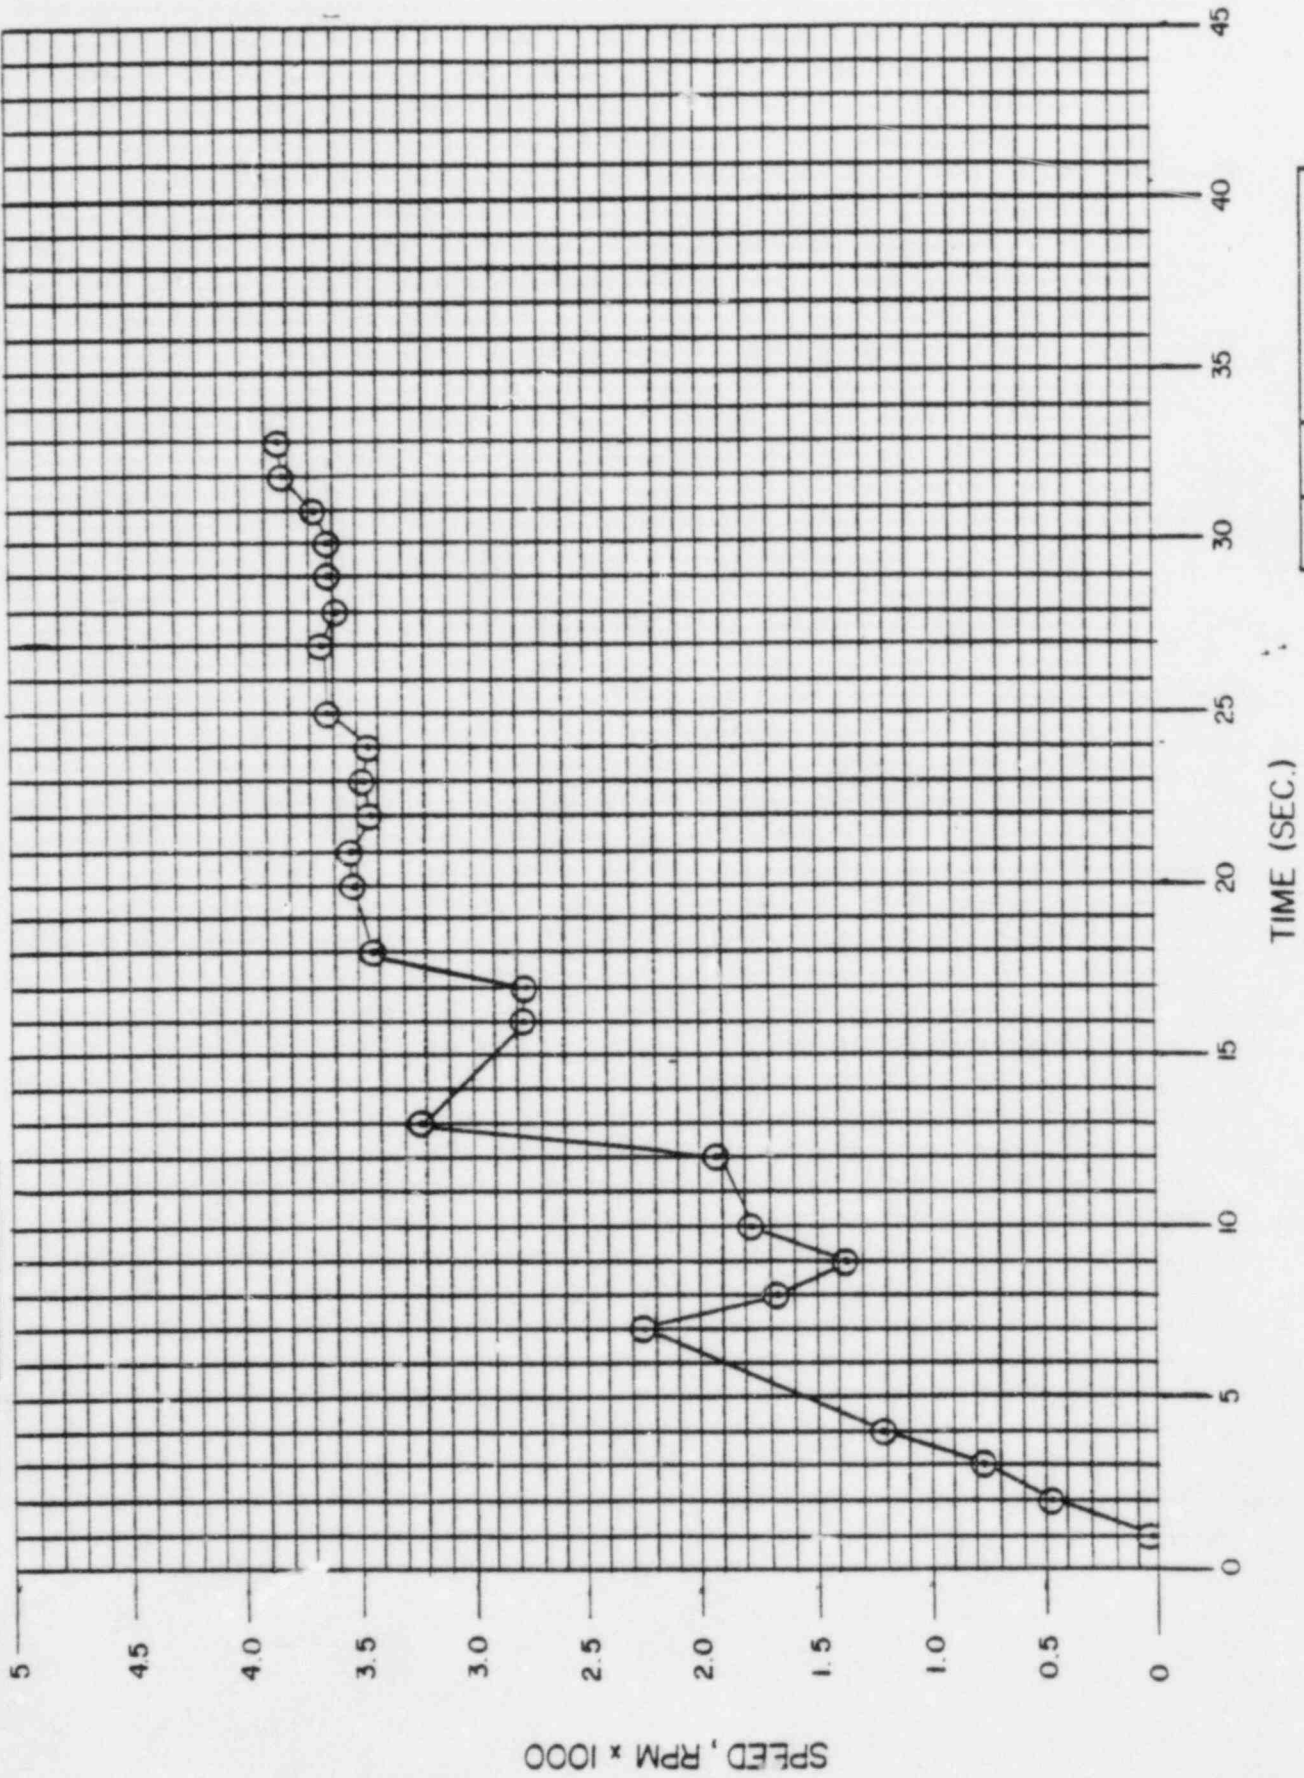
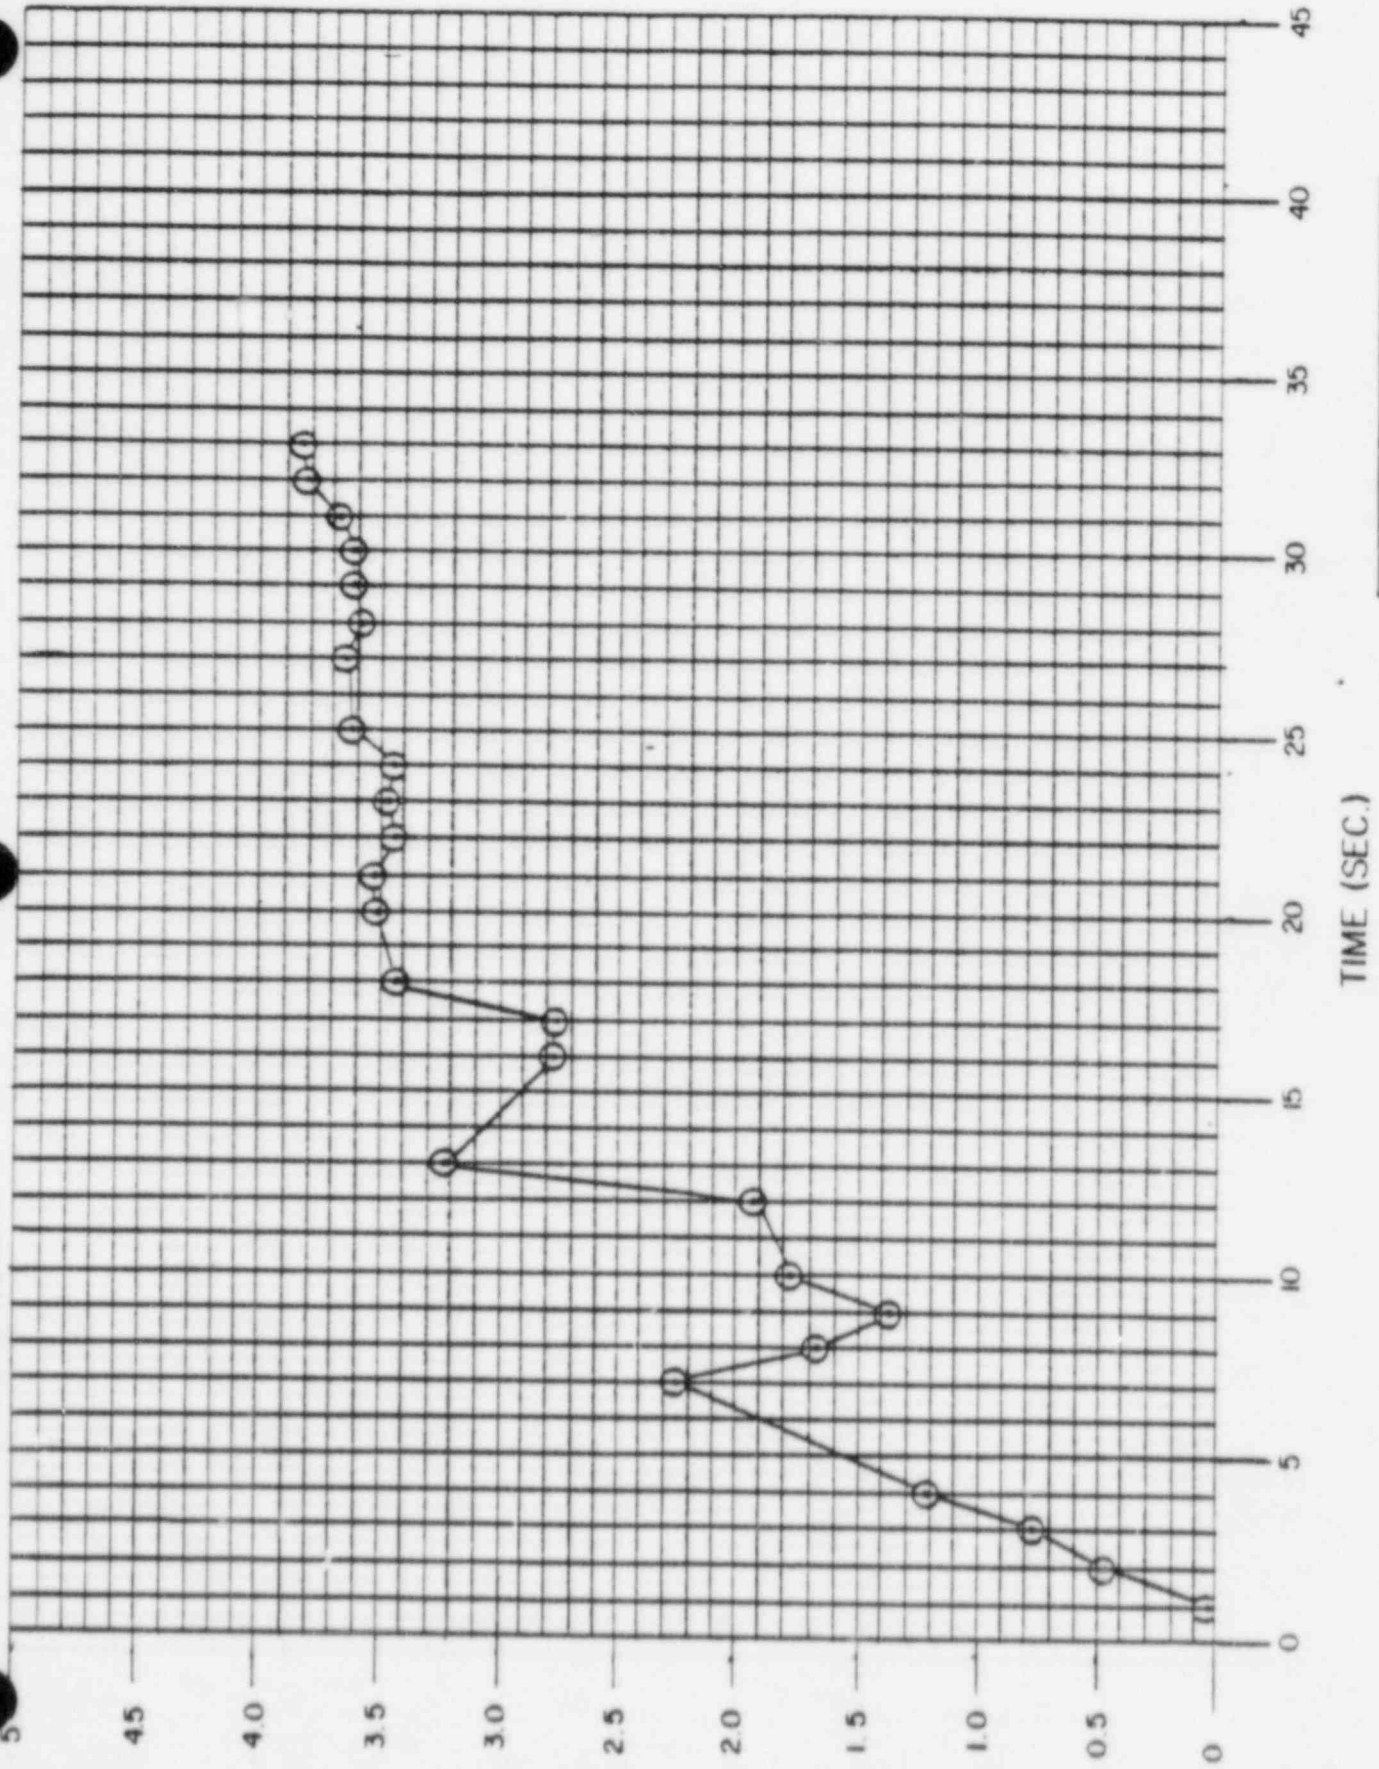
Figure 6

This event initiated a SFRCS trip on low SG level which, due to valve control changes made during the 1984 refueling outage, opened all four steam supply valves to the AFPTs. Also, AFPT #2 had the new PGG governor installed during the 1984 refueling outage. The speed characteristics are shown on Figures 6 and 7 of Attachment 2.

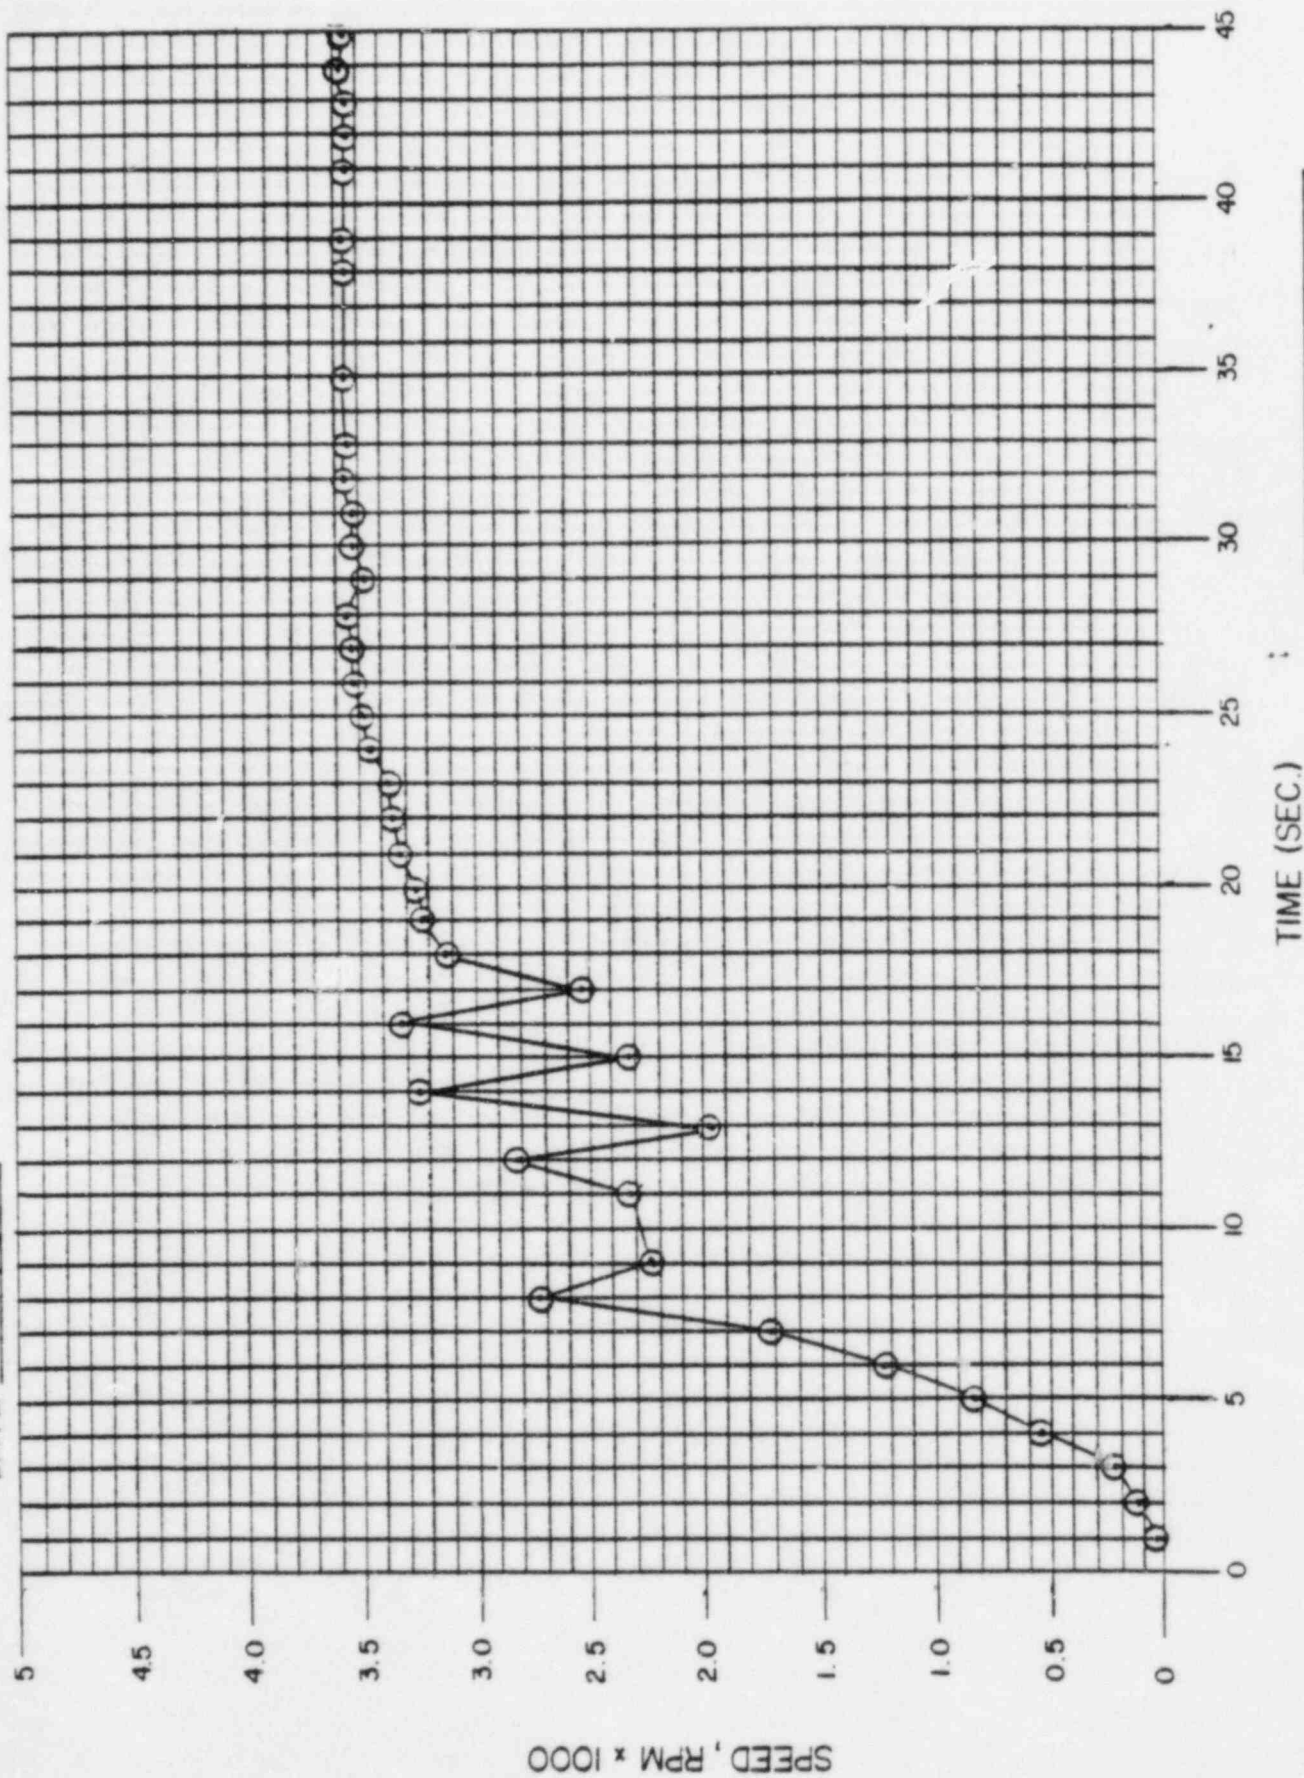
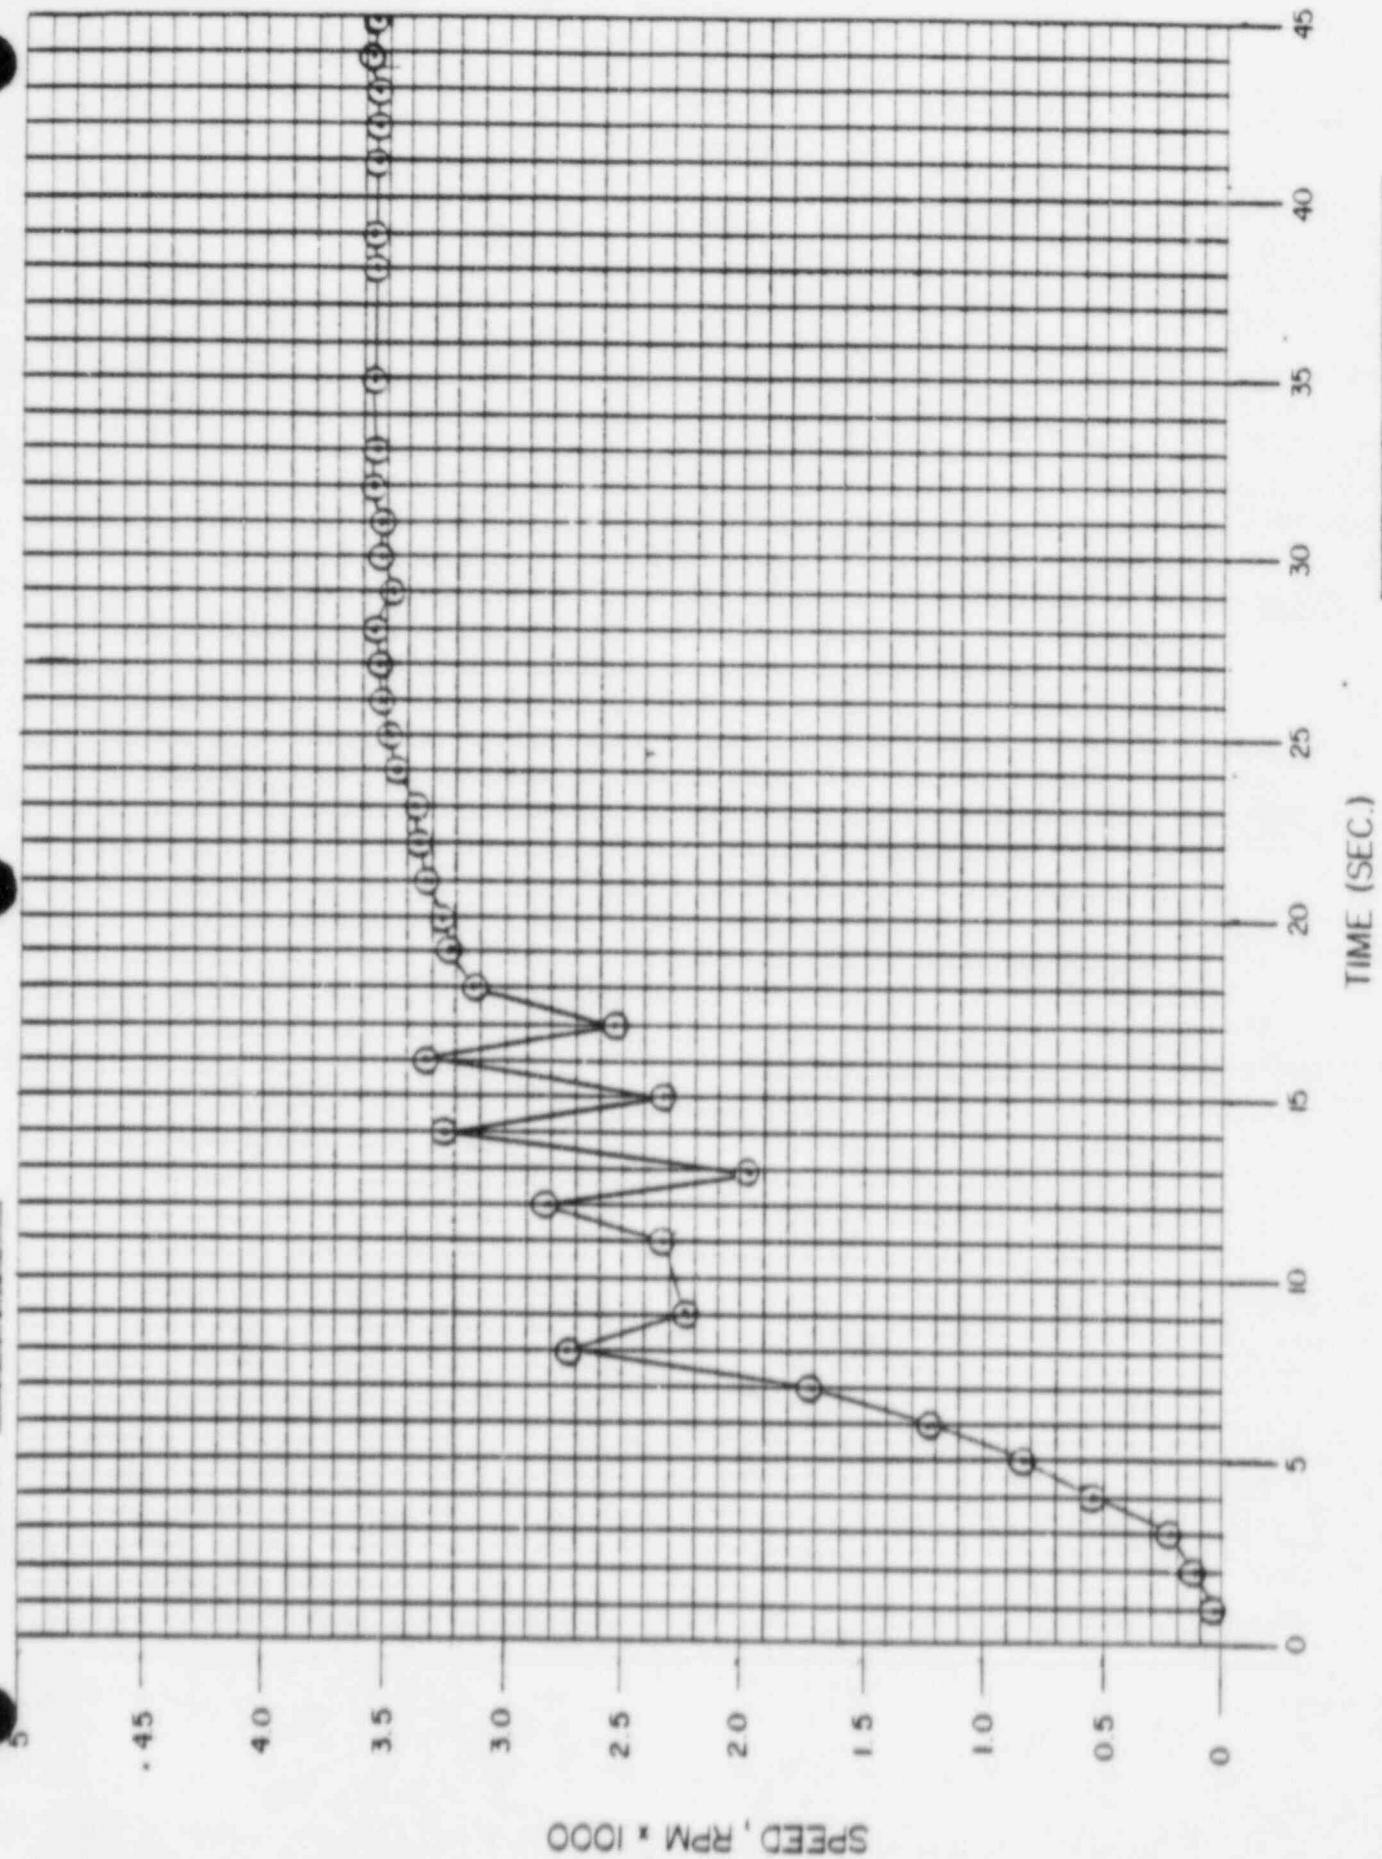
Figure 8

The speed characteristics are shown on Figures 8 and 9 of Attachment 2. A review of the speed characteristics for AFPT #1 show the typical characteristics consistently seen on AFPT #1 (i.e., several oscillations prior to reaching rated speed).

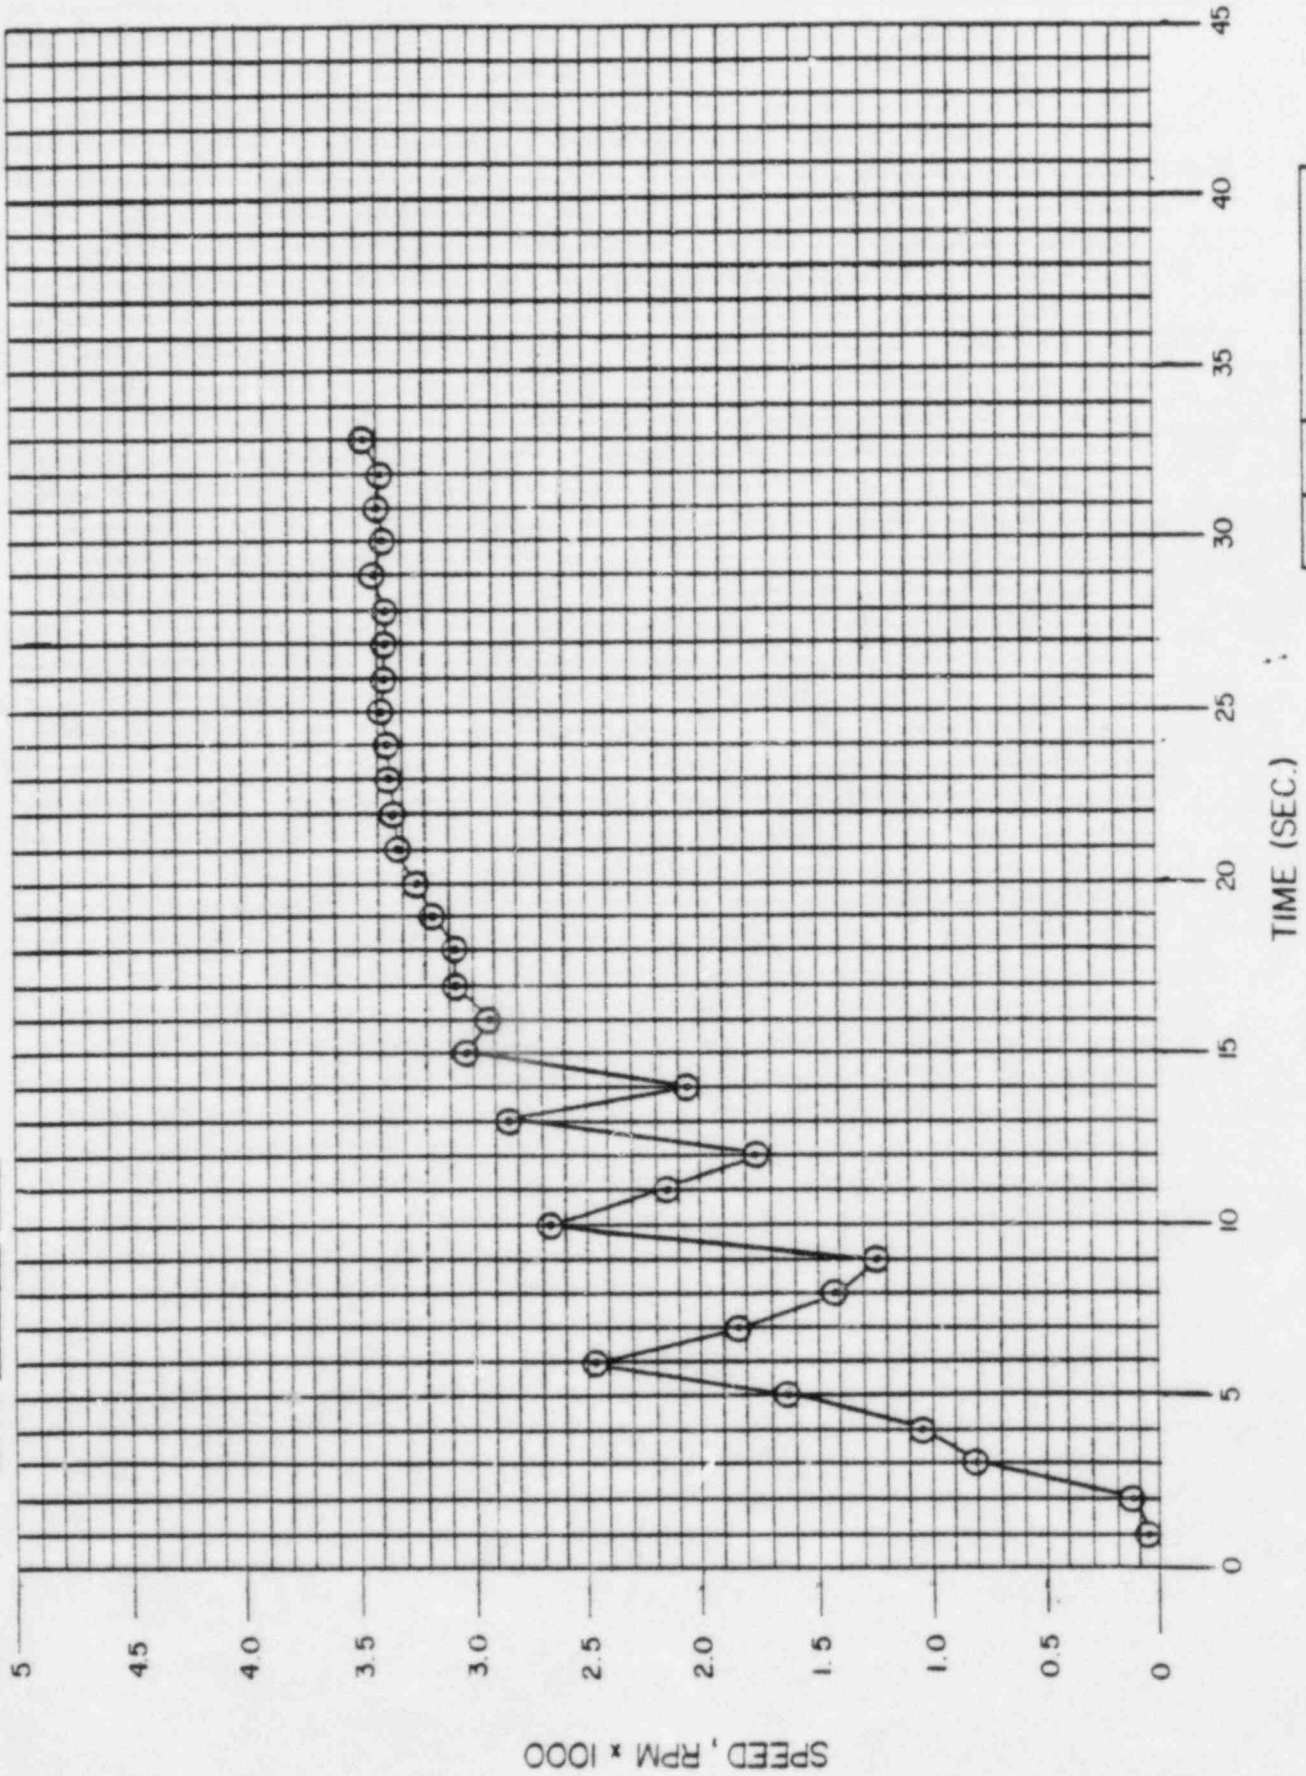
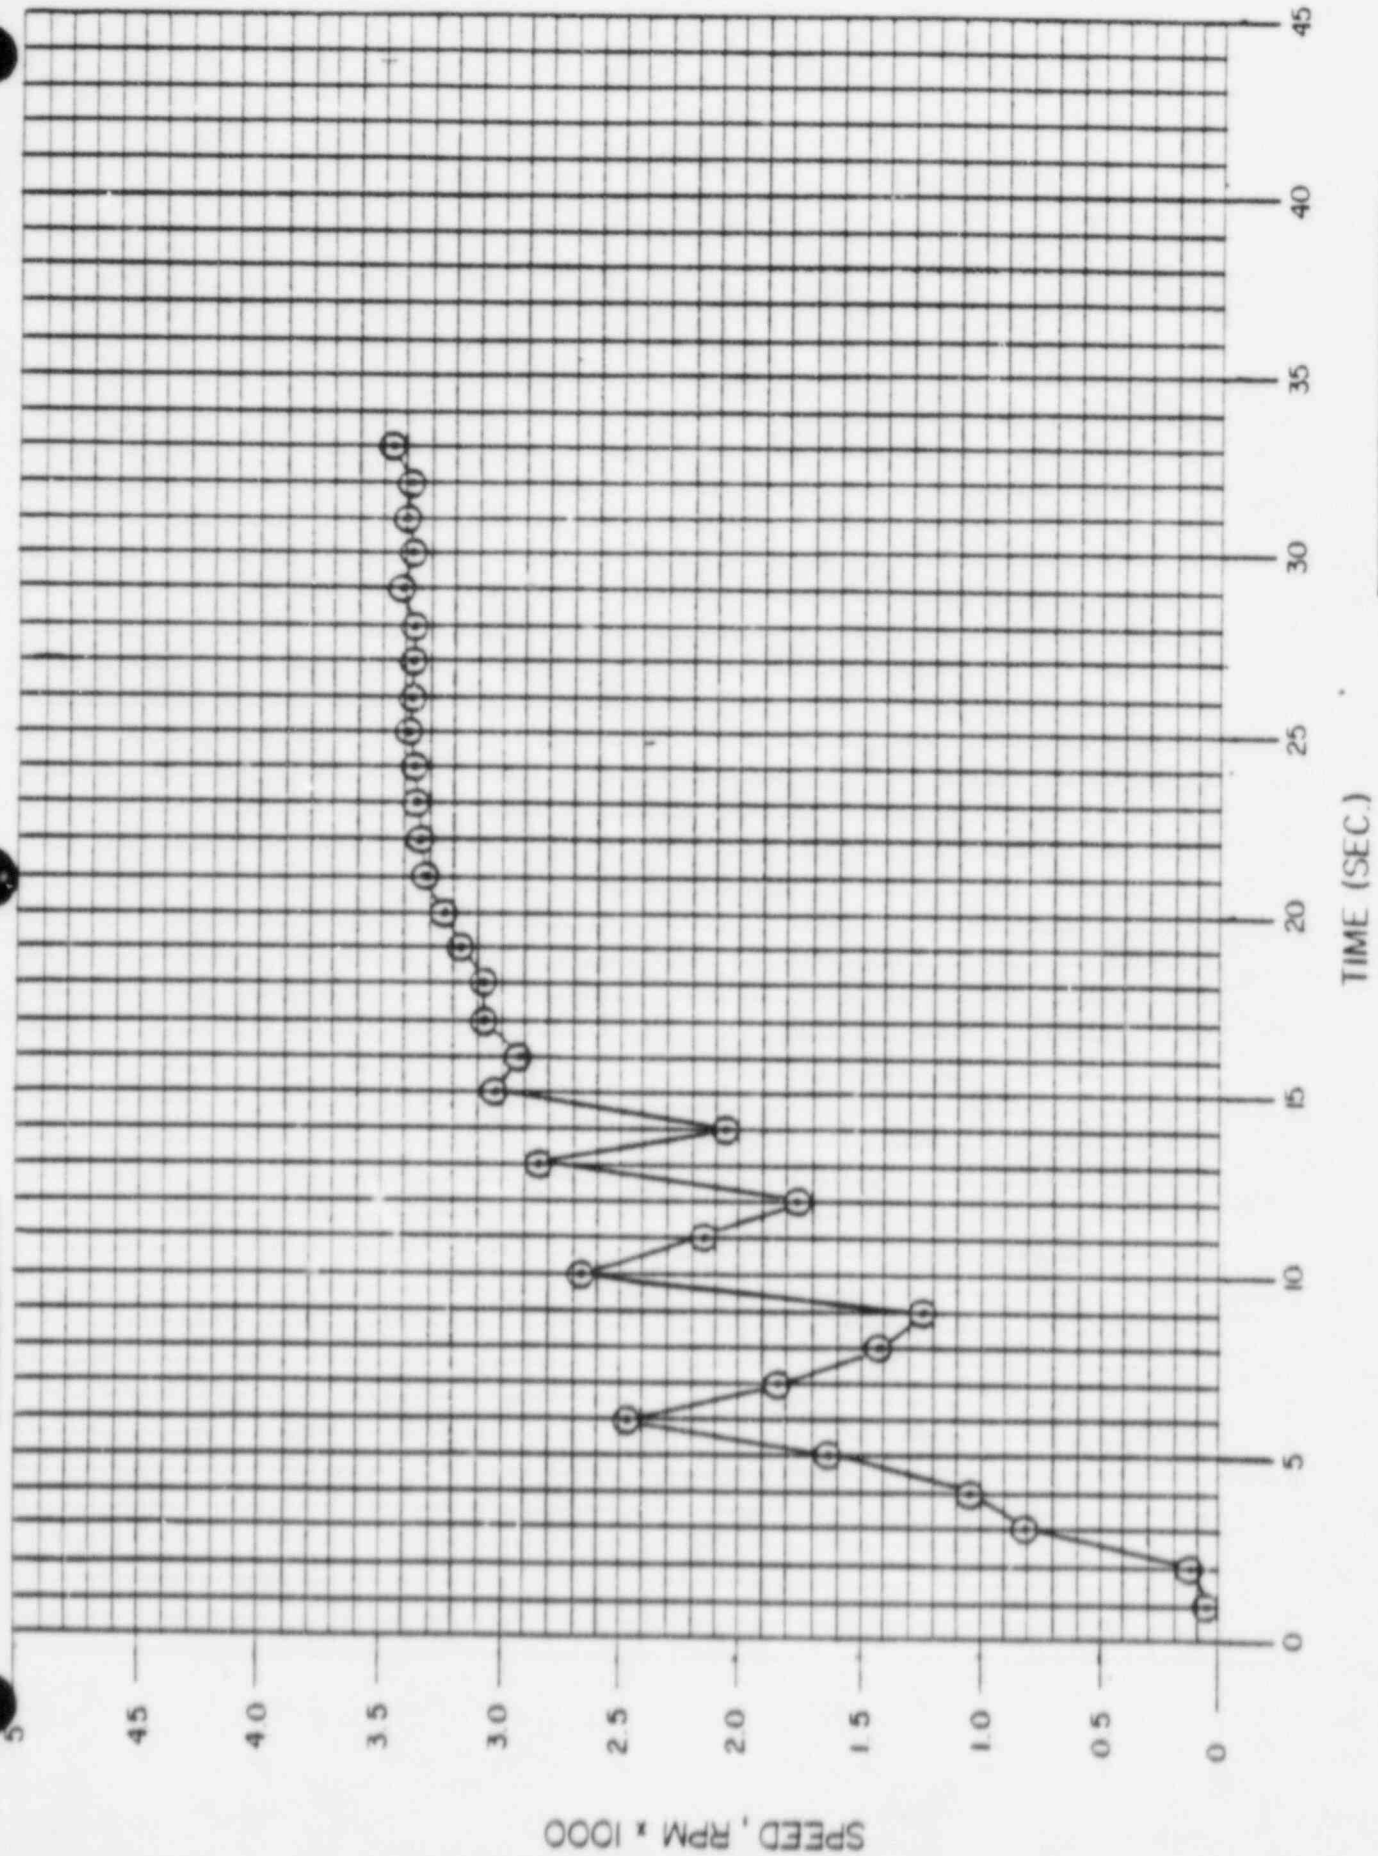
Figure 12

The speed characteristics are shown on Figures 12 and 13 of Attachment 2. A review of the speed characteristics for AFPT #1 shows the typical characteristics consistently seen on AFPT #1 (i.e., several oscillations prior to reaching rated speed).
