UNITED STATES OF AMERICA
NUCLEAR REGULATORY COMMISSION

BEFORE THE FACT-FINDING TASK FORCE

RE: Davis-Besse Event of June 9, 1985

This report documents the review of data from previous unit trips, the 6/9/85 trip, AFPT testing, and other utility overspeed trips to determine possible causes of the overspeed trips which occurred at Davis-Besse on 6/9/85. Based on this review, this report presents hypothesized causes of the observed overspeed.

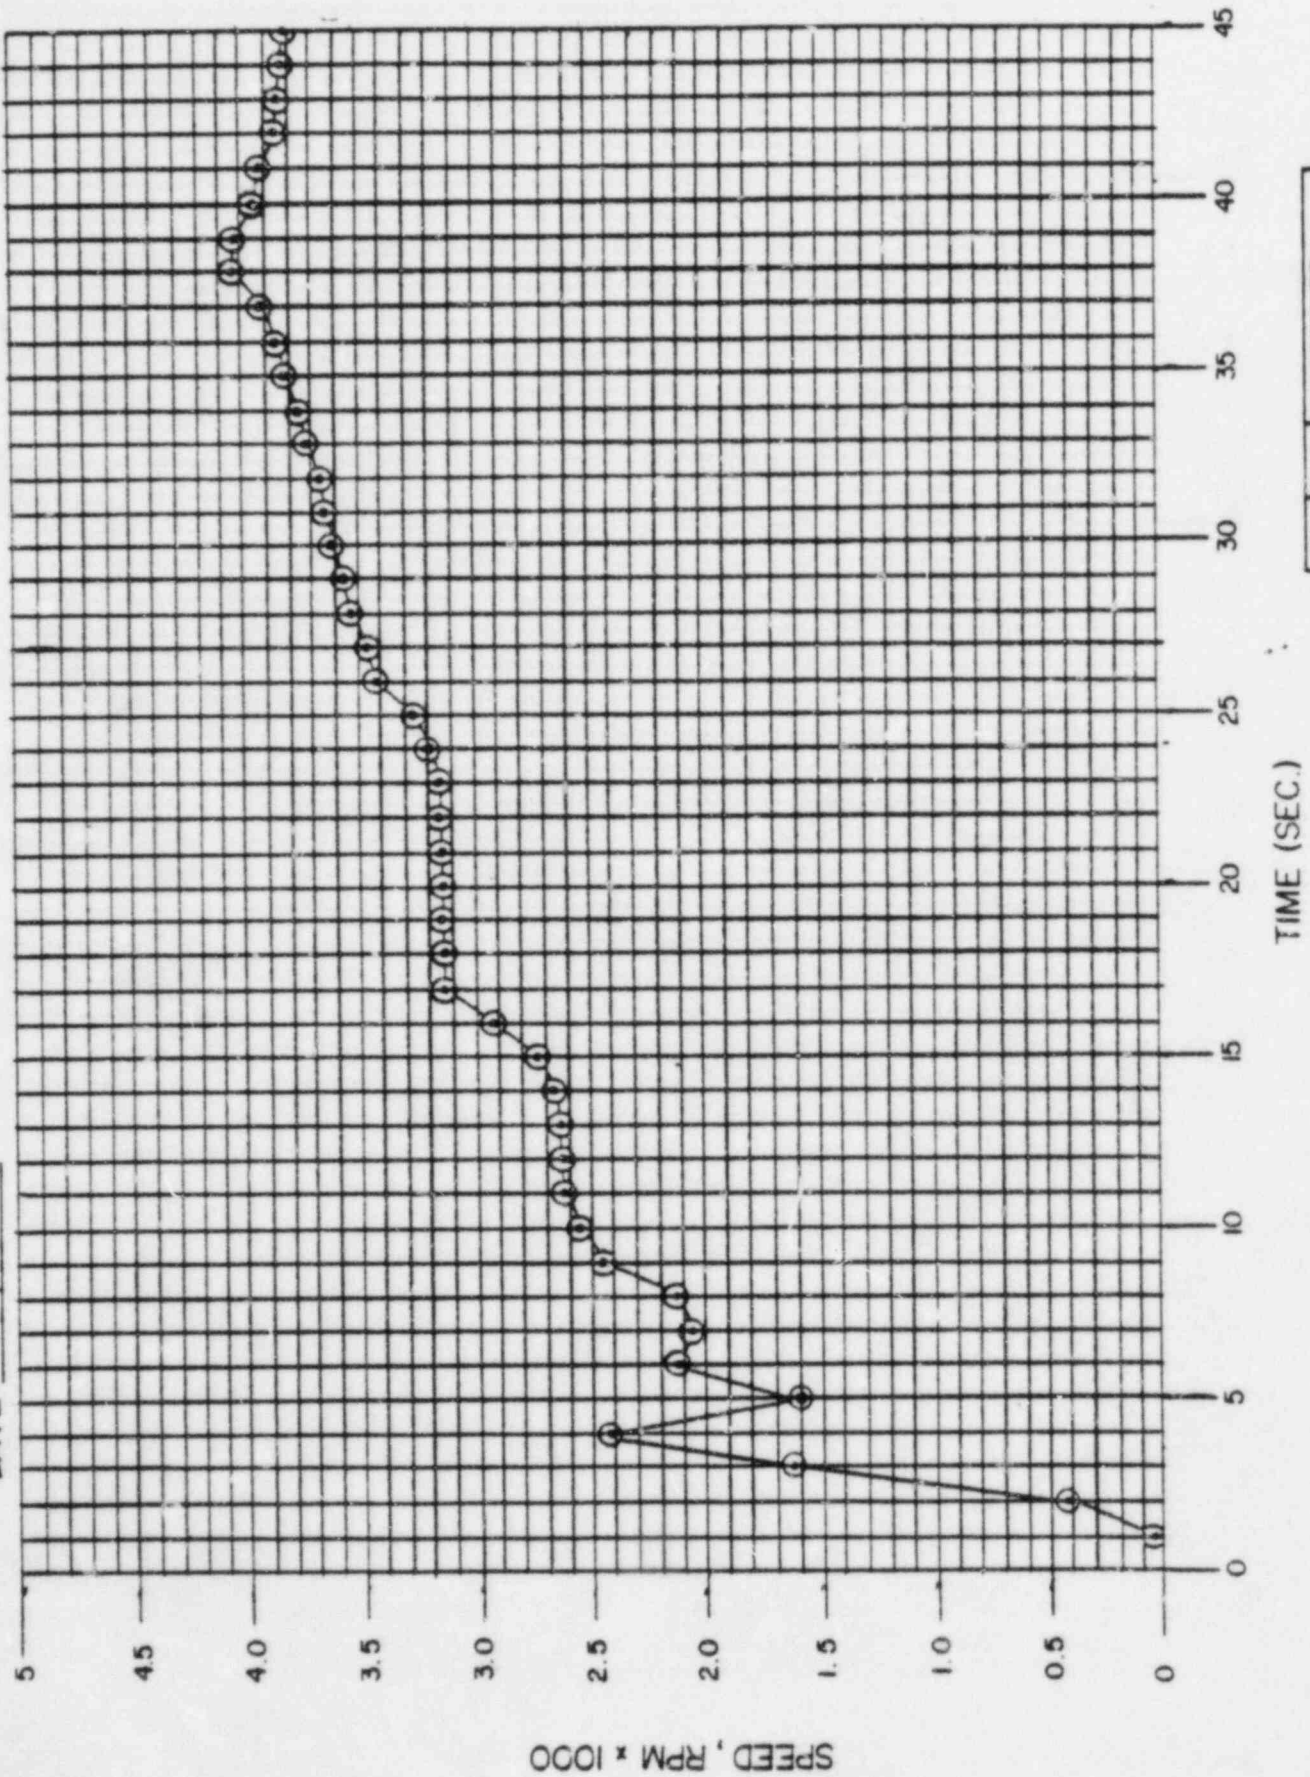
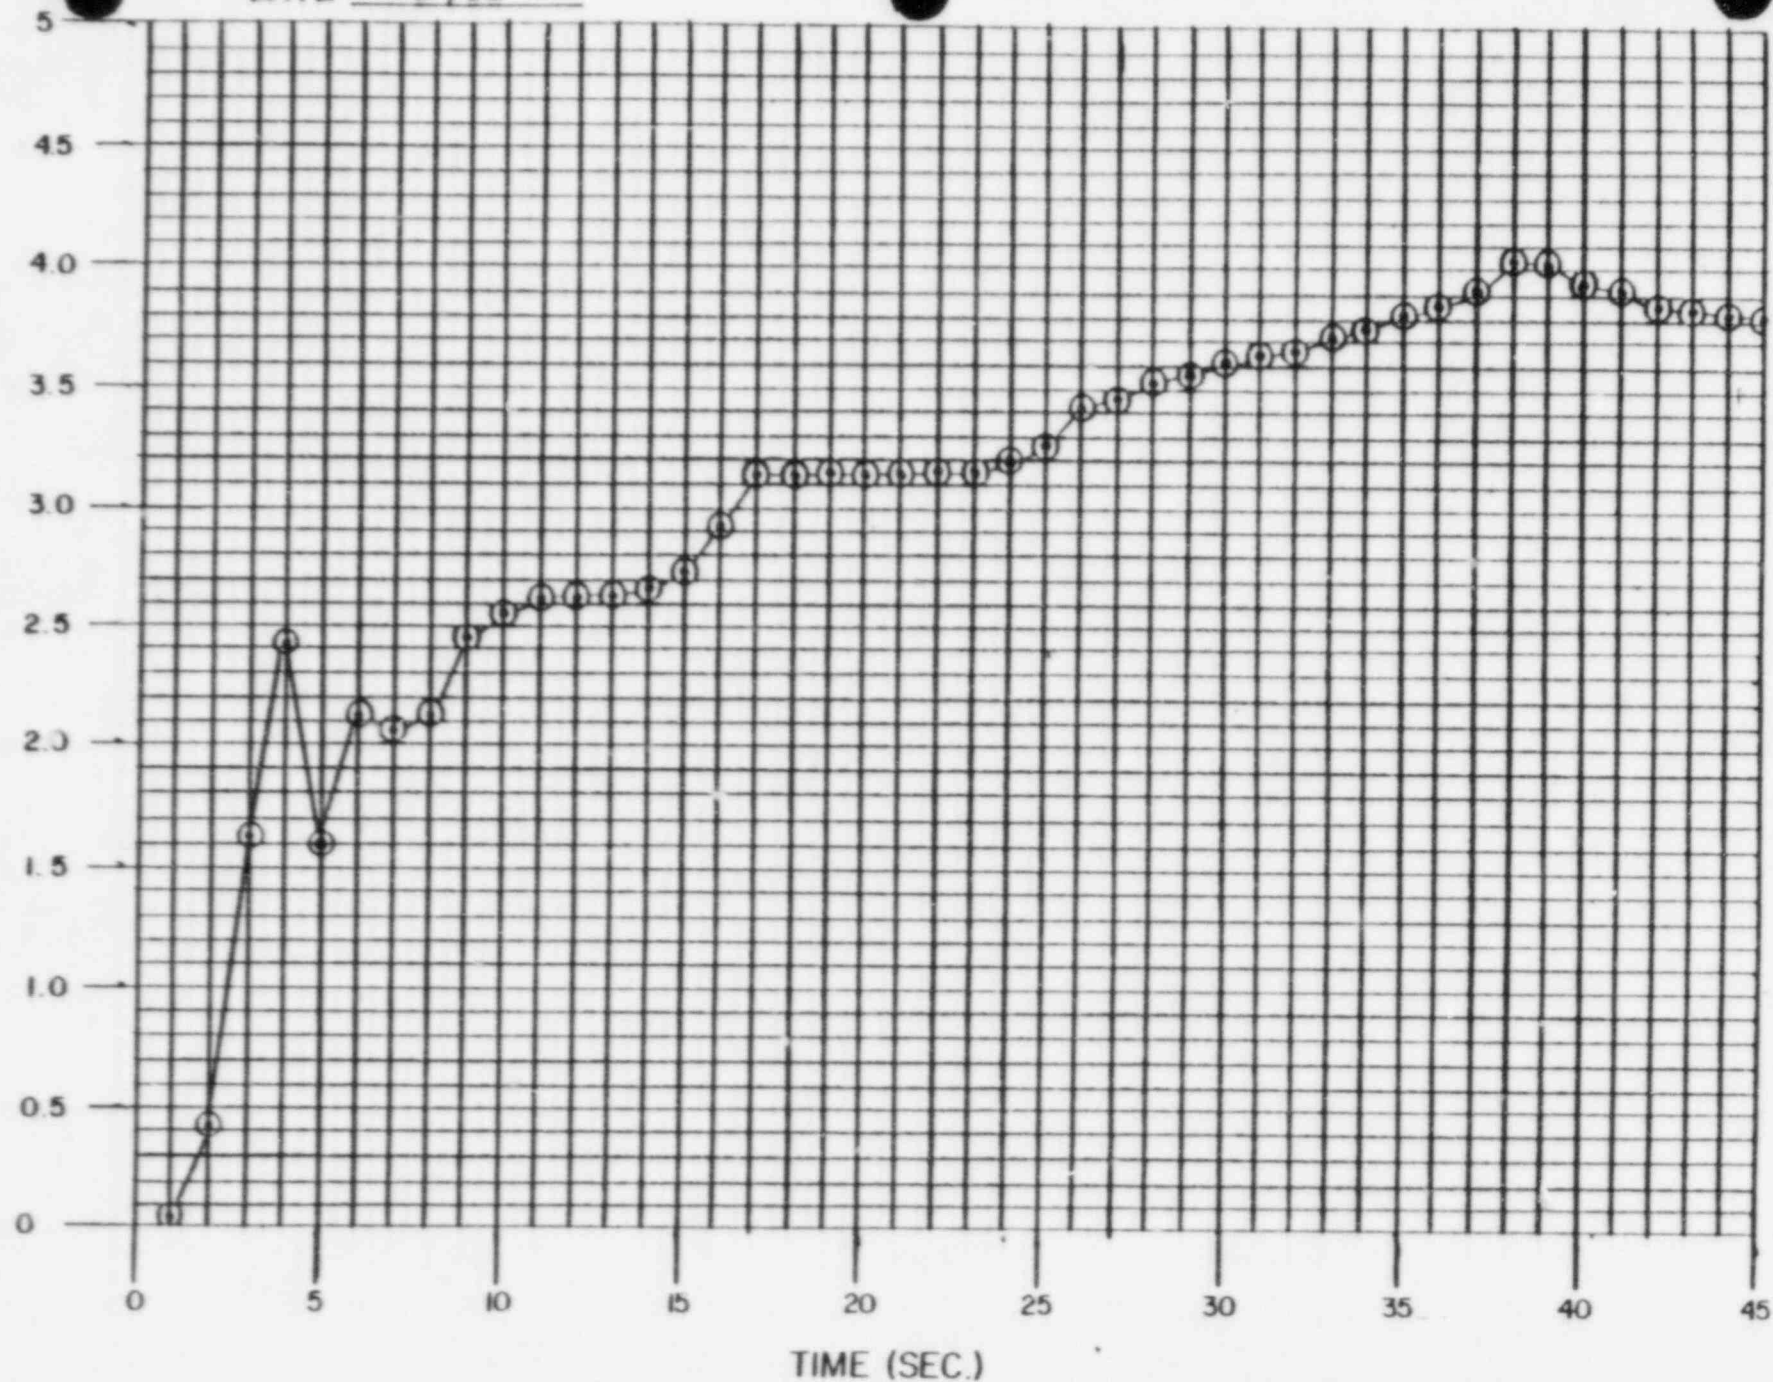
Figure 13

The speed characteristics are shown on Figures 12 and 13 of Attachment 2. A review of the speed characteristics for AFPT #1 shows the typical characteristics consistently seen on AFPT #1 (i.e., several oscillations prior to reaching rated speed).

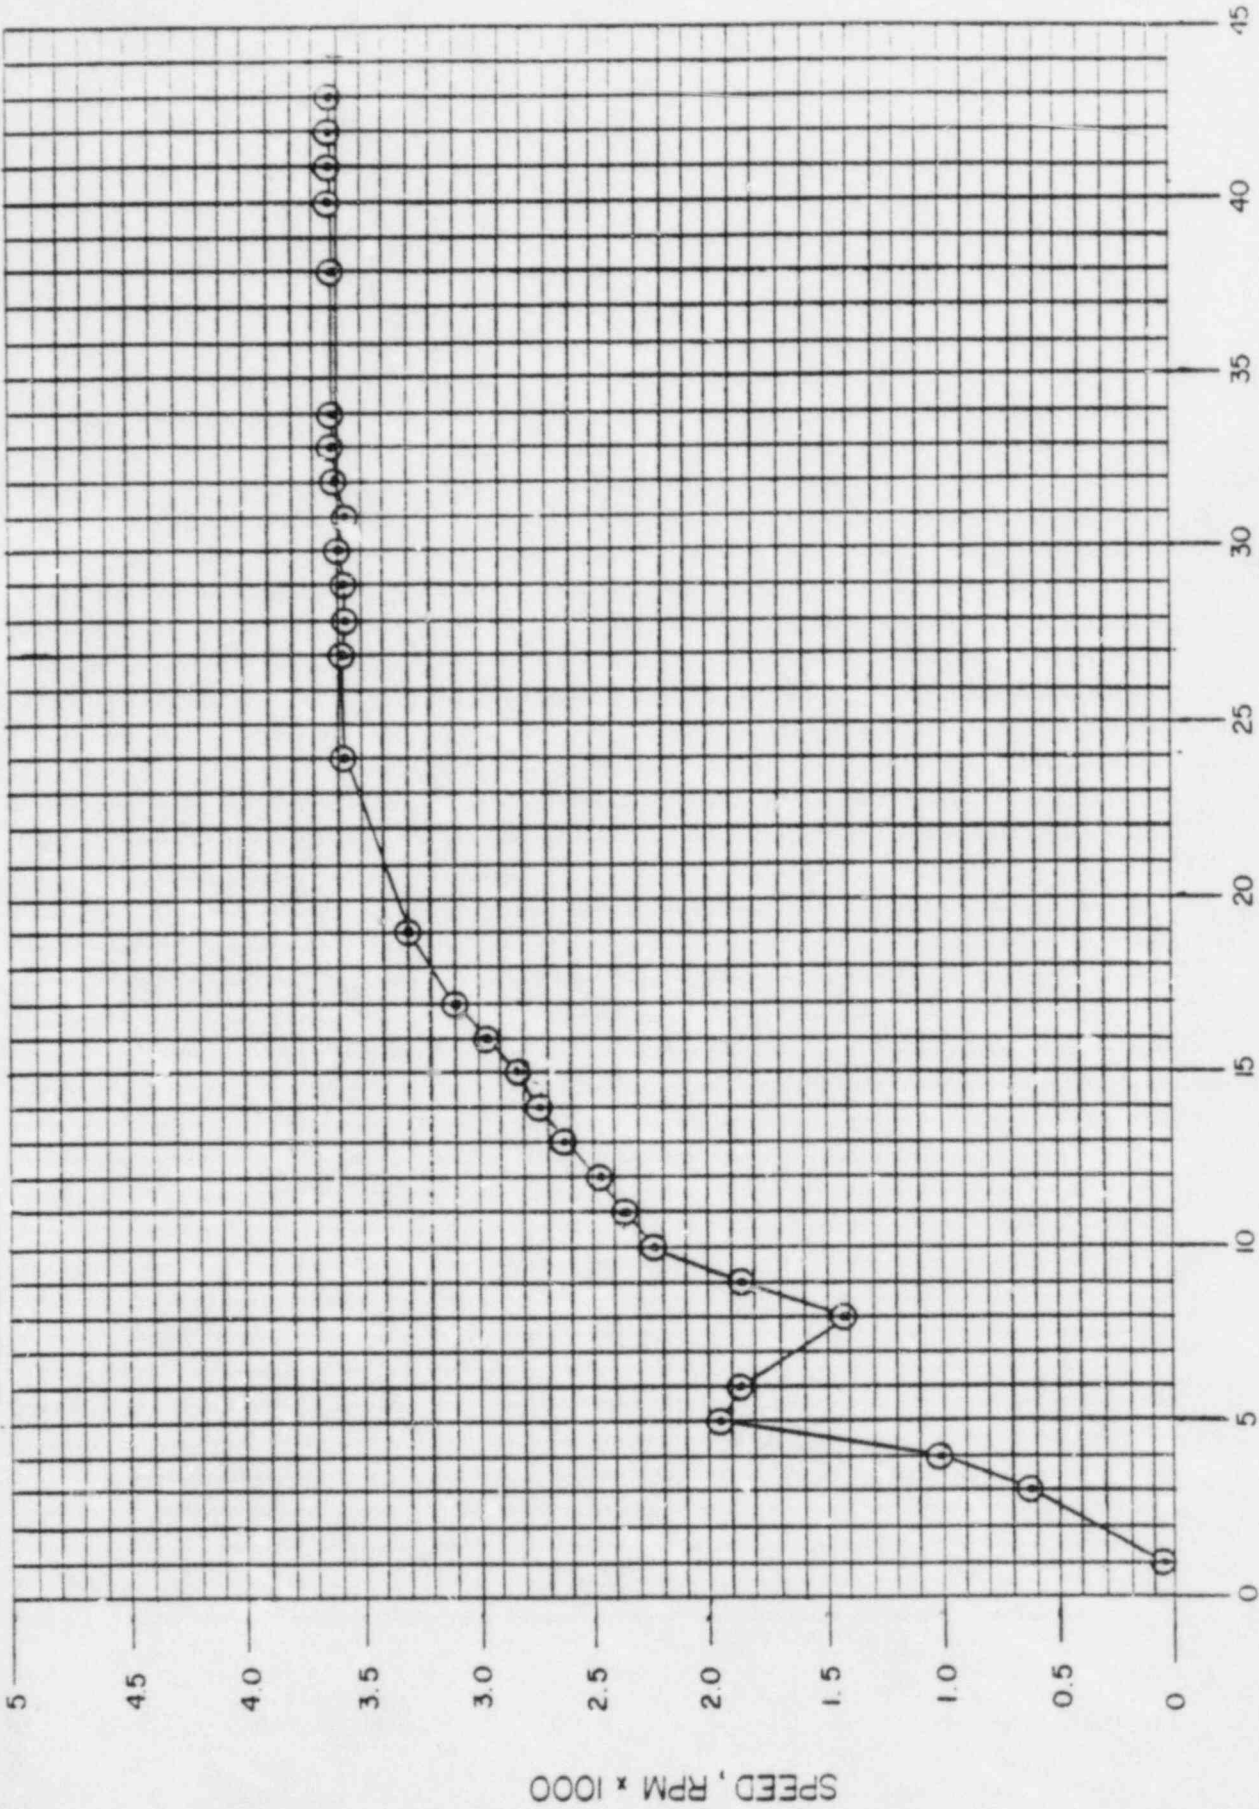
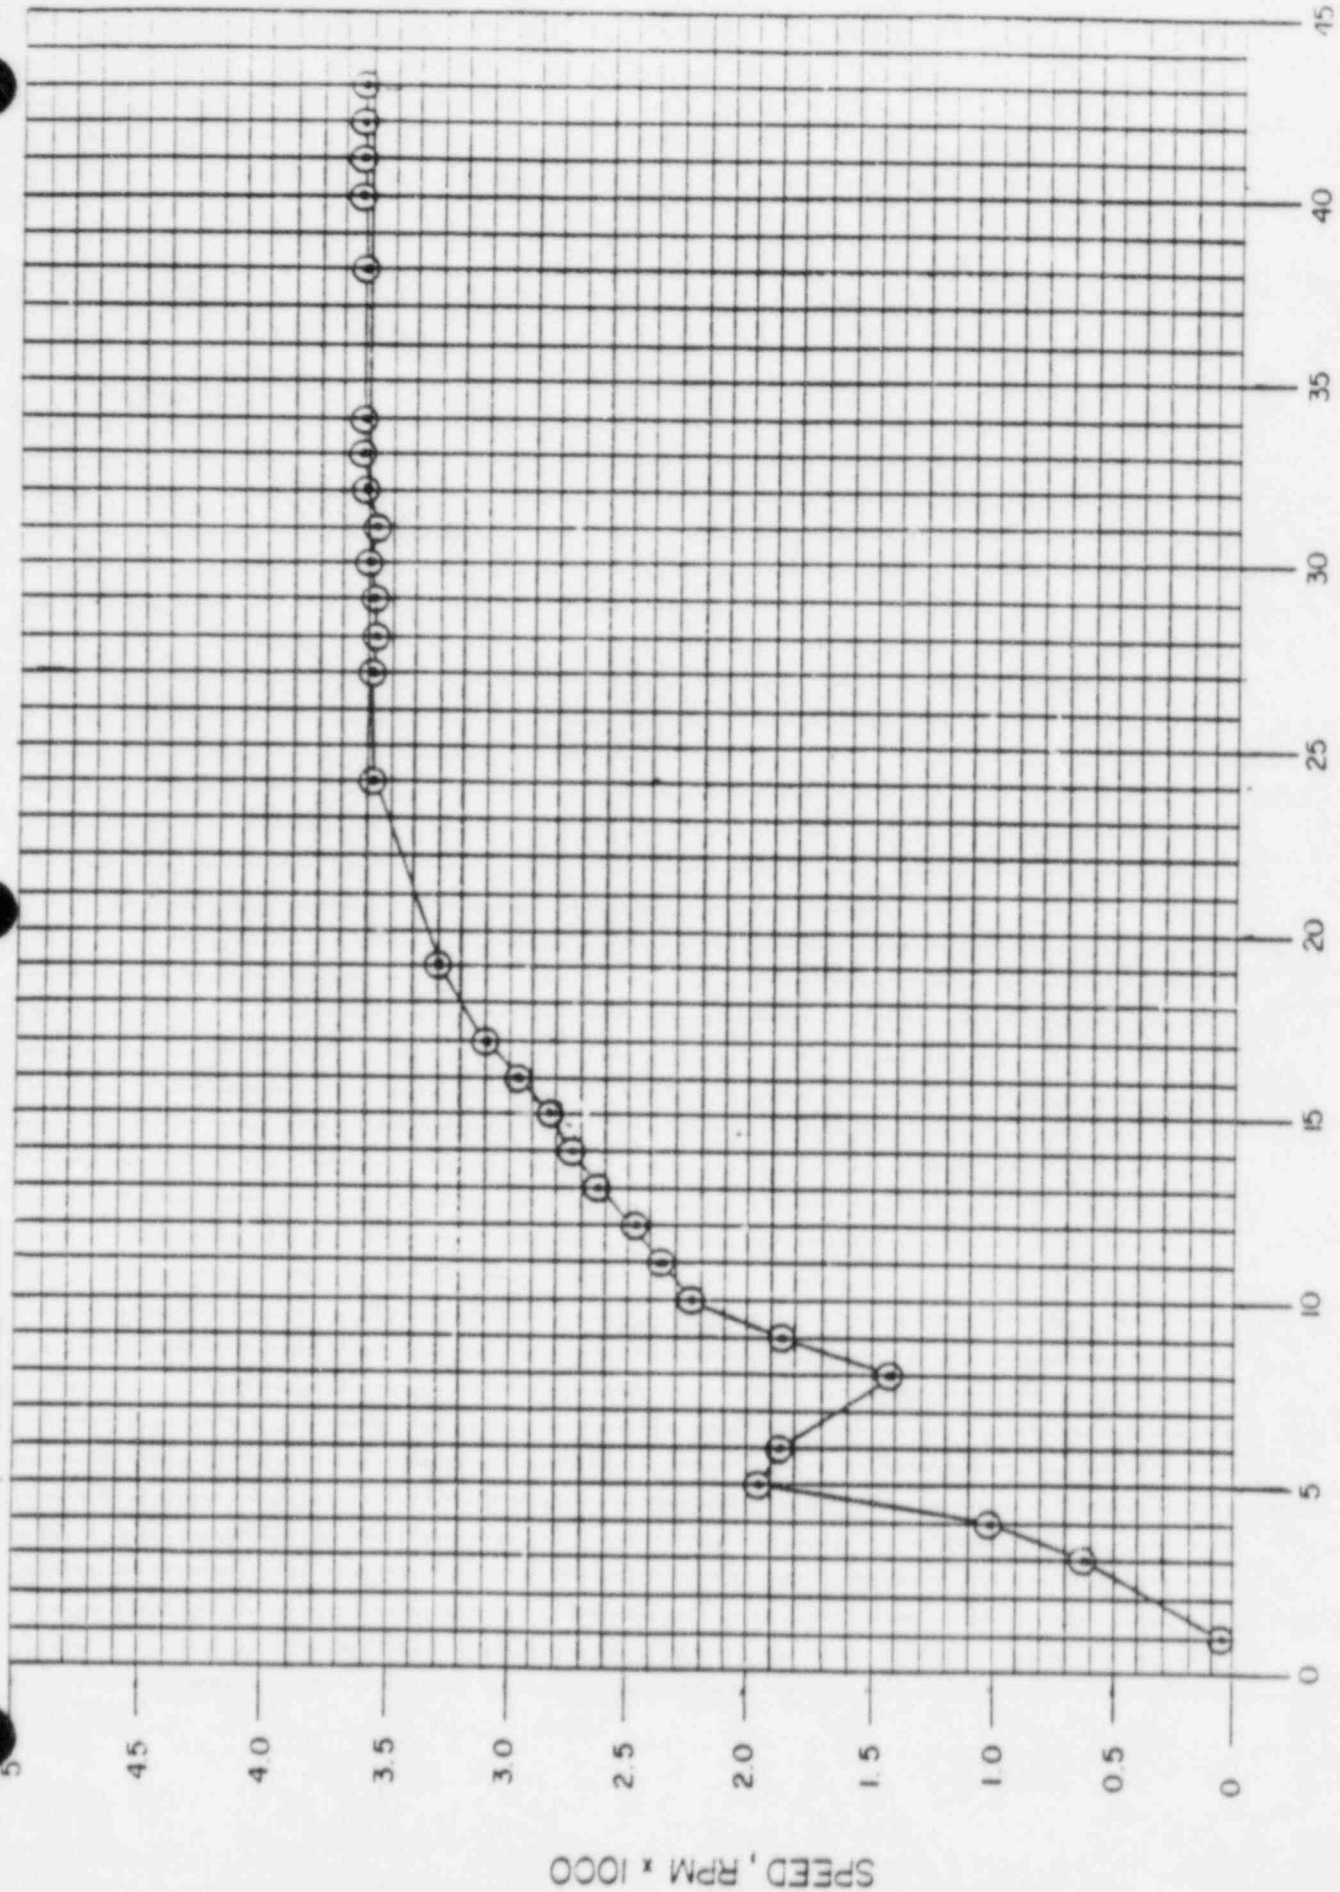
FIGURE 14
TIME (SEC.)

The speed characteristics are shown on Figures 14 and 15 of Attachment 2. A review of each speed vs. time characteristic shows a constant acceleration to rated speed. AFPT #1 does not exhibit oscillations seen at other times. The "smoothness" of these graphs may be attributable to the fact that minimal condensation would be expected since the lines were already heated.

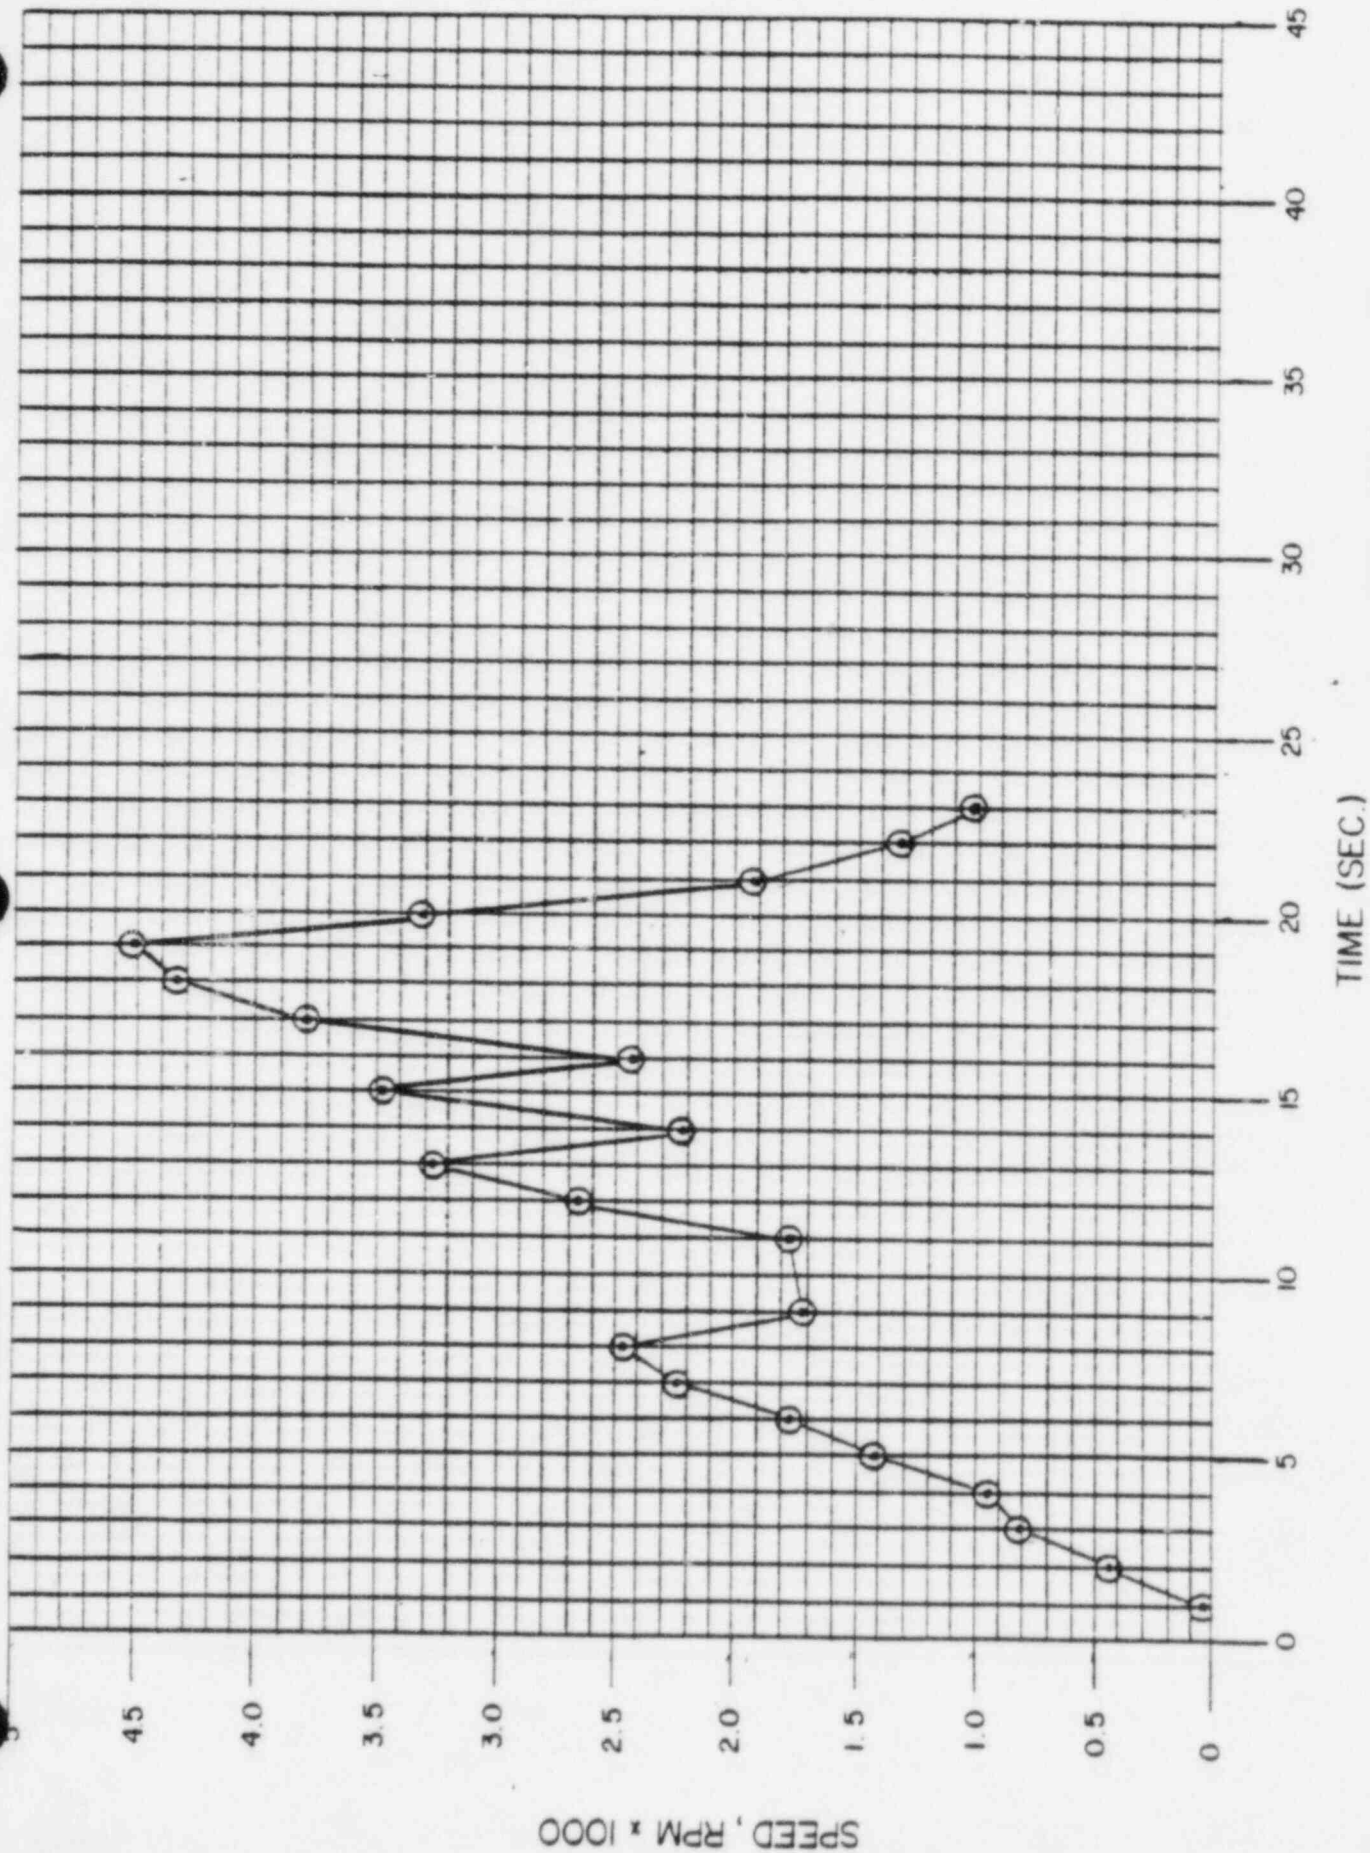
Figure 2

The speed characteristics are shown on Figures 2 and 3 of Attachment 2. A review of the speed vs. time characteristics for AFPT #1 shows the typical characteristics of several oscillations prior to reaching rated speed but the final oscillation was uncontrolled and increased turbine speed to the overspeed trip setpoint.
