Subject: Peach Bottom Atomic Power Station, Unit 2  
Core Spray In-Vessel Piping

# PEACH BOTTOM ATOMIC POWER STATION - UNIT 2

## CORE SPRAY SPARGER TEE-BOX

**Subject: Peach Bottom Unit 2 Core Spray Loop B Sparger Tee-Box Allowable Flaw Evaluation**

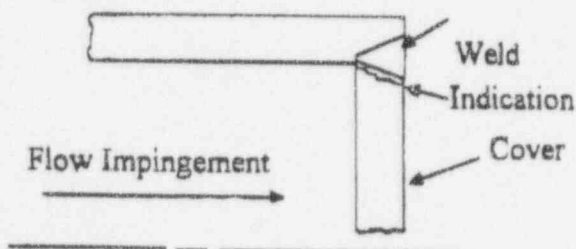
An evaluation of was performed to determine the allowable through-wall flaw length in the Peach Bottom Unit 2 Core Spray Loop B sparger tee box. Also, an evaluation was performed to determine the length of two uncracked ligaments, located opposite to each other. The applied loads at this condition are the pressure drop across the Tee box wall and the flow impingement loads due to core spray injection. A pressure drop of 85 psi and flow of 4000 gpm was used in the evaluation. The applied forces on the cover plate are 2456 lbs due to the pressure difference and 770.3 lbs due to the flow impingement.

The failure mode for this situation was ductile shear.

Based on these assumptions and methodology, calculations were performed to determine the allowable through-wall crack in the cover plate. Results of this calculation demonstrate that the allowable through-wall flaw can be 213° of the circumference of the cover plate. This is shown in the following schematic.
