U.S. NUCLEAR REGULATORY COMMISSION
REGION I

Report No. 96-08

Facility: Vermont Yankee Nuclear Power Station

Vermont Yankee Nuclear Power Station NRC Inspection Report 50-271/96-08

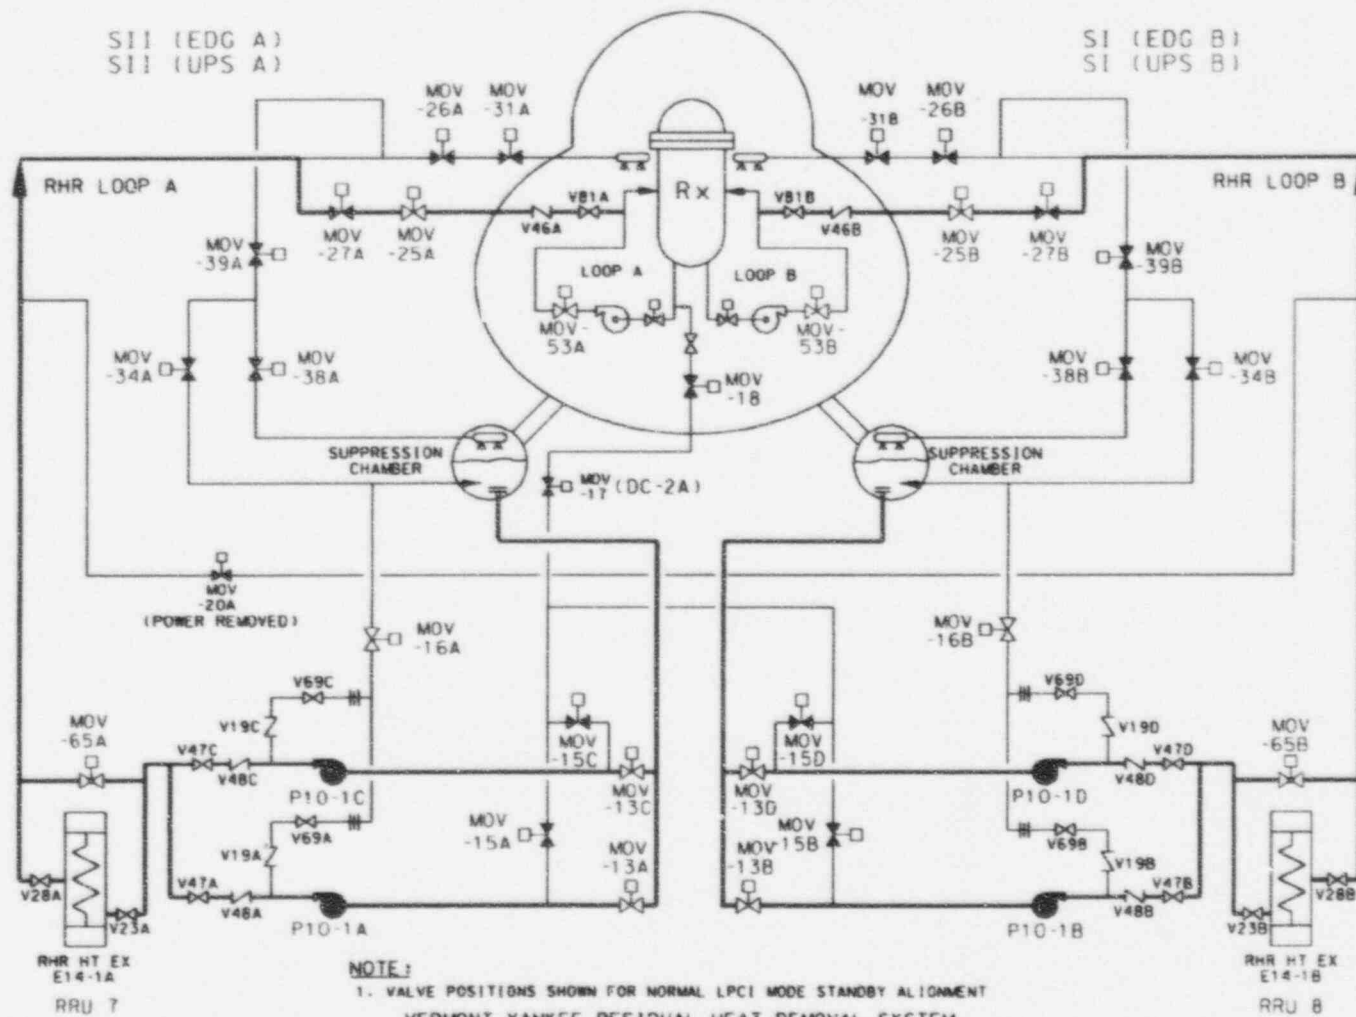
System Diagram

Appendix R Reanalysis Finding

- Event discovered as result of comprehensive review by fire protection team
- Review conducted as corrective action in response to Appendix R violation
- Cable-by-cable verification was in progress for all systems
- Cross-connects between Bus 3 and 4 identified
- Appendix R team identified single failure concern and promptly initiated event report process
