South Texas Project
Units 1 & 2
Docket Nos. STN 50-498, STN 50-4⁹9
First Interim Report Concerning
Pipe Support Eye-Rod Interferences

South Texas Project
Units 1 & 2
First Interim Report Concerning
Pipe Support Eye-Rod Interferences

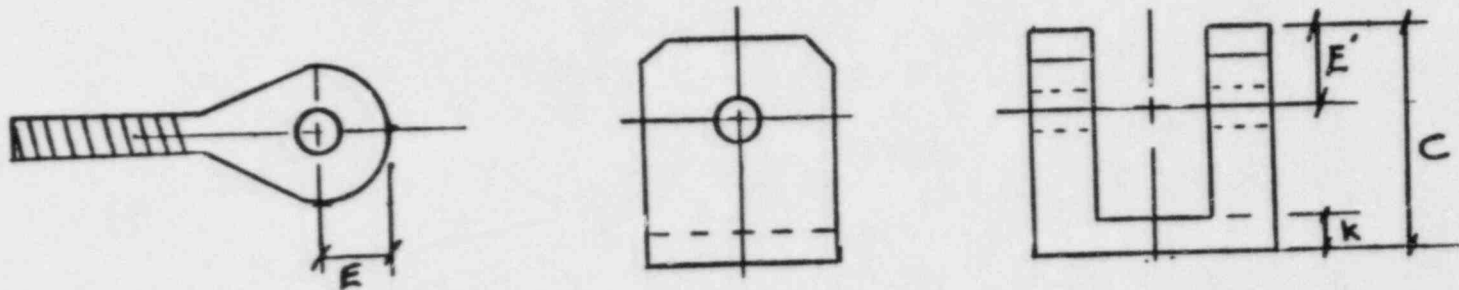
CALCULATED DESIGN CLEARANCES BASED ON NPSI DRAWINGS

The root cause of this problem appears to be a "stacking up of tolerances". As shown in Attachment 2, the calculated clearance for size 6, 10, and 14 struts with the additive "worst case" tolerances results in a zero clearance situation between the eye-rod and rear bracket even without the presence of forging trim on the eye-rod. Fabrication tolerances are apparently being met, but those specified tolerances can result in zero clearance. Additional measurements have been taken to determine if the interference exists because of the eye-rod, bracket, or both. The base thickness (K) of seven machined

Strut Size	Paddle E (Max) Inches	Machined* Rear Bracket "Worst Case" Dimensions				Calculated Clearance (C-E'-K)-E Inches
		C (Min) Inches	K (Max) Inches	E' (Max) Inches	Calculated C-E'-K Inches	
6	1.0625	2.0625	0.4375	0.5625	1.0625	0
8	1.3750	2.7500	0.5625	0.7500	1.4375	0.0625
10	1.6875	3.6250	0.8125	1.1250	1.6875	0
14	2.2500	4.5000	0.9375	1.3125	2.2500	0

*Note: Forged rear brackets have a "worst case" calculated clearance of 0.03125 inches for these strut sizes.
