INVESTIGATION OF FAILED FIELD ANCHOR HEADS
HVO16 AND HVO38 FROM THE J. M. FARLEY
NUCLEAR POWER PLANT UNIT 2 CONTAINMENT

INRYCO, INCORPORATED

April 9, 1985

BATTELLE
Columbus Laboratories
505 King Avenue
Columbus, Ohio 43201

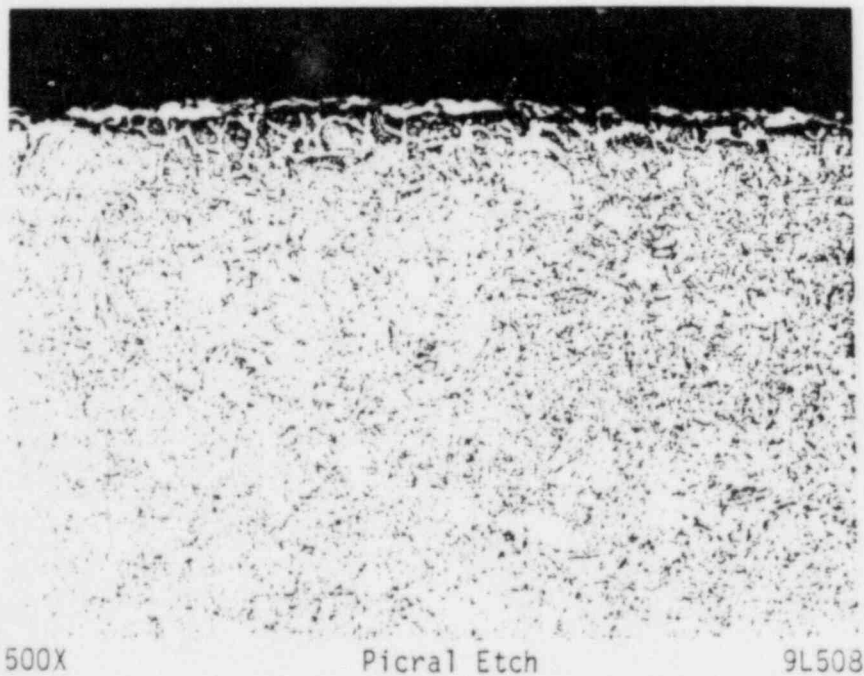
FIGURE 15. (Continued)

surface of the anchor heads and at the surfaces of the tendon holes. That partial decarburization is shown in Figure 15c; the light-etching patches of ferrite that extended inward from the surface to a depth of about 0.001 inch indicate the partial decarburization.
