SUBJECT: INVESTIGATION NOTIFICATION

Vogtle Elec. Gen. Plant Case No. 2-90-020 Opened: 11/06/90

LOSS OF OFFSITE POWER LEADS TO SITE AREA EMERGENCY

SUBJECT: ENFORCEMENT CONFERENCE SUMMARY
(NUREG-1410 AND NRC INSPECTION REPORT NOS. 50-424/90-16
AND 50-425/90-16)

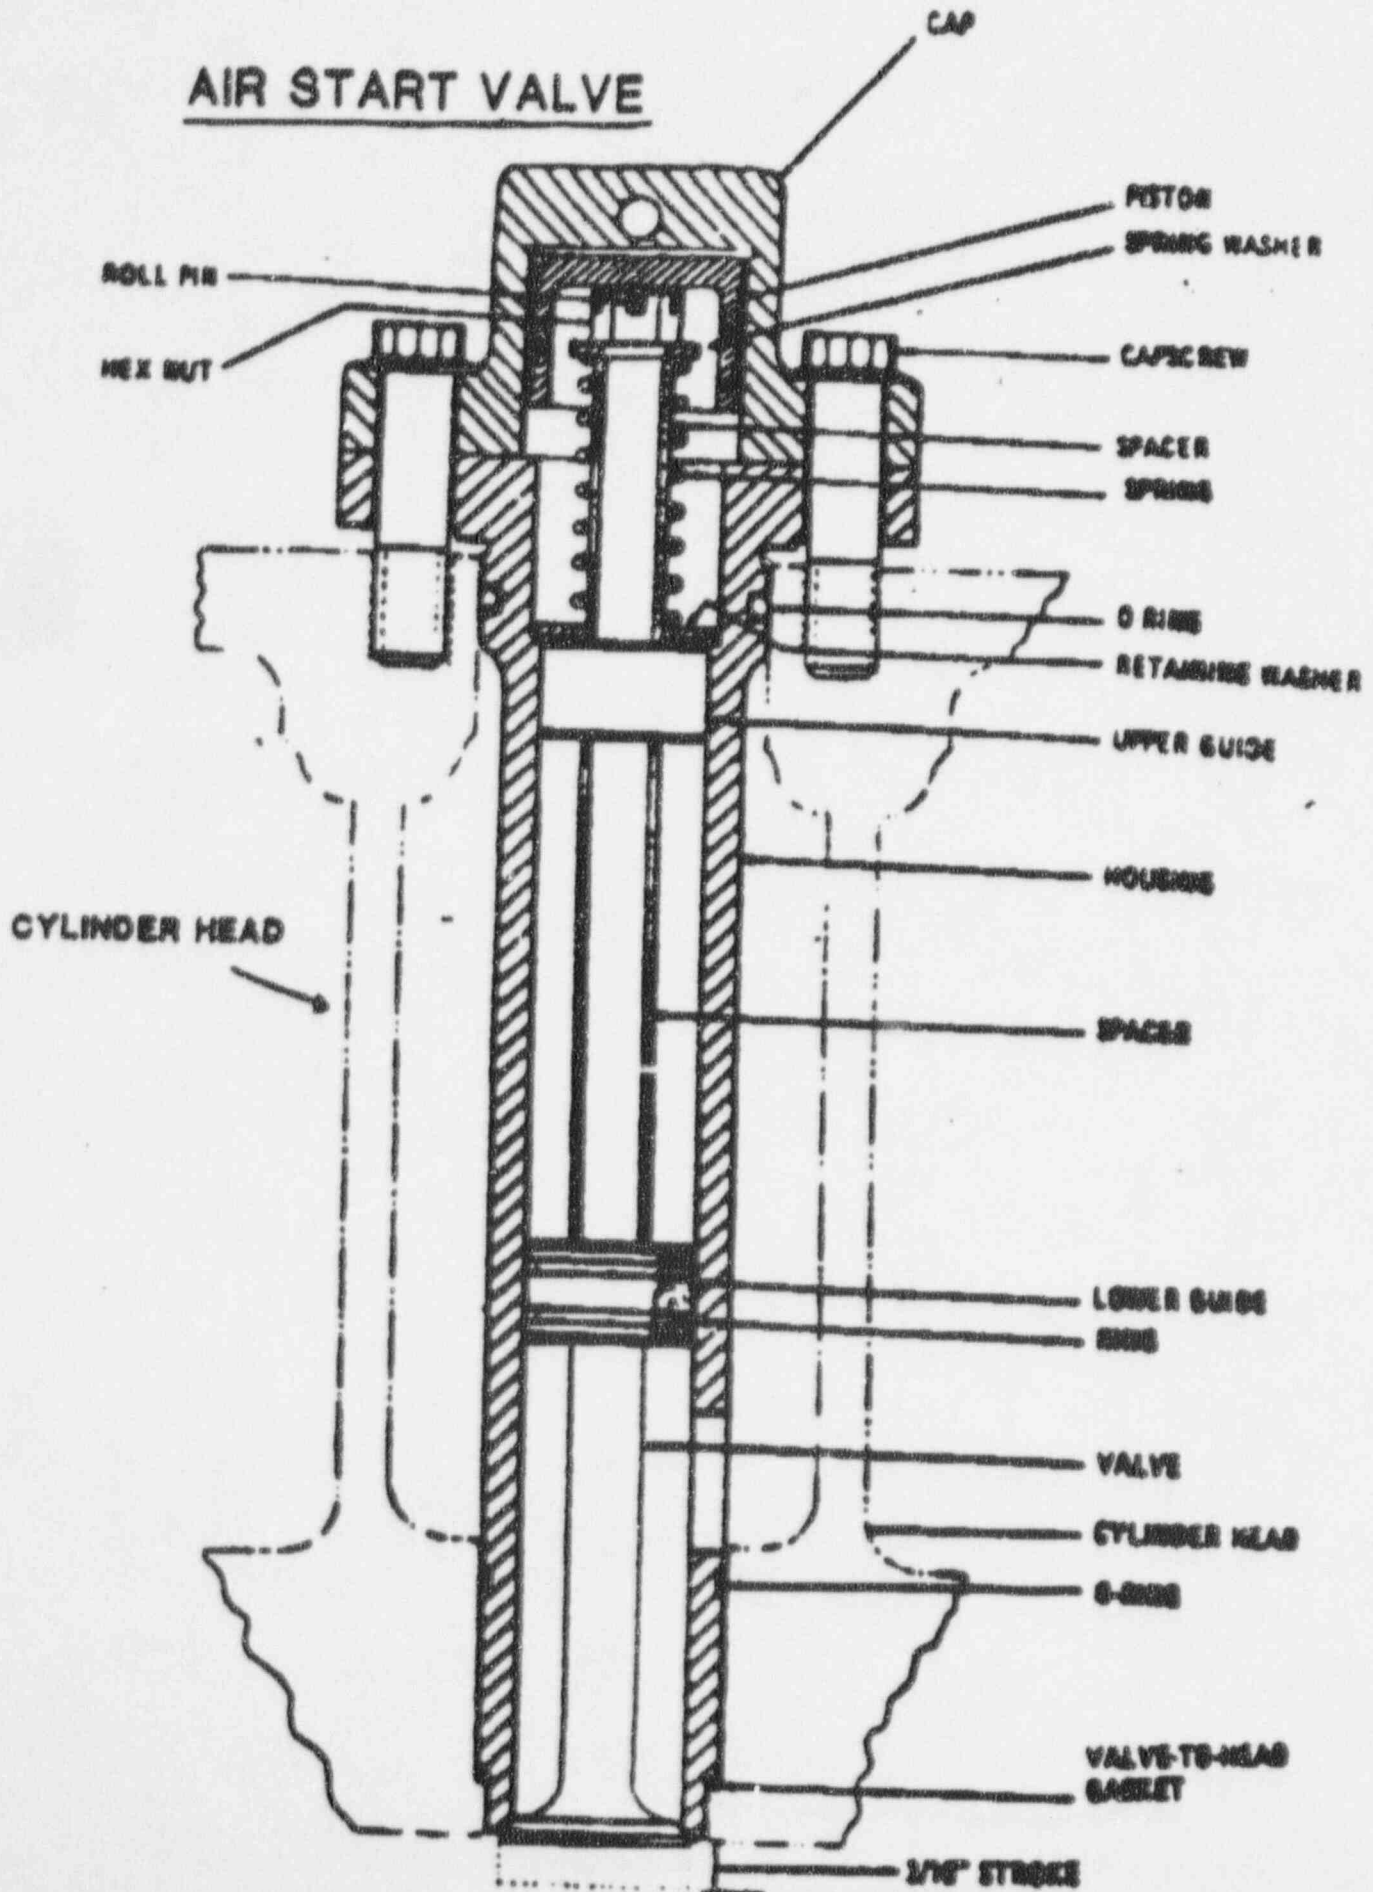
CALCON TEMPERATURE SENSOR MODEL A3500-W3

- . DG would not start if a particular crankshaft alignment and stuck air valve combination existed. This condition was ex__ during surveillance testing when half of the cylinders were isolated from starting air.
