U.S. NUCLEAR REGULATORY COMMISSION

Report No: 50-440/96015(DRS)

Facility: Perry Nuclear Power Plant

Pre-Decisional  
Enforcement Conference Presentation  
to the  
U.S. Nuclear Regulatory Commission

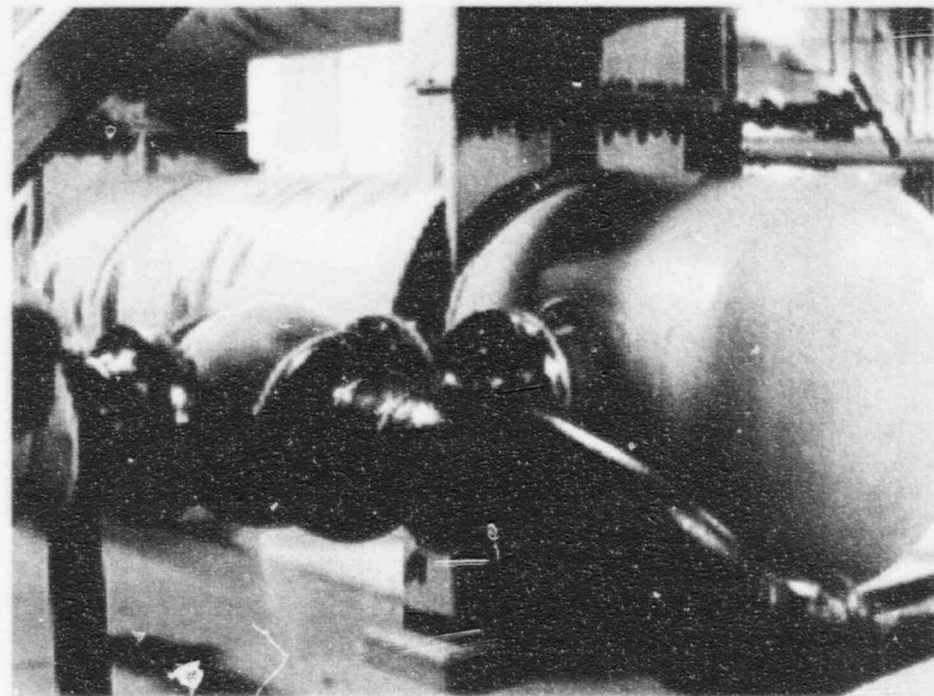
Time = - 12 min.

- » Flow induced (vortexing) heat transfer at the heat exchanger discharge piping, coupled with potential convective heat losses, resulted in the decay.

Heat Exchanger  
1P42-B0001B  
5/20/96  
Inlet

The infrared images shown below document the flow test performed on the 1P42-B0001B heat exchanger. This view is of the heat exchanger inlet. The entire test was run with the inlet 3-way temperature control valve in the **full bypass** position.

The image labeled T= -12 min was taken with P42 isolated, and P45 had been running for approximately 1 hour to cool the static water contained in the shell. The P42 Pump was started at T= 0 min. The other thermal image was taken 7 minutes after the start of the P42 pump.

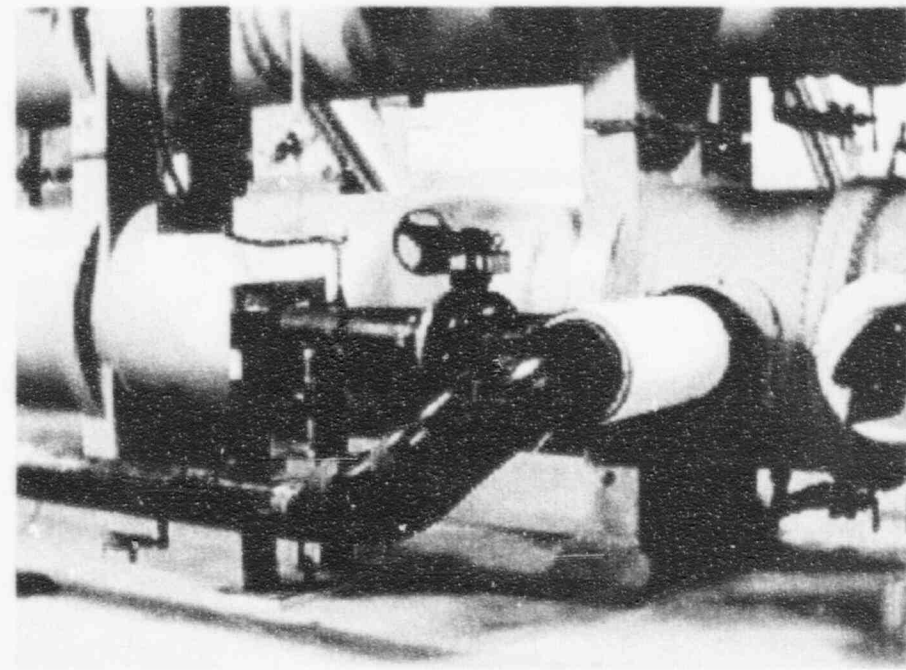
Time = - 9 min.

Heat Exchanger  
1P42-B0001B  
5/20/96  
Outlet

The infrared images shown below document the flow test performed on the 1P42-B0001B heat exchanger. This view is of the heat exchanger outlet. The entire test was run with the inlet 3-way temperature control valve in the **full bypass** position.

The image labeled T= -9 min was taken with P42 isolated, and P45 had been running for approximately 1 hour to cool the static water contained in the shell. The P42 Pump was started at T= 0 min. The other two thermal images were taken 1 minute and 5 minutes after the start of the P42 pump.

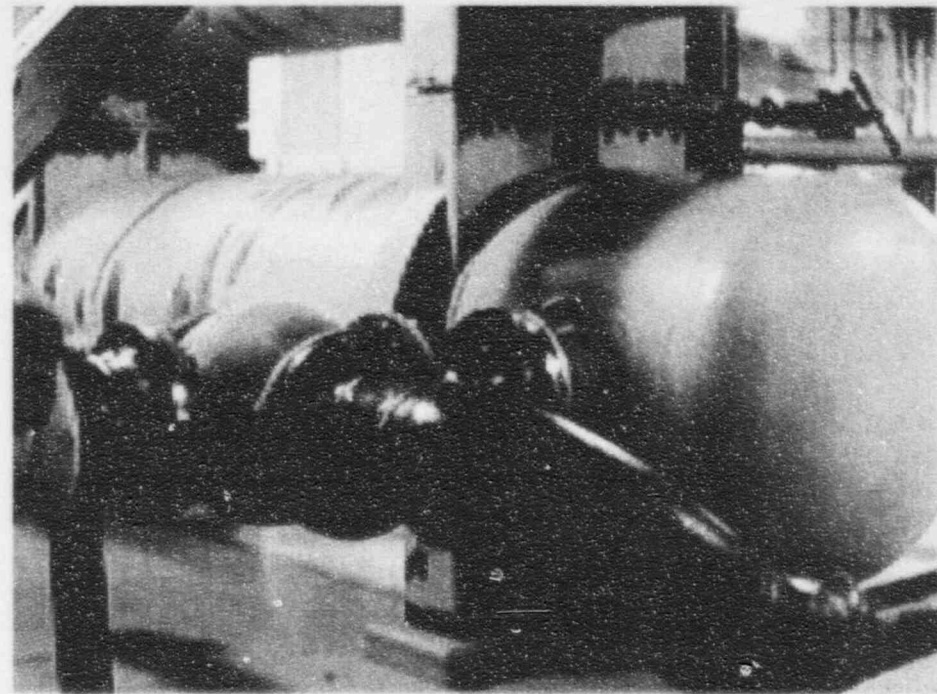
**Time = - 12 min.**

**Heat Exchanger**  
**1P42-B0001B**  
**5/20/96**  
**Inlet**

The infrared images shown below document the flow test performed on the 1P42-B0001B heat exchanger. This view is of the heat exchanger inlet. The entire test was run with the inlet 3-way temperature control valve in the **full bypass** position.

The image labeled T= -12 min was taken with P42 isolated, and P45 had been running for approximately 1 hour to cool the static water contained in the shell. The P42 Pump was started at T= 0 min. The other thermal image was taken 7 minutes after the start of the P42 pump.

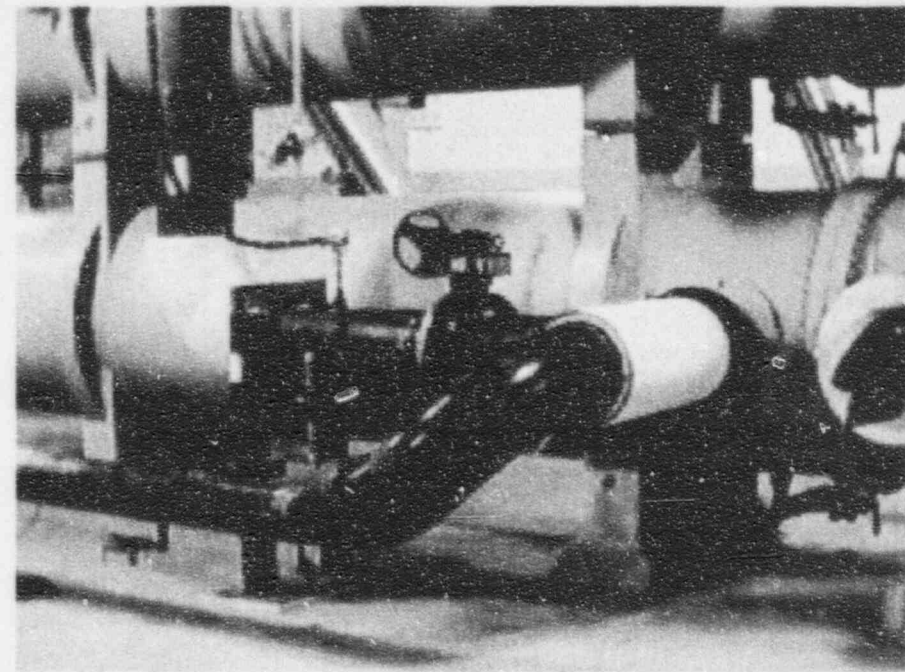
Time = - 9 min.

Heat Exchanger  
1P42-B0001B  
5/20/96  
Outlet

The infrared images shown below document the flow test performed on the 1P42-B0001B heat exchanger. This view is of the heat exchanger outlet. The entire test was run with the inlet 3-way temperature control valve in the full bypass position.

The image labeled T= -9 min was taken with P42 isolated, and P45 had been running for approximately 1 hour to cool the static water contained in the shell. The P42 Pump was started at T= 0 min. The other two thermal images were taken 1 minute and 5 minutes after the start of the P42 pump.
