**RADIOLOGIC AND ENGINEERING ASSESSMENT**

DOE ID NO.: GJ-04257-RS  
ADDRESS: 2312 MESA AVENUE

JULY 1985

URANIUM MILL TAILINGS REMEDIAL ACTION PROJECT OFFICE

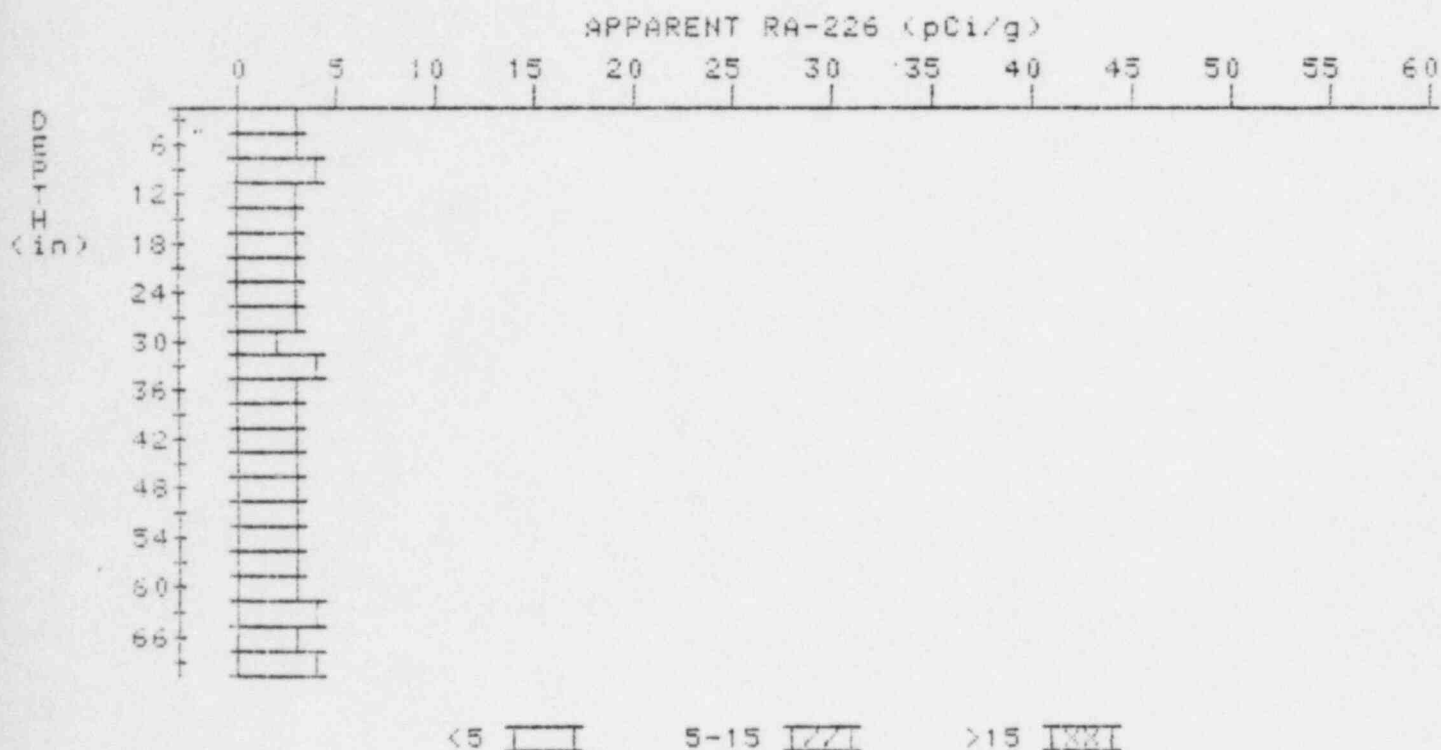
PROPERTY NUMBER: GJ-04257-R3  
HOLE NUMBER: 2  
LOCATION: 144264'

Depth (in)	Apparent Radium-226 (pCi/g) Undeconvolved	Apparent Radium-226 (pCi/g) Deconvolved
3	2.6	2.6
6	2.9	3.1
9	3.1	3.6
12	3.0	3.0
15	2.9	2.7
18	2.9	2.7
21	3.0	3.2
24	3.0	3.0
27	3.0	3.2
30	2.9	2.4
33	3.1	3.6
36	3.0	2.6
39	3.1	3.1
42	3.2	3.4
45	3.2	3.2

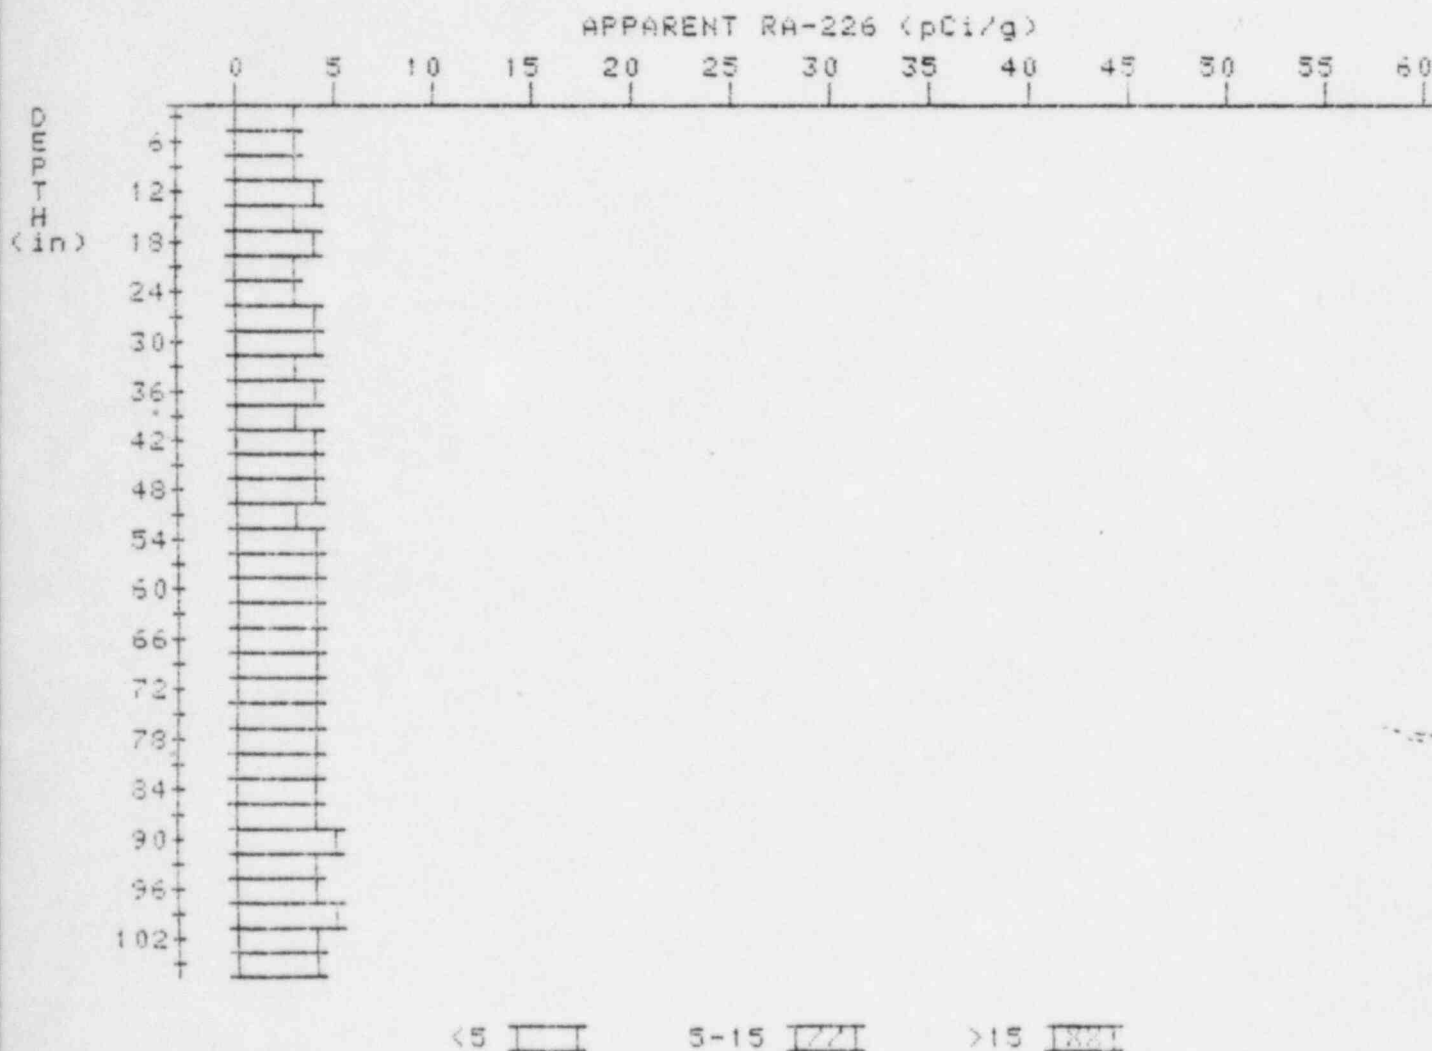
HOLE NUMBER: 10

Depth (in)	Apparent Radium-226 (pCi/g) Undeconvolved	Apparent Radium-226 (pCi/g) Deconvolved
3	2.8	2.8
6	3.1	3.5
9	3.2	3.0
12	3.4	3.9
15	3.3	2.9
18	3.4	3.6
