MEETING WITH NRC ON MIDLAND PLANT FILL STATUS AND RESOLUTION

July 18, 1979

NRC, Bethesda, Maryland

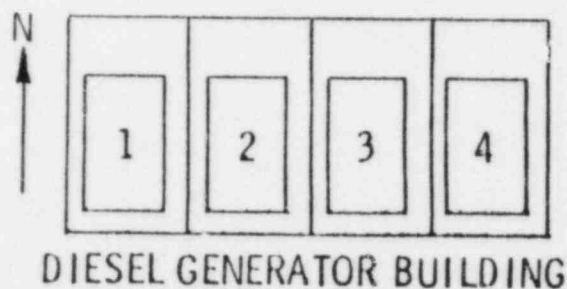
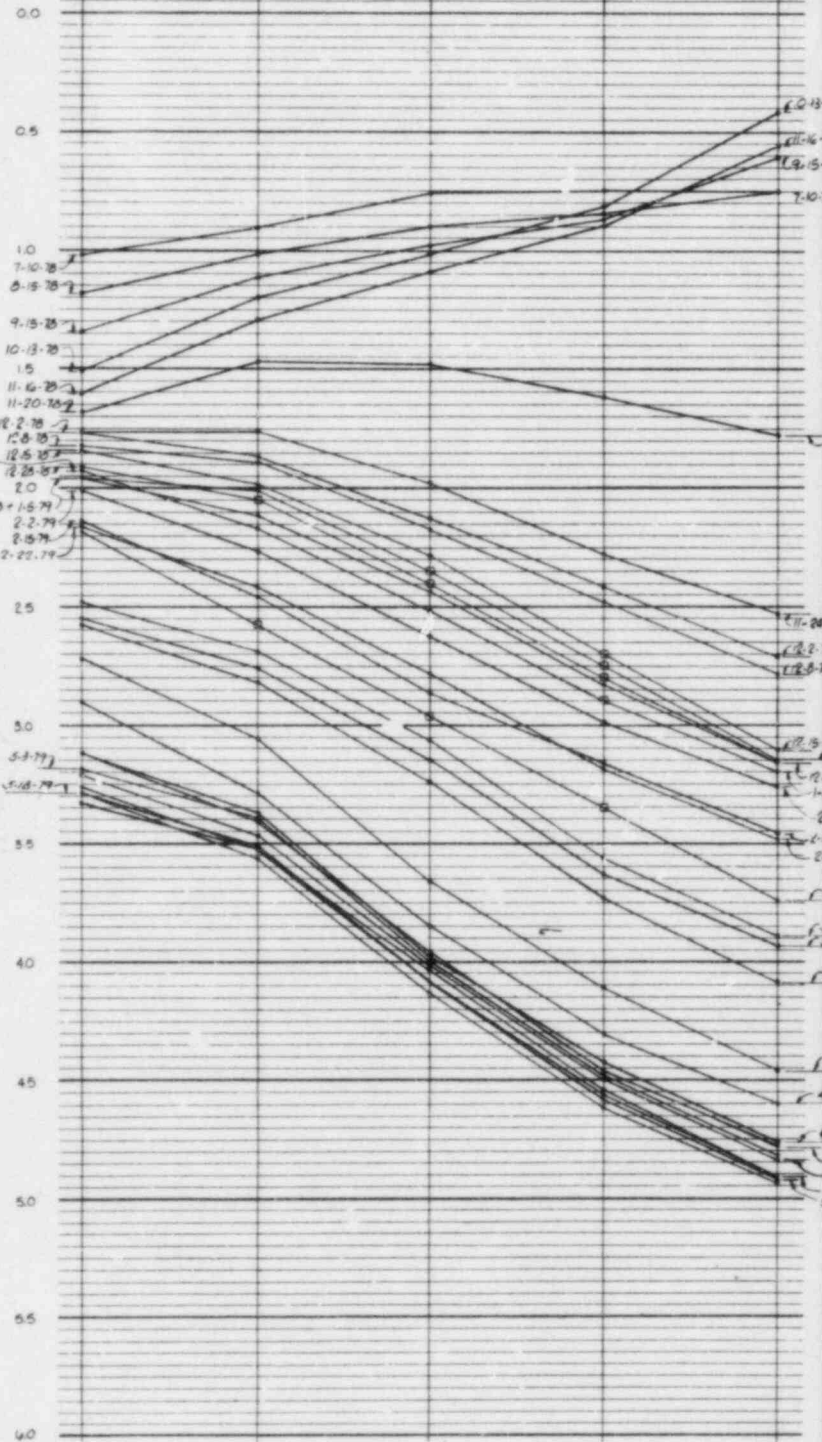
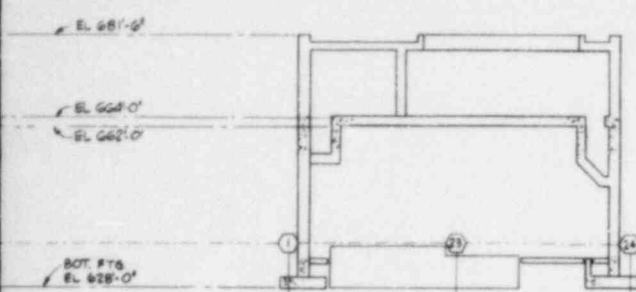
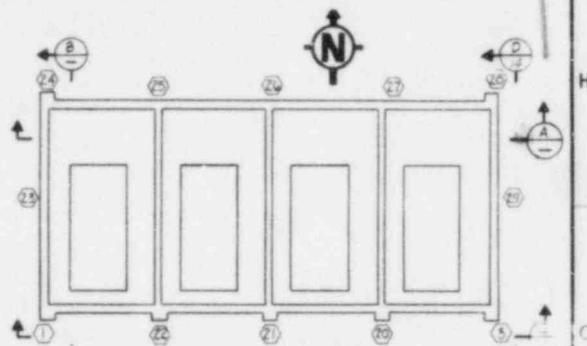
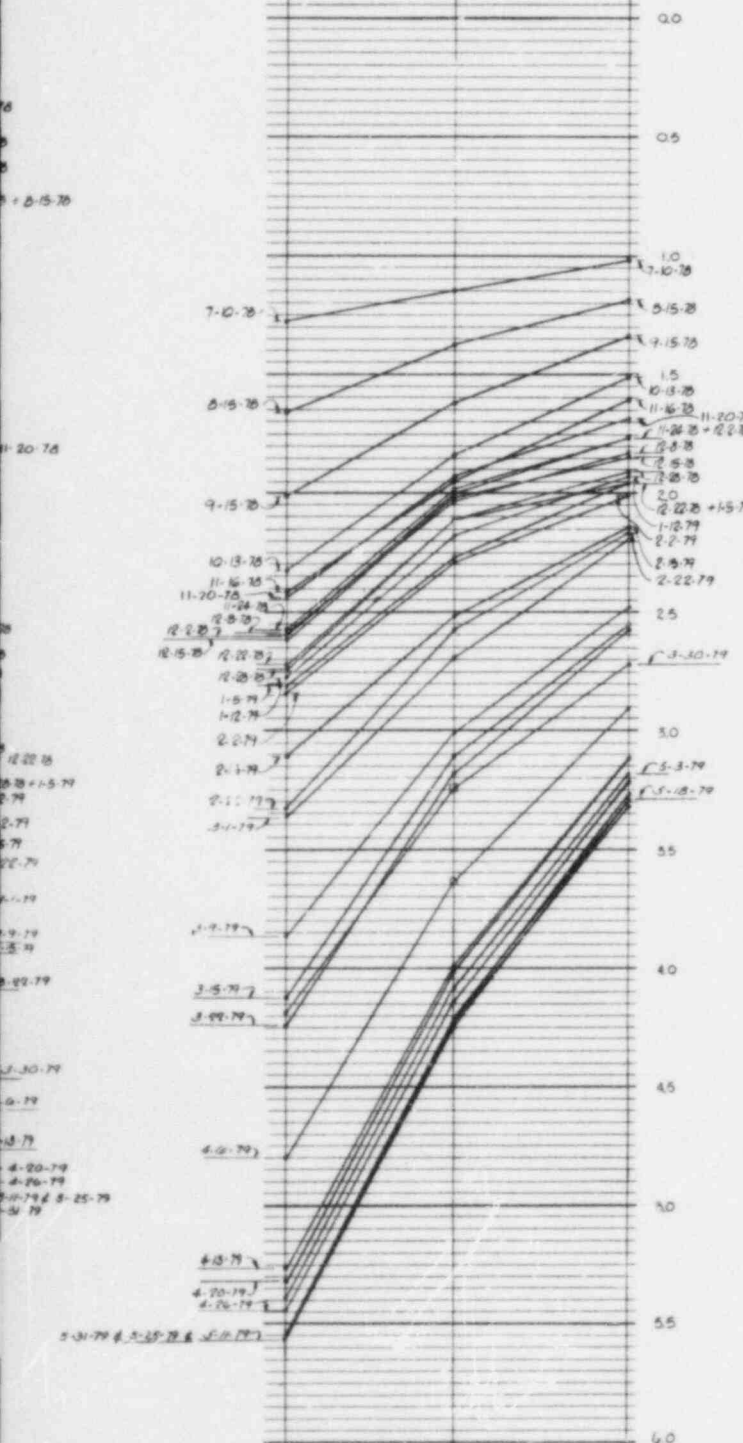
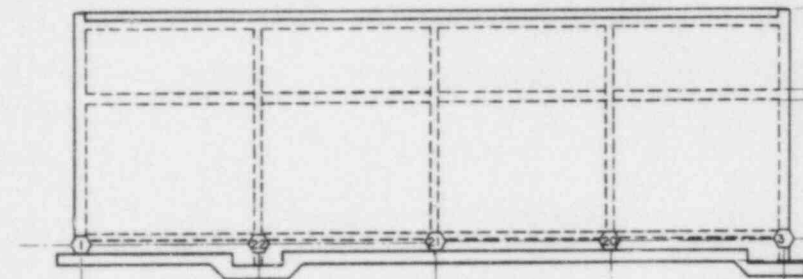
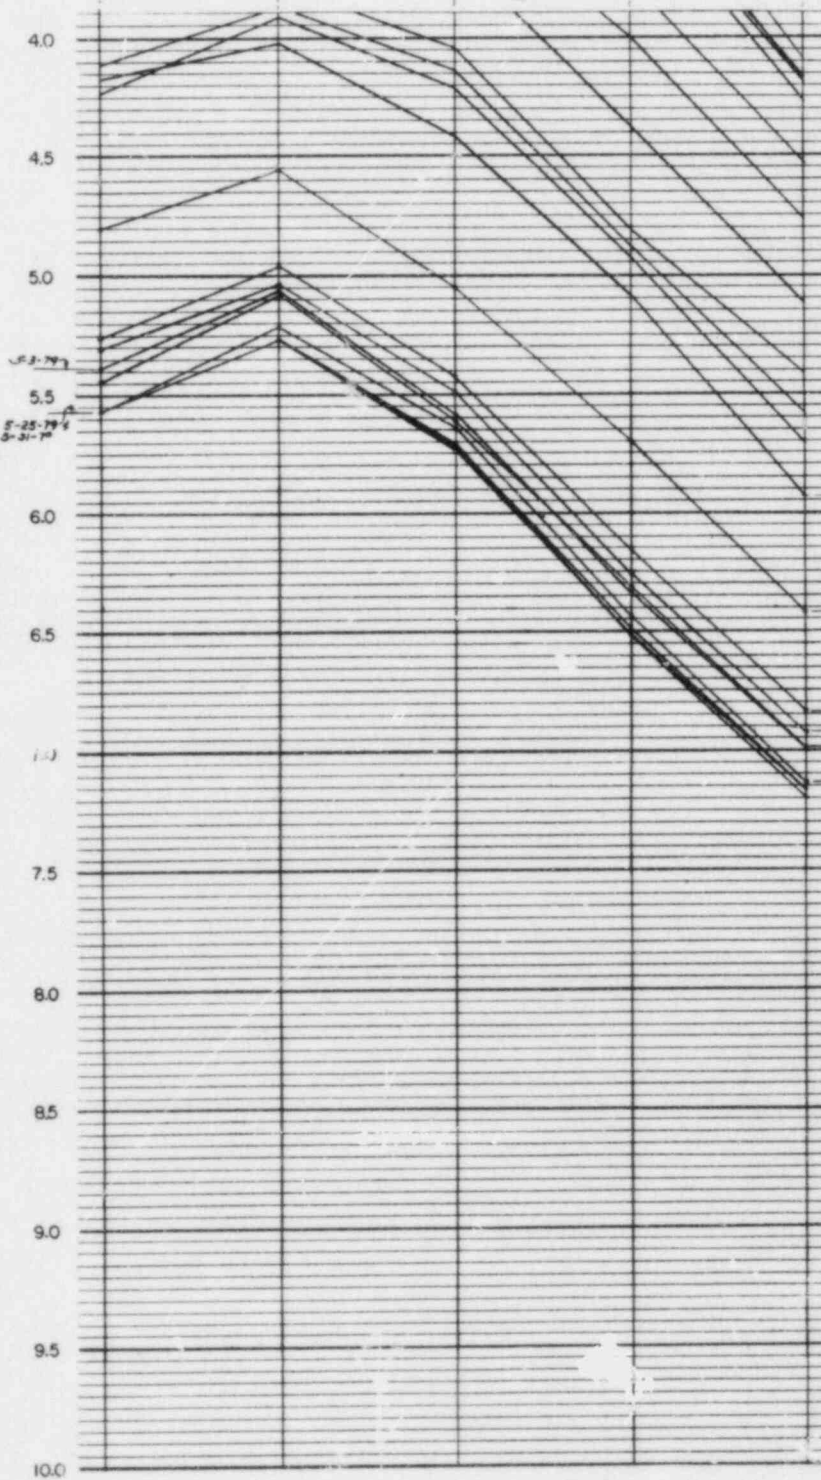
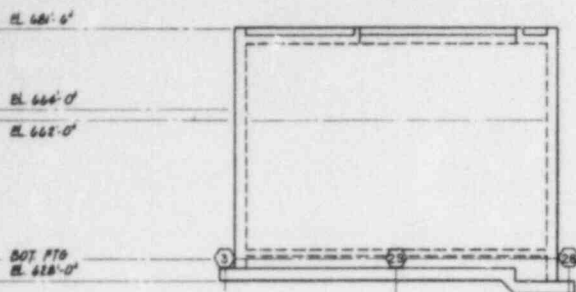
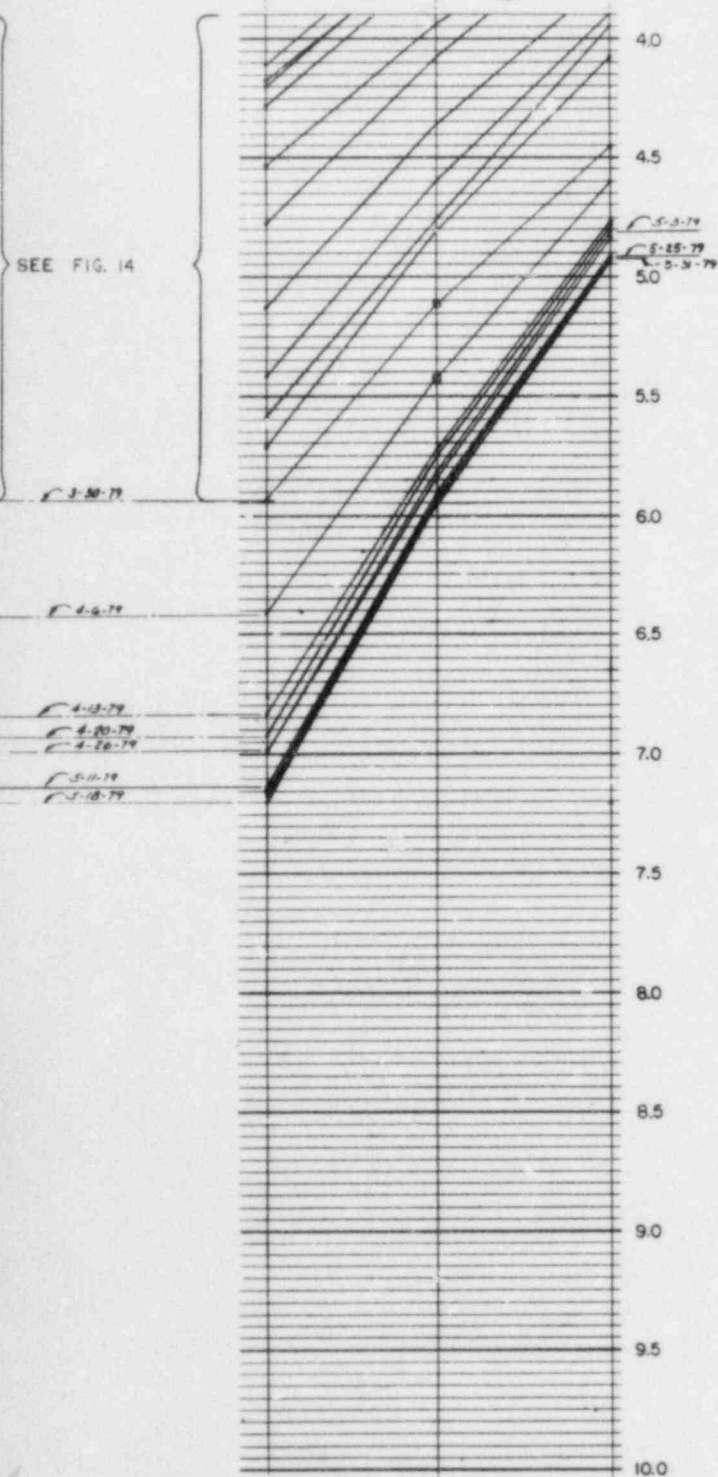
DIESEL GENERATOR BUILDING  
AVERAGE PEDESTAL SETTLEMENT VS TIME

Figure 15 shows in plan the extent of sand surcharge. The surcharge was gradually applied in steps. To date, the backfill under the diesel building is subjected to 20 feet of sand surcharge. Figure 16 shows a cross-section of the building and the surcharge. The surcharge produces stresses in the fill greater than the amount the fill would experience when the structure is operational. This surcharge will remain until excess pore pressures are essentially dissipated and the rate of residual settlement becomes small and can be predicted conservatively by extrapolation.

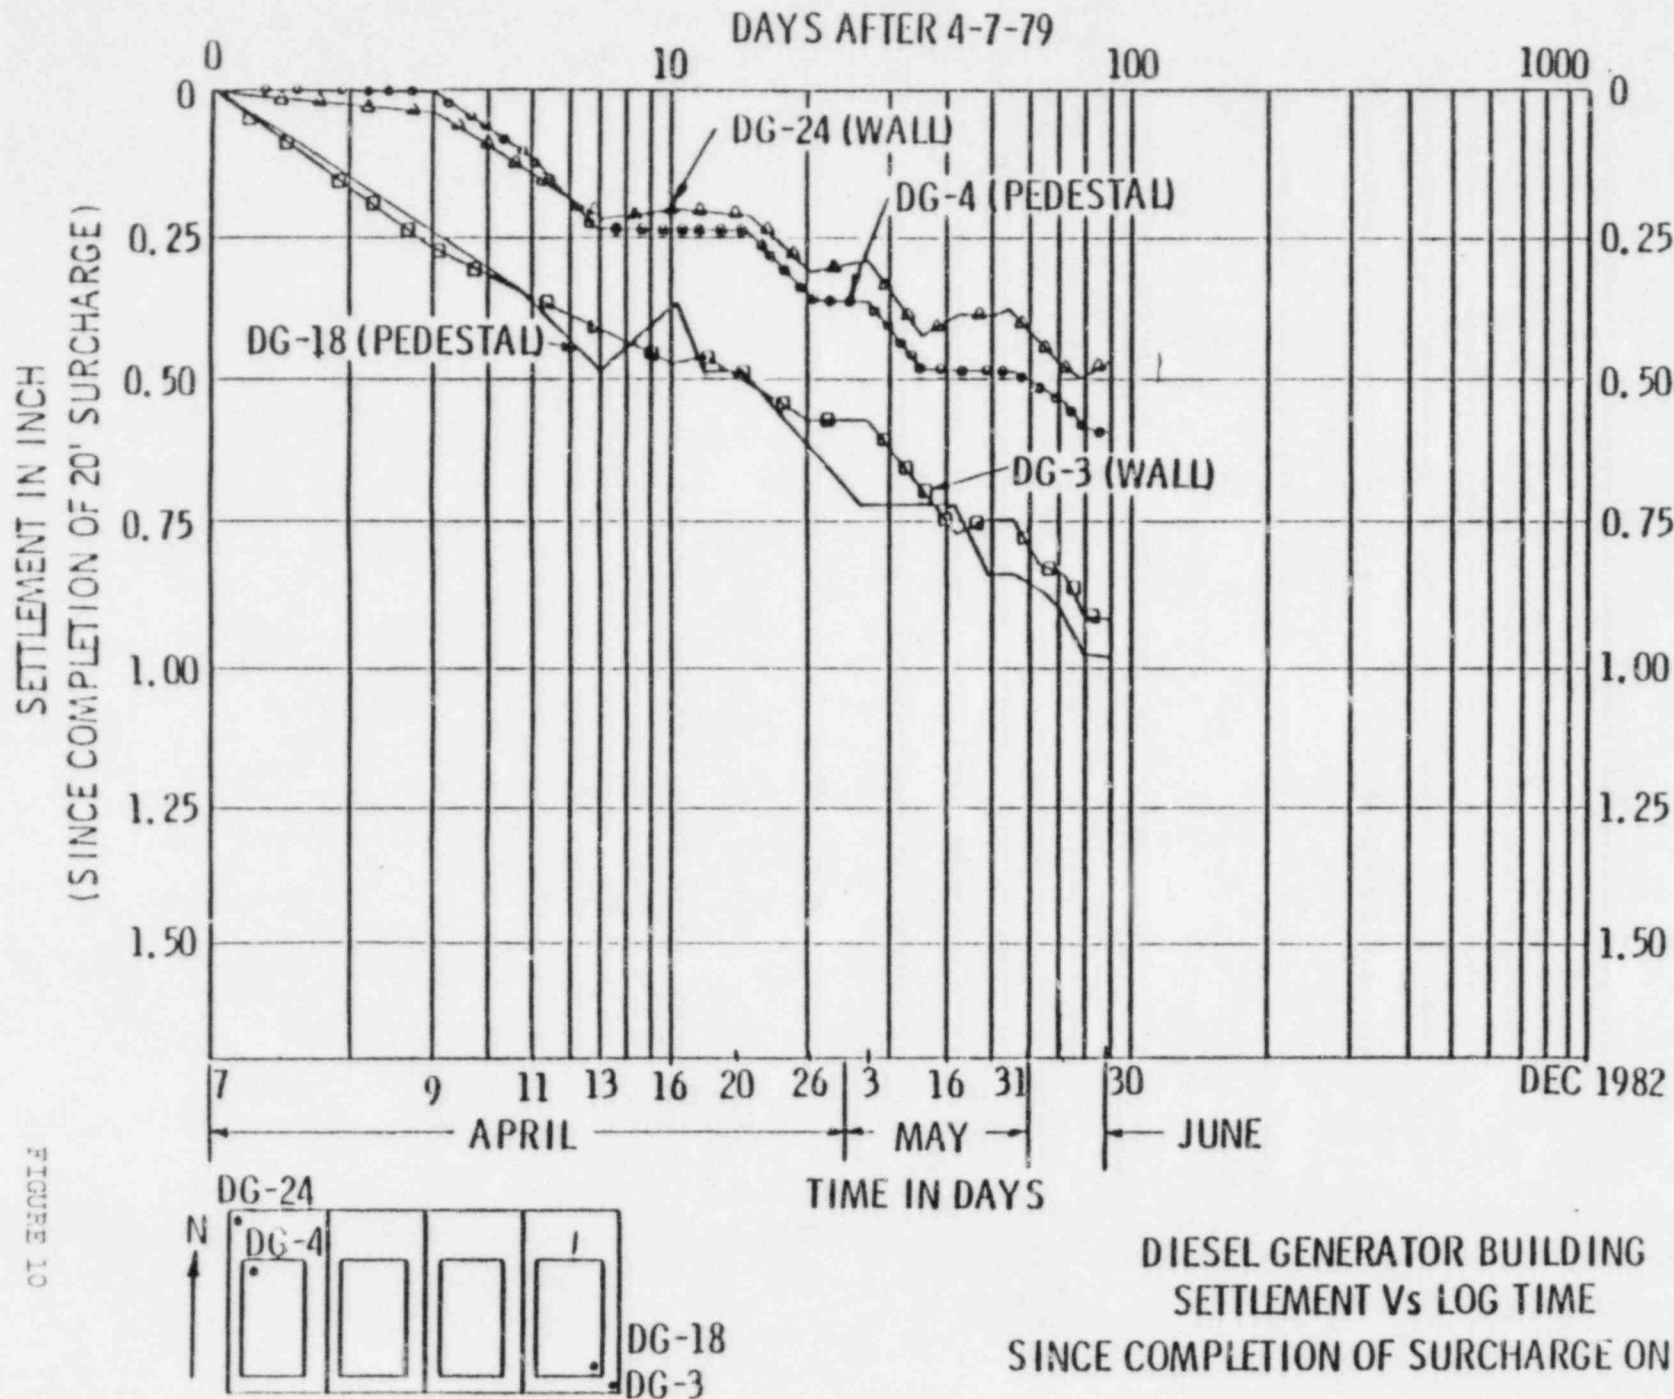
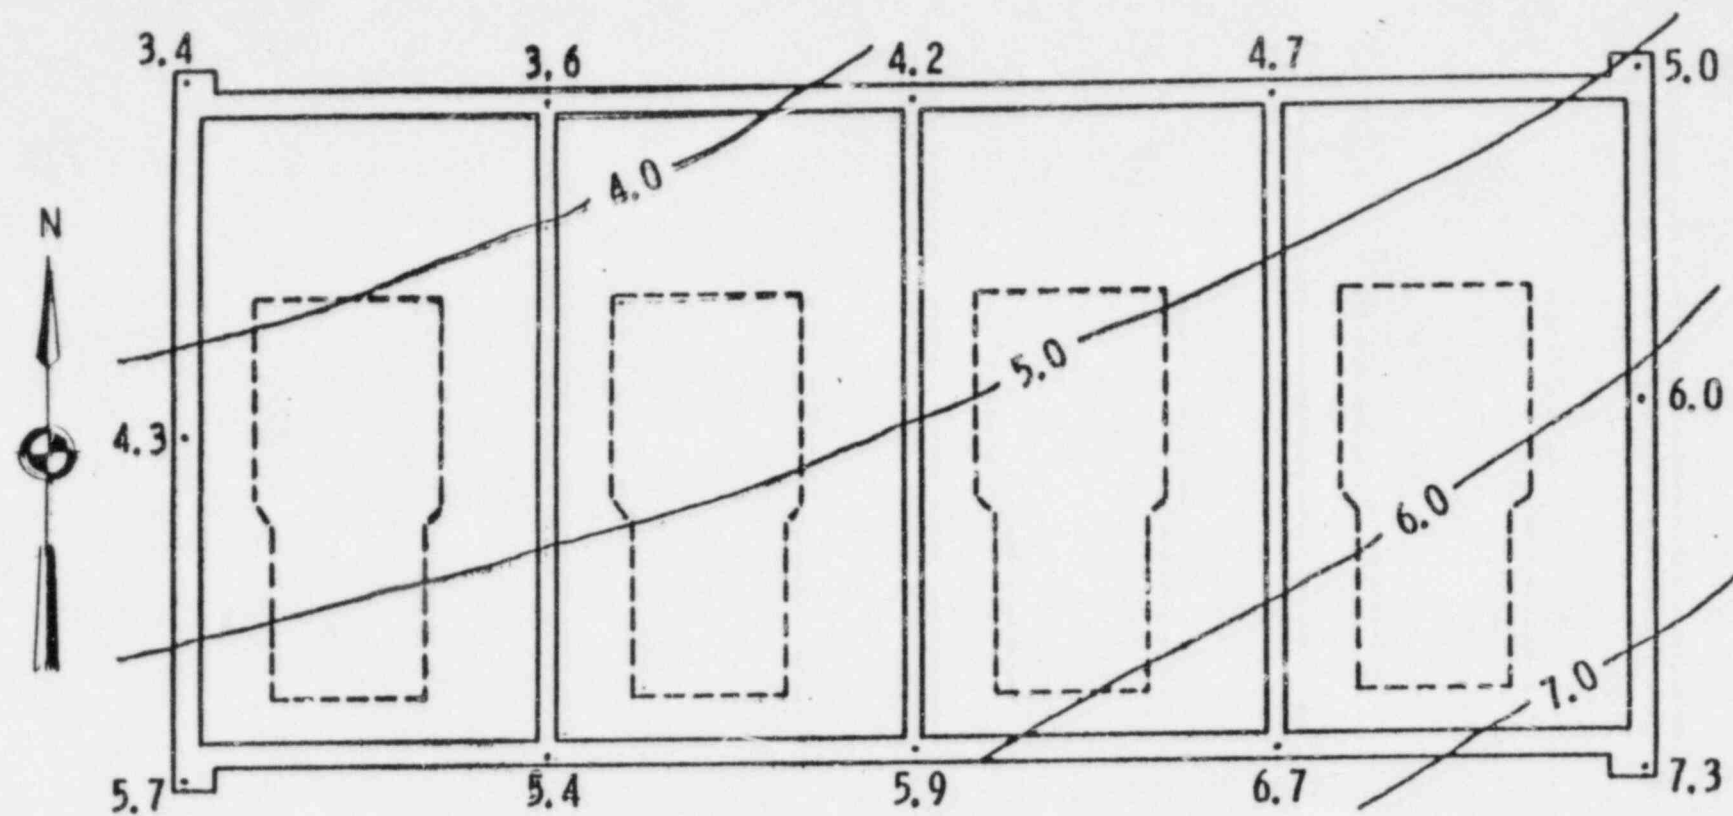
TOTAL SETTLEMENT OF WALLS FROM 7-14-78 TO 6-29-79 IN INCHES

It is very important to note that the Diesel Generator Building is the only Class I structure that was observed to have excessive settlement; however, as a result of the boring program we did find some areas with questionable soils beneath the structures. These areas were: Diesel Generator Building, Service Water Building overhang portion only, Auxiliary Building electrical penetration rooms and Feedwater Isolation Valve Pits. To correct the problems with the Diesel Generator Building it was decided to preload to consolidate the soils and accelerate the total settlement. (See Figure 6 on overall site layout of the power block.) Figure 7 shows the settlement of the four Diesel Generator pedestals vs the application of the surcharge. It can be seen that at the completion of the surcharge application the settlement appeared to be leveling out. Figures 8 and 9 show the settlement for the Diesel Generator Building. These figures are profiles looking north and looking in the east-west direction. Figure 10 shows settlement vs log time. Figure 11 highlights the elevation contours and differential settlement between the northwest and southeast parts of the structure. Figure 12 represents the various utilities beneath the building. It should be noted that the Diesel Generator Building was initially partially hung up on these utilities and that after they were freed the building settled in a more or less uniform fashion over the last few months. Figure 13 shows the location and types of instrumentation utilized to monitor the settlement of the building and instruments that were utilized during the preload program to determine when the pore pressure had decreased to normal.

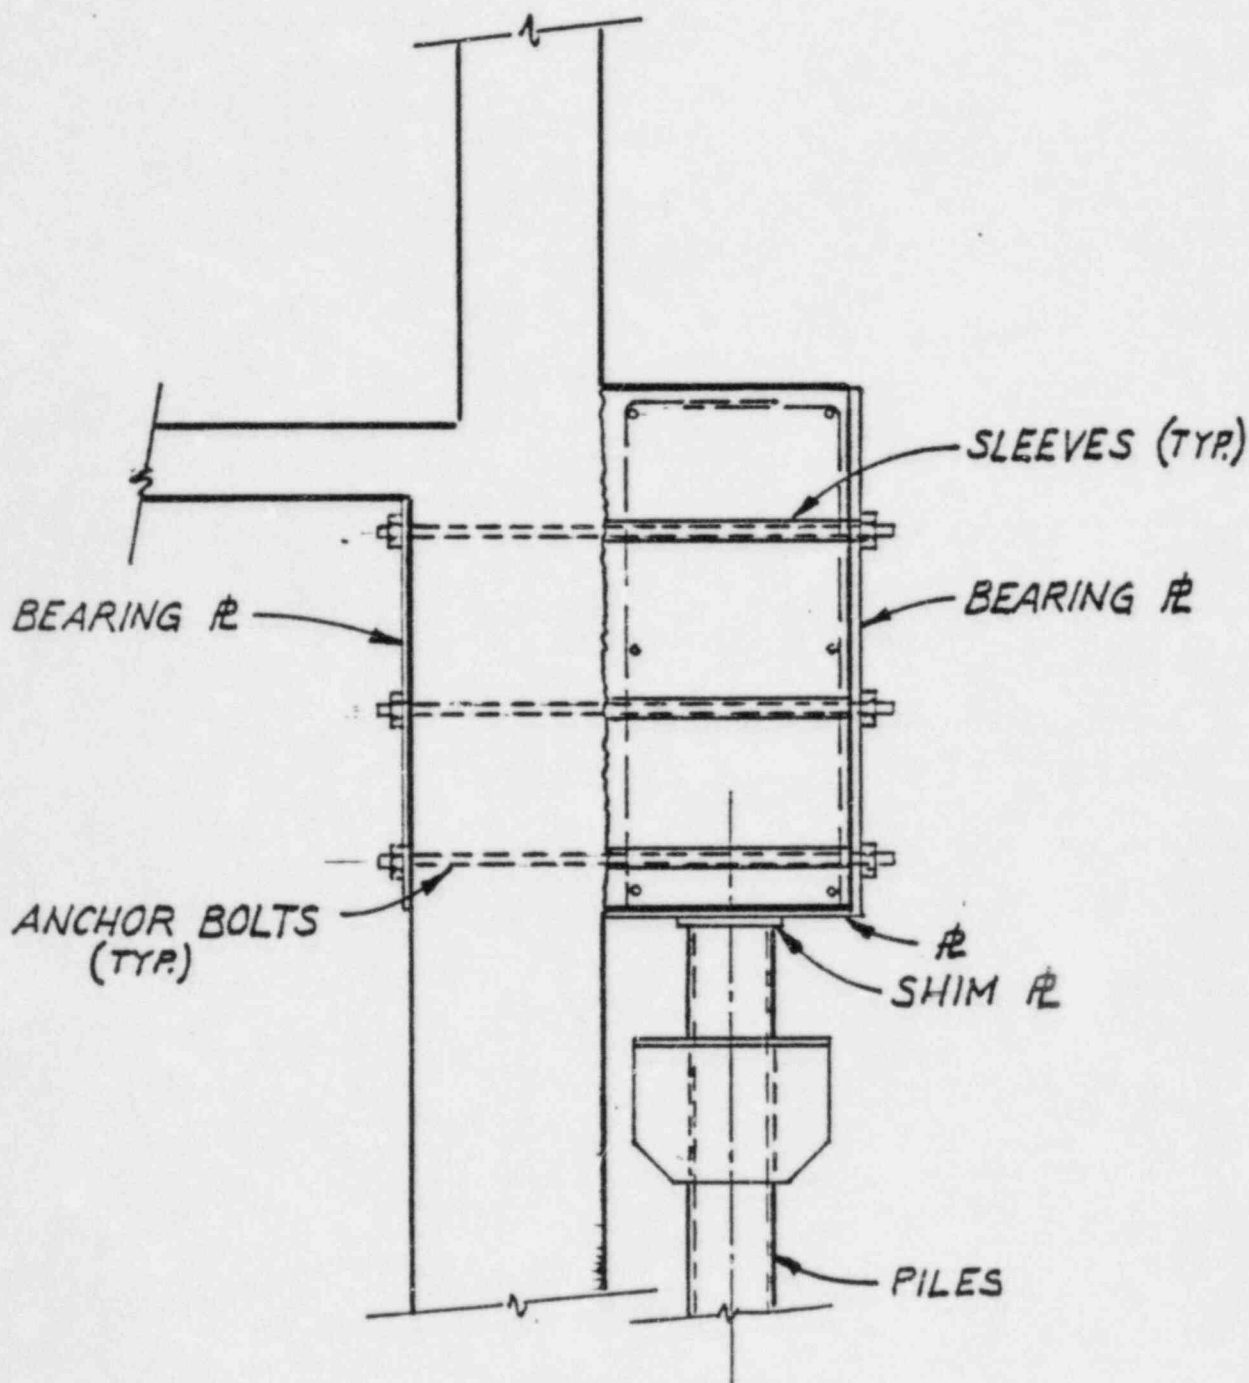
FIG.22

REDUCE CAPACITY OF A-540 BOLTS (T.S. = 105%)  
BY 25% TO ACCOUNT FOR STEEL RELAXING,  
CONCRETE CREEP AND ELASTIC SHORTENING.

As shown in Figure 22 the concrete corbels will be anchored to the wall by a system of anchor bolts. The pipe piles in turn will be jacked against the corbels to effect the transfer of load.

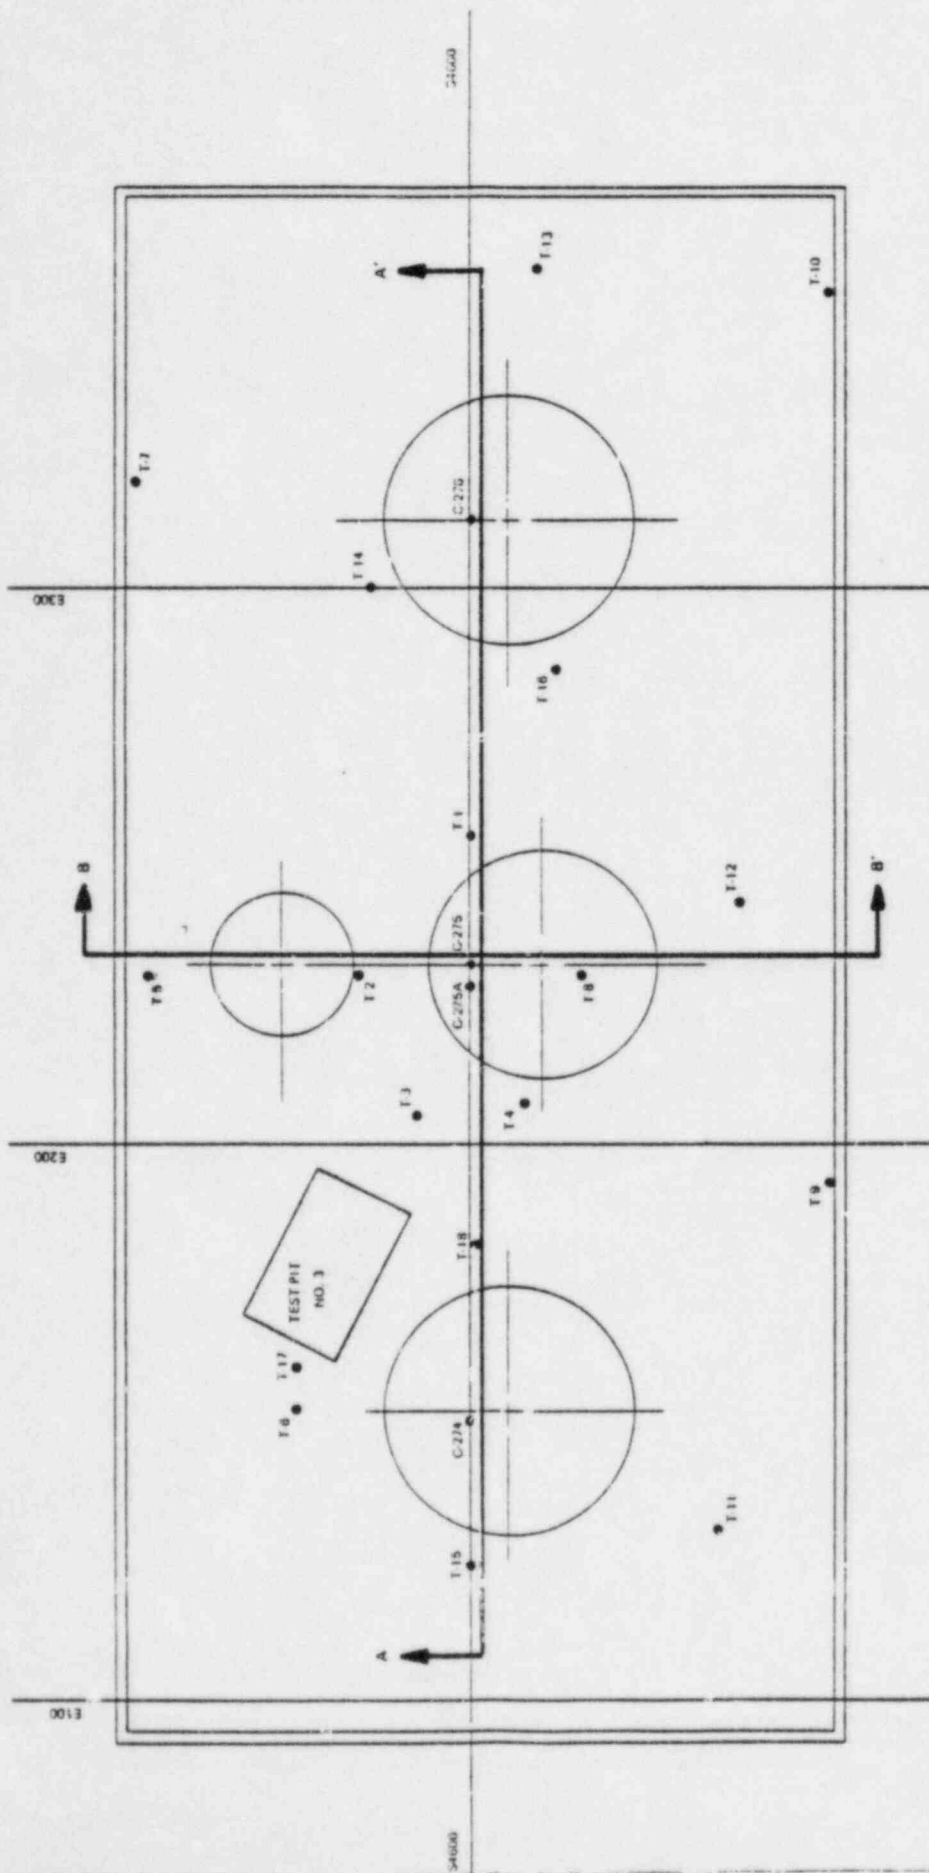
FIG.23

Figure 23 shows the tank farm in plan. There are two borated water storage tanks (BWST), a utility tank and a primary storage tank. Of these, only the BWSTs are safety-related. Each BWST has a capacity of 500,000 gallons and is 52 feet in diameter and 32 feet in height.

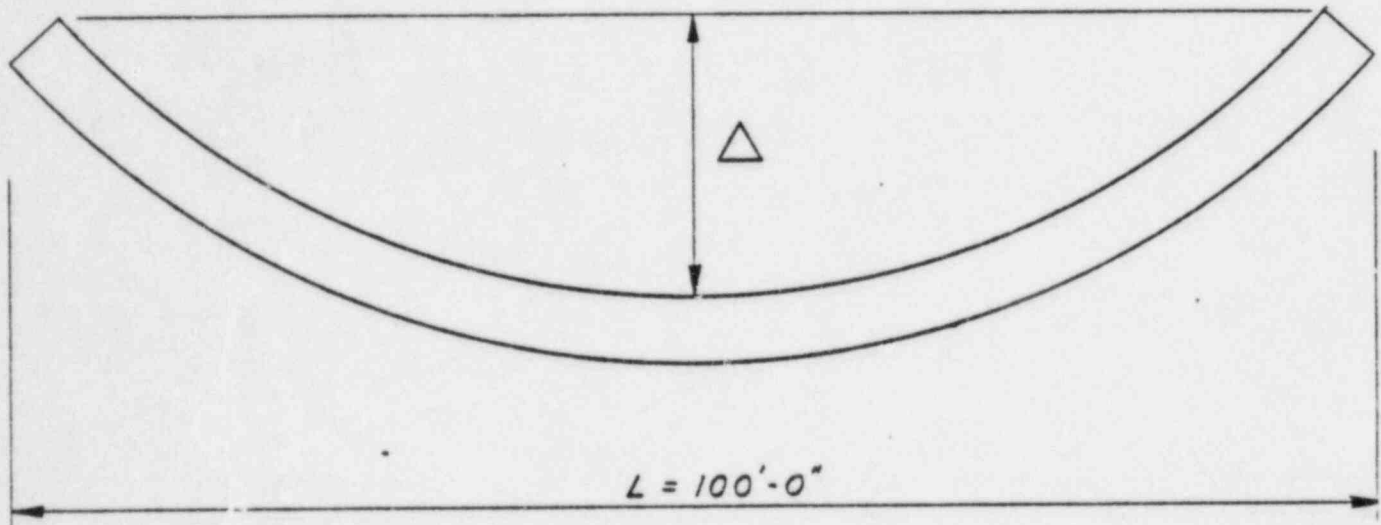
FIG.28

As shown in Figure 28, a preliminary calculation indicated that a typical duct bank of 100 feet in length can undergo a maximum of 12" of central deflection in pure bending at ultimate load.

FOR A DUCT BANK 54" x 35" DEEP  
 $\Delta$  WHEN STEEL YIELDS = 15"

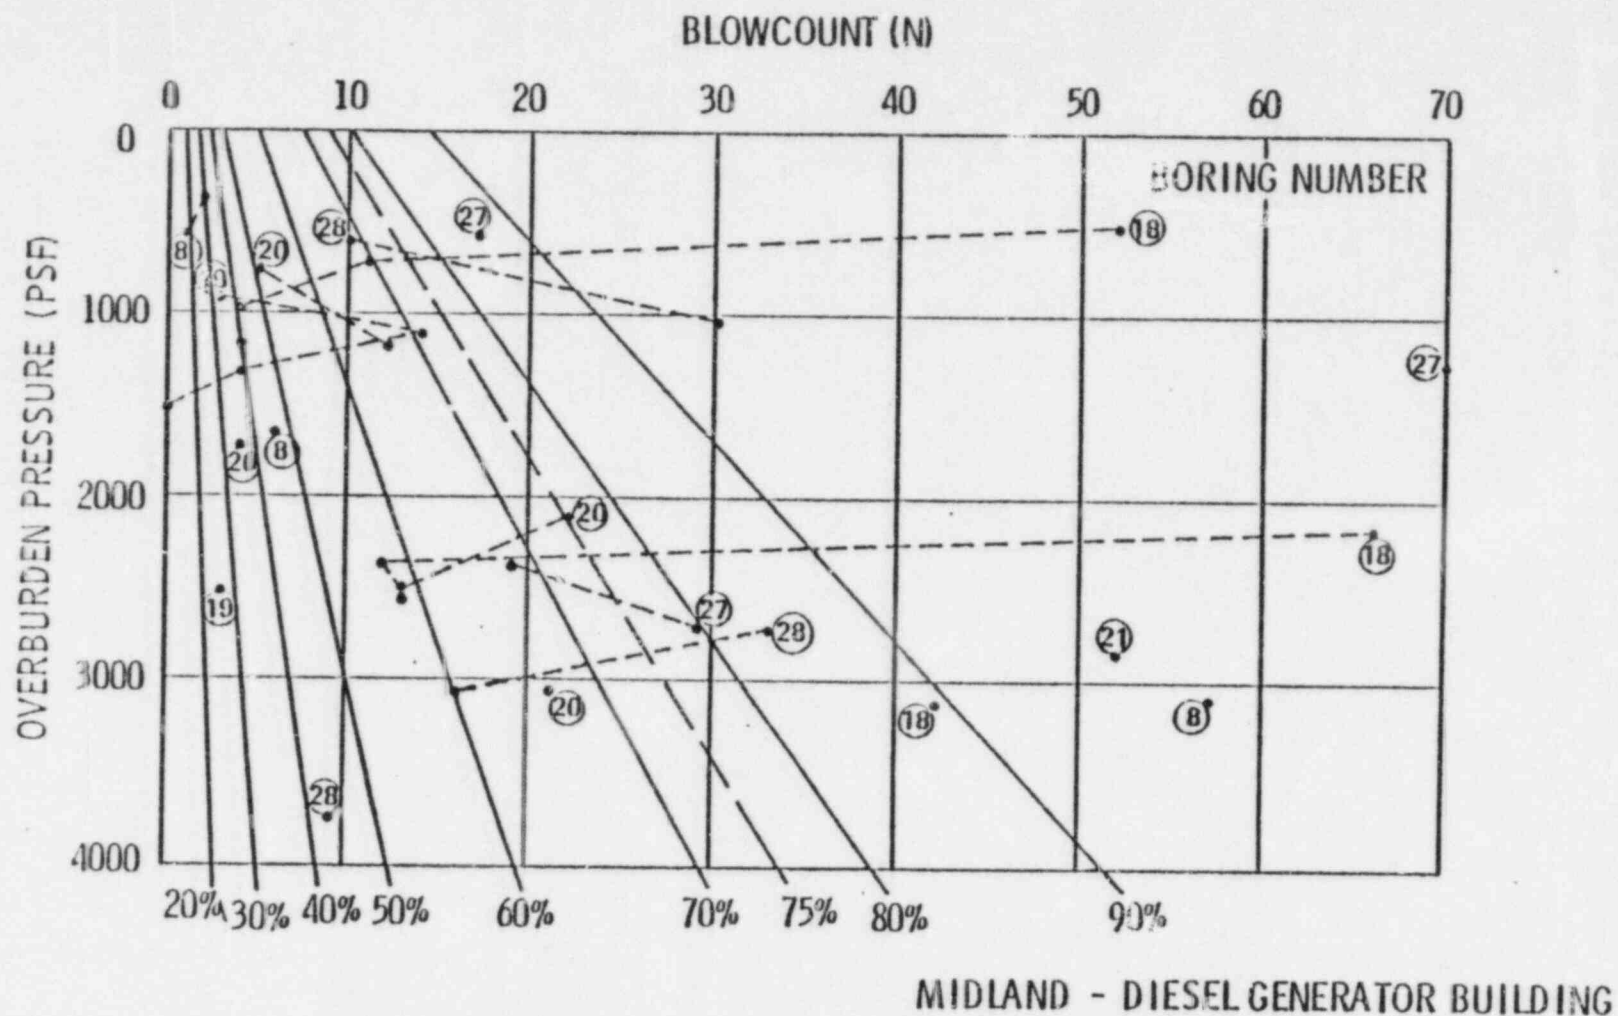
FIGURE 39B

Figure 39A illustrates that the standard penetration blowcounts from boring AX-9, AX-6 and AX-18 under the control tower indicate a factor of safety in excess of the required 1.5 in all cases. Figures 39B, C and D show the relationship between standard penetration resistance, relative density, and effective overburden pressure for the three areas indicated.

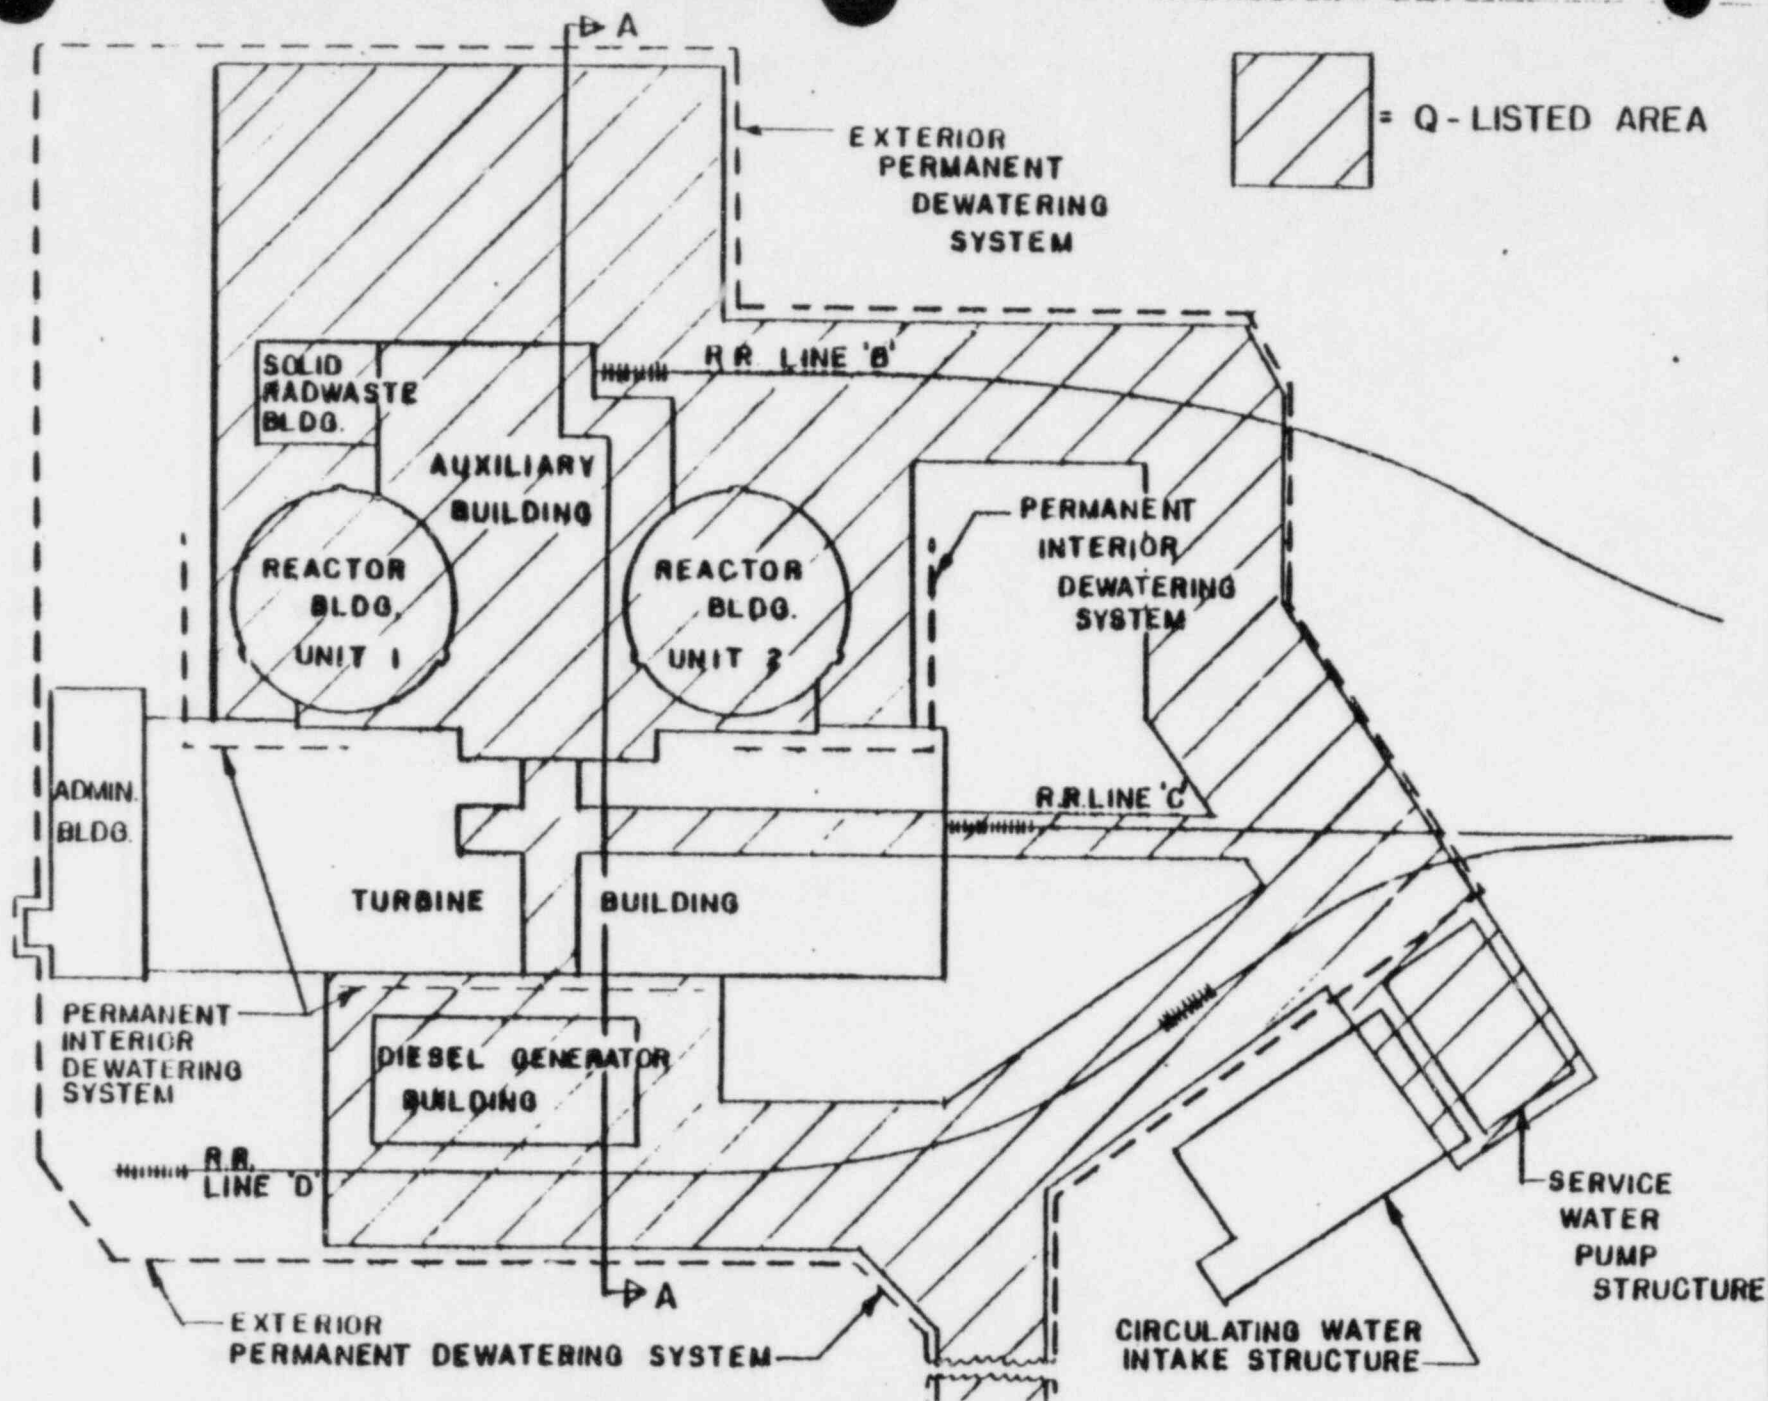
FIGURE 40

Figure 40 is a Plan View of Area Dewatering System. The soil as described before by others generally consists of sand and or clay fill placed on the original sand or clay strata. The original sand generally extends from elevation 570 to elevation 600 with clay beneath the sand - though in a few areas the underlying clay extends to the original ground surface.

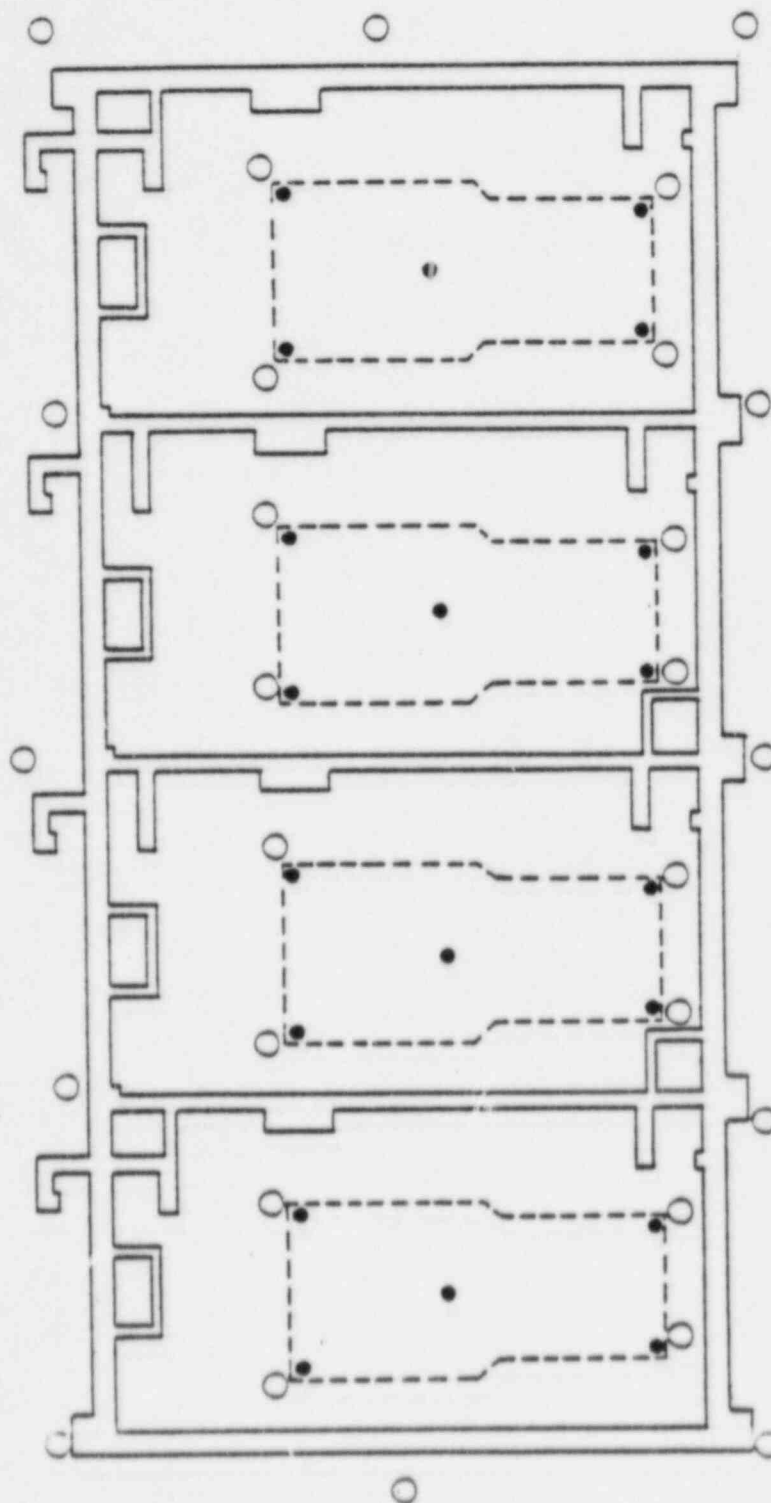
BUILDING AND PEDESTAL MOVEMENT  
MONITORING EQUIPMENT  
DIESEL GENERATOR BUILDING

Figures 50 through 53 illustrate locations of the various instruments associated with the preload program. Figure 50 shows the locations of building survey settlement markers and pedestal settlement rods. Figure 51 shows the location of surface settlement plates and borros anchors installed in the fill primarily at three different elevations to monitor the movement of the soil as a result of the surcharge. The figure also shows locations of 4 deep (elev 535) borros anchors installed for use as reference points for the precise measurements during secondary compression where the movement has subsided to a very small rate. Figure 52 illustrates locations of piezometers installed primarily at three different elevations below the building to monitor the dissipation of pore water pressure during consolidation. Figure 53 illustrates the locations of Sondex instruments intended for measuring soil rebound in order to estimate the modulus of elasticity below the building to check the range used in dynamic analysis.

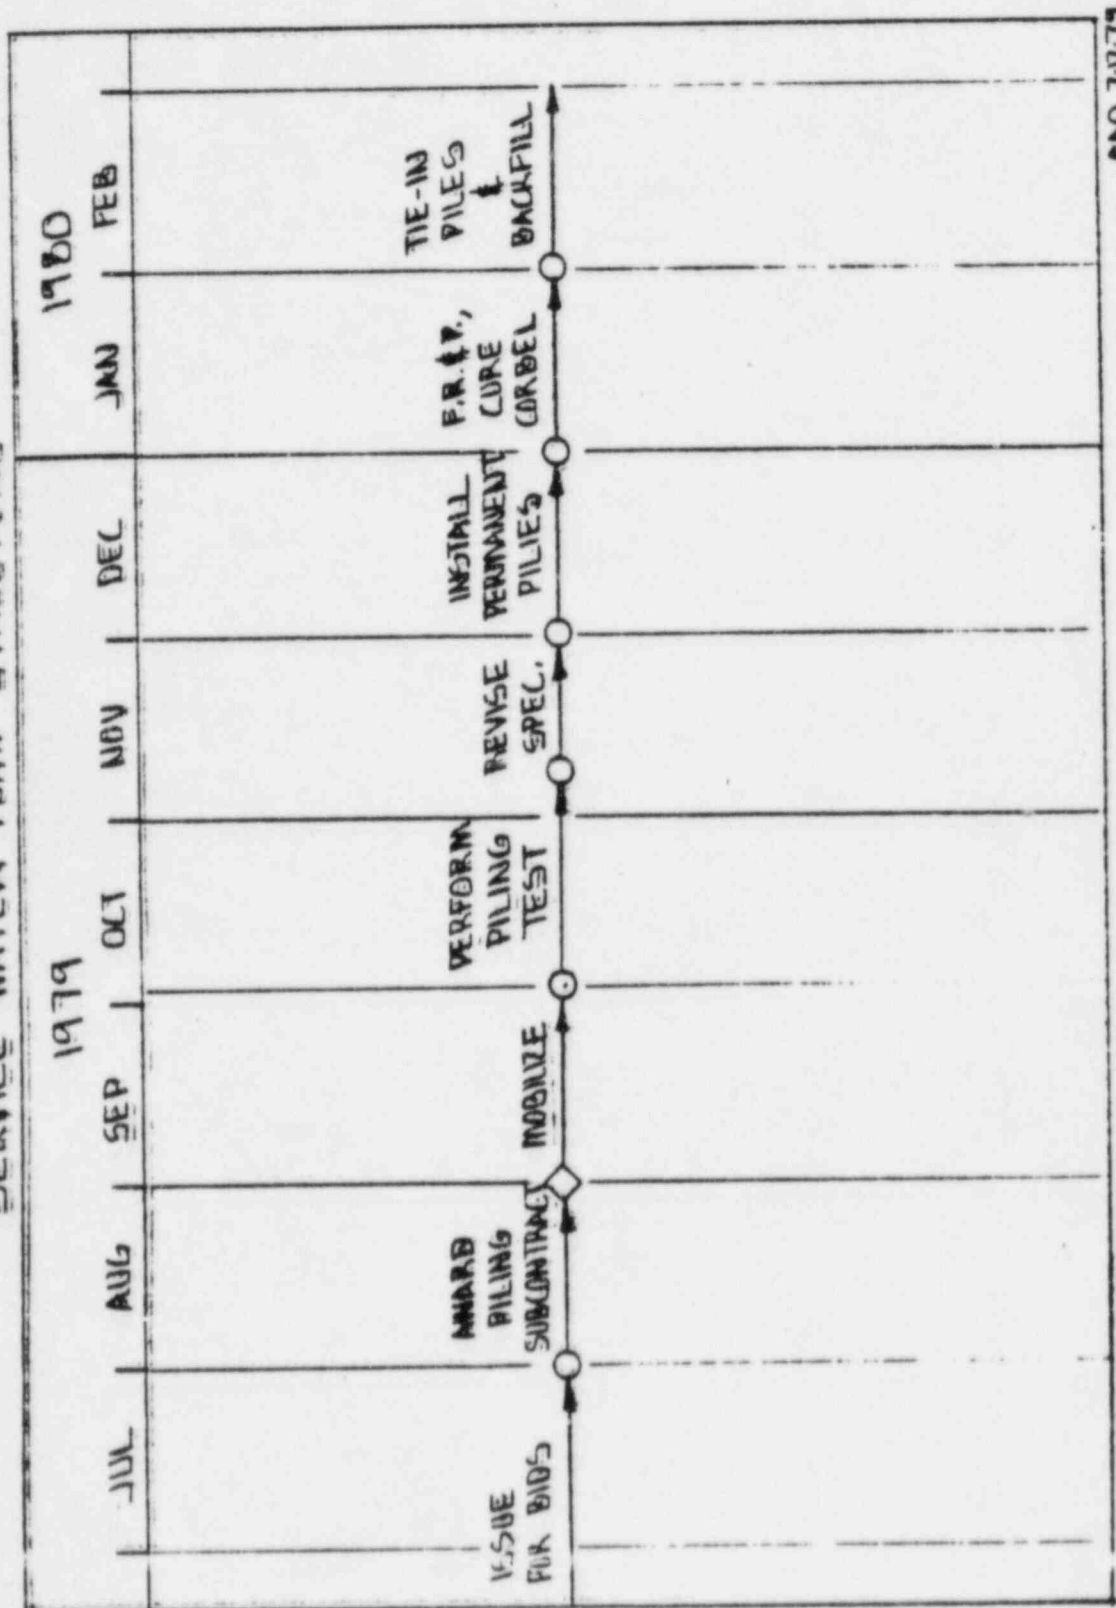
FIGURE 57

Figures 57 through 60 show the schedules of the four major remedial activities. The work on bearing piles for the Service Water Pump structure (Figure 57) will commence as soon as the administrative activities were completed, probably this fall, and should be completed sometime in early 1980. Since this is an independent activity it is expected to have no impact on the overall project schedule.
