MEETING WITH NRC ON MIDLAND PLANT FILL STATUS AND RESOLUTION

July 18, 1979

NRC, Bethesda, Maryland

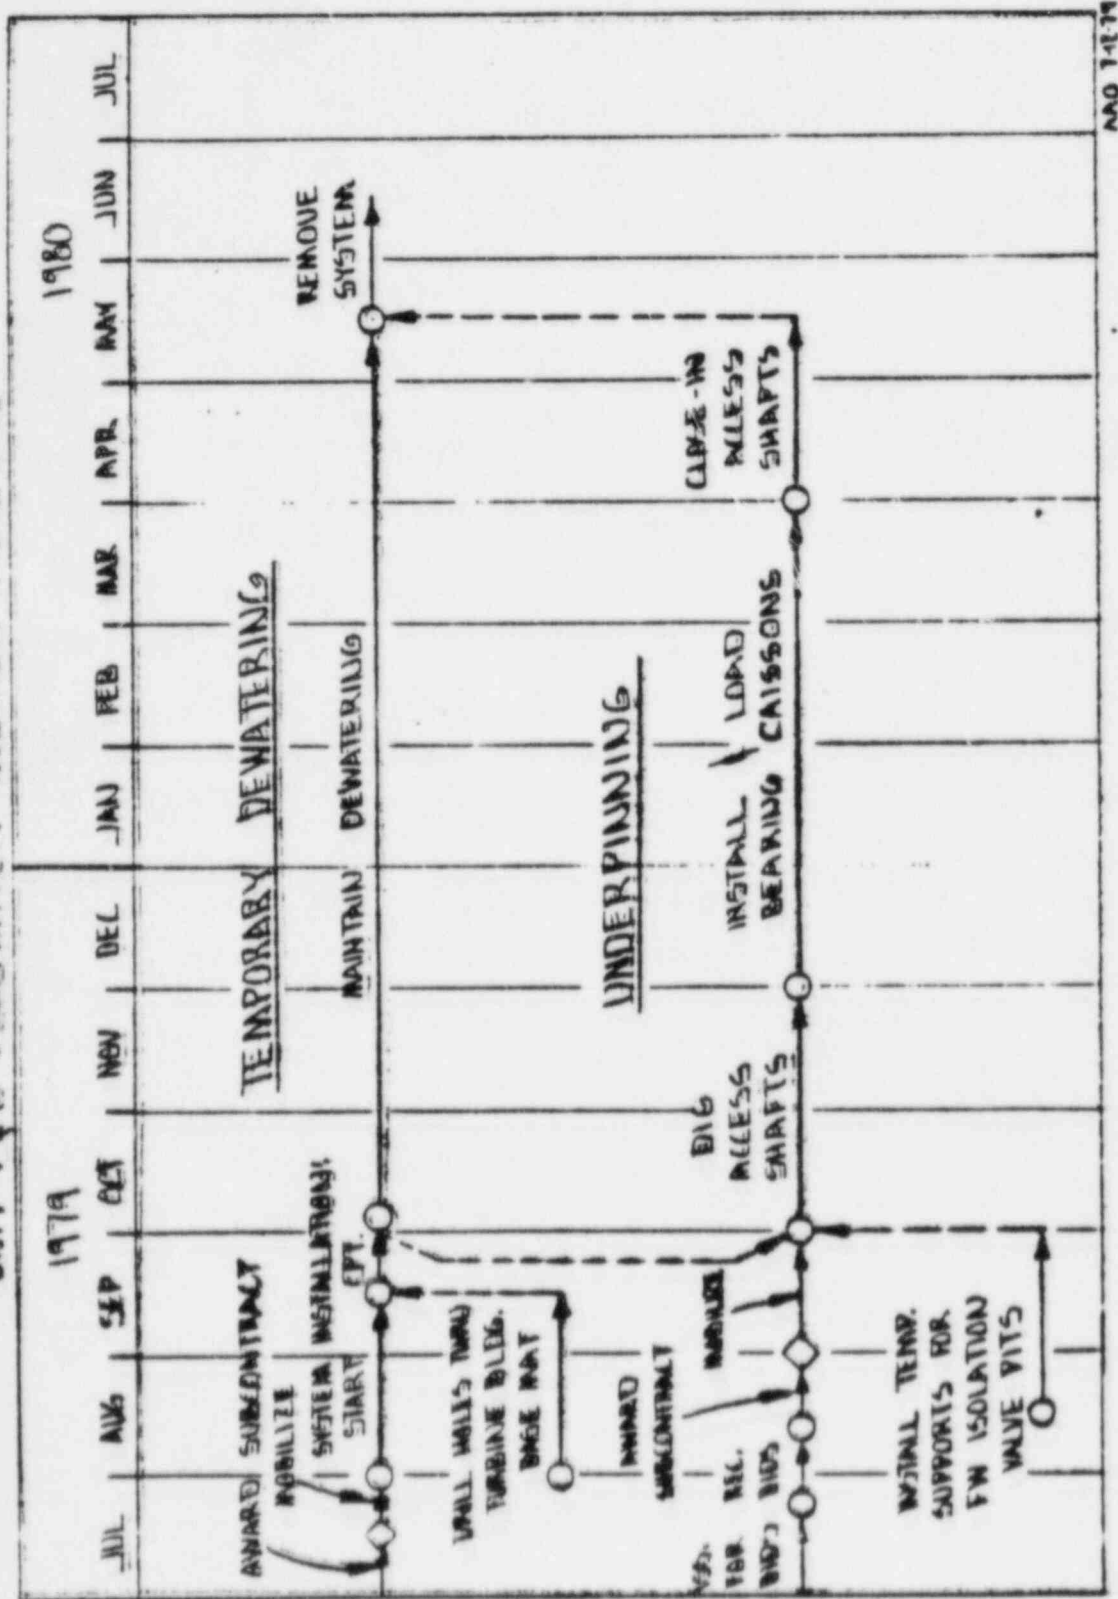
FIGURE 58

Figure 58 covering the Unit 1 and 2 Auxiliary Building Electrical Penetration areas and the Unit 1 and 2 Feedwater Isolation Valve Pits indicates that this work should complete about mid 1980; however, the actual schedule would probably extend 2-3 months beyond the dates shown. Again this is a separate activity and would not have an impact on the overall project schedule; however, it should be noted that this work would probably cause some additional work for construction due to congestion in the areas where other activities were taking place. It is not expected to be a major problem.

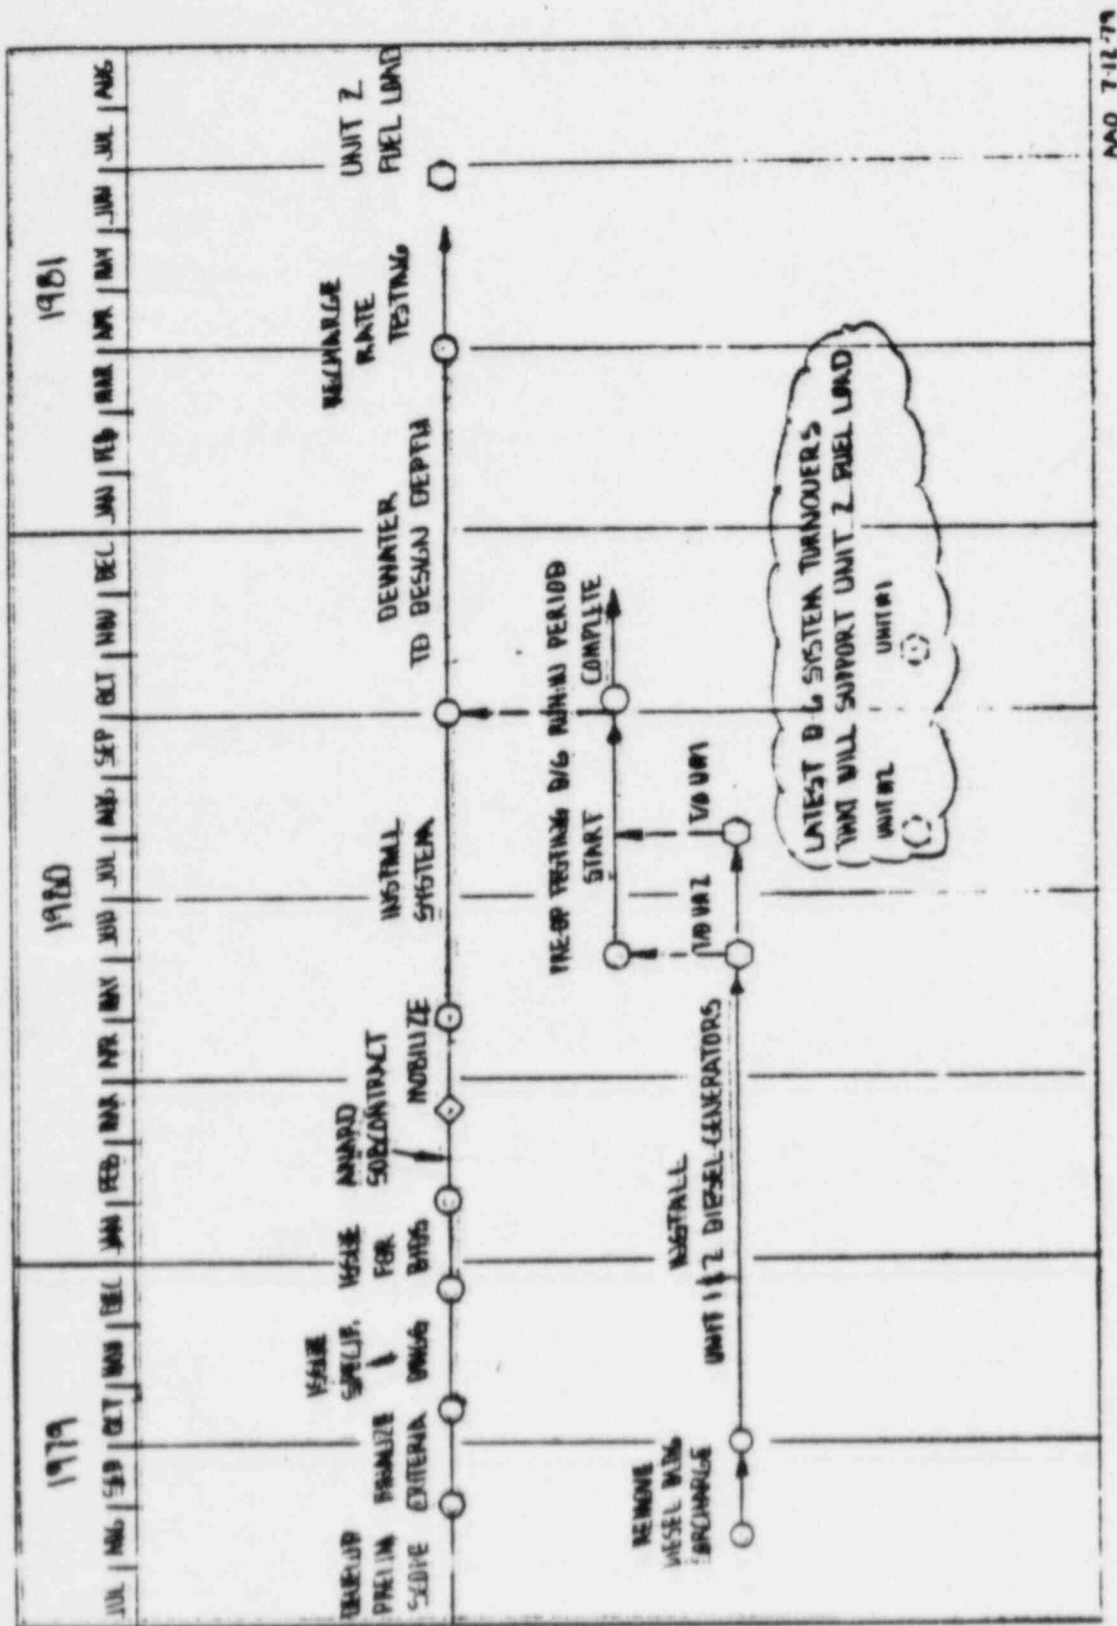
FIGURE 60

Figure 60 shows the permanent plant dewatering system. We had previously informed the NRC that because of the preloading activities there could be an overall impact of two months on the project schedule. At this time, because of a revised testing philosophy, the Unit 1 and 2 Diesel Generator turnovers need not take place until November of 1980 and August of 1980 respectively. This actually allows some float time in the schedule.

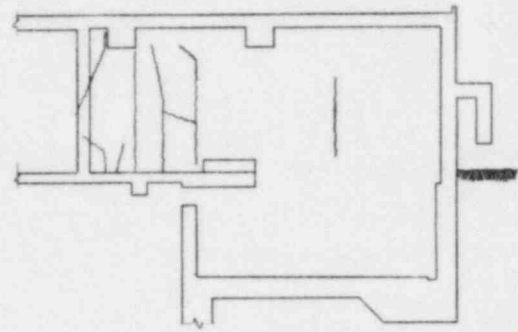
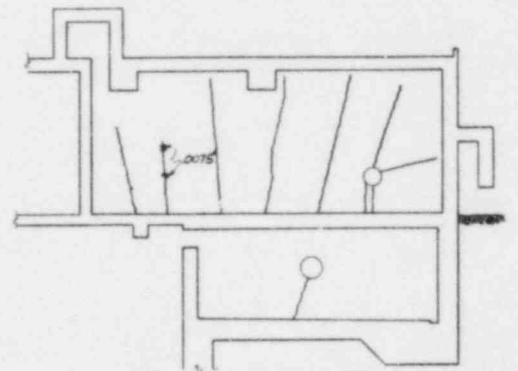
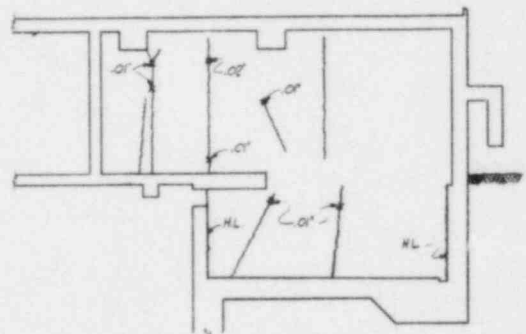
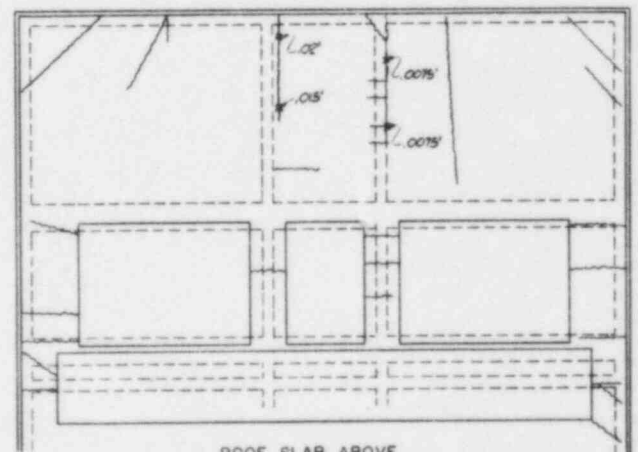
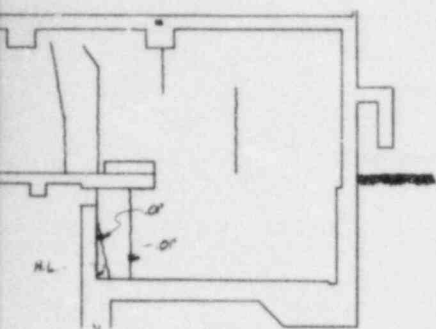
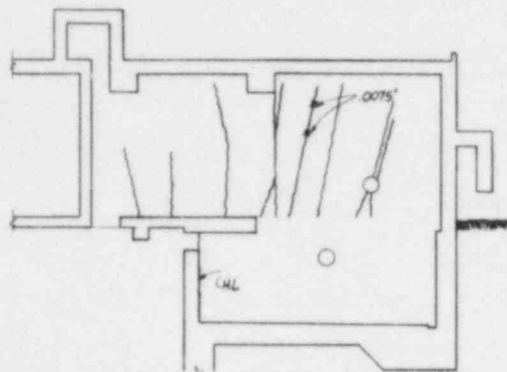
- 1. ALL CRACKS ARE HAVING OR LESS THAN .005" THICK UNLESS NOTED
