**VIRGINIA ELECTRIC AND POWER COMPANY**  
**NORTH ANNA POWER STATION UNITS 1 AND 2**  
**SERVICE WATER GROUNDWATER SPECIAL REPORT**

SERVICE WATER GROUNDWATER  
LEVEL EVALUATION

SERVICE WATER RESERVOIR GROUNDWATER  
LEVEL EVALUATION

NORTH ANNA POWER STATION

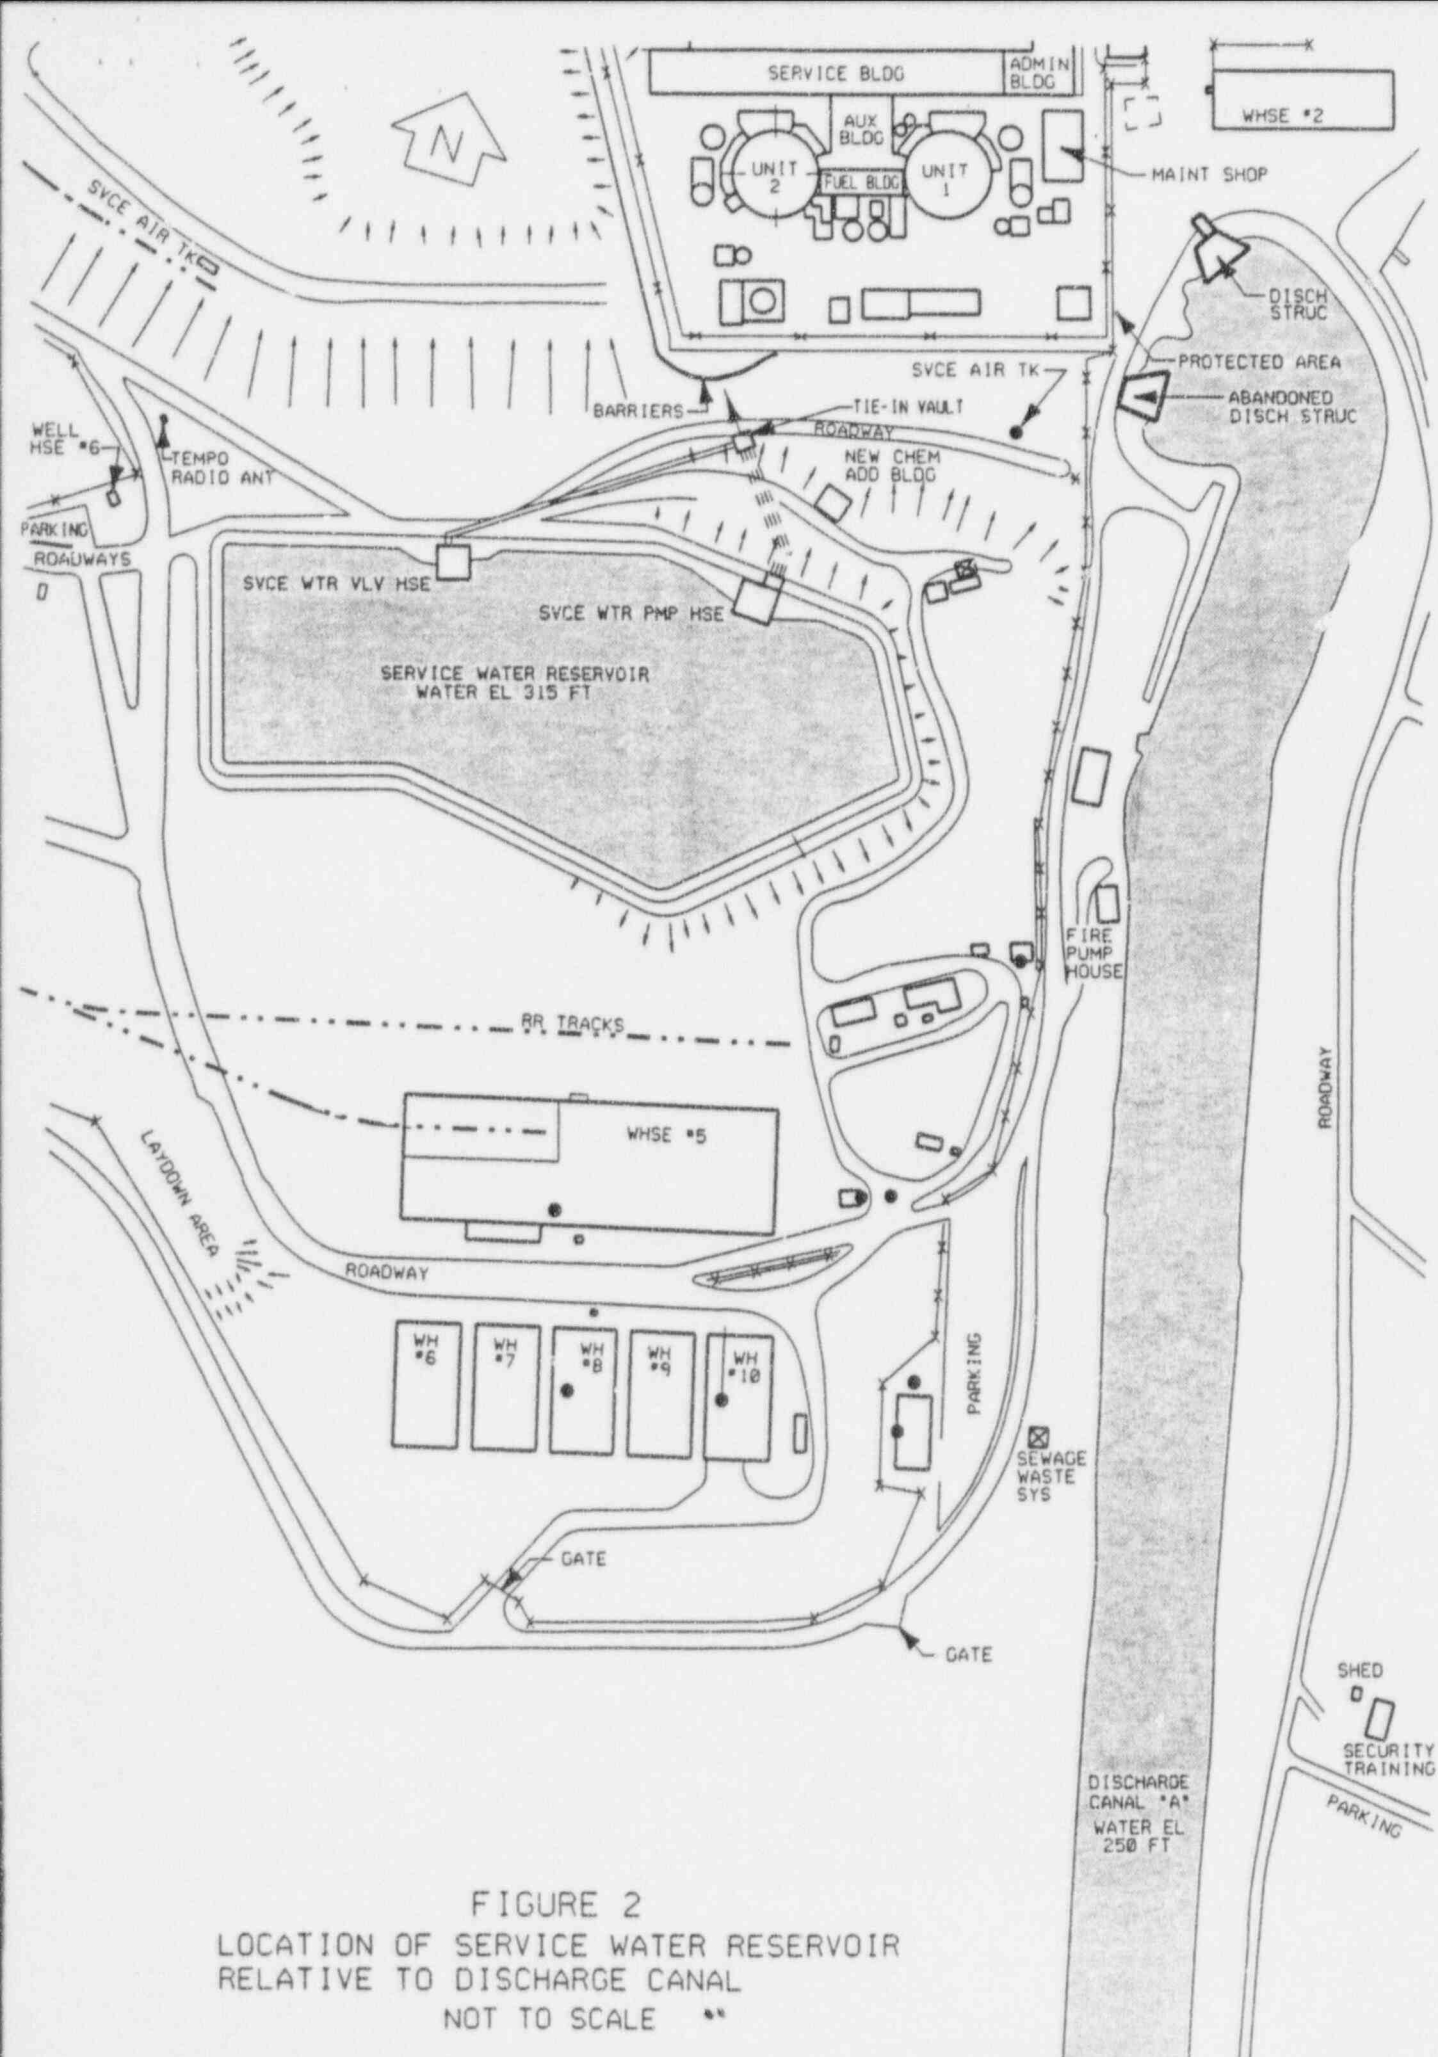
FIGURE 2  
LOCATION OF SERVICE WATER RESERVOIR  
RELATIVE TO DISCHARGE CANAL  
NOT TO SCALE

would result in less water being discharged from the area near the SWR towards the lake and more water build-up under the SWR. The location of the discharge canal which is a part of the lake and the SWR are shown on Figure 2.
